Pima Environmental Services, LLC  
1601 N. Turner Ste 500  
Hobbs, NM 88240  
575-964-7740

June 3, 2021

**Re: Site Remediation and Closure Report  
Diamond PWU 22 #11H  
API No. 30-015-42809  
GPS: Latitude 32.645343 Longitude -104.071826  
UL "I", Sec. 21, T19S, R29E  
Eddy County, NM  
NMOCD Ref. No. NAPP2105355033  
Pima Project No.: 1-73**

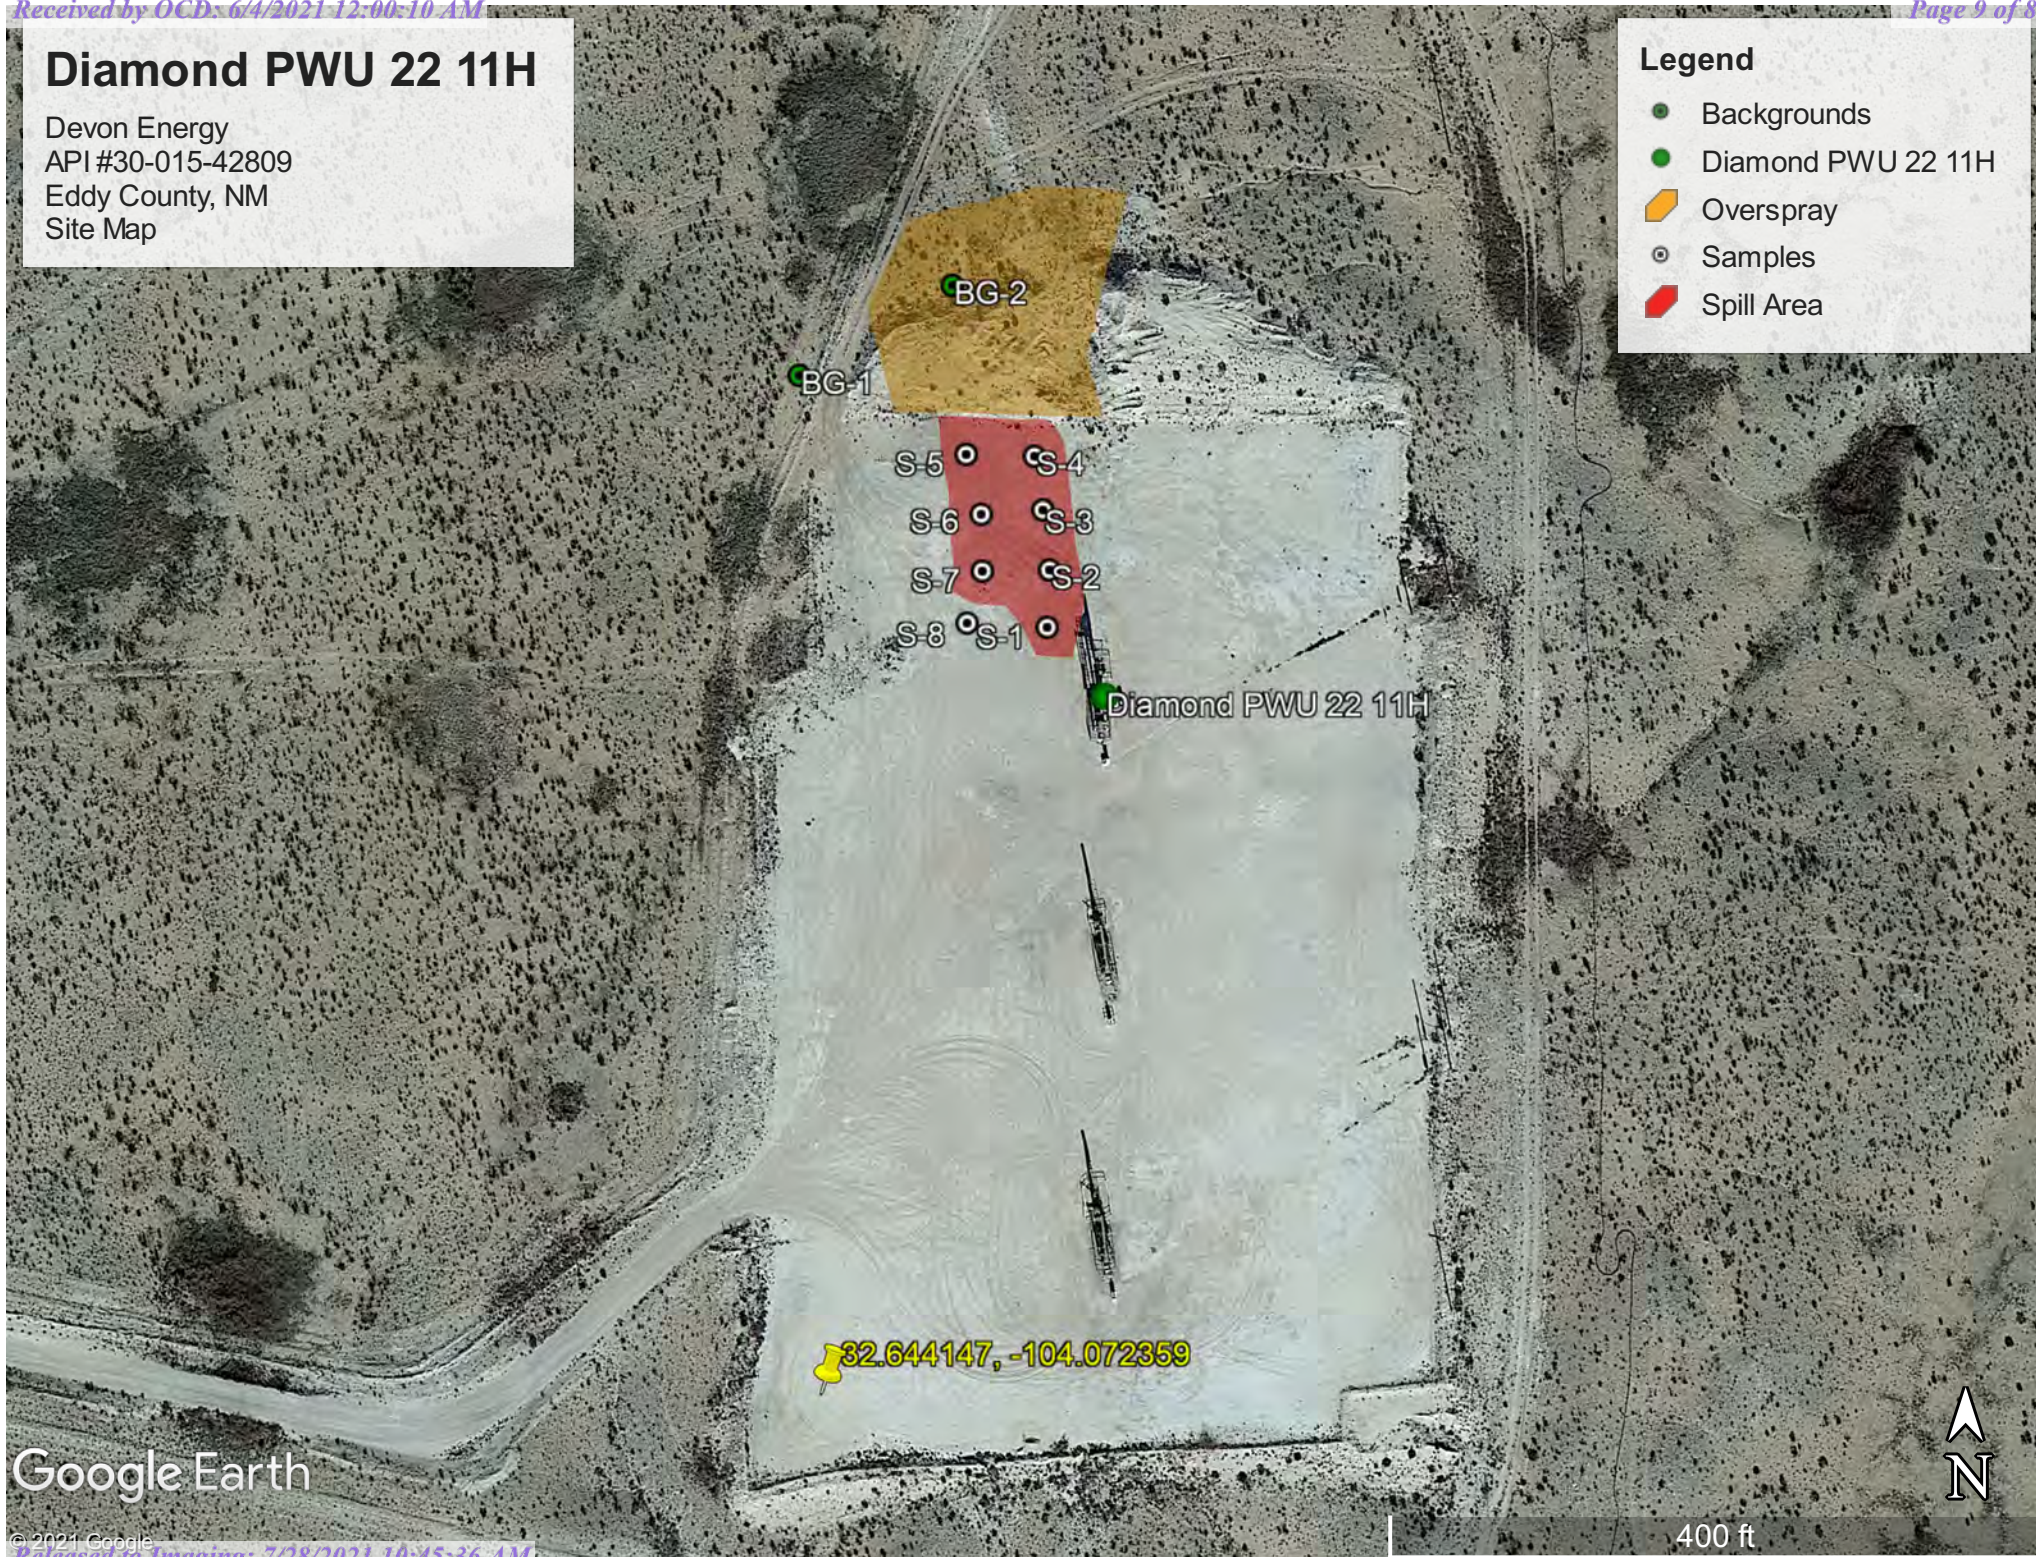
4 - Site Map

Devon Energy  
API #30-015-42809  
Eddy County, NM  
Site Map

- Backgrounds
- Diamond PWU 22 11H
- Overspray
- Samples
- Spill Area

On March 17<sup>th</sup>, 2021, Pima mobilized personnel and equipment to conduct remedial activities. We tilled and worked the entire affected area on the pad to a depth of 12"-18", then treated with a bio-remediation chemical solution. This process was repeated twice more to make sure all the contaminated soil could be neutralized with this treatment. The pasture that was affected by an overspray was treated topically with a bio-remediation chemical solution. Photographic documentation can be found in Appendix D.
