Release Notification

RE: Closure Report
Incident ID: nAPP2109056450
AEP #: 20210109-0245-112934
Location: BLM Lease Road # 112934

AEP #:	20210107-2100-unknown 20210109-0245-unknown
Location:	Lease Roads & Abe #001
RE:	Suspect unauthorized discharges by unknown operator

Executive Summary

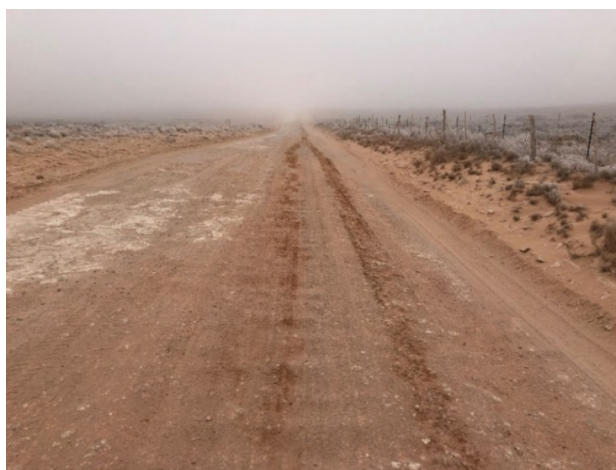
AEP's environmental team identified suspect unauthorized discharges upon arriving to the AEP lease the morning of January 9th (Figure 1). The environmental team proceeded to track the suspect unauthorized discharges using GPS technology and the ArcGIS Collector mapping application. Plate 1 shows the observed suspect unauthorized discharge that occurred along a segment of the lease road on AEP's Federal lease NMNM 112934. The length of the release along AEP's lease road is 0.5 miles and is located in Unit Letter A & H, T21S R32E Sec 25; with a coordinate midpoint at 32.4534958°, -103.6199454. The release area was located on the right-of-way as shown on Figure 1.

Figure 1: Suspect unauthorized discharge along the north/south lease road; viewing north. Time/Date: 2021-01-09 08:41:09. GPS: 32.4751778 N, 103.6201083 W.

After collection of hand auger samples, the surface was restored per 19.15.29.13 NMAC as a lease access road right-of-way for oil and gas operations.

Characterization sample results exhibited concentrations below the most stringent closure criteria listed in Table 1 of 19.15.29 NMAC. No remediation is necessary and we respectfully ask NMOCD for closure of the regulatory file.

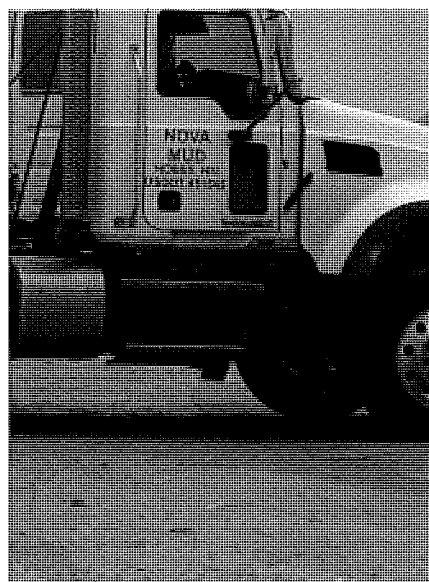
AEP personnel observed produced water transporting activities later in the afternoon of January 9th (Exhibit 1) from the Marathon Battle 34 Federal #4 lease.

*Exhibit 1: Produced water transport activities on the Marathon Battle 34 Federal #4 lease.
Date/Time: 2021-01-09 15:28:39.
GPS: 32.4434250 N, 103.5660167 W*

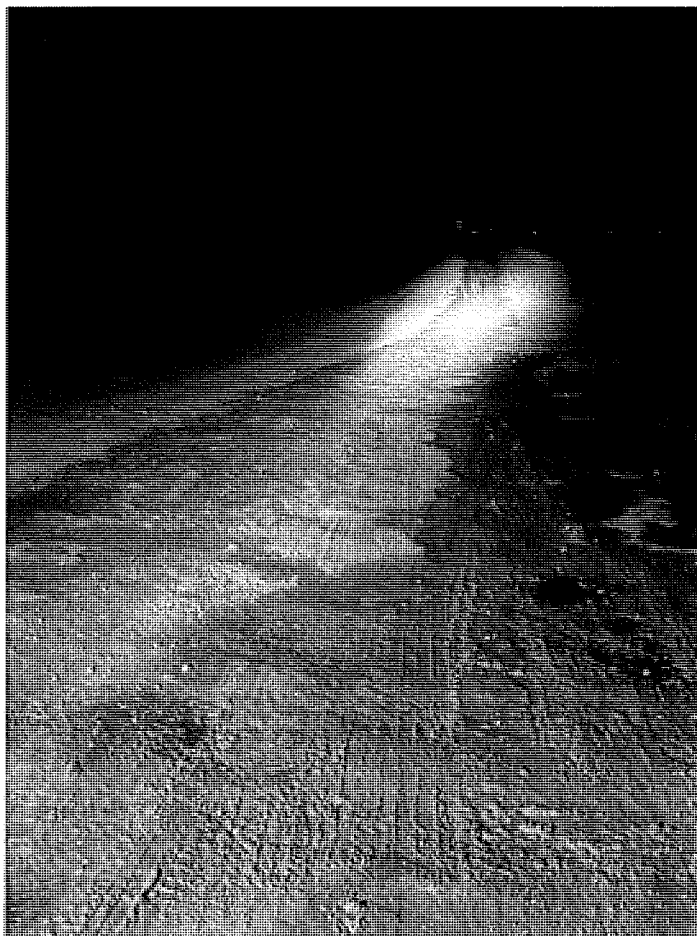
Figure 1, below, shows the suspect discharge "West of cattle guard to Dagger State offices" captured by the night crew.

Figure 1: Suspect unauthorized discharge at "West of cattle guard to Dagger State offices". Photo is viewing south along the north/south lease road in Sec. 31; T21S.R33E. Date/Time: 2021-01-07 21:47:18. GPS: 32.4511111 N, 103.6200000 W (approximate)

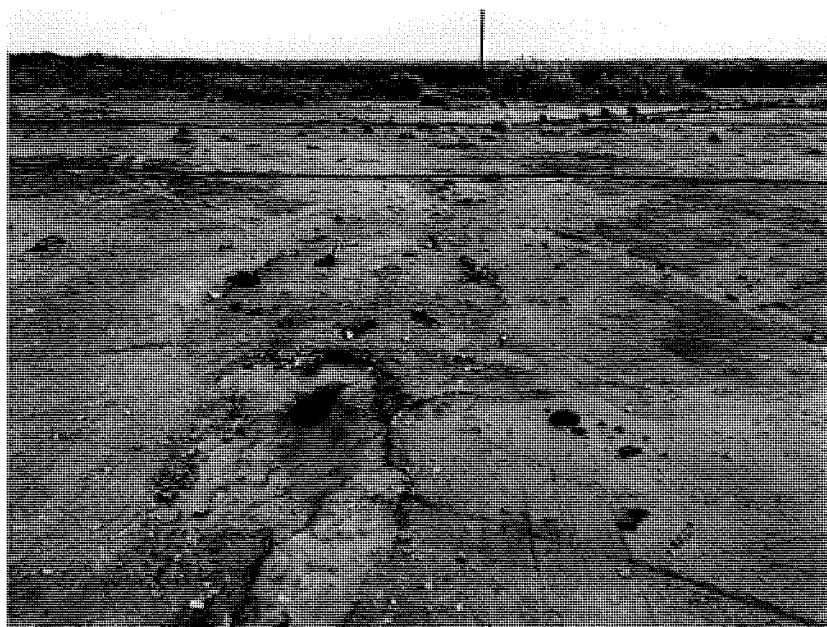
Figure 4: Suspect unauthorized discharge at the AEP lease Abe #1. Photo is viewing north from the discharge point (foreground). Wet soil defines the release extent. Date/Time: 2021-01-09 11:20:41. GPS: 32.4447250 N, 103.5756750 W.

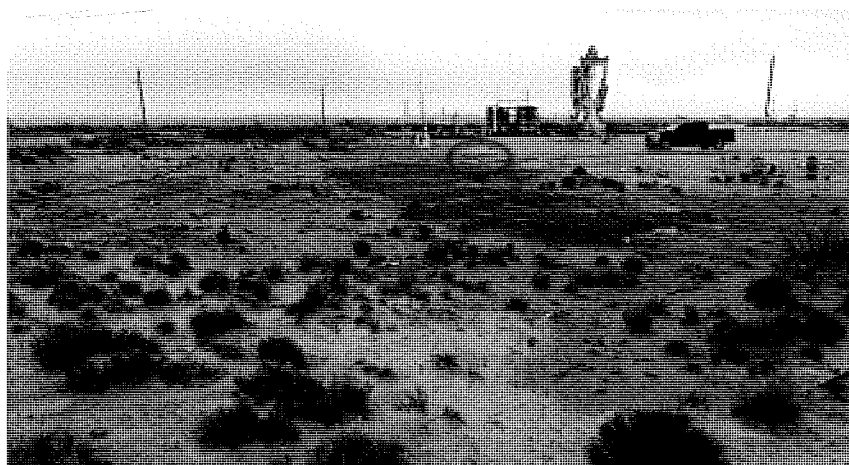
Figure 5: Suspect unauthorized discharge at the AEP lease Abe #1. Photo is viewing east-southeast from the northwestern extent. The red circle identifies the discharge point. Wet soil defines the release extent. Date/Time: 2021-01-09 11:22:29. GPS: 32.4446528 N, 103.5762333 W

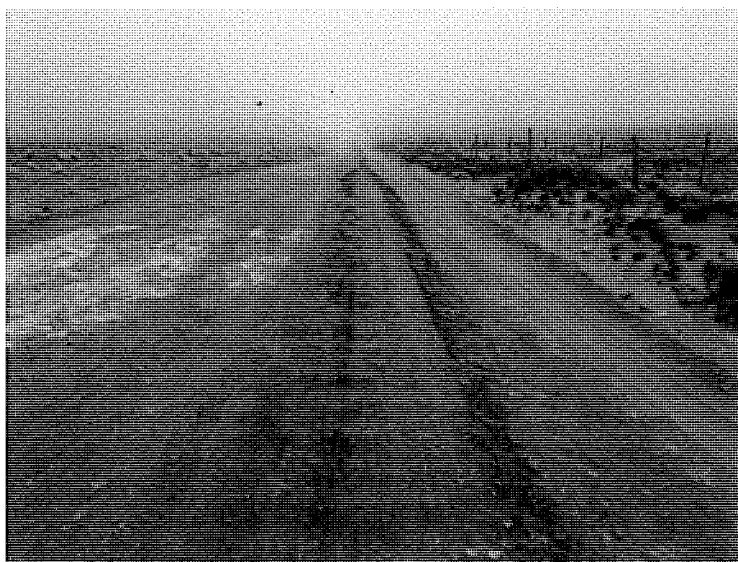
1. The track along the north/south lease (Figure 6) that turned east at the Tomahawk SWD.

Figure 6: Suspect unauthorized discharge along the north/south lease road; viewing north. Location of photo is plotted on Plate 3. Time/Date: 2021-01-09 08:41:09. GPS: 32.4751778 N, 103.6201083 W.

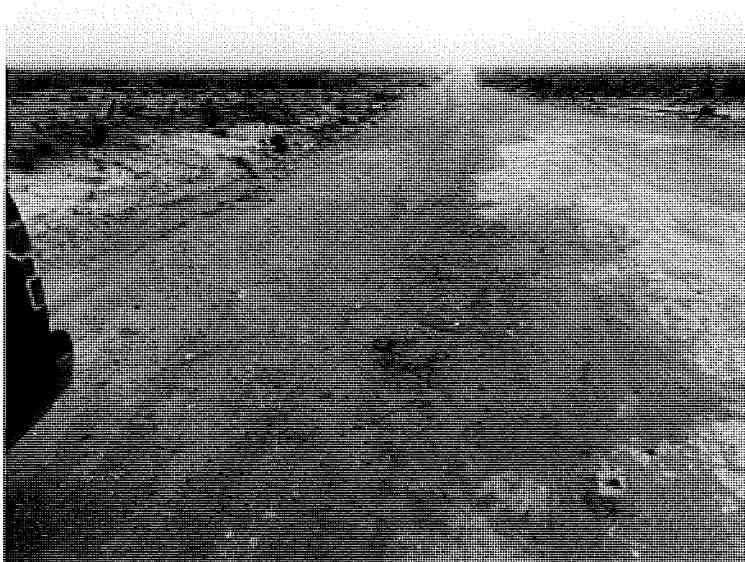
Figure 7: Suspect unauthorized discharge in an area commonly known as the “Abe lease area”. The discharge was tracked south toward the east/west lease road, continued west to the Tomahawk SWD, then turned north on the north/south lease road as shown on Plate 3. Date/Time: 2021-01-09 09:24:41. GPS: 32.4485278 N, 103.5752500 W.

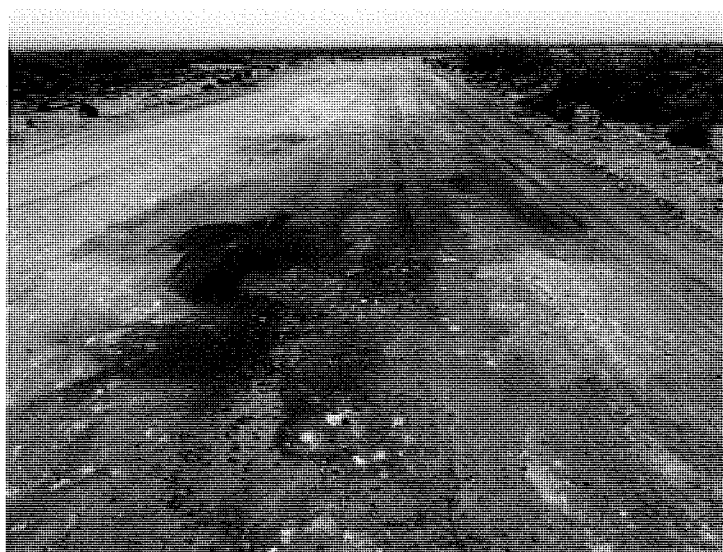
2. A 0.5-mile section within the “Abe lease area” tracking northwest to southeast. Figures 8 and 9 shows discharges along the route. The northwest node of the segment is located at the entrance to the shared location of the BC Operating Abe State #2 tank battery (API: 30-025-42066; Figure 10) and the Marathon Abe Unit #2 wellhead (API: 30-025-34146).

Figure 8: Suspect unauthorized discharge at the southern node of the 0.5-mile tracked route within the “Abe lease area”. Photo is viewing south at the node terminus. Date/Time: 2021-01-09 09:43:18. GPS: 32.4502861 N, 103.5768667 W.

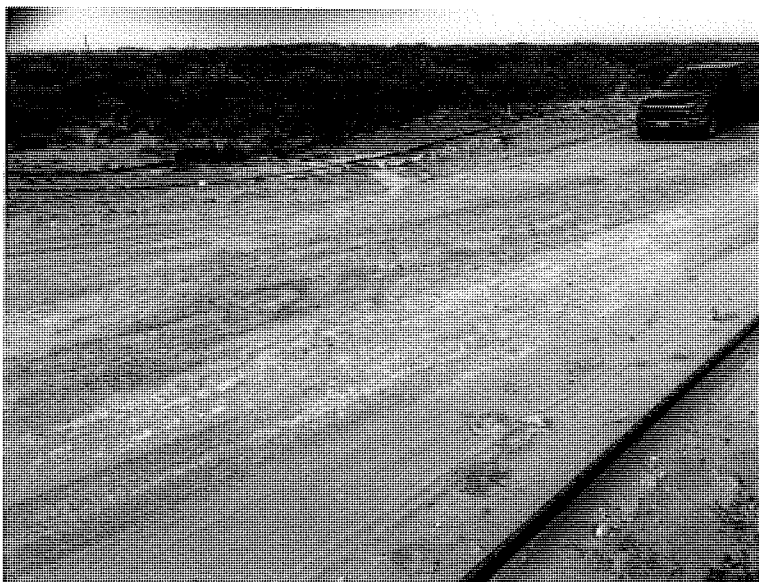
Figure 9: Suspect unauthorized discharge along the 0.5-mile tracked route within the "Abe lease area". Discharge flowed off the lease road. Date/Time: 2021-01-09 09:54:37. GPS: 32.4514611 N, 103.5797722 W.

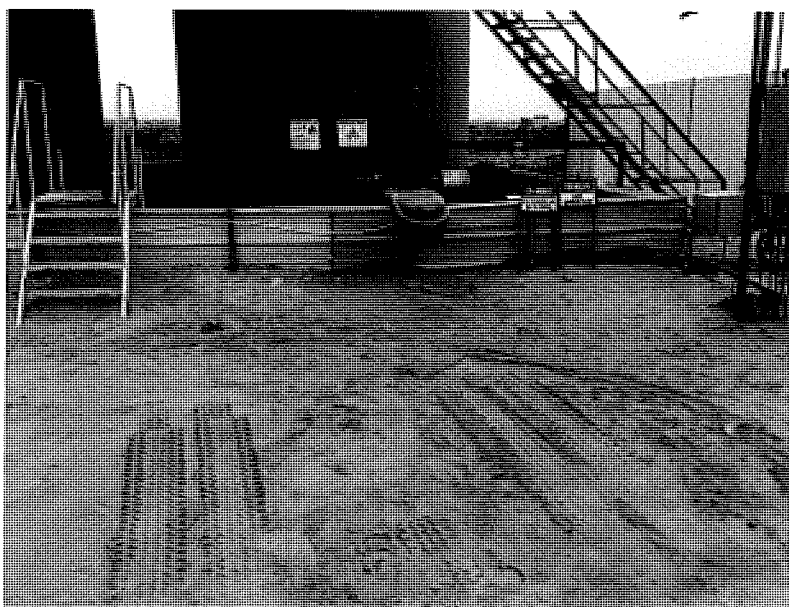
Figure 10: Loading area at BC Operating Abe State #2 tank battery (API: 30-025-42066). Date/Time: 2021-01-09 12:40:27. GPS: 32.4522361 N, 103.5884861 W.

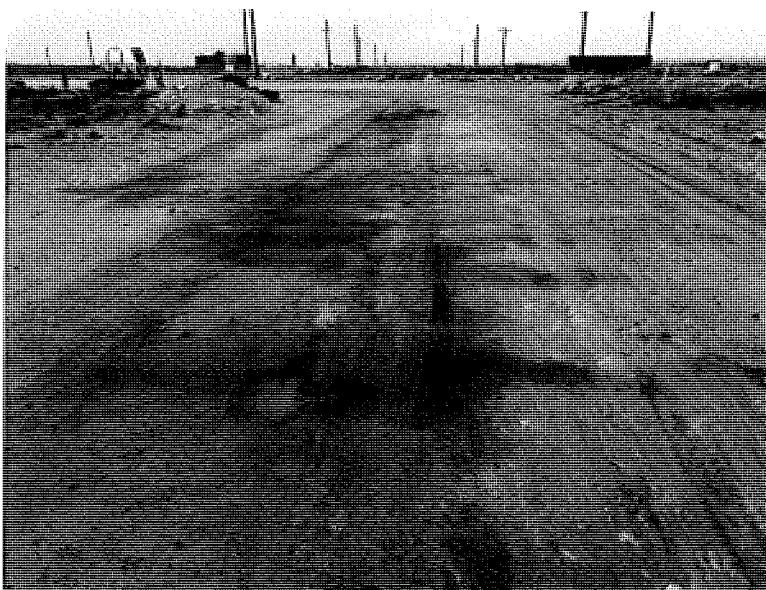
3. Suspect unauthorized discharge along a north/south 0.2-mile segment near the Battle 34 lease area. The suspect unauthorized discharge was tracked to the Marathon Battle 34 Federal 4H lease (API: 30-025-42636). Figures 11 – 13 show photos of discharge along the north/south lease road as mapped on Plate 3.

Figure 11: Suspect unauthorized discharge along a 0.2-mile segment of a north/south lease road near the area commonly call the "Battle 34 lease area". Photo is viewing south toward the east/west lease road. The Battle 34 Federal 4H tank battery is visible in photo background. Date/Time: 2021-01-09 10:29:53. GPS: 32.4468278 N, 103.5666889 W.
