CLOSURE REPORT

VERMEJO SWD #1

2RP-4882

PREPARED BY: HUNGRY HORSE, LLC

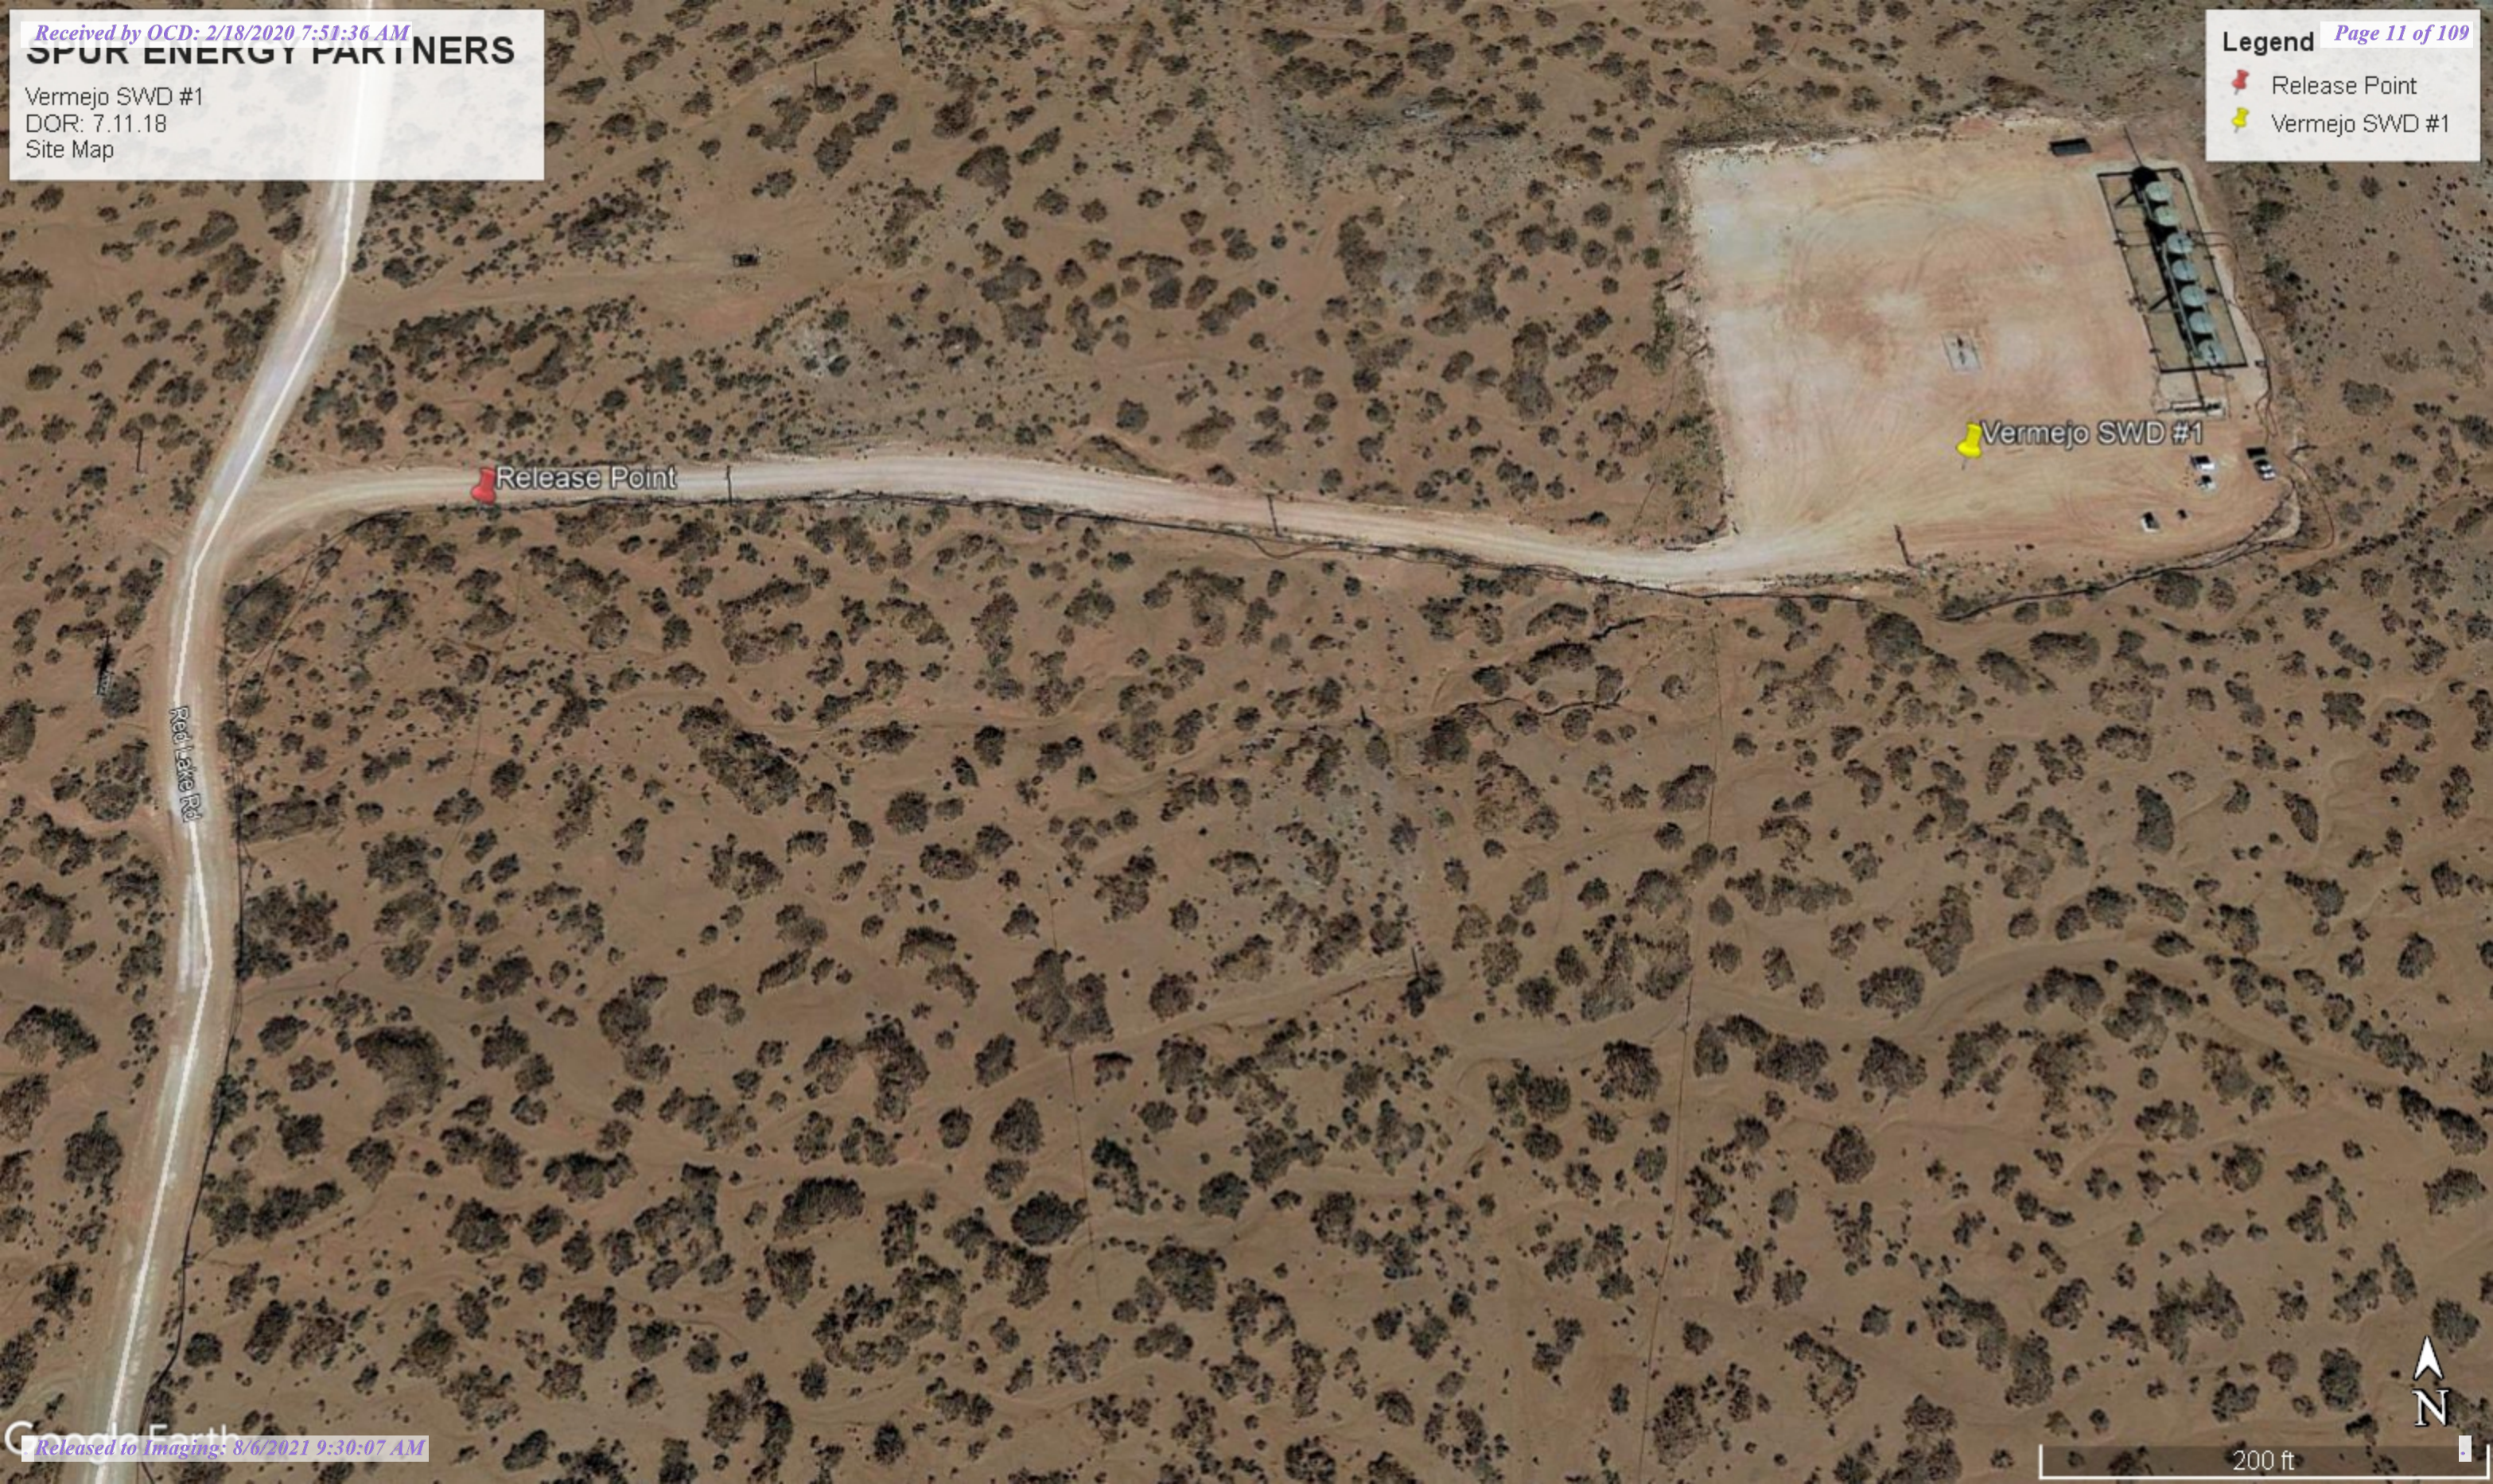
Vermejo SWD #1
DOR: 7.11.18
Groundwater Map

A water well record search of the New Mexico Office of the State Engineer (NMOSE) Potable Water Well (POD) Geographic Information System (GIS) data portal identified that no ground water was found within 1000' from the release site. Further investigation showed that one registered well (POD# RA 12307) was identified northeast at 2,542' (.48 Miles) from the site with a known depth of 58 ft. below ground surface (bgs). Another registered well (POD# RA 12456) was identified southwest at 6,194' (1.17 Miles) with a known depth of 92' bgs. The use of this land is predominantly used for commercial oil and gas production and the nearest well (POD# RA 12307) is being utilized for to set the site ground water data.

-   RA 12307 POD 1 2542' FR SITE 58'DGW
-   RA12456 POD1 6194' FR SITE 92'DGW
-   Release Point
-   Vermejo SWD #1
