RICE *Operating Company*

RE: Termination Request**Rice Operating Company – BD SWD System****BD Jct. F-15 (1R426-255): UL/F, Sec. 15, T21S, R37E**

Investigation and Characterization Plan (ICP) Report

CAP Report and Soil Closure Request

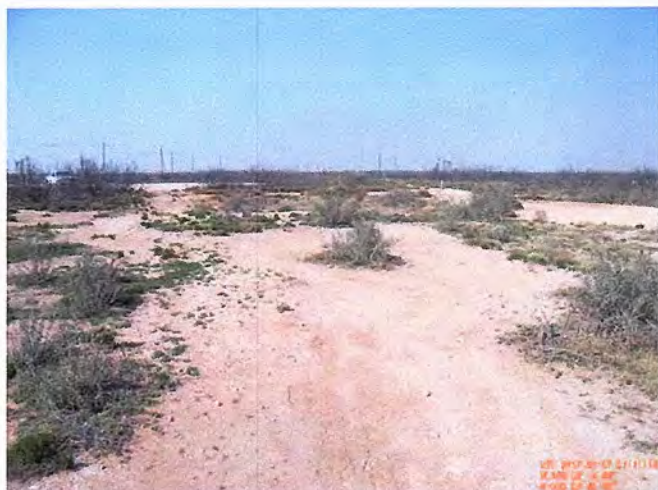
3/7/2017

Site prior, facing north

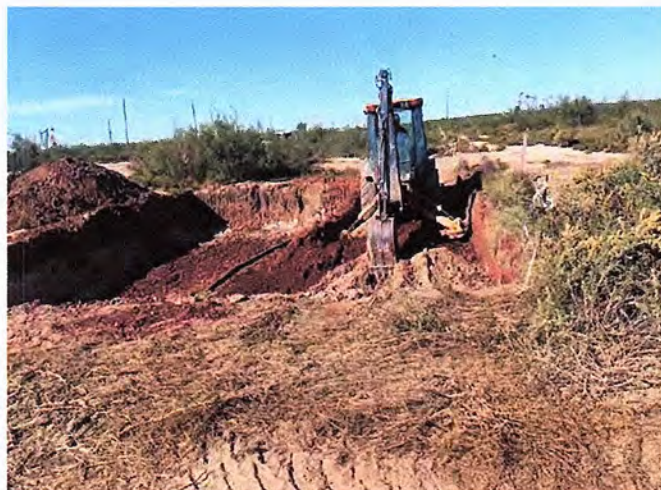
10/23/2017

Excavating the site to 5 ft bgs, facing north

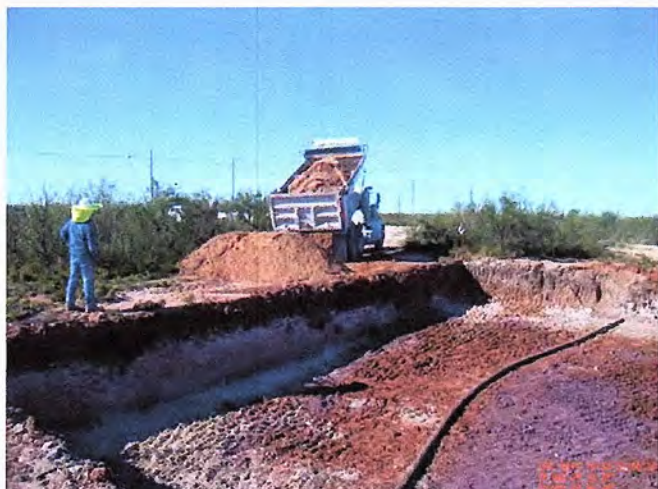
10/30/2017

Excavation complete to a depth of 5-ft bgs and importing soil, facing northwest

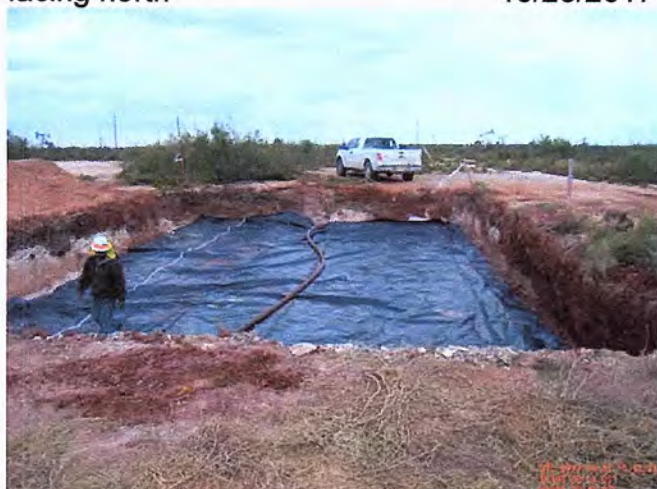
10/31/2017

20-mil reinforced liner installed at 4.5 ft bgs, facing north

In order to inhibit the downward migration of residual constituents through the vadose zone, ROC installed a 20-mil reinforced poly liner across the site with the dimensions of 35x50 ft, which covered the previously installed 30x30 ft clay liner. A total of 396 cubic yards of excavated soil were taken to a NMOCD approved facility for disposal. The bottom of the excavation was padded with 6 inches of imported blow sand and a 20-mil reinforced liner was installed and properly seated at 4.5 ft bgs. The top of the liner was padded with 6 inches of imported blow sand, and the excavation was backfilled to ground surface with blended backfill soil and imported topsoil. A sample of the blended backfill and a sample of the imported topsoil were field tested for hydrocarbons using a PID, resulting in readings of 0.5 and 1.1 ppm, respectively. Each sample was sent to a commercial laboratory for analysis of chloride and returned a result of 16 mg/kg and <16 mg/kg, respectively. The backfilled site was then seeded with a blend of native vegetation. Vegetation above the liner will also provide a natural infiltration barrier for the site, since plants capture water through their roots thereby reducing the volume of water moving through the vadose zone.

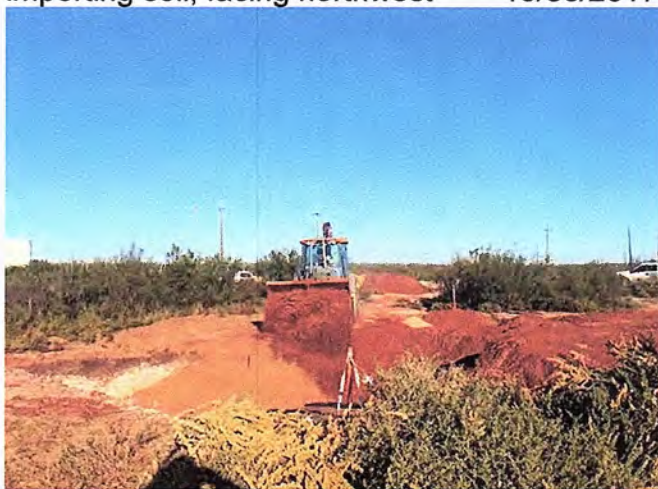
11/1/2017

Backfilling above the liner, facing southeast

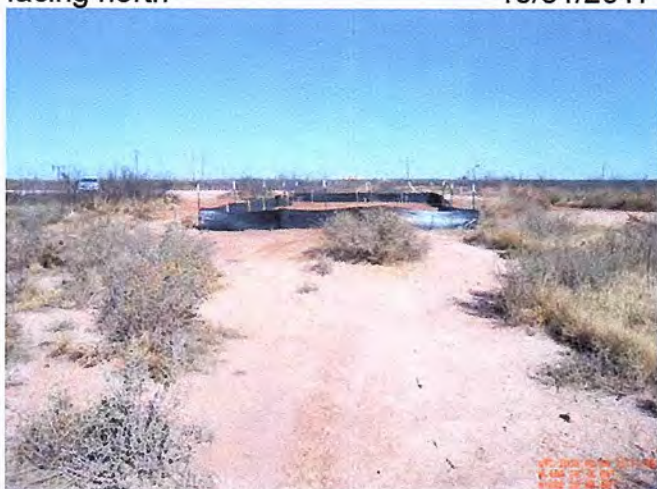
2/8/2018

Site complete, facing north
