Release Notification

**RE: Closure Request
Remuda 100
Incident Number NAPP2103632350
Eddy County, New Mexico**

PHOTOGRAPHIC LOG		
XTO Energy, Inc.	Remuda 100 Eddy County, New Mexico	TE012921024

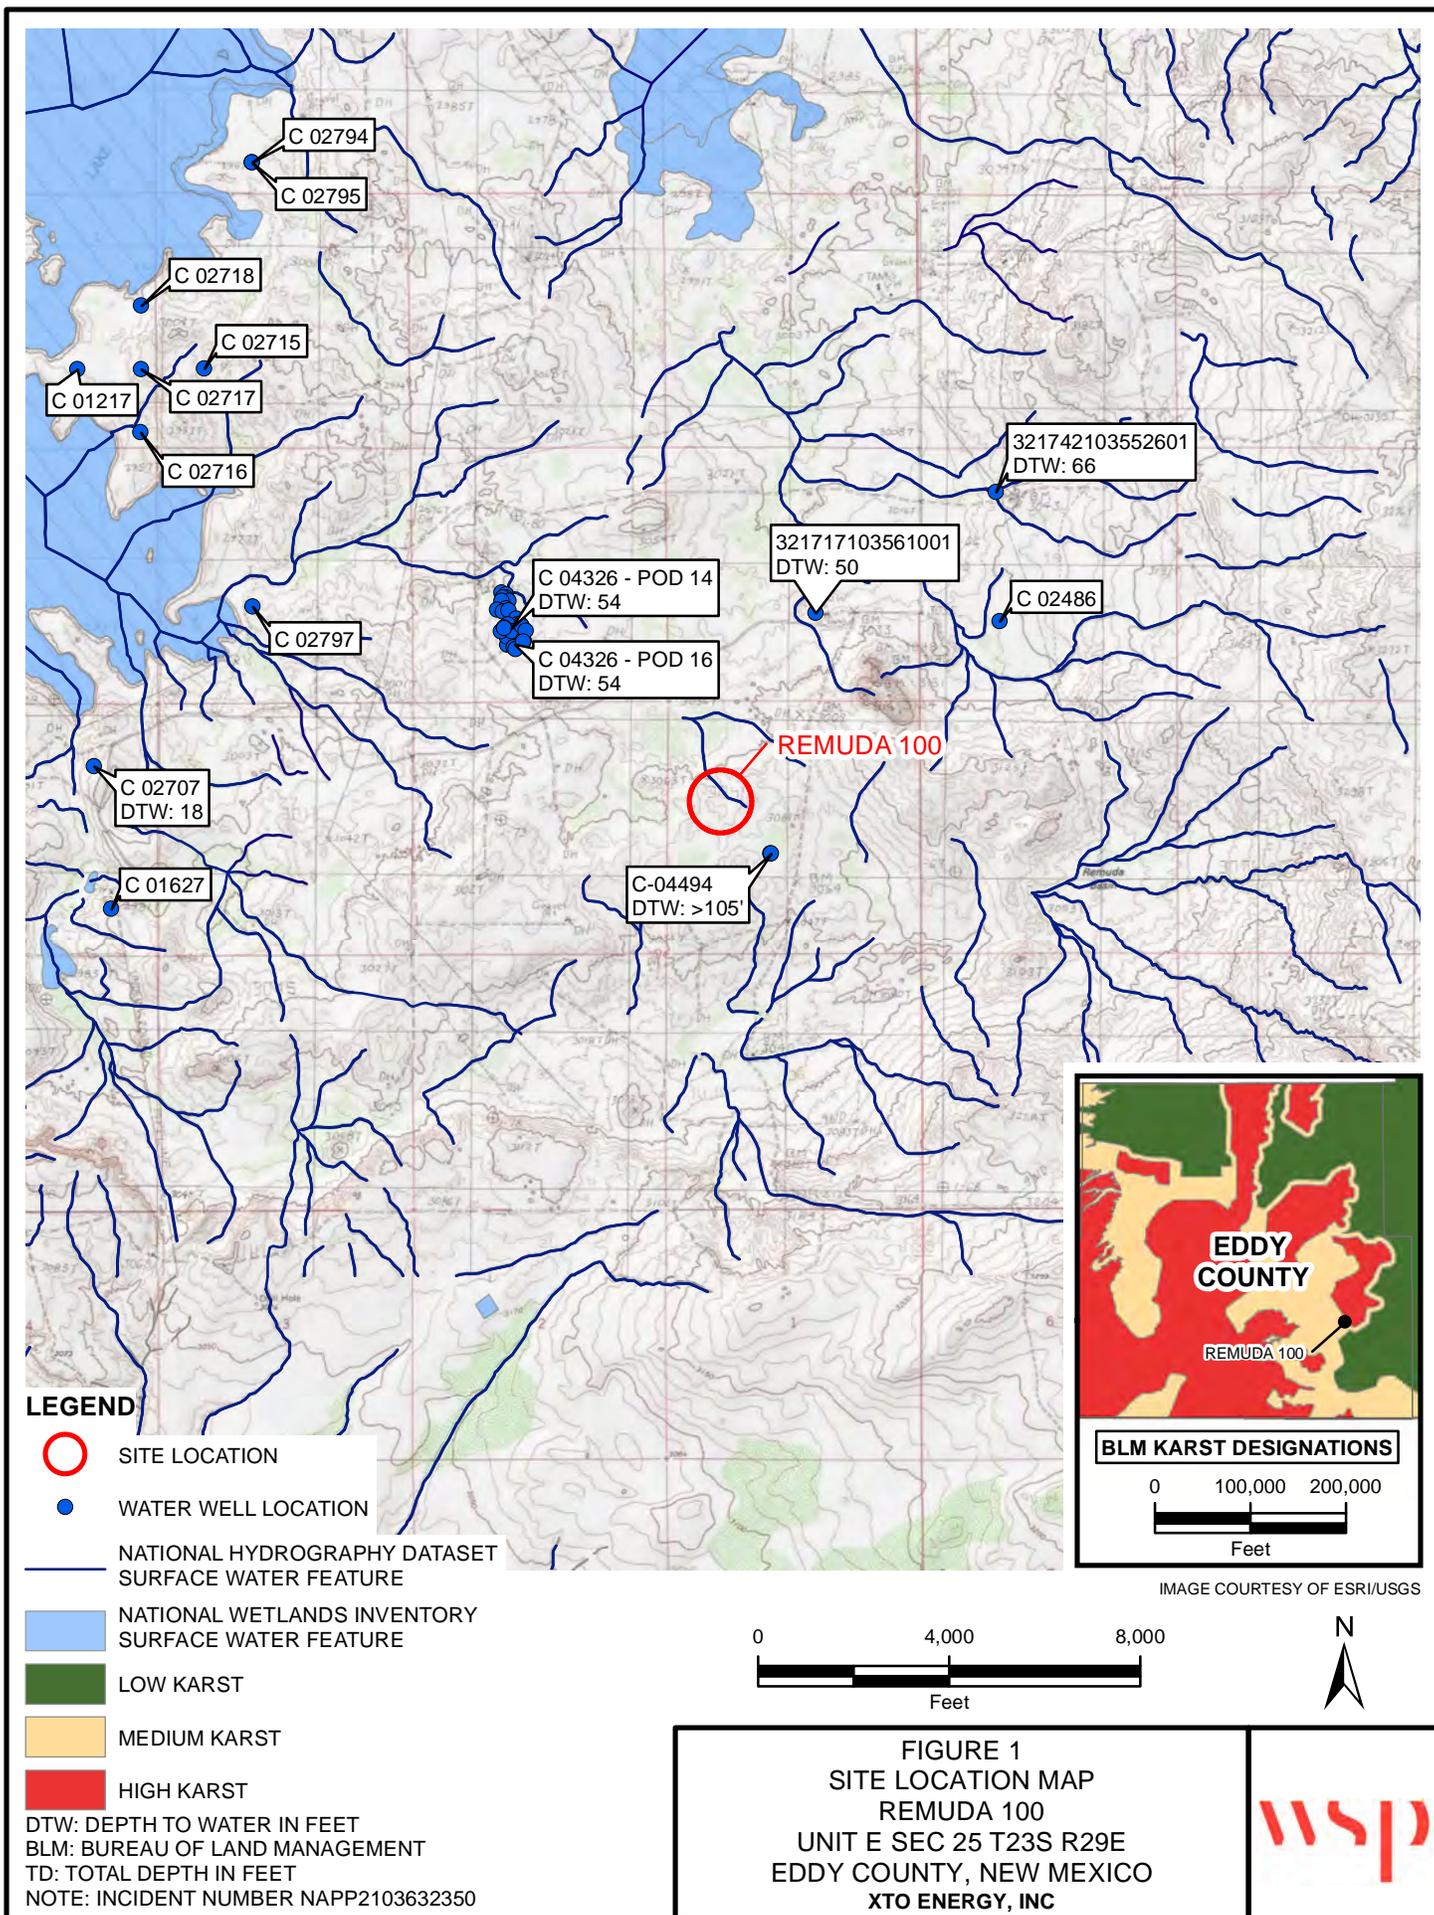
WSP characterized the Site according to Table 1, *Closure Criteria for Soils Impacted by a Release*, of Title 19, Chapter 15, Part 29, Section 12 (19.15.29.12) of the New Mexico Administrative Code (NMAC). Depth to groundwater at the Site is greater than 100 feet below ground surface (bgs) based on a recent soil boring drilled for determination of regional groundwater depth. During January 2021, WSP installed a soil boring within 0.5 miles of the Site utilizing a truck-mounted hollow-stem auger rig. Soil boring C-04494 was drilled to a depth of 105 feet bgs. A WSP geologist logged and described soils continuously. No moisture or groundwater was encountered during drilling activities. The borehole lithologic/soil sampling log is included in Attachment 1. The location of the borehole is approximately 0.28 miles southeast of the Site and is depicted on

Figure 1. The borehole was left open for over 72 hours to allow for potential slow infill of groundwater. After the 72-hour waiting period without observing groundwater, it was confirmed that groundwater beneath the Site is greater than 105 feet bgs. The borehole was properly abandoned with drill cuttings and hydrated bentonite chips. The well records are included in Attachment 1.

The closest significant watercourse to the Site is an unnamed ravine, located approximately 166 feet northeast of the Site. The Site is greater than 200 feet from a lakebed, sinkhole, or playa lake and greater than 300 feet from an occupied residence, school, hospital, institution, church, or wetland. The Site is greater than 1,000 feet to a freshwater well or spring and is not within a 100-year floodplain or overlying a subsurface mine. The Site is not underlain by unstable geology (medium potential karst designation area). Site receptors are identified on Figure 1.

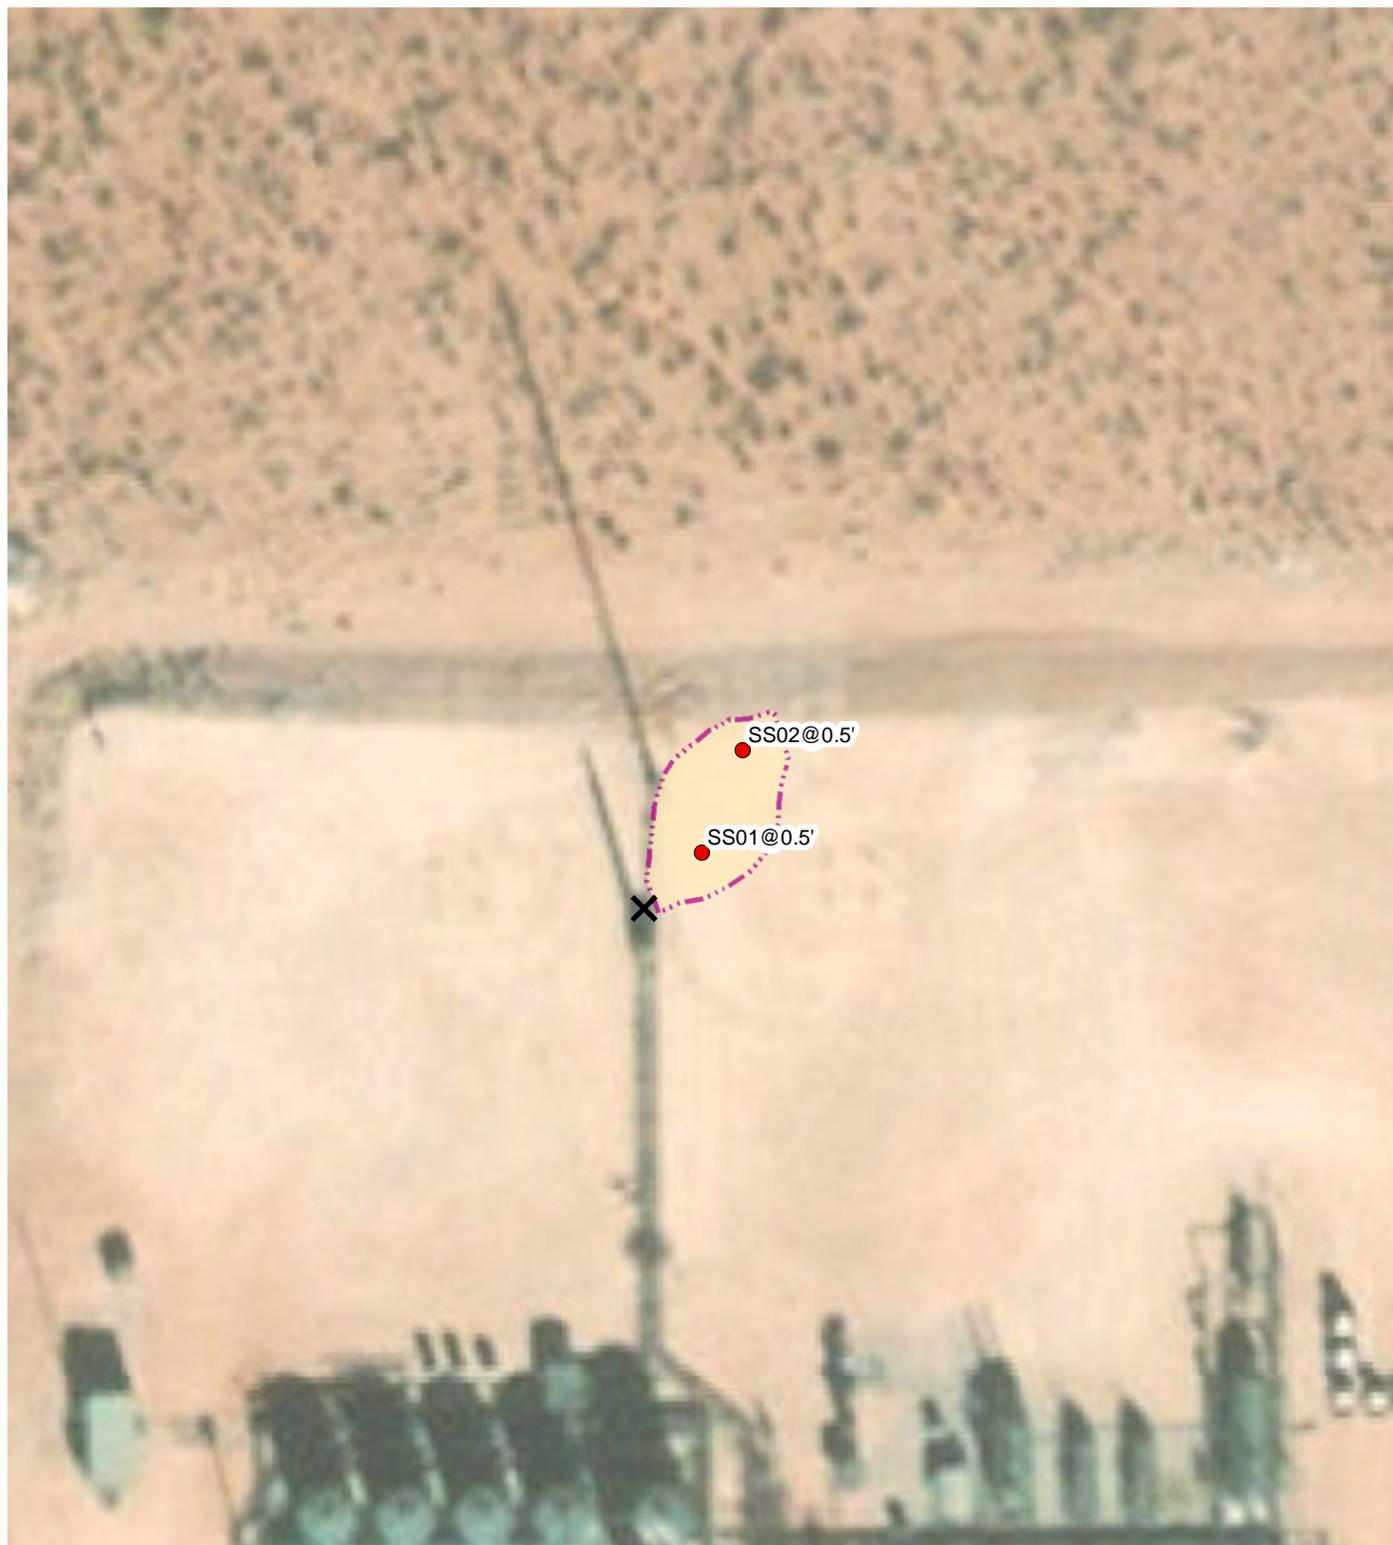
FIGURE 2
PRELIMINARY SOIL SAMPLE LOCATIONS
 REMUDA 100
 UNIT E SEC 25 T23S R29E
 EDDY COUNTY, NEW MEXICO
 XTO ENERGY, INC.

On February 3, 2021, WSP personnel visited the Site to evaluate the release extent based on information provided on the Form C-141 and visual observations. WSP personnel collected two preliminary assessment soil samples (SS01 and SS02) within the release extent from a depth of approximately 0.5 feet bgs to assess the lateral extent of impacted soil. The preliminary soil samples were field screened for volatile aromatic hydrocarbons and chloride utilizing a calibrated photoionization detector (PID) and Hach® chloride QuanTab® test strips, respectively. The release extent and preliminary soil sample locations were mapped utilizing a handheld Global Positioning System (GPS) unit and are depicted on Figure 2.

Laboratory analytical results for preliminary soil samples SS01 and SS02 indicated that chloride concentrations exceeded the Closure Criteria. Benzene, BTEX, and TPH concentrations were compliant with the Closure Criteria. Based on visible staining in the release area, elevated field screening results, and laboratory analytical results for the preliminary soil samples, excavation activities were warranted.

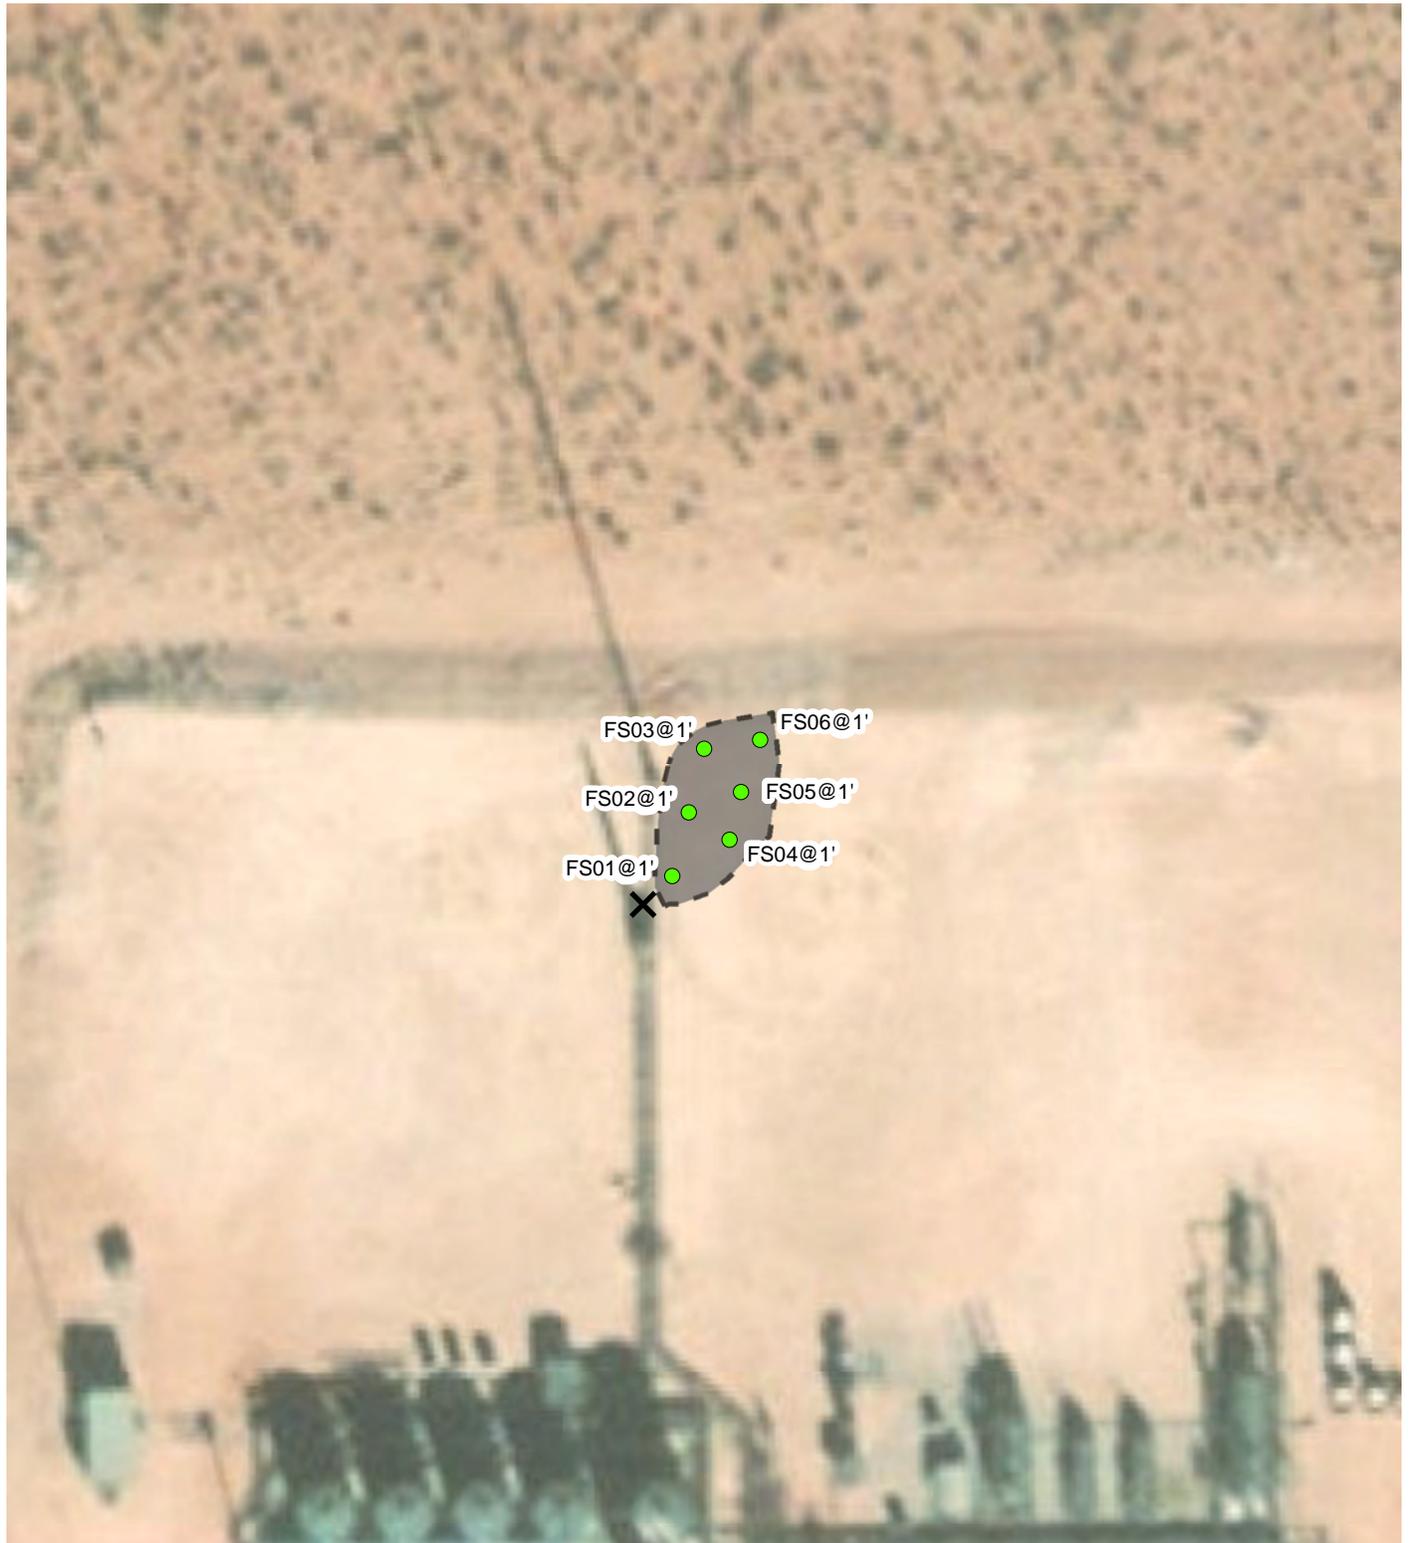
FIGURE 3
EXCAVATION SOIL SAMPLE LOCATIONS
 REMUDA 100
 UNIT E SEC 25 T23S R29E
 EDDY COUNTY, NEW MEXICO
 XTO ENERGY, INC.

Following removal of impacted soil, WSP collected 5-point composite soil samples every 200 square feet from the floor of the excavation. The 5-point composite samples were collected by placing five equivalent aliquots of soil into a 1-gallon, resealable plastic bag and homogenizing the samples by thoroughly mixing. Composite soil samples FS01 through FS06 were collected from the floor of the excavation from a depth from of 1-foot bgs. Due to the shallow depth of the excavation, the floor samples included materials from any sidewalls. The excavation soil samples were collected, handled, and analyzed following the same procedures as described above. The excavation extent and excavation soil sample locations are presented on Figure 3.

The excavation measured approximately 1,200 square feet. A total of approximately 45 cubic yards of impacted soil was removed during the excavation activities. The impacted soil was transported and properly disposed of at the R360 Facility in Hobbs, New Mexico. After completion of confirmation sampling, the excavation was backfilled.

Laboratory analytical results for preliminary soil samples SS01 and SS02 indicated that chloride concentrations exceeded the Closure Criteria. Laboratory analytical results for excavation floor samples FS01 through FS06 indicated that benzene, BTEX, TPH, and chloride concentrations were compliant with the Closure Criteria. Laboratory analytical results are summarized in Table 1 and laboratory analytical reports are included as Attachment 3.

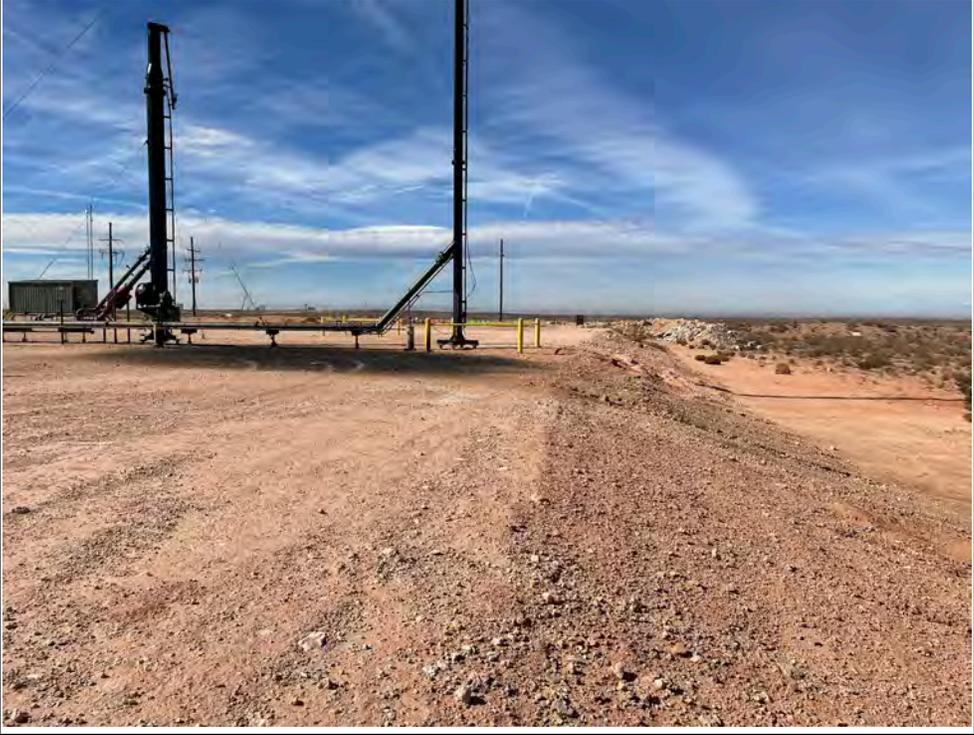
Photo No.	Date	
1	April 14, 2021	
Western view of flare and release area.

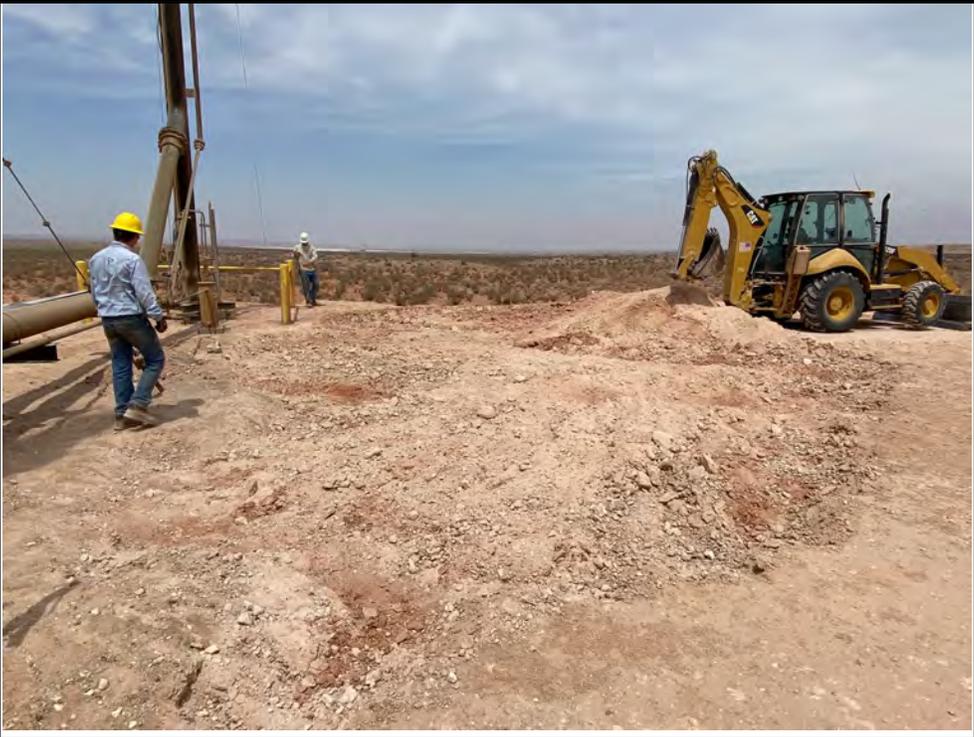
Photo No.	Date	
2	April 14, 2021	
Northern view of excavation area.

On April 14, 2021, WSP personnel returned to the Site to oversee excavation activities as indicated by visible staining, field screening activities, and laboratory analytical results for the preliminary samples. Excavation activities were performed using track-mounted backhoe, transport vehicle, and hydrovac. To direct excavation activities, WSP screened soil for volatile aromatic hydrocarbons and chloride utilizing a PID and Hach® chloride QuanTab® test strips, respectively. Photographic documentation is included in Attachment 2.

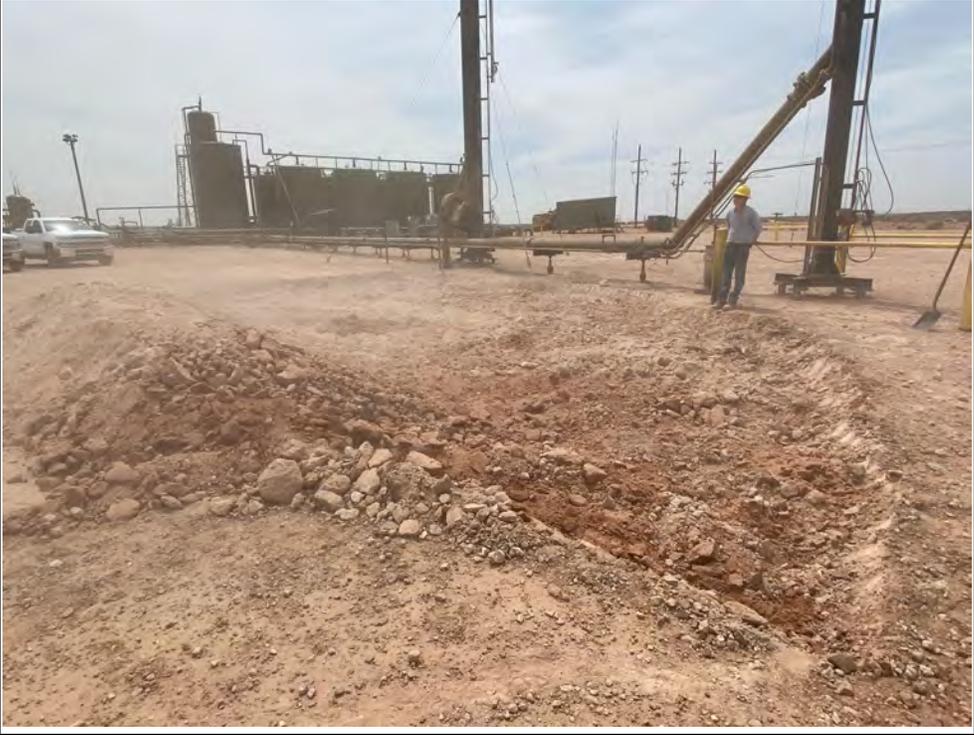
Photo No.	Date	
3	April 14, 2021	
Southwestern view of excavation area.

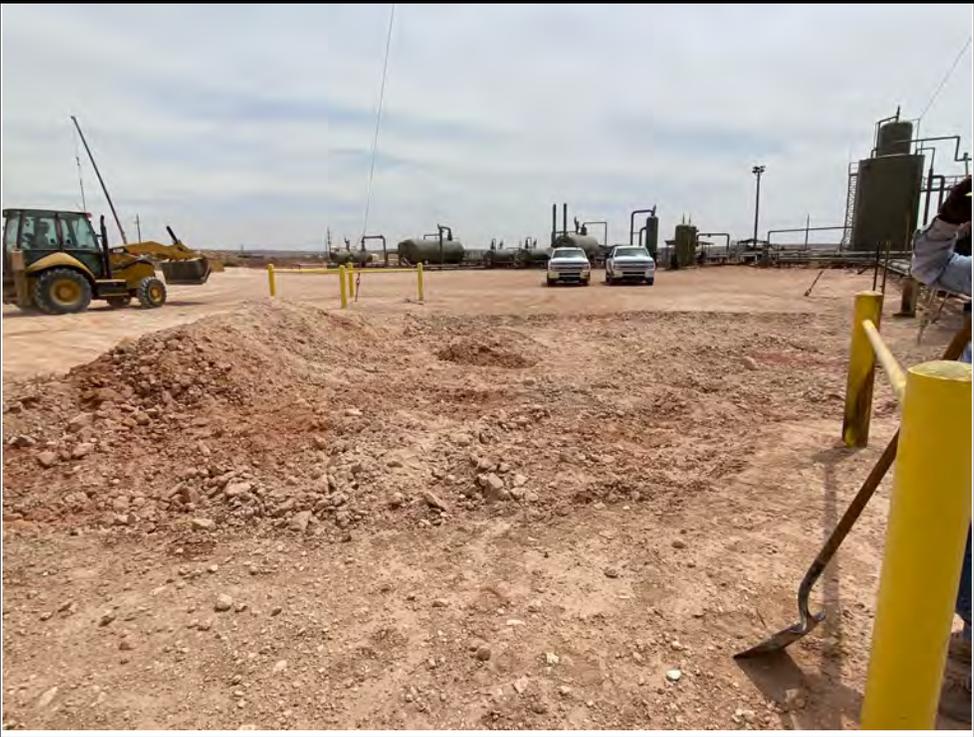
Photo No.	Date	
4	April 14, 2021	
Southern view of excavation area.

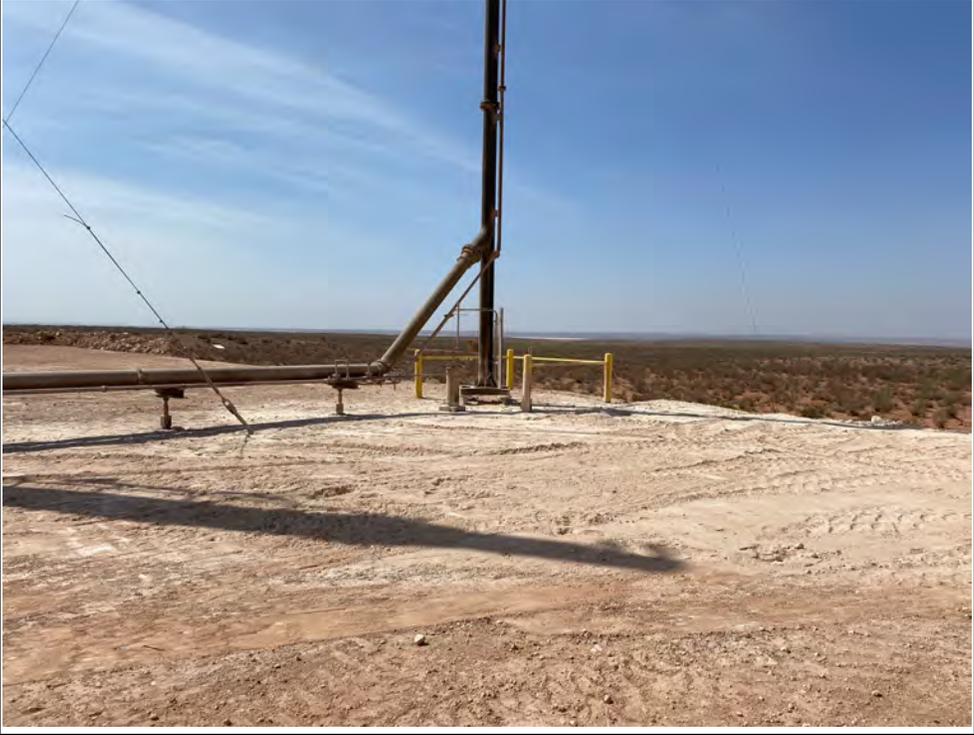
Photo No.	Date	
5	April 14, 2021	
Northwestern view of backfilled excavation.

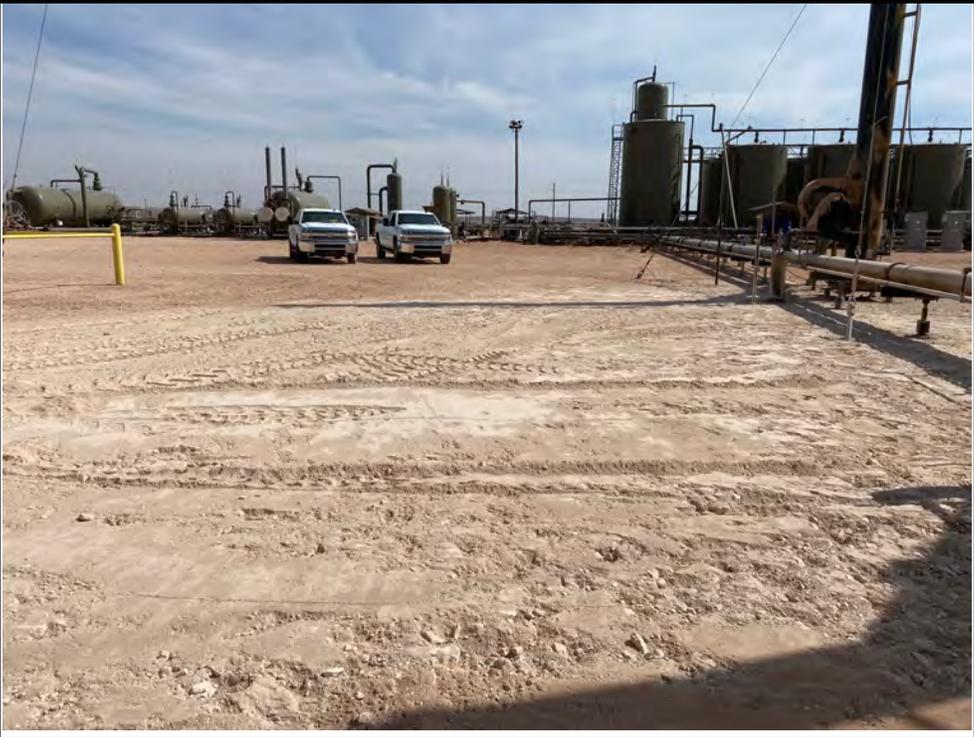
Photo No.	Date	
6	April 14, 2021	
Southern view of backfilled excavation.
