**RE: Termination Request**

**Rice Operating Company – BD SWD System**

**BD Jct. K-20-2 (1R426-10): UL/K, Sec. 20, T21S, R37E**

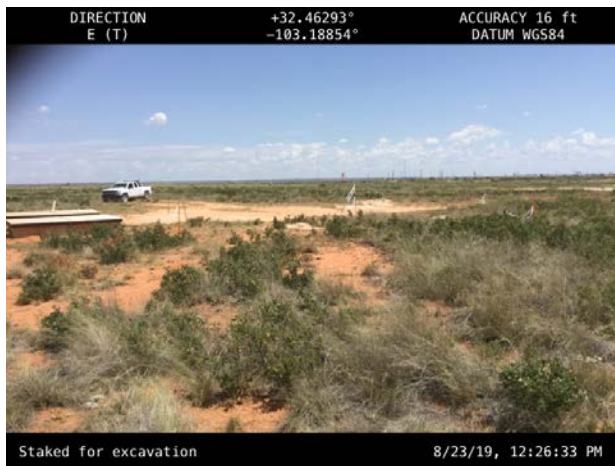
Site prior to excavation, facing east 8/23/2019

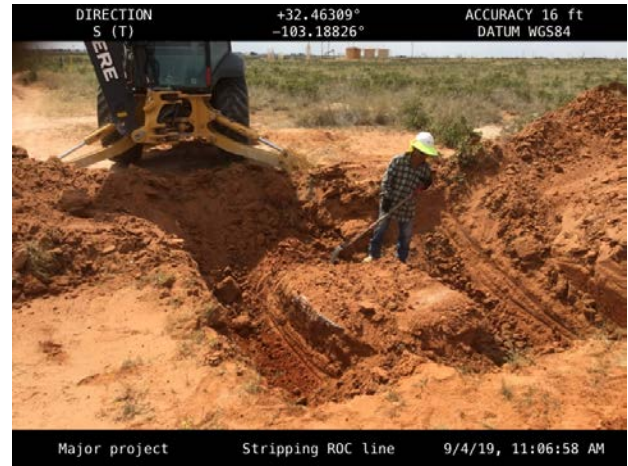
Hand spotting line, facing south 9/4/2019

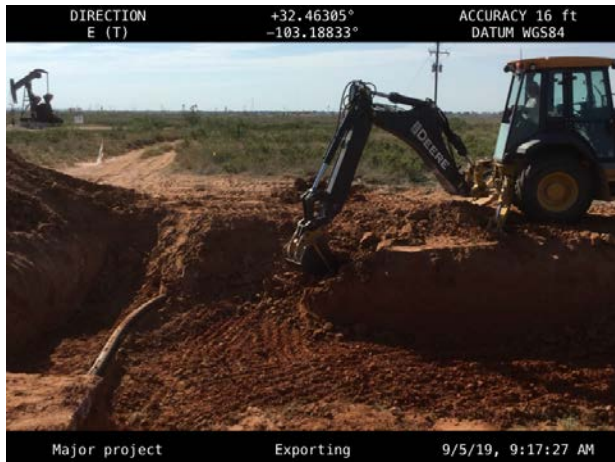
Excavating the site to a depth of 5 ft bgs, facing east 9/5/2019

In order to inhibit the downward migration of residual constituents through the vadose zone, ROC excavated the site to a depth of 4.5 ft bgs and installed and properly seated a modified 95x89-ft, 20-mi reinforced liner. A representative composite sample was collected from the 4-

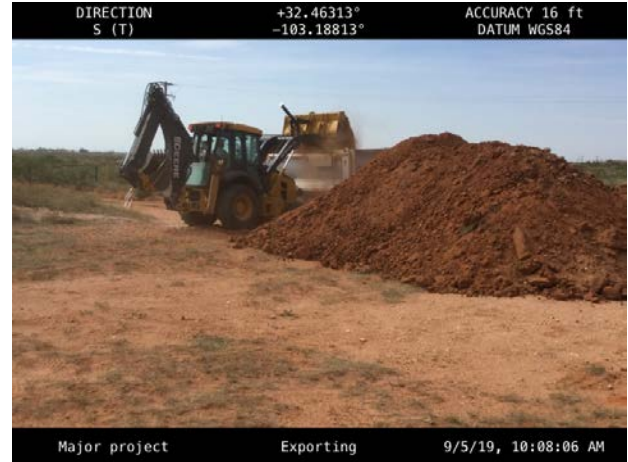
Exporting excavated soil, facing south 9/5/2019

walls and was analyzed by a commercial laboratory for chloride and hydrocarbon. The composite sample resulted in a chloride concentration of 128 mg/kg, GRO/DRO/EXT-DRO concentrations below detectable limit, and BTEX concentrations below detectable limit. A total of 1,536 cubic yards of excavated soil were taken to a NMOCD approved facility for disposal. The top of the liner was padded with imported soil, and the excavation was backfilled to ground surface and contoured to the surrounding area. A sample of the imported soil was analyzed by a commercial laboratory for chloride and hydrocarbon, resulting in a concentration of chloride, GRO/DRO/EXT-DRO, and BTEX below detectable limits. The backfilled site was then seeded with a blend of native vegetation. Vegetation above the liner will also provide a natural infiltration barrier for the site, since plants capture water through their roots thereby reducing the volume of water moving through the vadose zone.

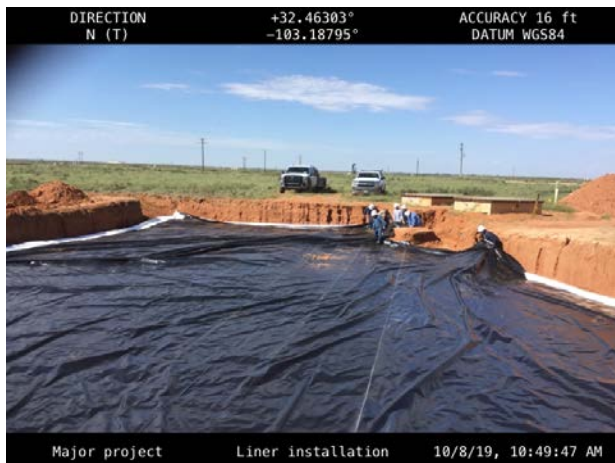
Installing and properly seating the 20-mil, reinforced liner, facing north 10/8/2019

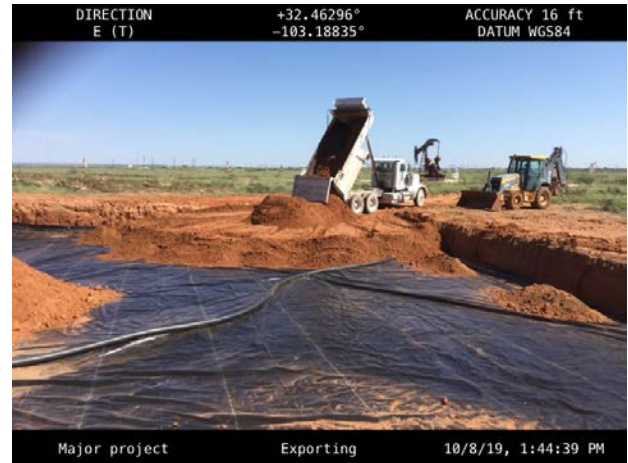
Backfilling and padding the liner with imported soil, facing east 10/8/2019

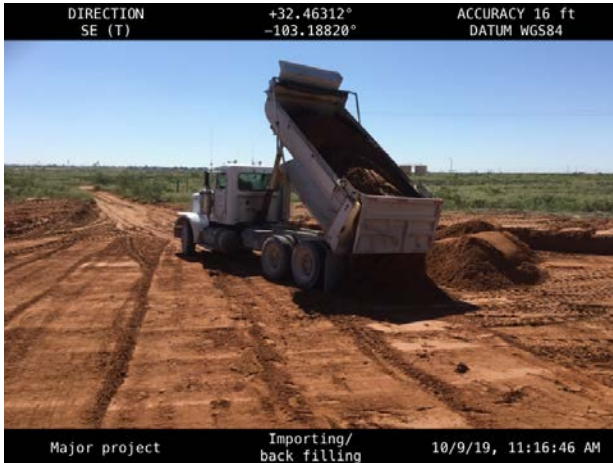
Importing and backfilling the excavation with top soil, facing southeast 10/9/2019

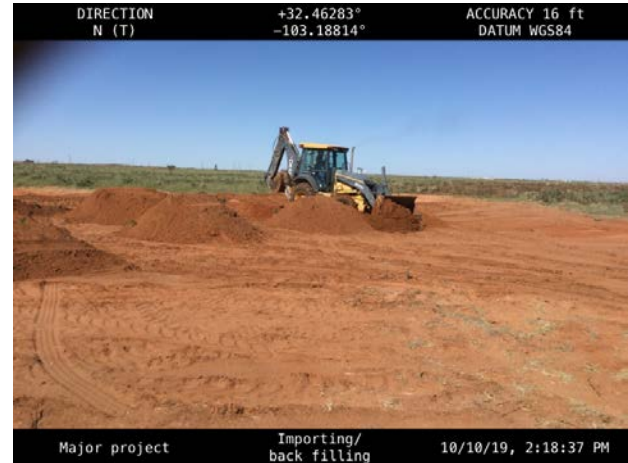
Backfilling and contouring the site, facing north 10/10/2019

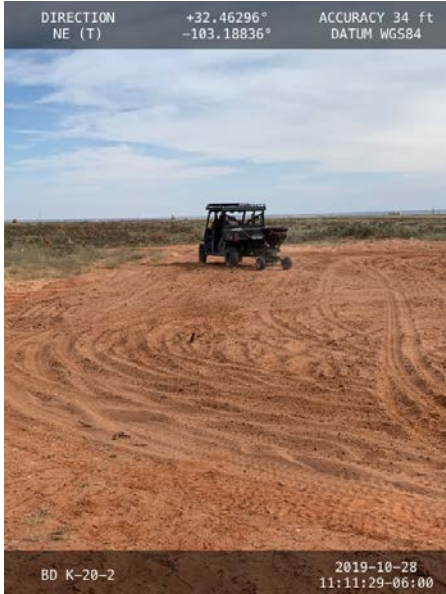
Seeding site, facing northeast 10/28/2019

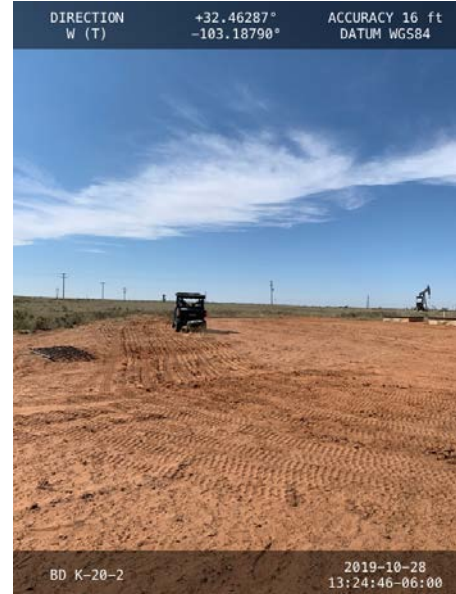
Tiling in the seed, facing west 10/28/2019

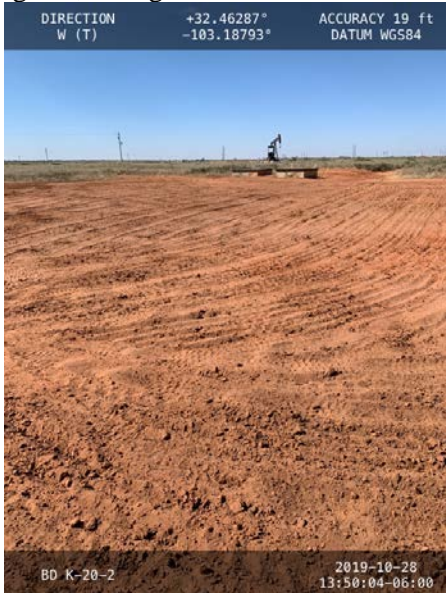
Site complete, facing west 10/28/2019

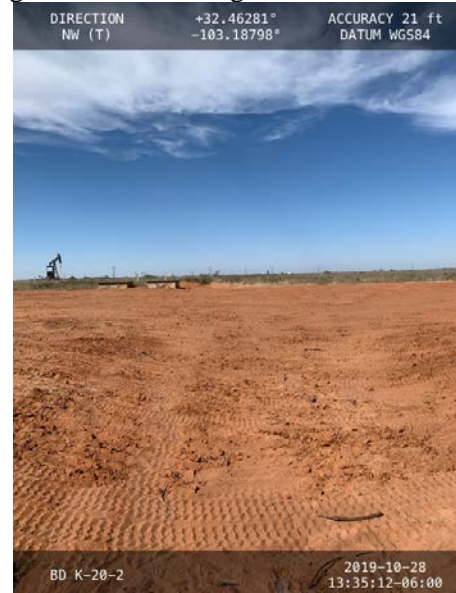
Site complete, facing northwest 10/28/2019
