Delineation Report and Remediation Plan

Lost Tank 16 State #004 Producing Oil Well
Produced Water Spill Site
Lea County, New Mexico
NMOCD Incident ID No. nAPP2105635743

June 2021
AECOM Project No. 60657216

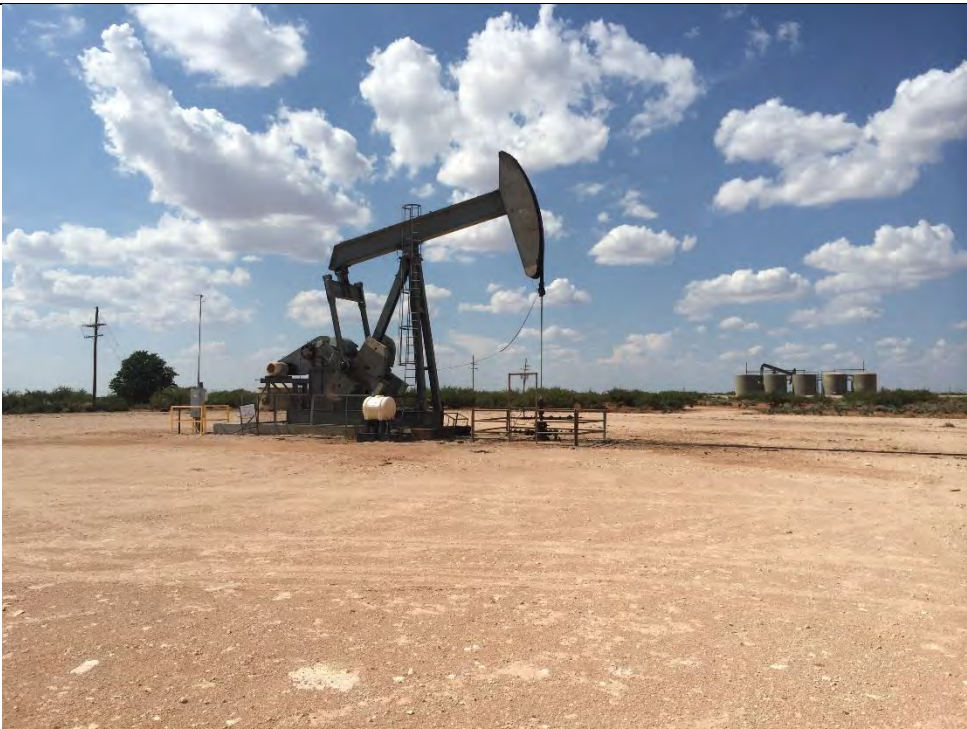
SPILL AREA	
Photograph No. 1

Photographer: J. Lovely	
Date: 7/29/2019	
Comments: Looking north at pump jack and wellhead.	
SPILL AREA	
Photograph No. 2

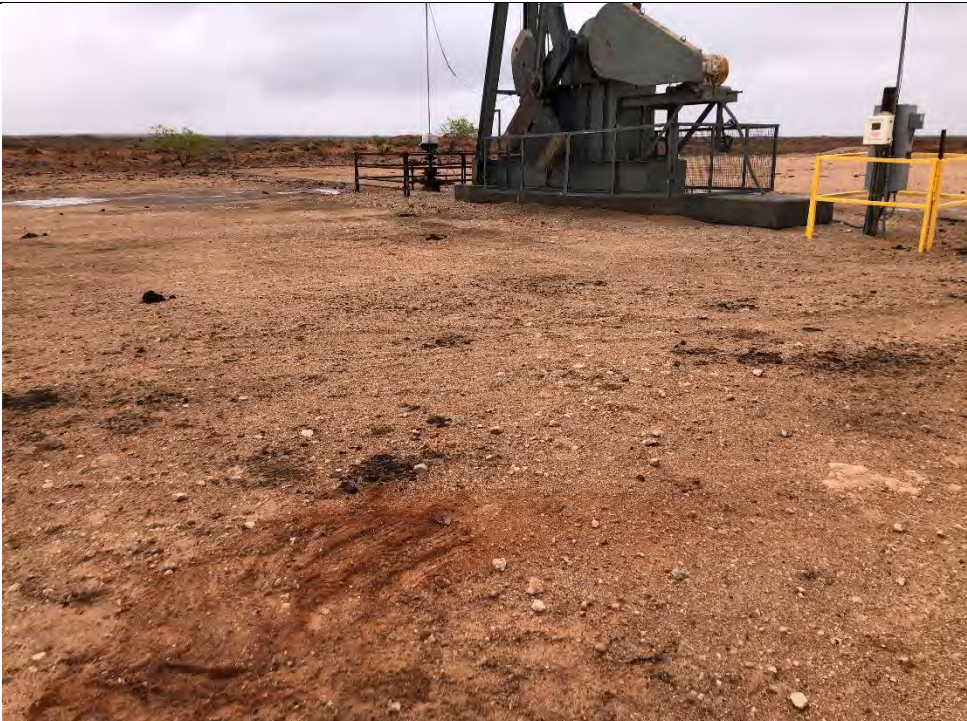
Photographer: J. Lovely	
Date: 4/29/2021	
Comments: Looking east at pump jack, well head and spill area from the location of soil boring LTB-1.

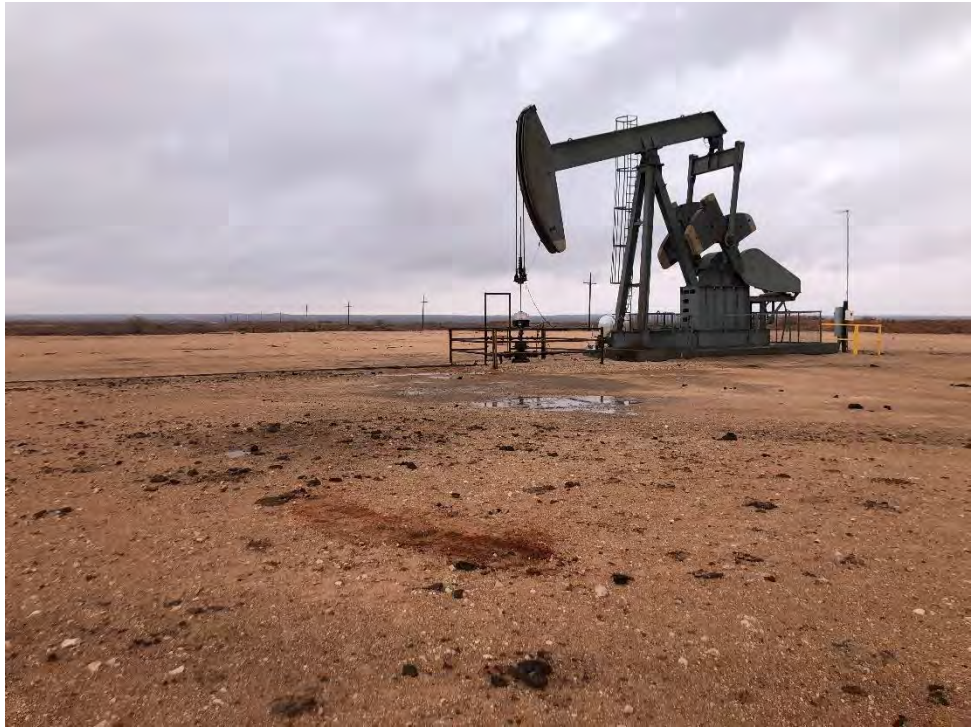
Client: Chevron MCBU	Project Number: 60657216
Project Name: Lost Tank 16 State #004	Site Location: Lea County, New Mexico
SPILL AREA	
Photograph No. 3

Photographer: J. Lovely	
Date: 4/29/2021	
Comments: Looking south at pump jack, well head and spill area from the location of soil boring LTB-4.	
SPILL AREA	
Photograph No. 4

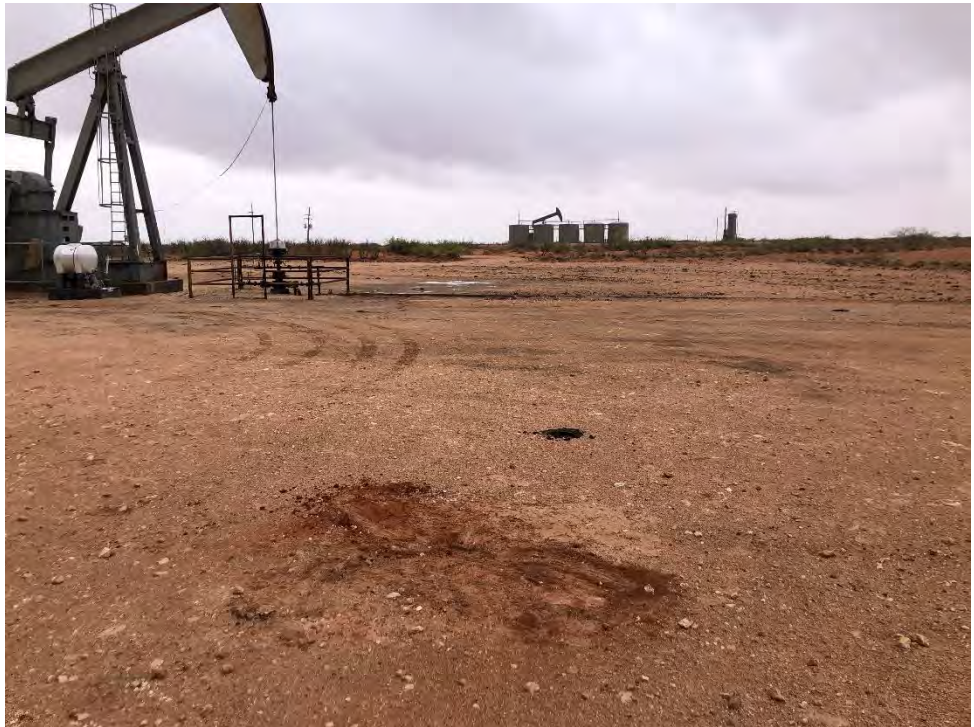
Photographer: J. Lovely	
Date: 4/29/2021	
Comments: Looking north-northwest at the pump jack, well head and spill area from the location of soil boring LTB-2.
