REMEDICATION DOCUMENTATION AND CLOSURE REPORT

FOR THE
PRODUCTION FLUID RELEASE
ASSOCIATED WITH THE

VACUUM UNIT WELL #103

SEPTEMBER 2002

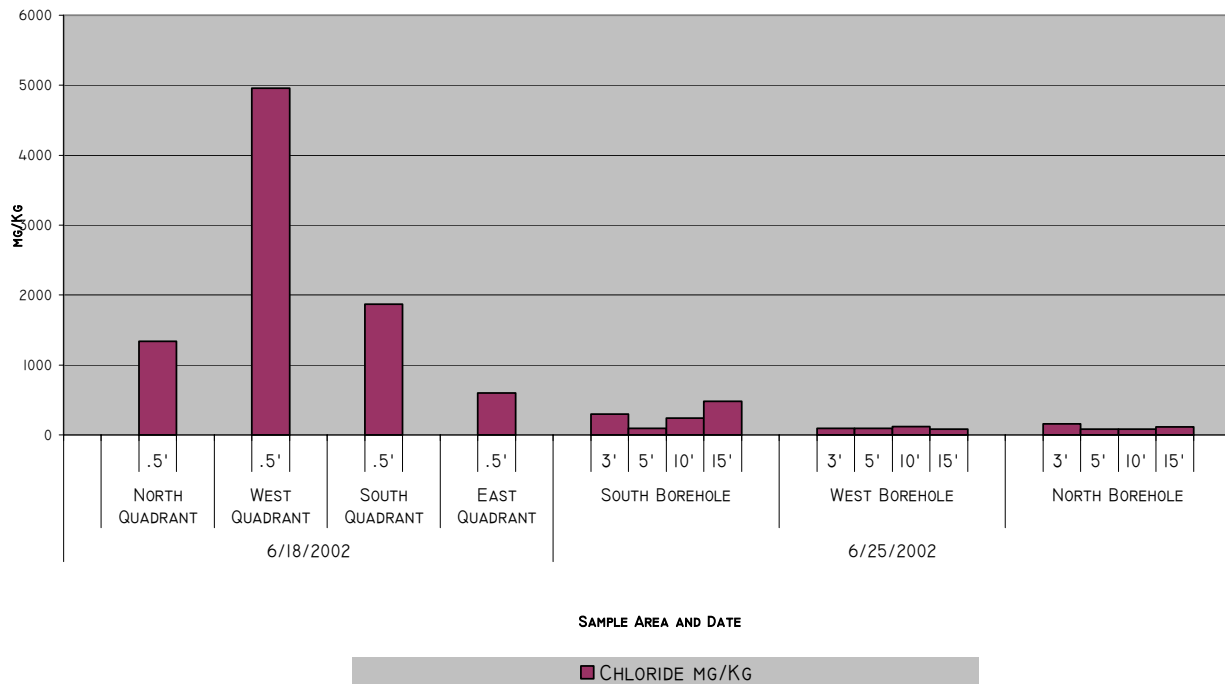
**CHEVRONTEXACO
VACUUM UNIT WELL #103
CHLORIDE DELINEATION**

The NMOCD remedial goals have been achieved at this site. The Chloride concentrations in the South Borehole should not pose a threat to local ground water given that the surface is now covered with approximately 12" of compacted caliche. Application/treatment of the vegetated overspray area with MicroBlaze Spill Control will accelerate bio-attenuation and fertilize the area. ChevronTexaco personnel will monitor the status of the vegetation. The original laboratory analytical reports and data summary are included as Attachment III and the data is illustrated below.

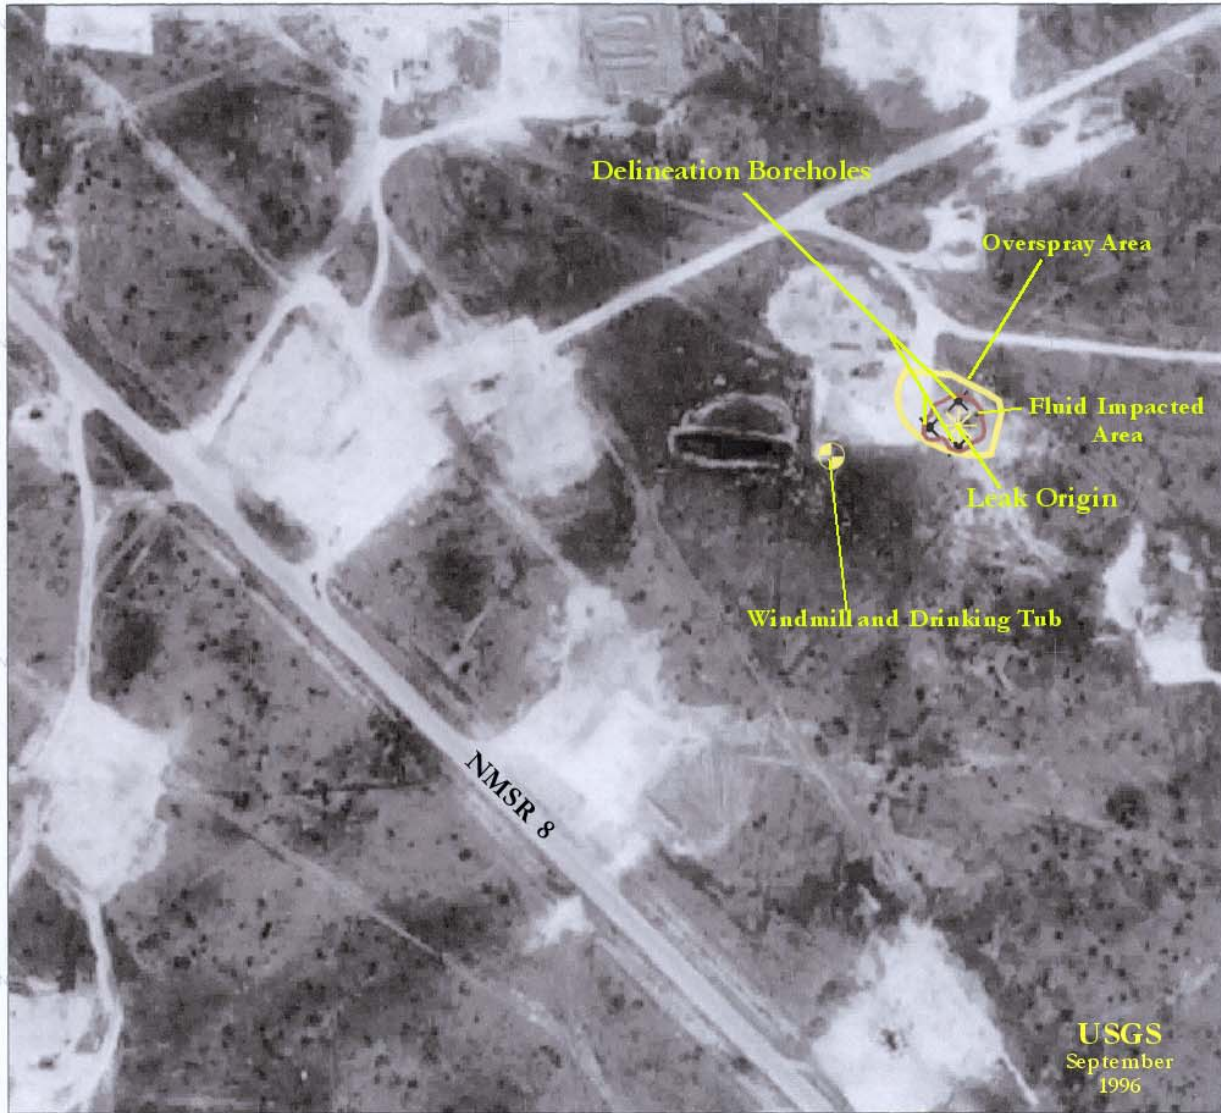
CHEVRONTEXACO
 VACUUM UNIT
 WELL #103
 UL-F SEC 6
 T18S R35E
 LEA Co. NM
 AFFECTED
 SURFACE AREA
 ~16,612 SQFT
