**Re: Site Assessment and Closure Report
Love Shack Federal Com #111H
API No. 30-025-48401
GPS: Latitude 32.03678858 Longitude -103.39598297
UL "M", Sec. 17, T26S, R35E
Lea County, NM
NMOCD Ref. No. NAPP2118732162**

Pima Environmental Services, LLC (Pima) has been contracted by Titus Oil & Gas (Titus) to perform a spill assessment and has prepared this closure report for an acid release that occurred at the Love Shack Federal Com #111H (Love Shack). The initial C-141 was submitted on July 6th, 2021 (Appendix C). This incident was assigned Incident ID NAPP2118732162, by the New Mexico Oil Conservation Division (NMOCD).

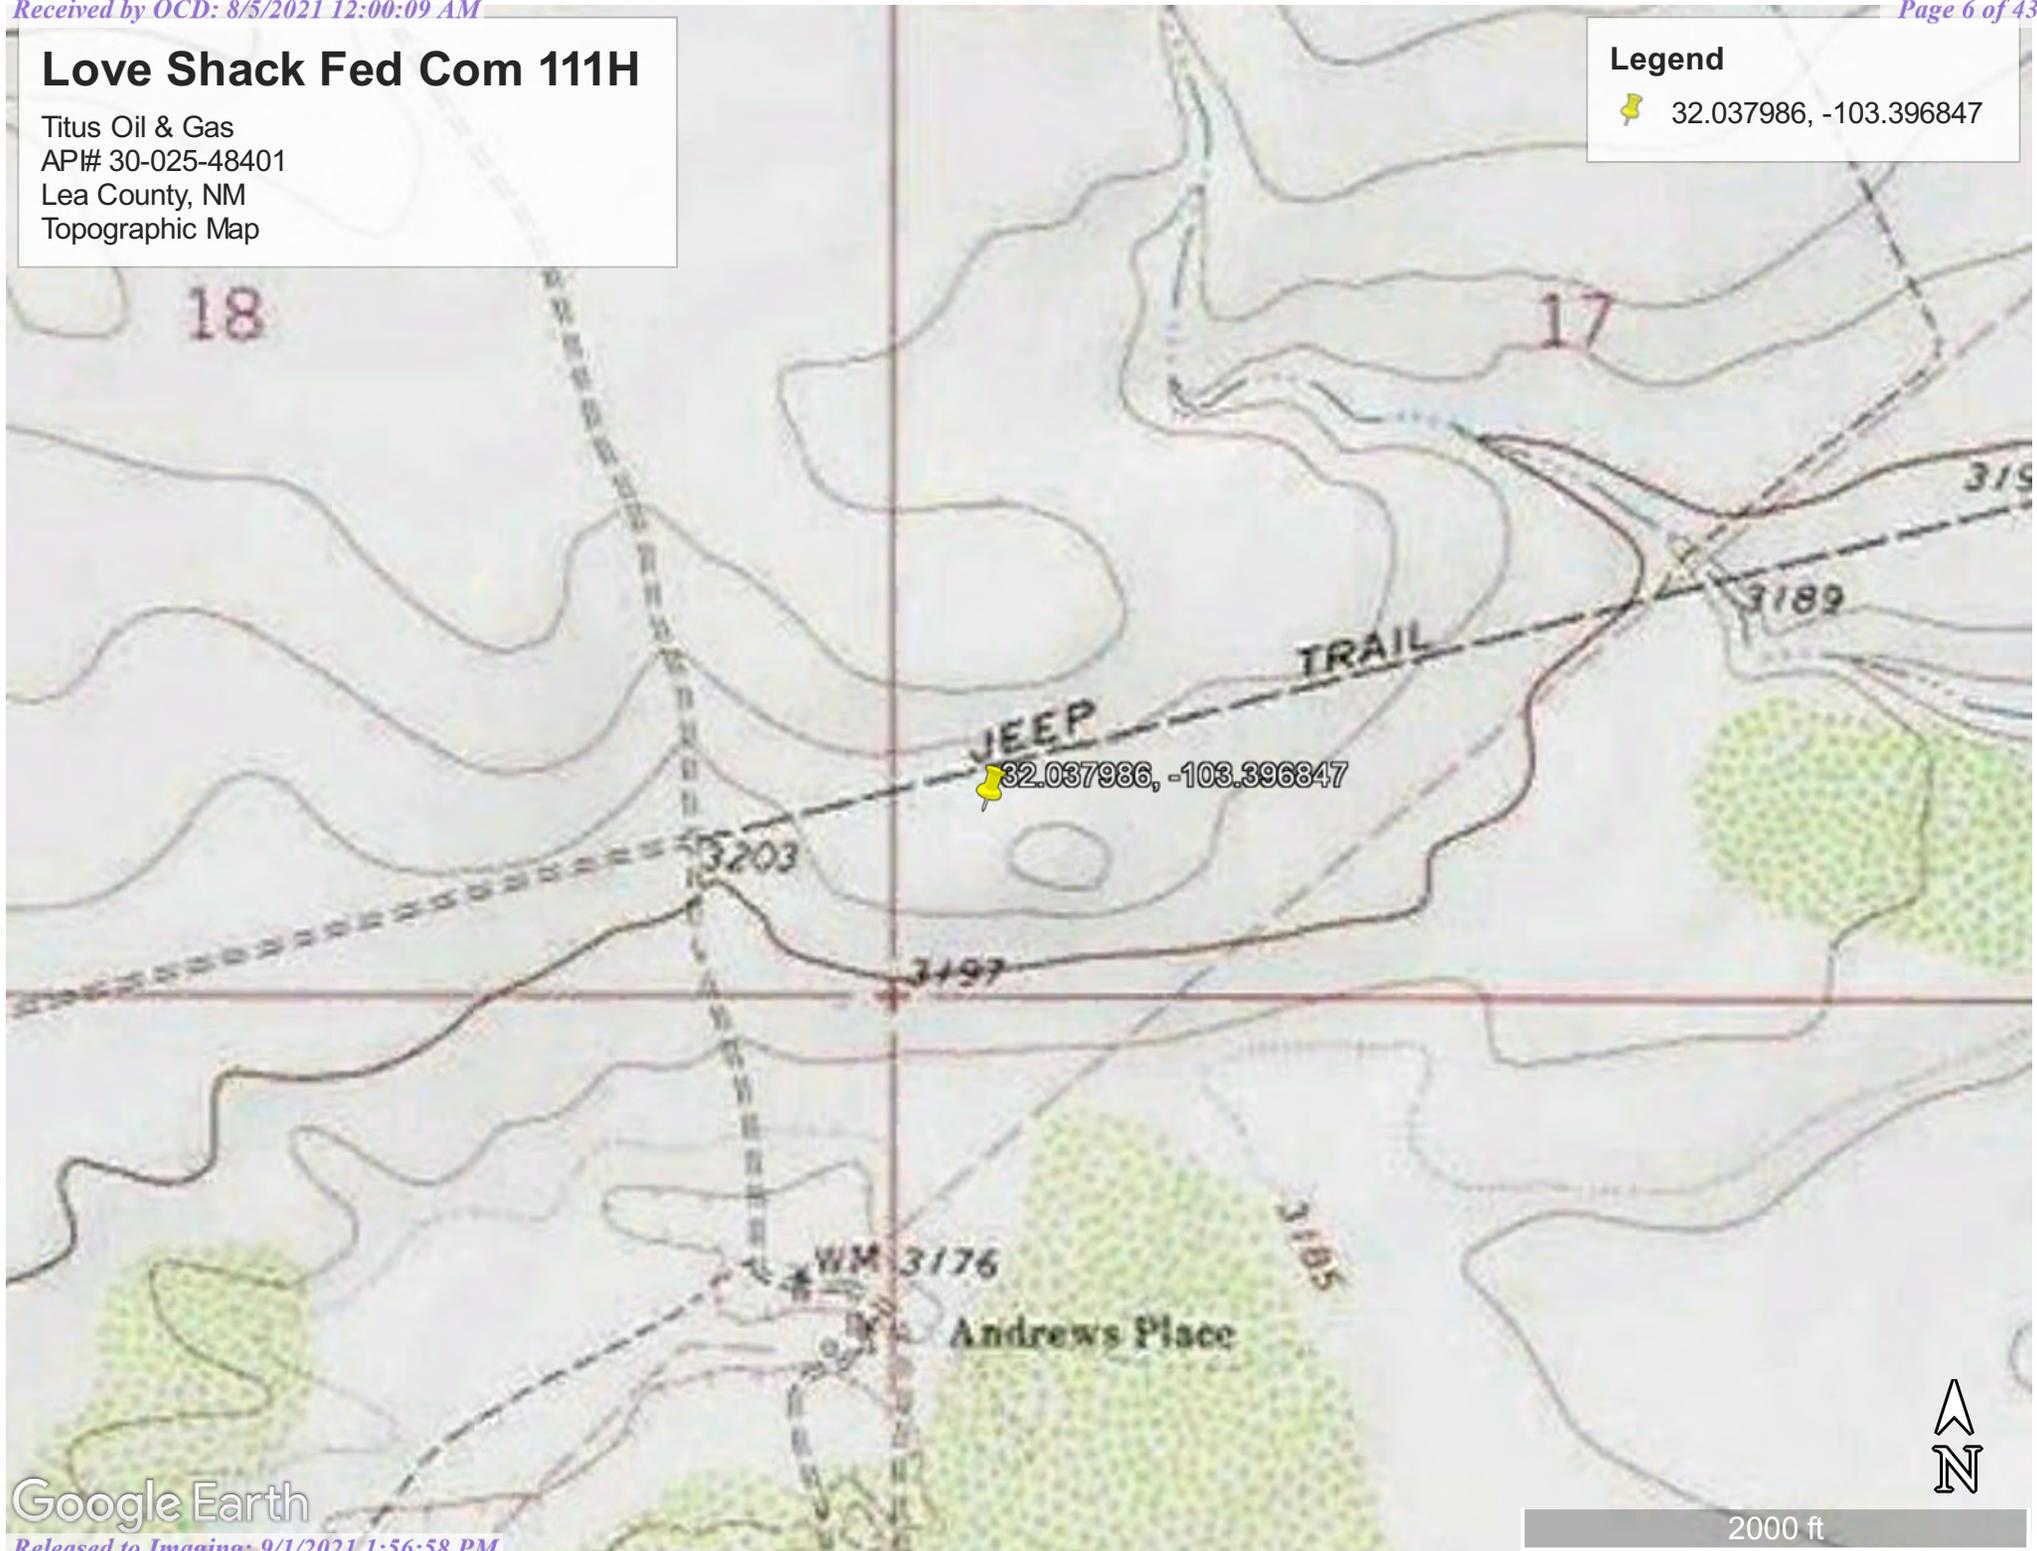
Titus Oil & Gas
AP# 30-025-48401
Lea County, NM
Topographic Map

Reference Figure 2 for a Topographic Map.

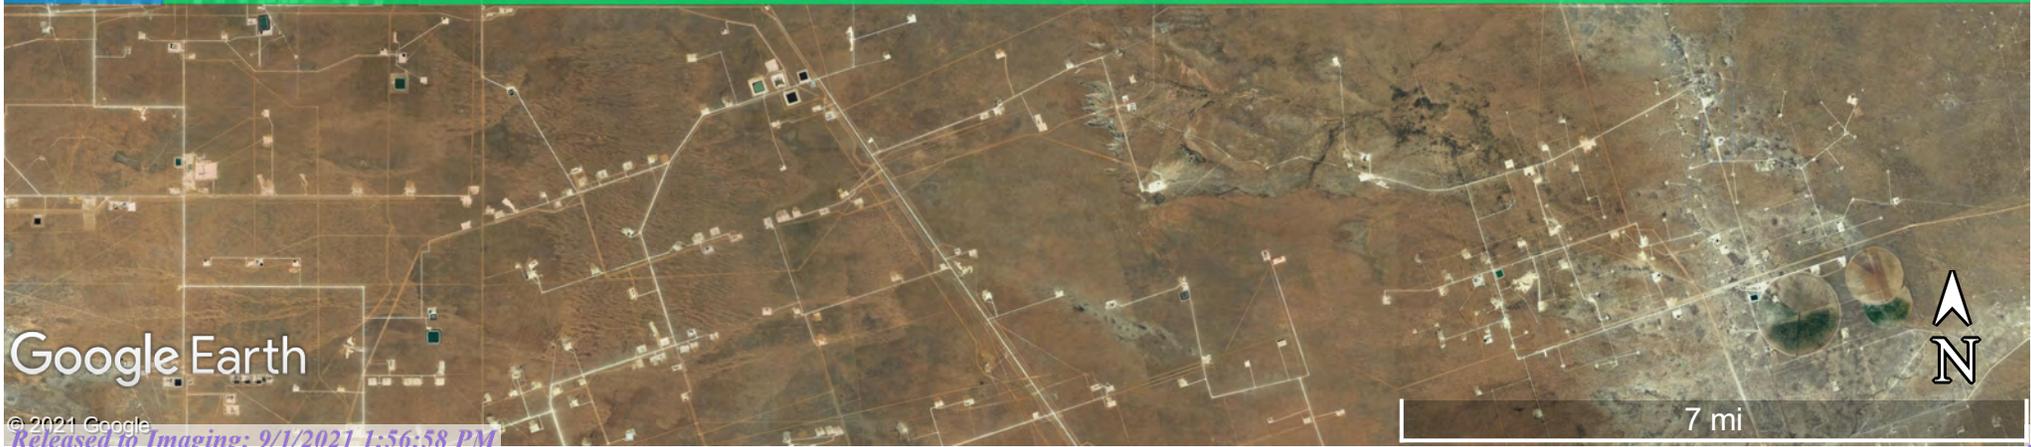
Titus Oil & Gas
API# 30-025-48401
Lea County, NM
Karst Map

Per the New Mexico Bureau of Geology and Mineral Resources, the geology is in the Quaternary Formation- Eolian and piedmont deposits (Holocene to middle Pleistocene). Interlayered eolian sands and piedmont-slope deposits along the eastern flank of the Pecos River valley, primarily between Roswell and Carlsbad. Typically capped by thin eolian deposits. The soil in this area is made up of Kermit-Palomas fine sands, 0 to 12 percent slopes according to the United States Department of Agriculture Natural Resources Conservation Service soil survey (Appendix B). The drainage courses in this area are excessively drained. There is a low potential for karst geology to be present in the area of the Love Shack (Figure 3).

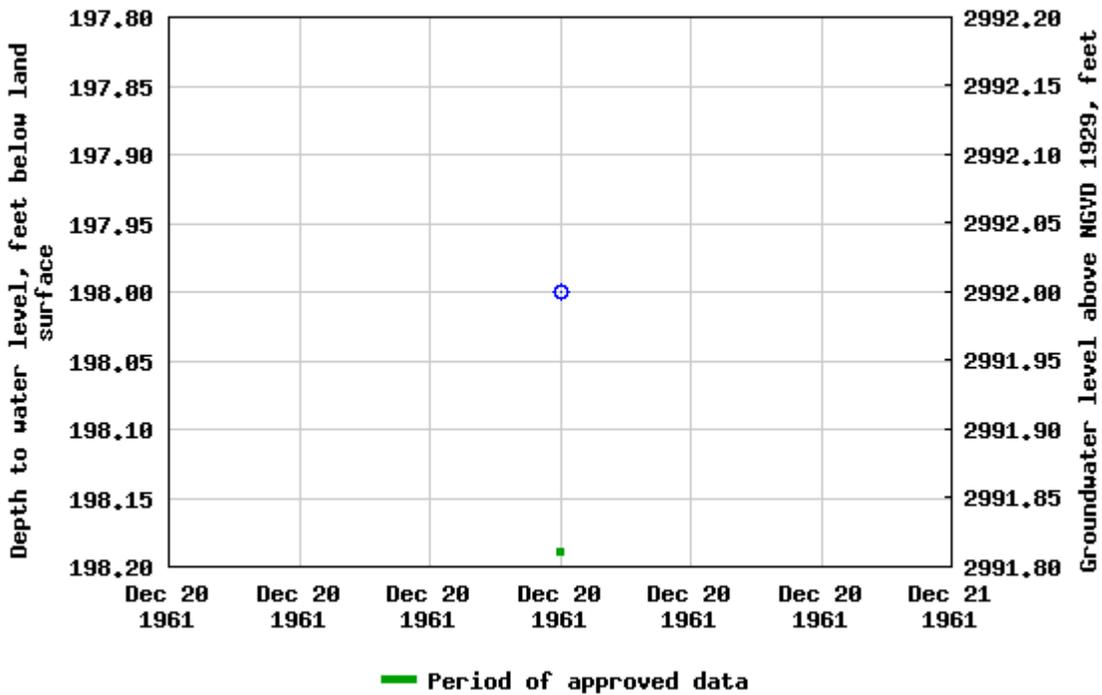
USGS 320150103235501 26S.35E.19.142

According to the New Mexico Office of the State Engineer, depth to the nearest groundwater in this area is 230 feet below grade surface (BGS). According to the United States Geological Survey (USGS), the nearest groundwater is 198 feet BGS. The closest waterway is a playa located approximately 9.03 miles to the southeast of this location. See Appendix A for referenced water surveys and a surface water map.
