**RE: Closure Request
Corral Canyon Fed #4H
Remediation Permit Number 2RP-3713
Eddy County, New Mexico**

LT Environmental, Inc. (LTE), on behalf of XTO Energy, Inc. (XTO), presents the following Closure Request report detailing site assessment, soil sampling, and excavation activities at the Corral Canyon Fed #4H (Site) in Unit P, Section 5, Township 25 South, Range 29 East, in Eddy County, New Mexico (Figure 1). The purpose of the site assessment, soil sampling, and excavation activities was to address impacts to soil after a natural gas fire and release of crude oil and produced water at the Site.

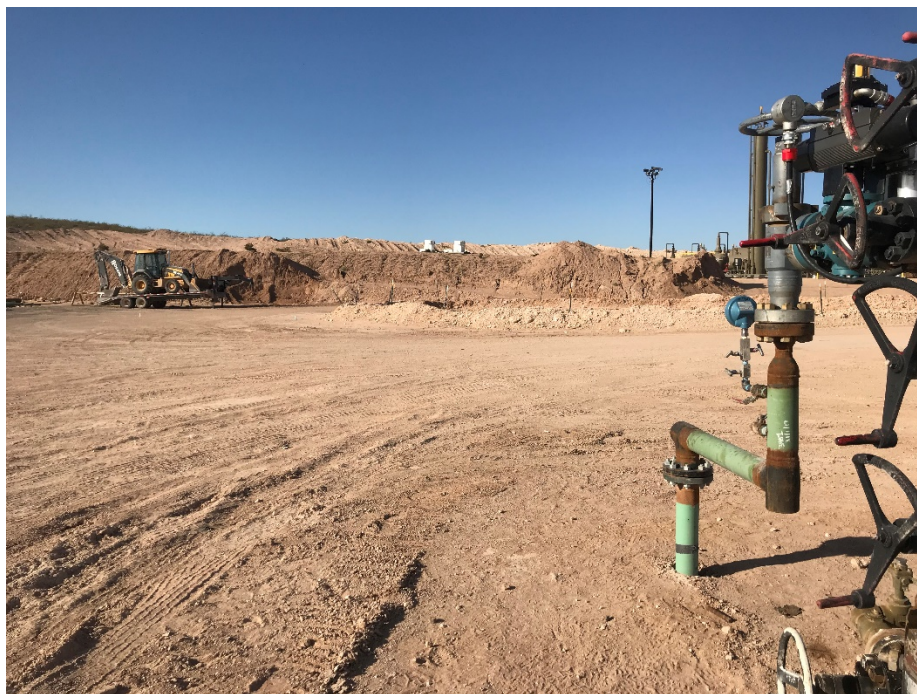
Photograph 1: View of wellhead and former release area, during assessment activities.

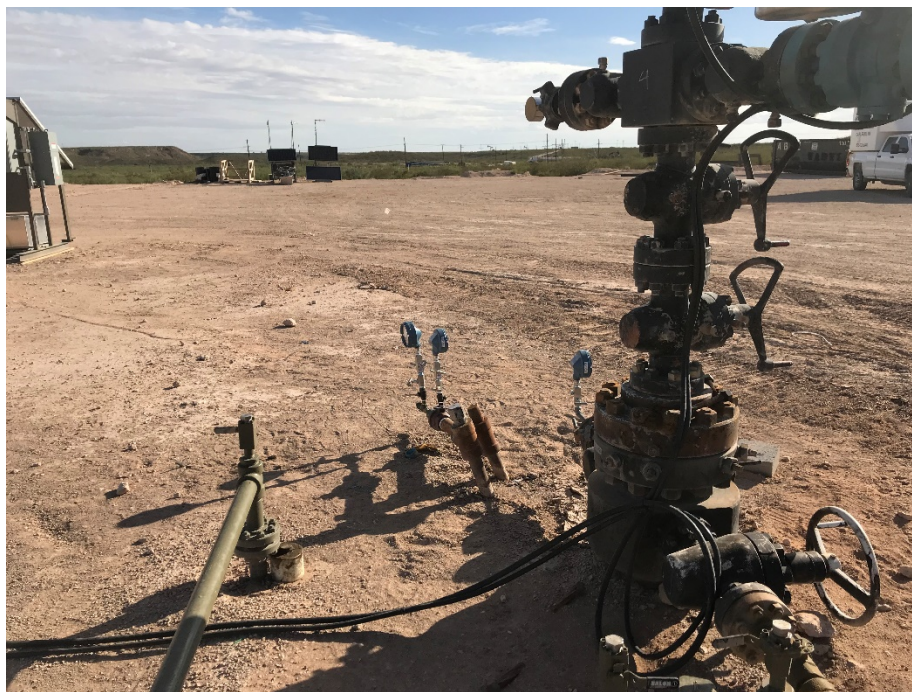
Photograph 2: View of wellhead and former release area, during assessment activities.

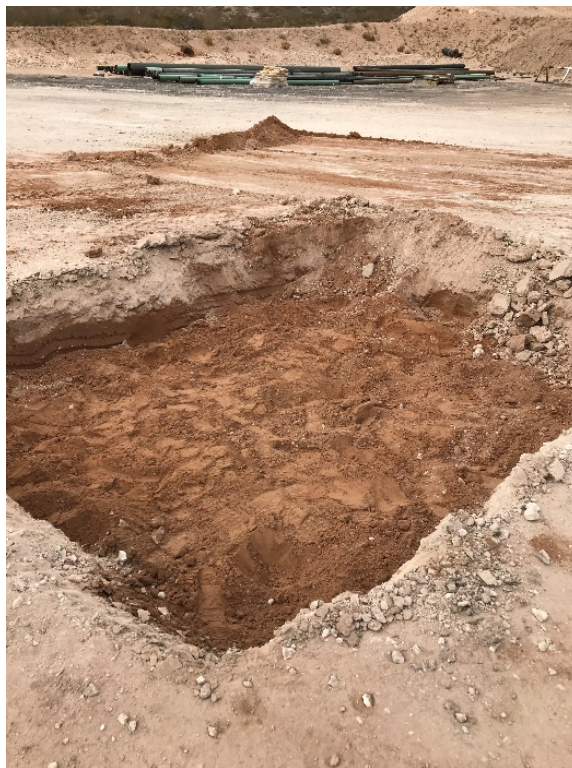
Photograph 3: View of open excavation.

The excavation measured approximately 150 square feet in area and was completed to a depth of 2 feet bgs. A total of approximately 15 cubic yards of impacted soil were removed from the excavation. The impacted soil was transported and properly disposed of at the R360 Landfill located in Hobbs, New Mexico.

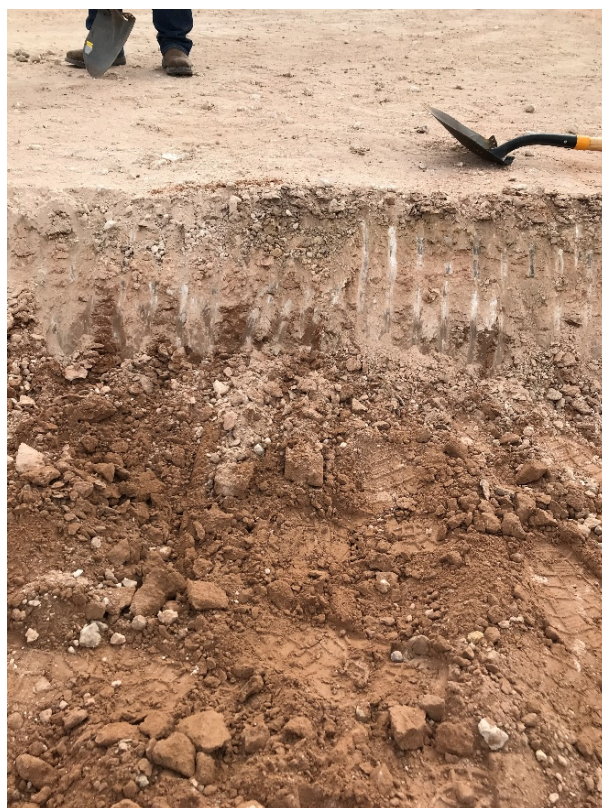
Photograph 4: View of open excavation.

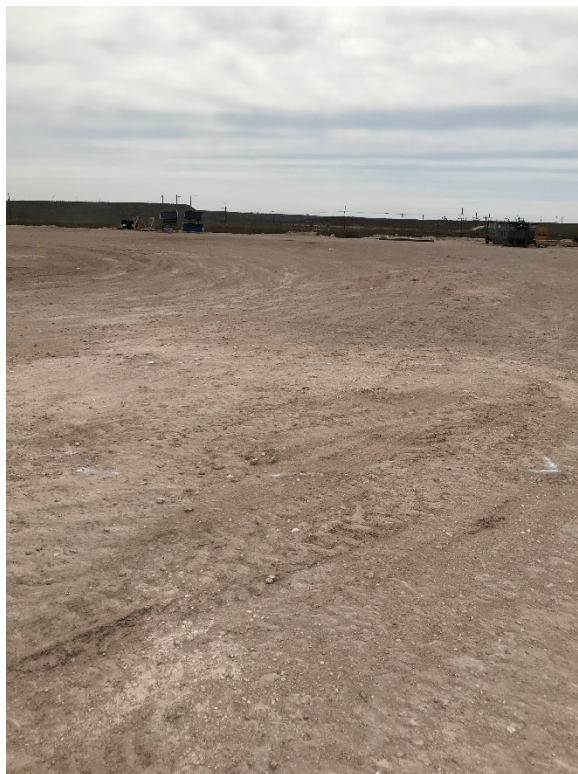
Photograph 5: View of backfilled excavation.

Initial response efforts, natural attenuation, and excavation of impacted soil have mitigated impacts at this Site. XTO requests no further action for RP Number 2RP-3713. XTO backfilled the excavation with material purchased locally and recontoured the Site to match pre-existing site conditions. An updated NMOCD Form C-141 is included in Attachment 1.

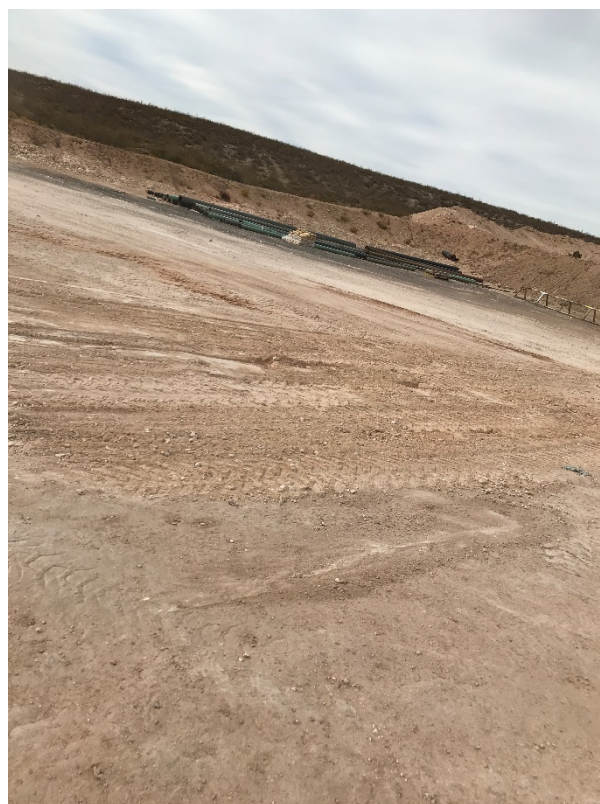
Photograph 6: View of backfilled excavation.
