Re: Site Assessment and Closure Report
Pure Grace State #001
API No. 30-015-24119
GPS: Latitude 32.2595024 Longitude -104.1760178
UL "J", Sec. 34, T23S, R27E
Eddy County, NM
NMOCD Ref. No. 2RP-2995

Pima Environmental Services, LLC (Pima) has been contracted by Devon Energy Production Company (Devon) to perform a spill assessment and has prepared this Closure Report for a produced water and oil release that occurred at the Pure Grace State #1 (Pure Grace). The initial C-141 was submitted on May 7, 2015 (Appendix C). This incident was assigned 2RP-2995, Incident ID NAB1513152308, by the New Mexico Oil Conservation Division (NMOCD).

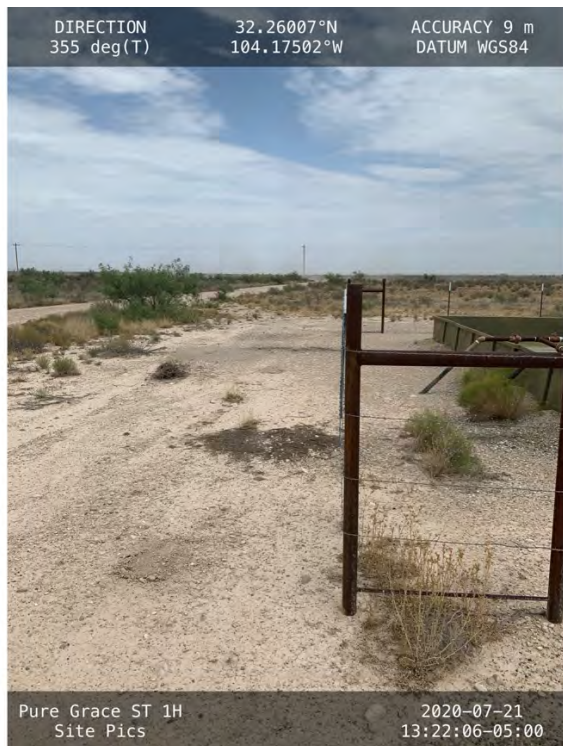
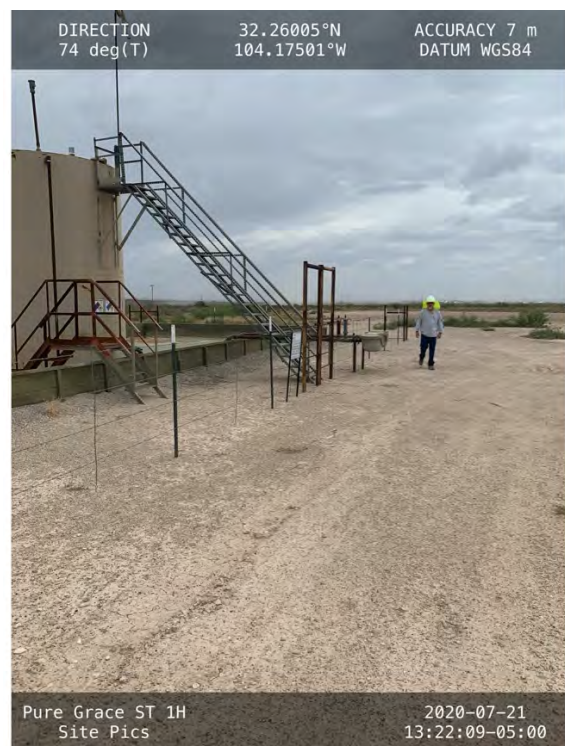
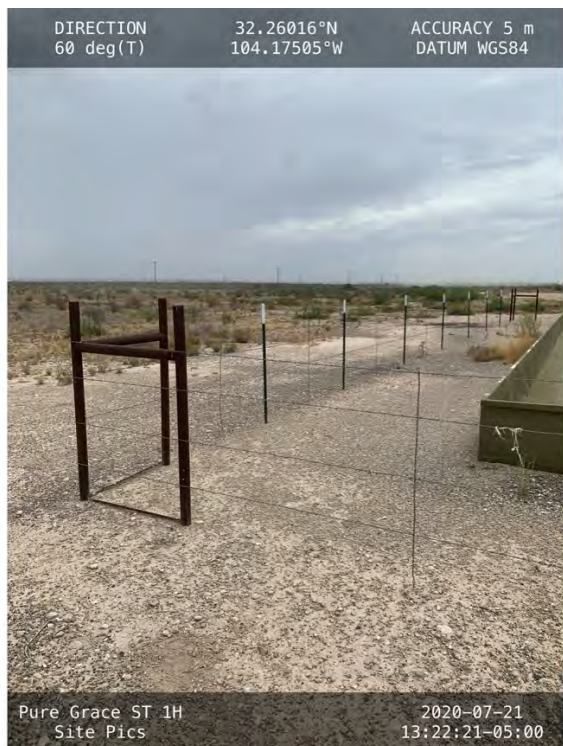
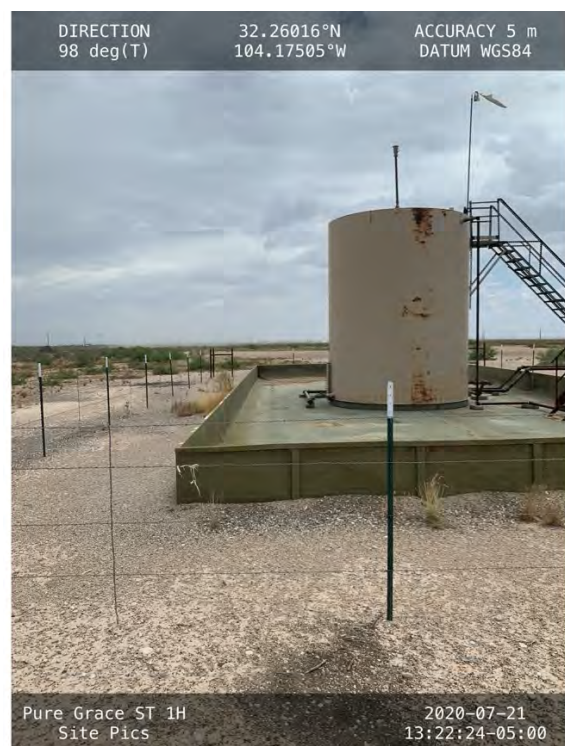
Appendix D:
Photographs

On July 23, 2020, Pima Environmental conducted a site assessment and obtained soil samples to confirm the integrity of the liner, and the containment was not breached. The laboratory results of this sampling event can be found in the following data table.

The sample results were below NMOCD Closure Criteria 19.15.29 NMAC. Based on these findings, no remediation activities were needed at this location.
