## Remediation Summary & Soil Closure Request

**ETC Texas Pipeline, Ltd.**

**Rajin Cajin Pipeline**

**NMOCD Reference No. nAPP2121030753**

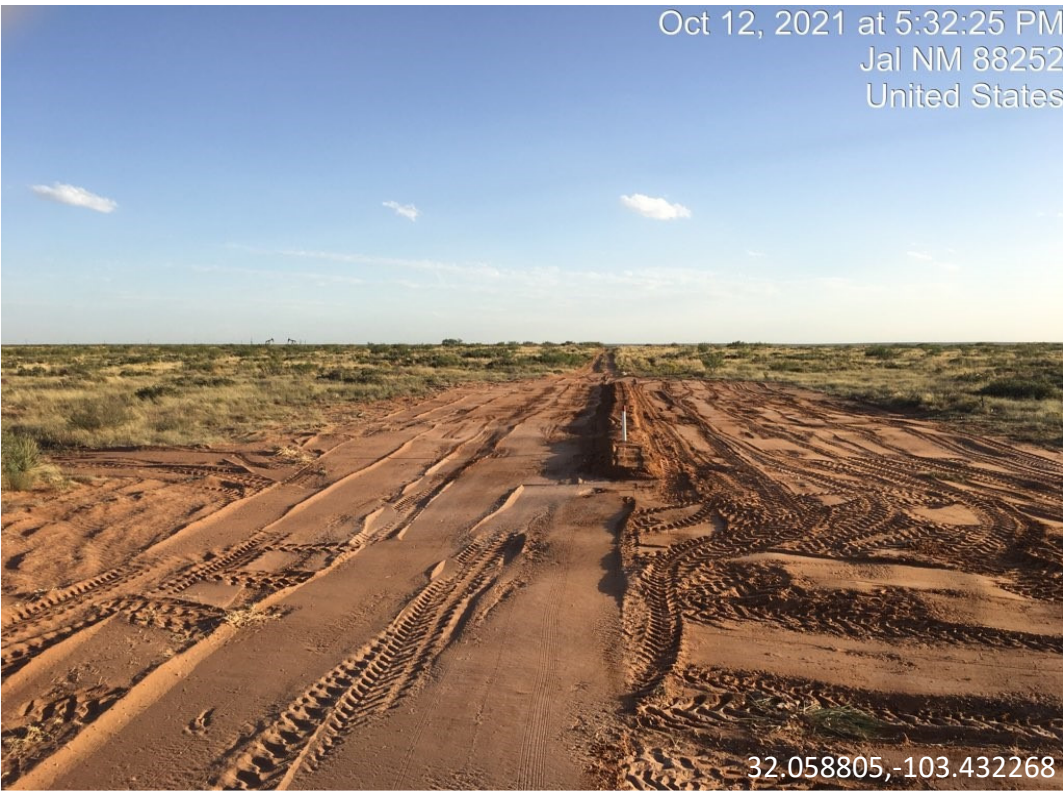
<b>Photo Number:</b> 7	<div>Oct 12, 2021 at 5:32:25 PM Jal NM 88252 United States</div>

<div>32.058805,-103.432268</div>
<b>Photo Direction:</b> South-Southeast	
<b>Photo Description:</b>  View of the remediated area after backfilling and regrading.

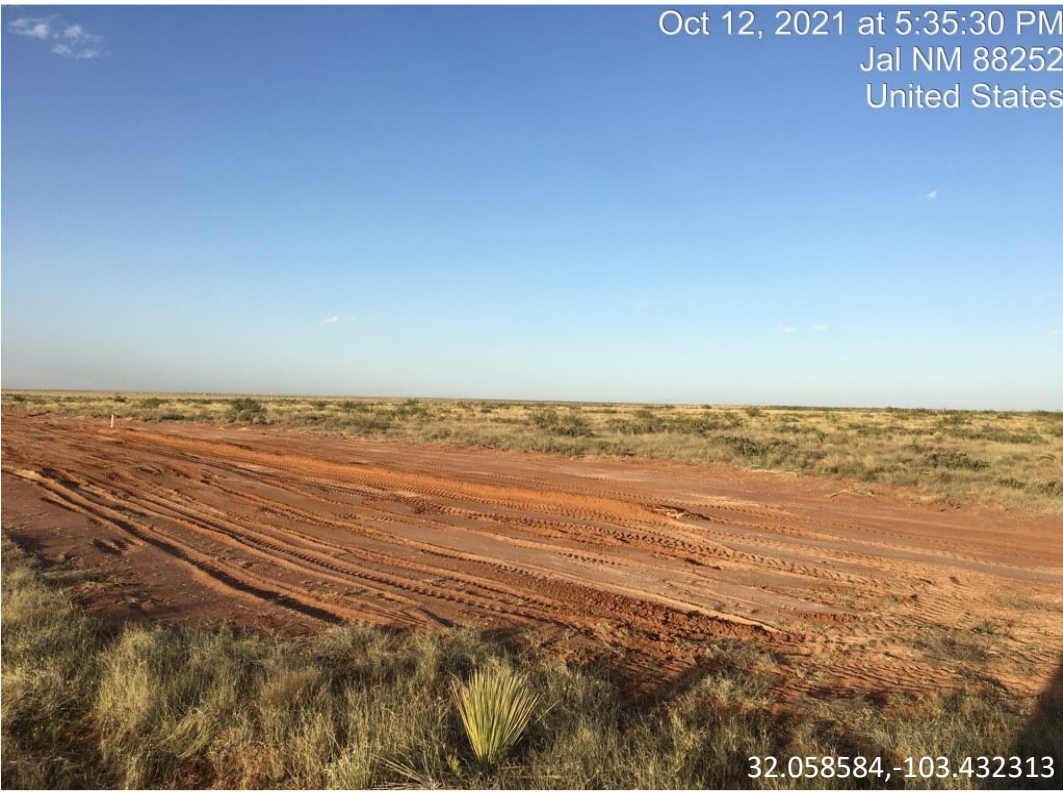
<b>Photo Number:</b> 8	<div>Oct 12, 2021 at 5:35:30 PM Jal NM 88252 United States</div>

<div>32.058584,-103.432313</div>
<b>Photo Direction:</b> Northeast	
<b>Photo Description:</b>  View of the remediated area after backfilling and regrading.
