**RE: Closure Request
James Ranch Unit DI 2
Incident Number nAPP2113941916
Eddy County, New Mexico**

WSP USA Inc. (WSP) on behalf of XTO Energy, Inc. (XTO), presents the following Closure Request detailing site assessment and soil sampling activities at the James Ranch Unit DI 2 (Site) in Unit K, Section 25, Township 22 South, Range 30 East, in Eddy County, New Mexico (Figure 1). The purpose of the site assessment and soil sampling activities was to assess for the presence or absence of impacts to soil following a release of crude oil at the Site. Based on field observations, field screening activities, and soil sample analytical results, XTO is submitting this Closure Request and requesting no further action (NFA) for Incident Number nAPP2113941916.

PHOTOGRAPHIC LOG		
XTO Energy, Inc.	James Ranch Unit DI 2 Eddy County, New Mexico	nAPP2113941916

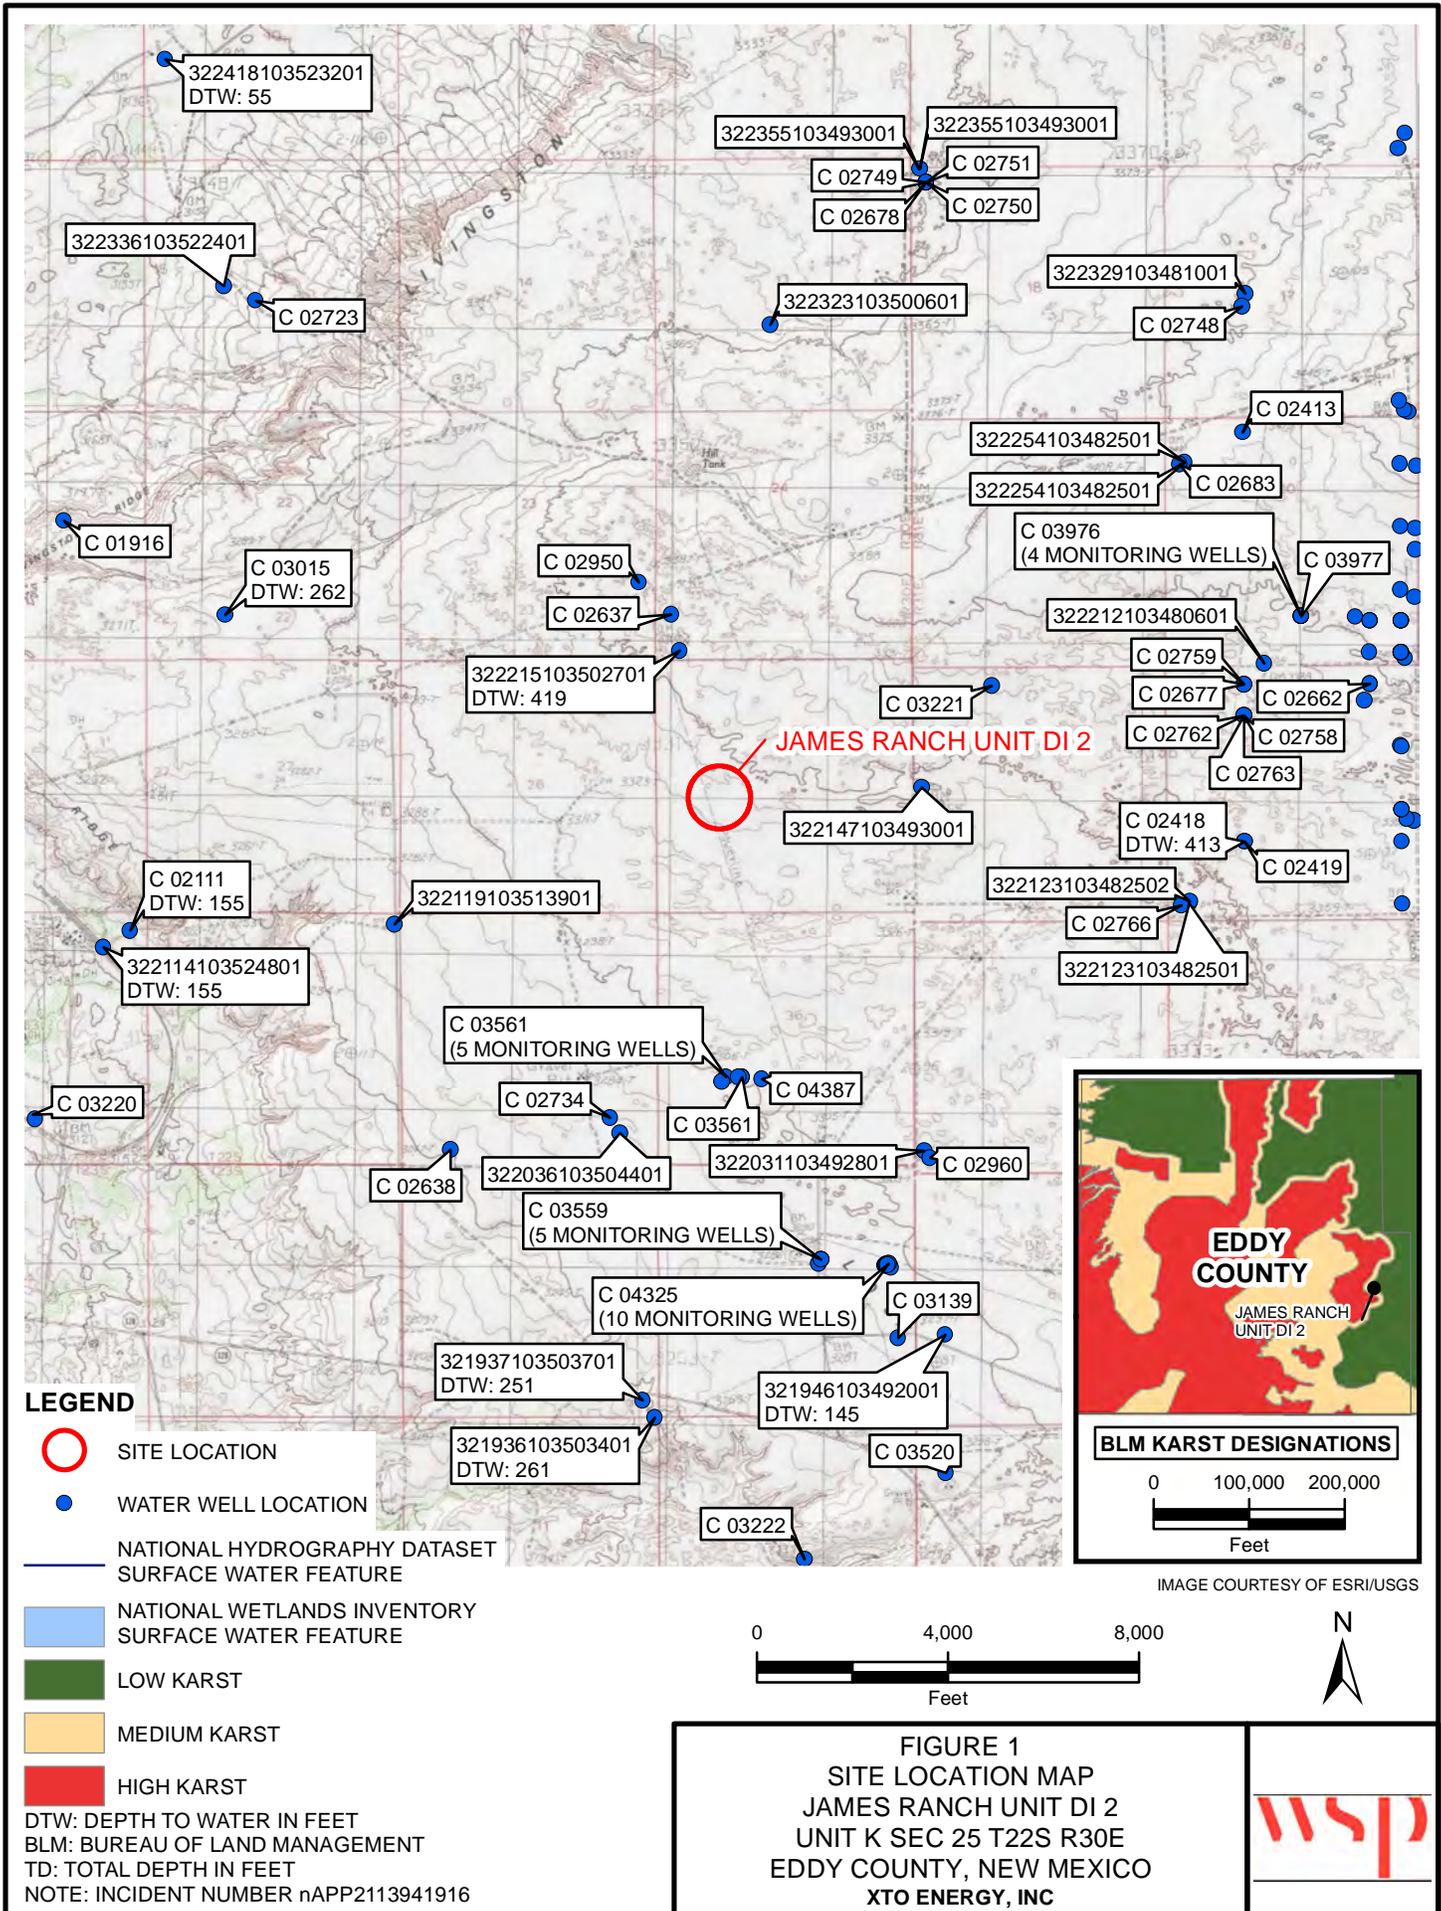
The closest continuously flowing or significant watercourse to the Site is an intermittent riverine, located approximately 5,107 feet northeast of the Site. The Site is greater than 200 feet from a lakebed, sinkhole, or playa lake and greater than 300 feet from an occupied residence, school, hospital, institution, church, or wetland. The Site is greater than 1,000 feet to a freshwater well or spring and is not within a 100-year floodplain or overlying a subsurface mine. The Site is not underlain by unstable geology (low potential karst designation area). Site receptors are identified on Figure 1.

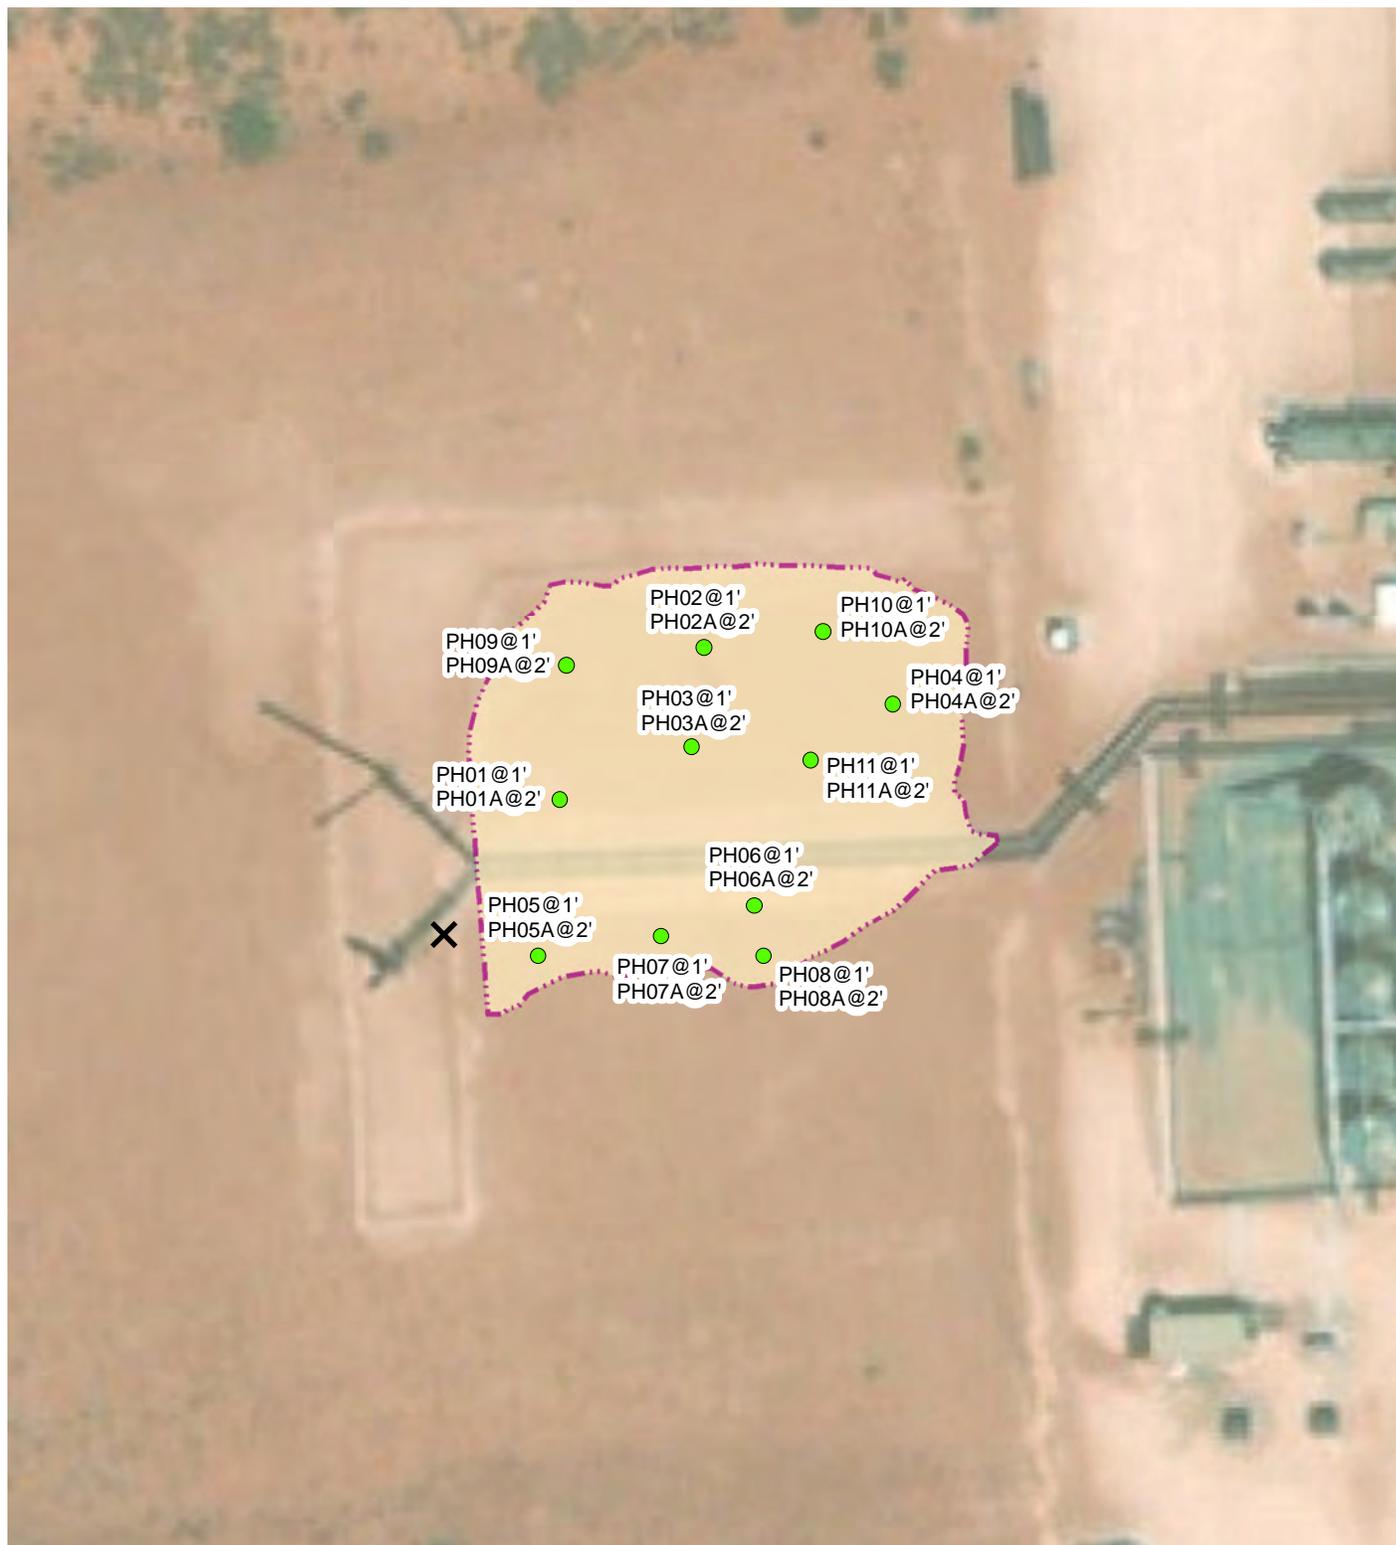
FIGURE 2
DELINEATION SOIL SAMPLE LOCATIONS
 JAMES RANCH UNIT DI 2
 UNIT K SEC 25 T22S R30E
 EDDY COUNTY, NEW MEXICO
 XTO ENERGY, INC.

On July 7, 2021, WSP personnel visited the Site to evaluate the release extent based on information provided on the Form C-141 and visual observations. Eleven potholes (PH01 through PH11) were advanced using a track-mounted backhoe to a depth of approximately 2 feet bgs within the release extent. Delineation soil samples were collected from each pothole from depths of 1-foot and 2 feet bgs. Soil from the potholes was field screened for volatile aromatic hydrocarbons and chloride utilizing a calibrated photoionization detector (PID) and Hach® chloride QuanTab® test strips, respectively. Field screening results and observations for each pothole were logged on lithologic/soil sampling logs, which are included in Attachment 2. The release extent and delineation soil sample locations were mapped utilizing a handheld Global Positioning System (GPS) unit and are depicted on Figure 2. All potholes were backfilled with soil removed. Photographic documentation was conducted during the site visit. Photographs are included in Attachment 3.

Laboratory analytical results for delineation pothole soil samples PH01/PH01A through PH11/PH11A, collected at 1-foot and 2 feet bgs, indicated that benzene, BTEX, TPH-GRO/TPH-DRO, TPH, and chloride concentrations were compliant with the Closure Criteria. The laboratory analytical results are summarized in Table 1 and the complete laboratory analytical reports are included in Attachment 4.

Site assessment activities were conducted at the Site to assess for the presence or absence of impacted soil resulting from the May 17, 2021 crude oil fire. Laboratory analytical results for the soil samples collected within the release extent, indicated that benzene, BTEX, TPH-GRO/TPH-DRO, TPH, and chloride concentrations were compliant with the Site Closure Criteria and compliant with the most stringent Table 1 Closure Criteria. Based on the soil sample analytical results, no impacted soil was identified, and no further remediation was required. As such, XTO respectfully requests no further action for Incident Number nAPP2113941916.

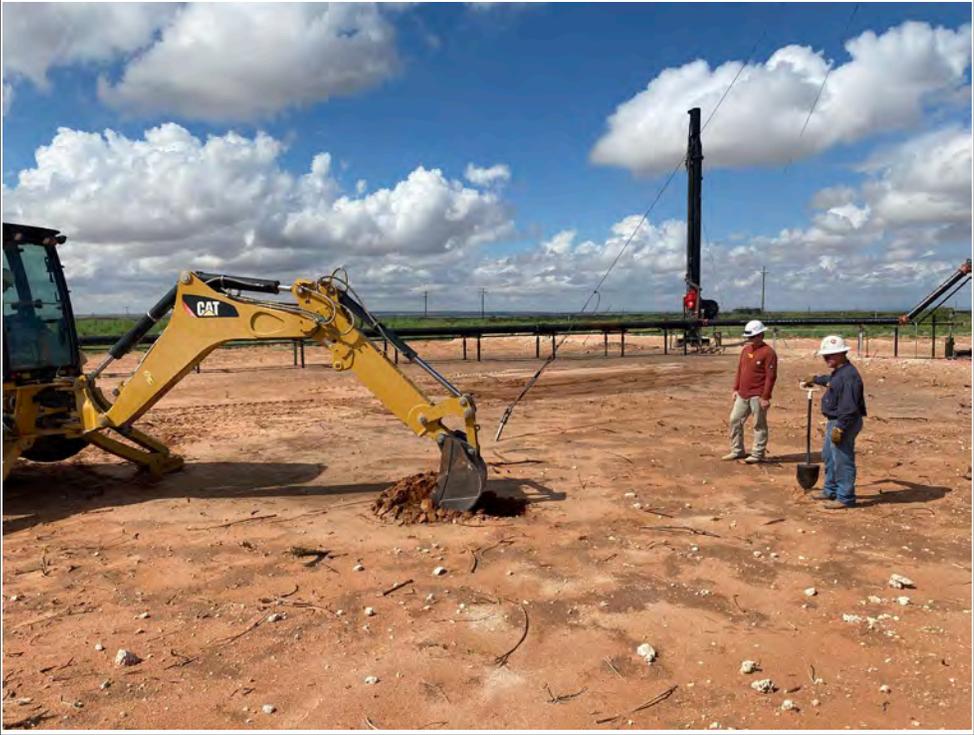
Photo No.	Date	
1	July 7, 2021

Southwest facing view of delineation activities.

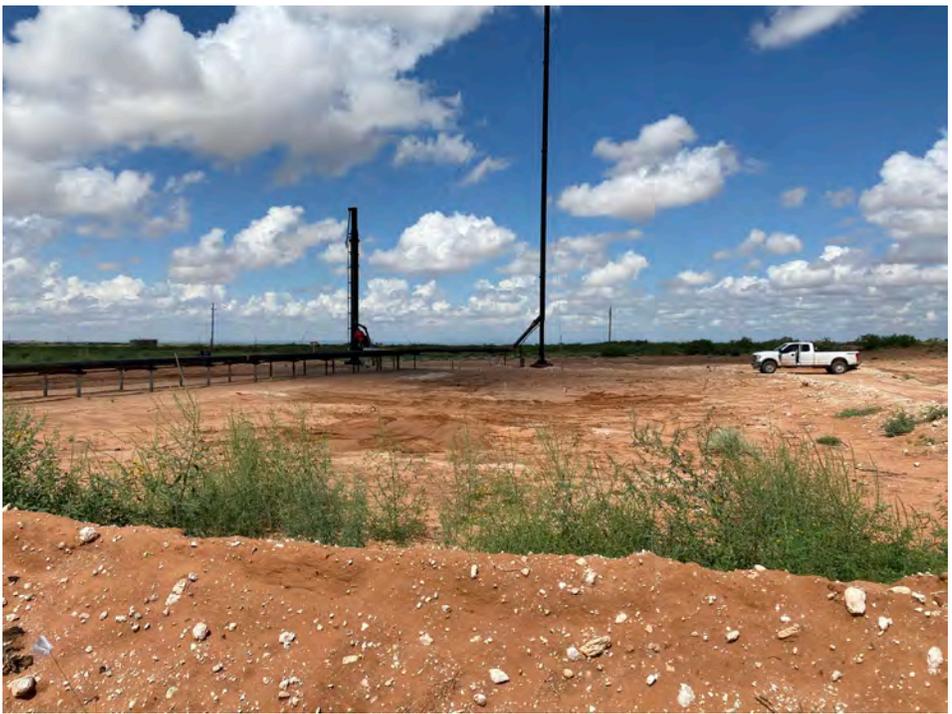
Photo No.	Date	
2	July 7, 2021

Southwest facing view of release extent during delineation activities.
