Report Type: Closure Request 1RP-3280

Site:	Elvis Tank Battery Release					
Company:	ConocoPhillips					
Section, Township and Range	Unit Letters F	Sec. 20	T 17S	R 32E		
Lease Number:	API No. 30-025-33584					
County:	Lea					
Release GPS:	32.82216°			-103.79091°		
Surface Owner:	Federal					
Mineral Owner:						
Directions:	From Maljamar, NM (Hwy 82/Maljamar Rd): Head south on Maljamar Rd. for 2.74 miles. Turn right on Conoco Rd. Head west for 1.62 miles. Turn right onto dirt road. Head north for 0.37 miles. Arrive at location.

**Subject: Closure Request
ConocoPhillips
Elvis Tank Battery Release
Unit Letter F, Section 20, Township 17 South, Range 32 East
Lea County, New Mexico
1RP-3280
Incident ID# NTO1424038926**

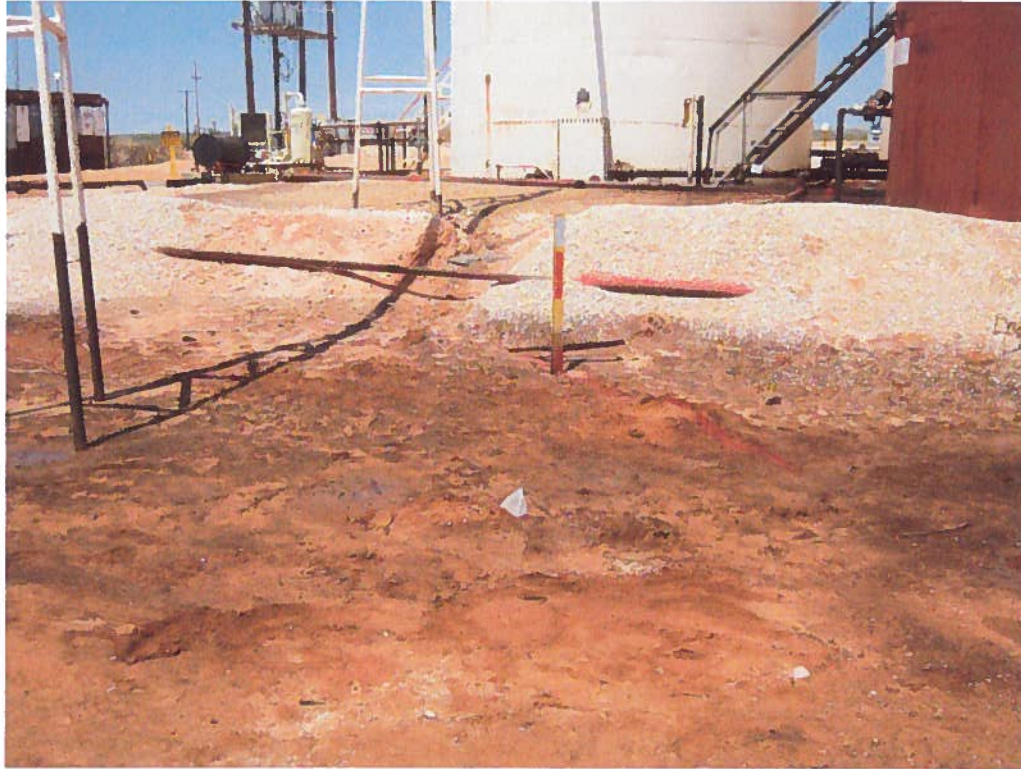
View North – Area of AH-2

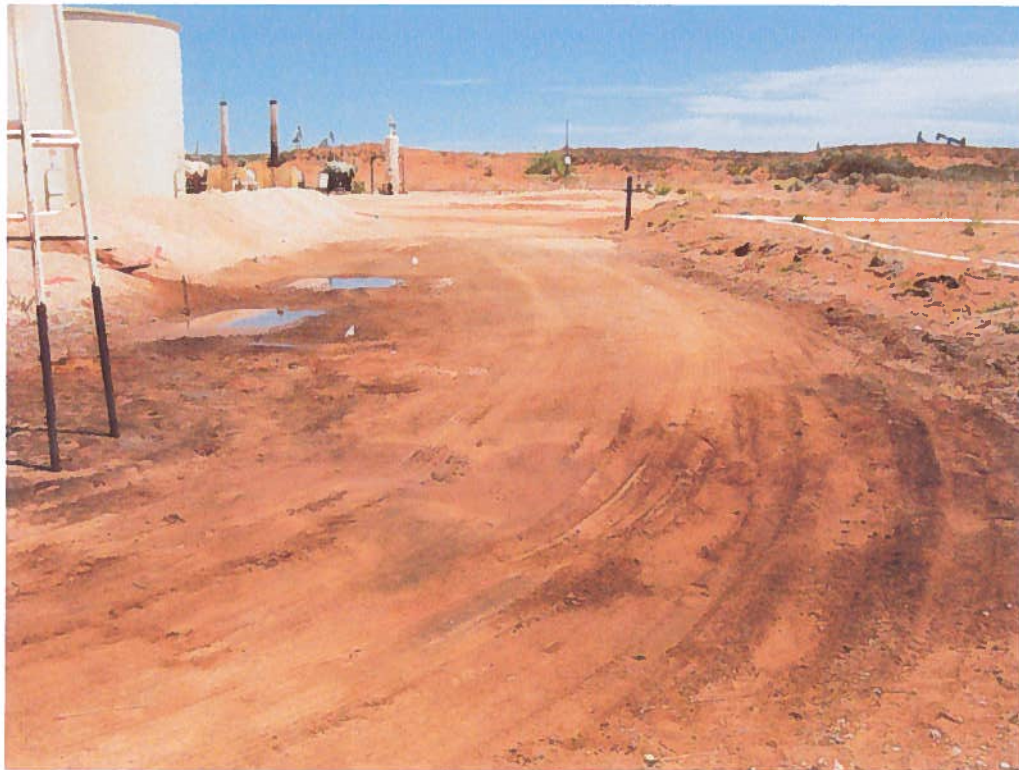
View East – Area of AH-2 and AH-3

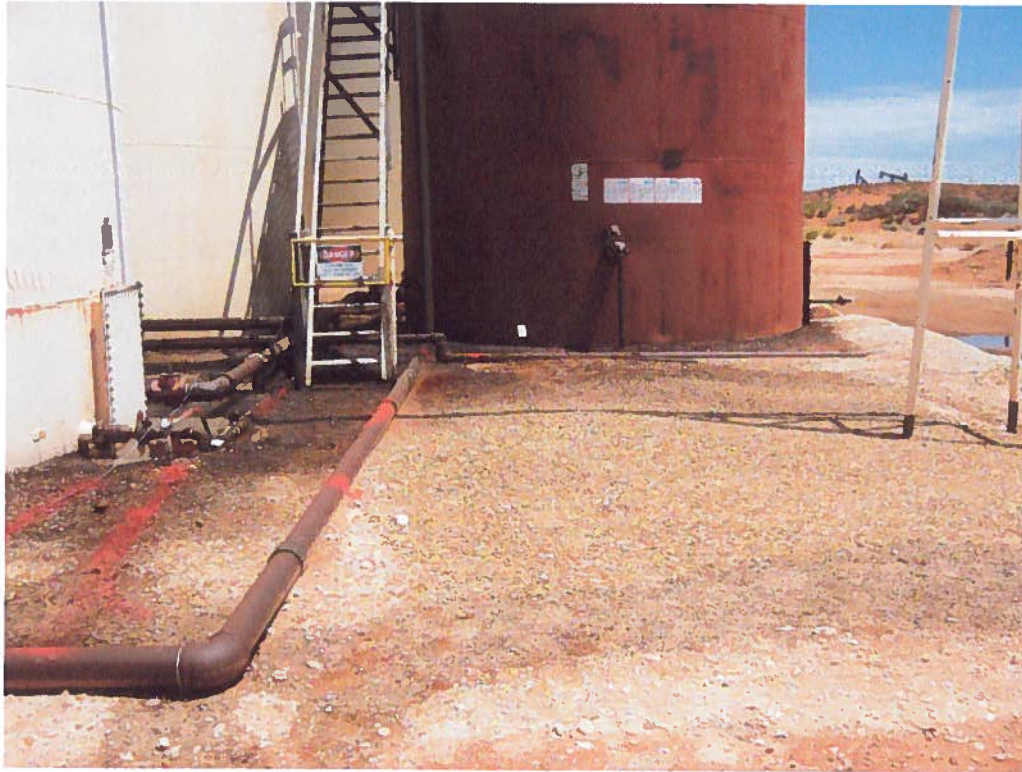
View East – Area of AH-6

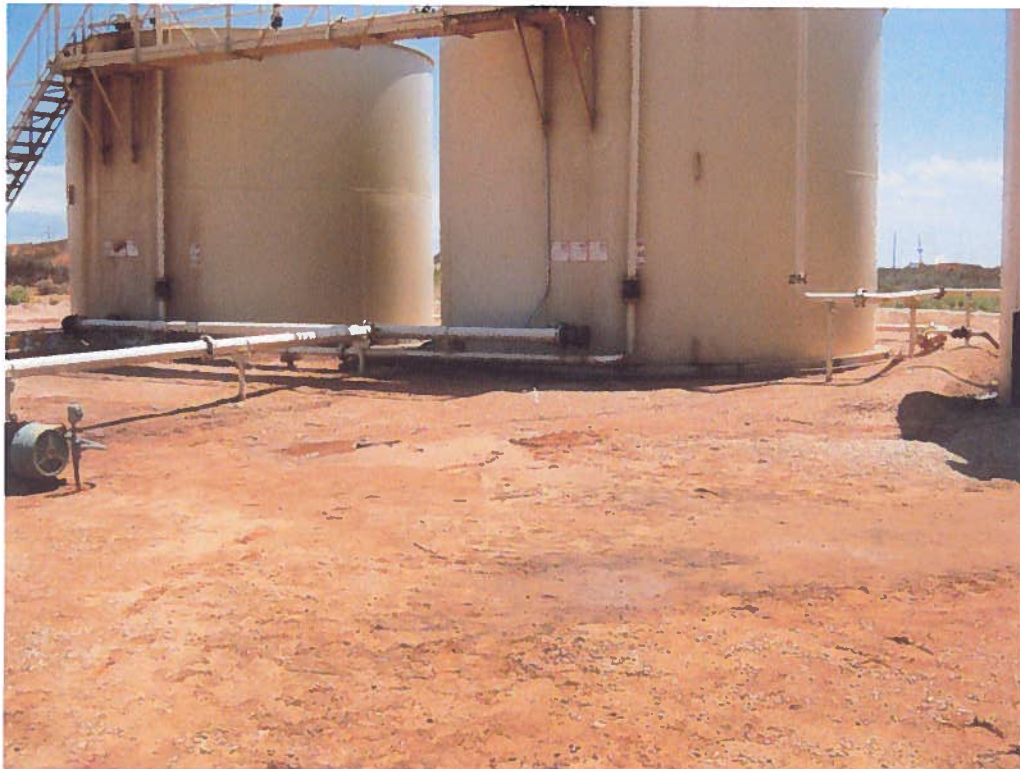
View Southeast – Area of AH-5

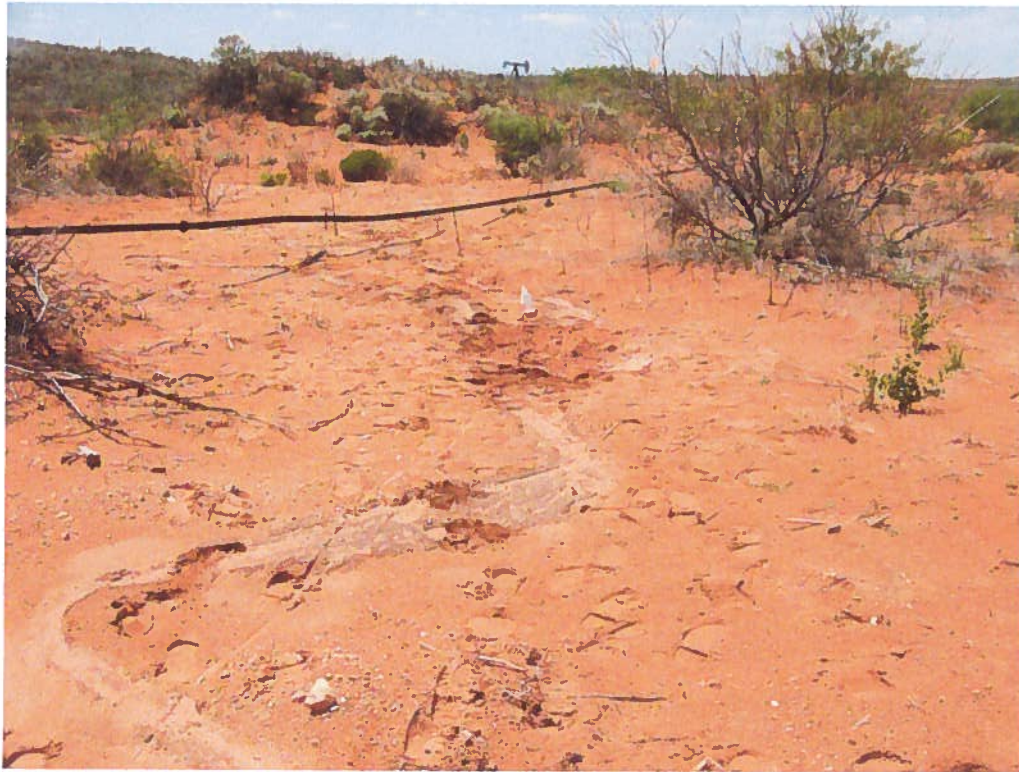
View West – Area of AH-7

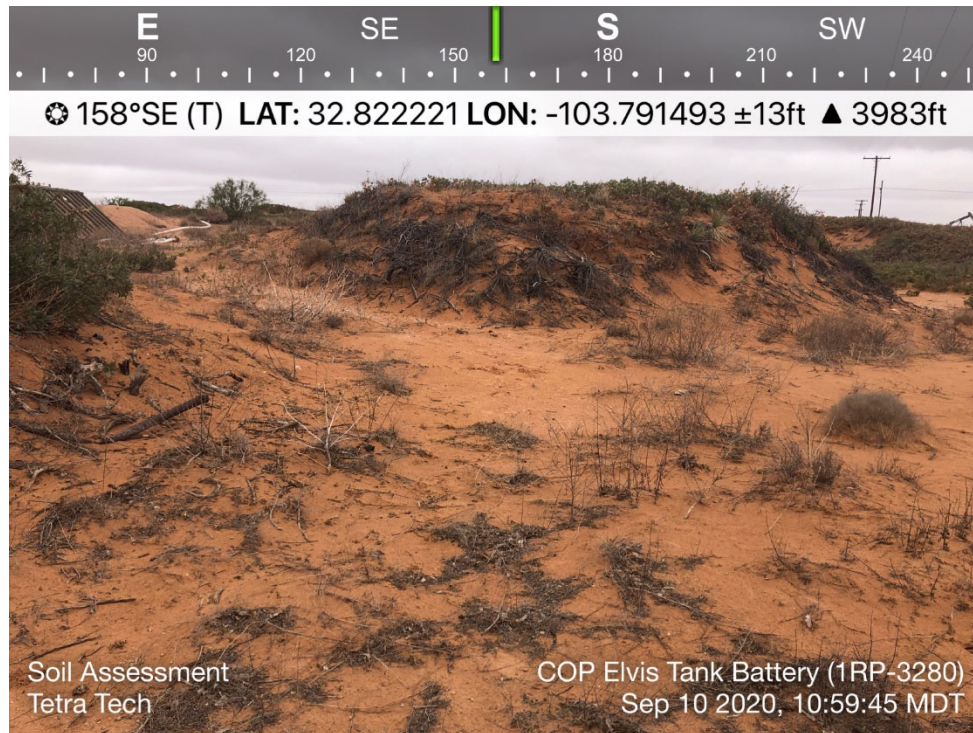
TETRA TECH, INC. PROJECT NO. 212C-MD-02304	DESCRIPTION	View southeast. Central portion of release footprint west of the lease pad.	3
	SITE NAME	Elvis Tank Battery Release – 1RP-3280	9/10/2020
