RICE *Operating Company*

RE: Termination Request**Rice Operating Company – EME SWD System****Vacuum Jct. A-36 (1R425-83): UL/A, Sec. 36, T17S, R34E**

**Vacuum Jct. A-36 (1R425-83)
Unit Letter A, Section 36, T17S, R34E**

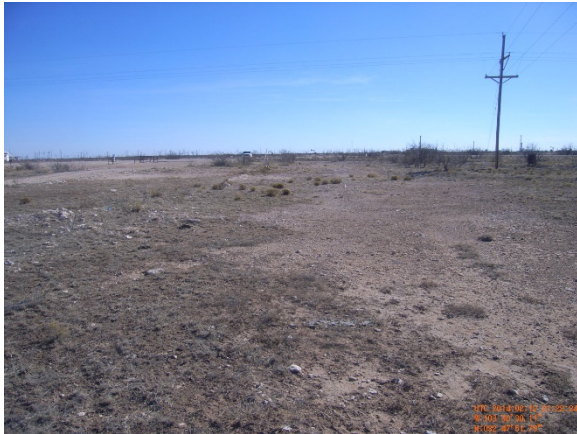
Site prior, facing south 2/12/2014

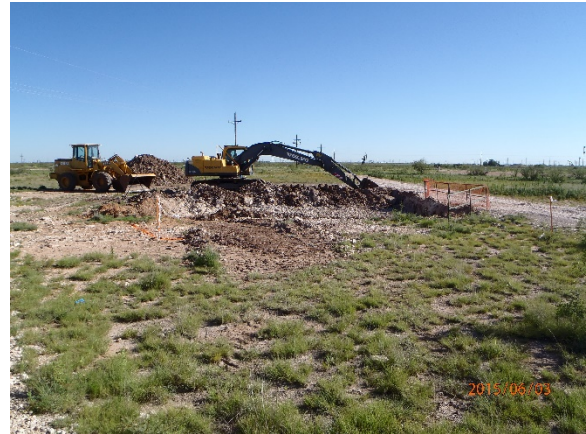
Excavating the site, facing north 6/3/2015

A Corrective Action Plan (CAP) summarizing the soil sampling was submitted to NMOCD and approved on May 15th, 2015. The CAP proposed installing a modified 70x42-ft, 20-mil reinforced liner at a depth of 3.5 ft bgs, due to the presence of hard rock in the area. In June 2015, the area was excavated to a depth of 3.5 ft bgs and the excavation was padded with 6 inches of imported blow sand. A 20-mil reinforced liner was installed and properly seated at a depth of 3 ft bgs. The top of the liner was padded with an additional 6 inches of imported blow sand. Approximately 282 cubic yards of excavated soil were exported to a NMOCD approved facility. The remaining excavated soil was returned to the excavation and imported soil was used to contour the site to the surrounding area. The disturbed area was then seeded with a blend of native vegetation.

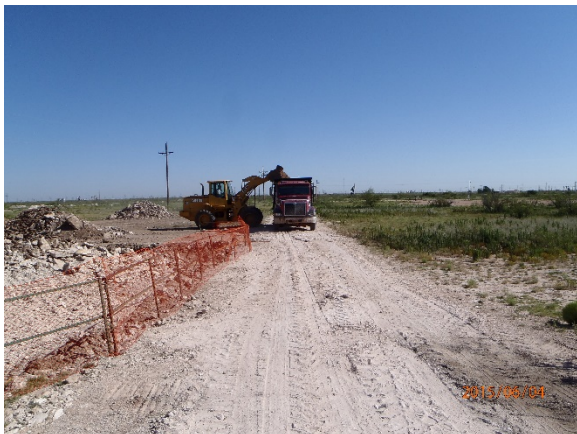
Exporting excavated soil, facing north 6/4/2015

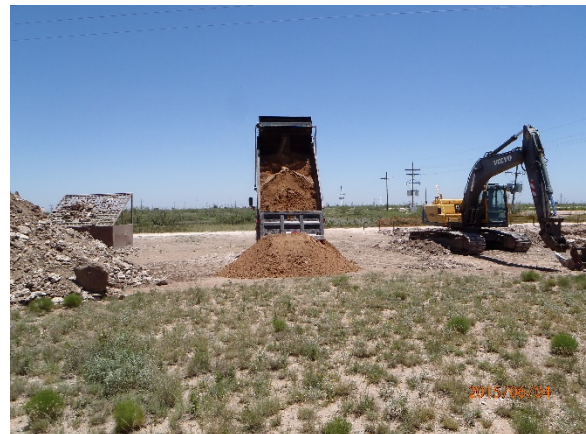
Importing blow sand, facing east 6/4/2015

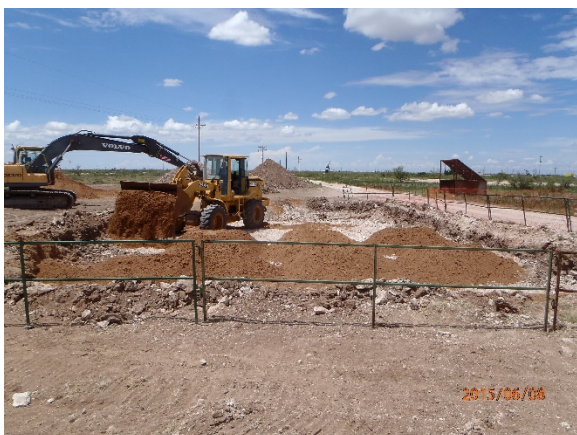
Padding excavation, facing north 6/8/2015

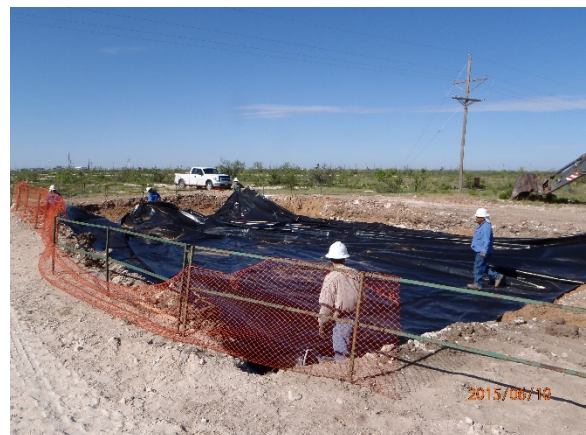
Installing 20-mil, reinforced liner, facing southwest 6/10/2015

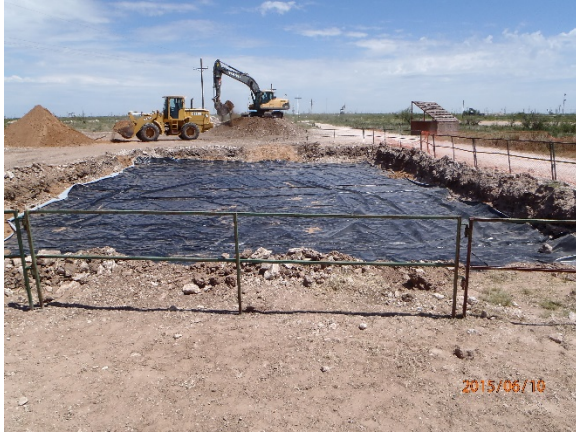
Liner is installed at 3.5 ft bgs, facing north 6/10/2015

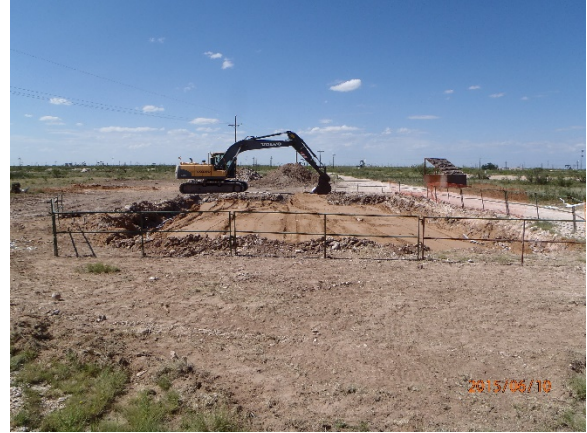
Padding the top of liner, facing north 6/10/2015

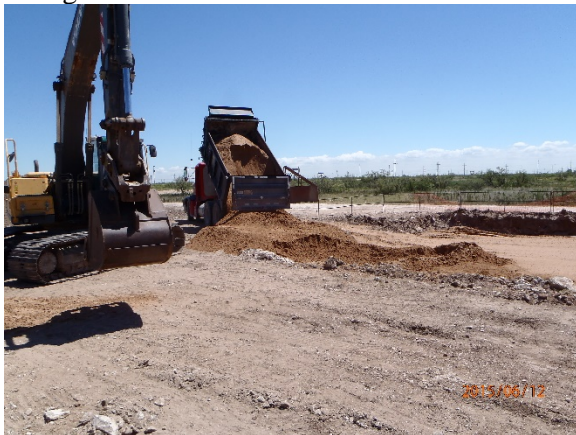
Backfilling with the excavation with imported blow sand, facing northeast 6/12/2015

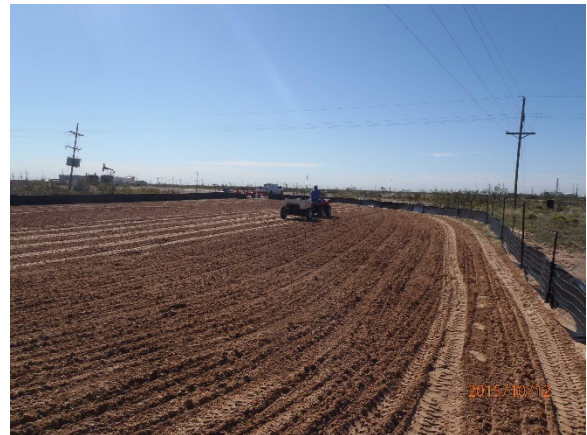
Seeding the backfilled site, facing southeast 10/12/2015

Custom Seed Mix	<input checked="" type="checkbox"/>	Prescribed Mix	<input type="checkbox"/>	Seed Mix Name:	7 lbs of Warm Season, 7 lbs of Blue Grama	Date:	7/14/2015
Broadcast	<input checked="" type="checkbox"/>				Method:	Drop Seeder	
Soil conditions during seed:	Dry	<input checked="" type="checkbox"/>	Damp	<input type="checkbox"/>	Wet		
Observations:	Tilled into soil

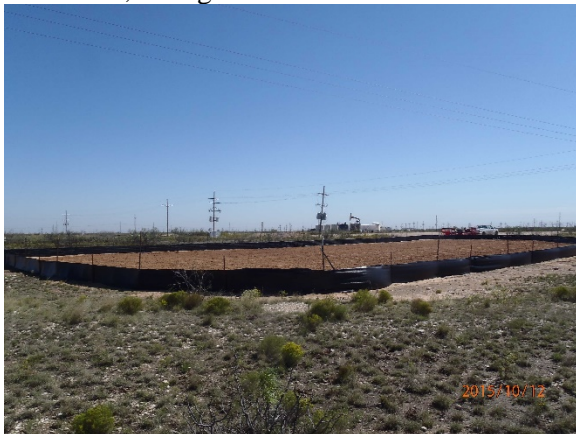
Site complete, facing southeast 10/12/2015

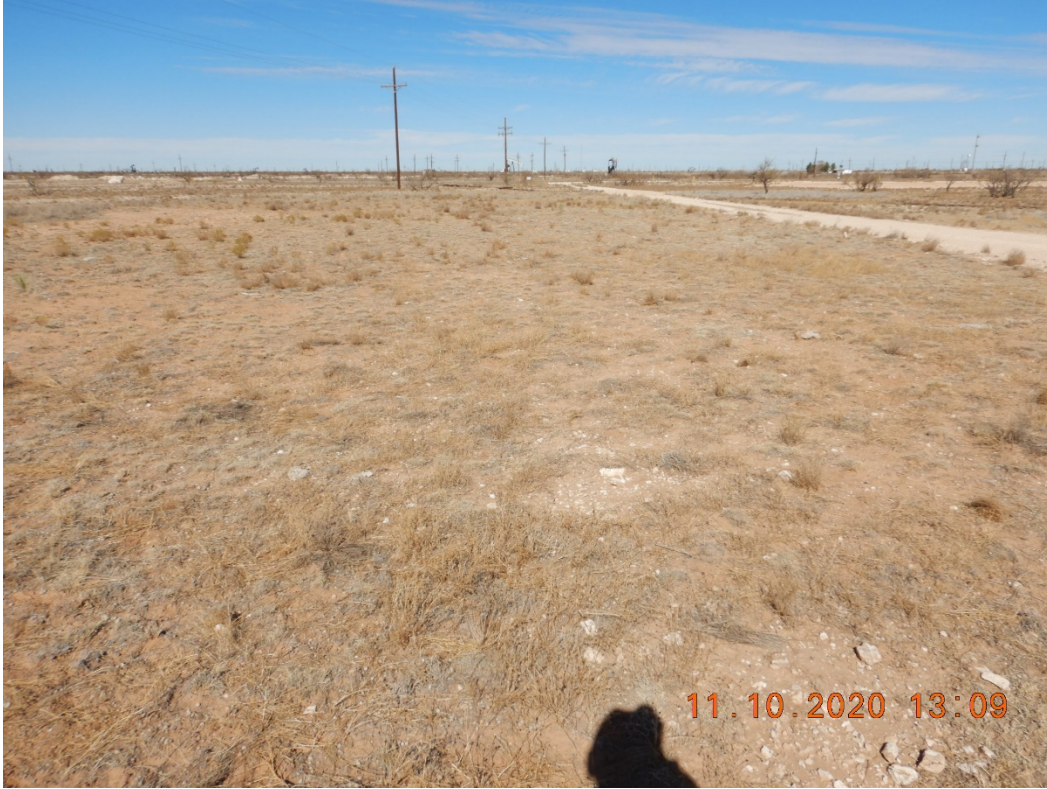
11/10/2020

Facing North
