RE: Termination Request

Rice Operating Company – BD SWD System

BD H-3 (1R426-32): UL/H, Sec. 3, T22S, R37E

Investigation and Characterization Plan (ICP) Report

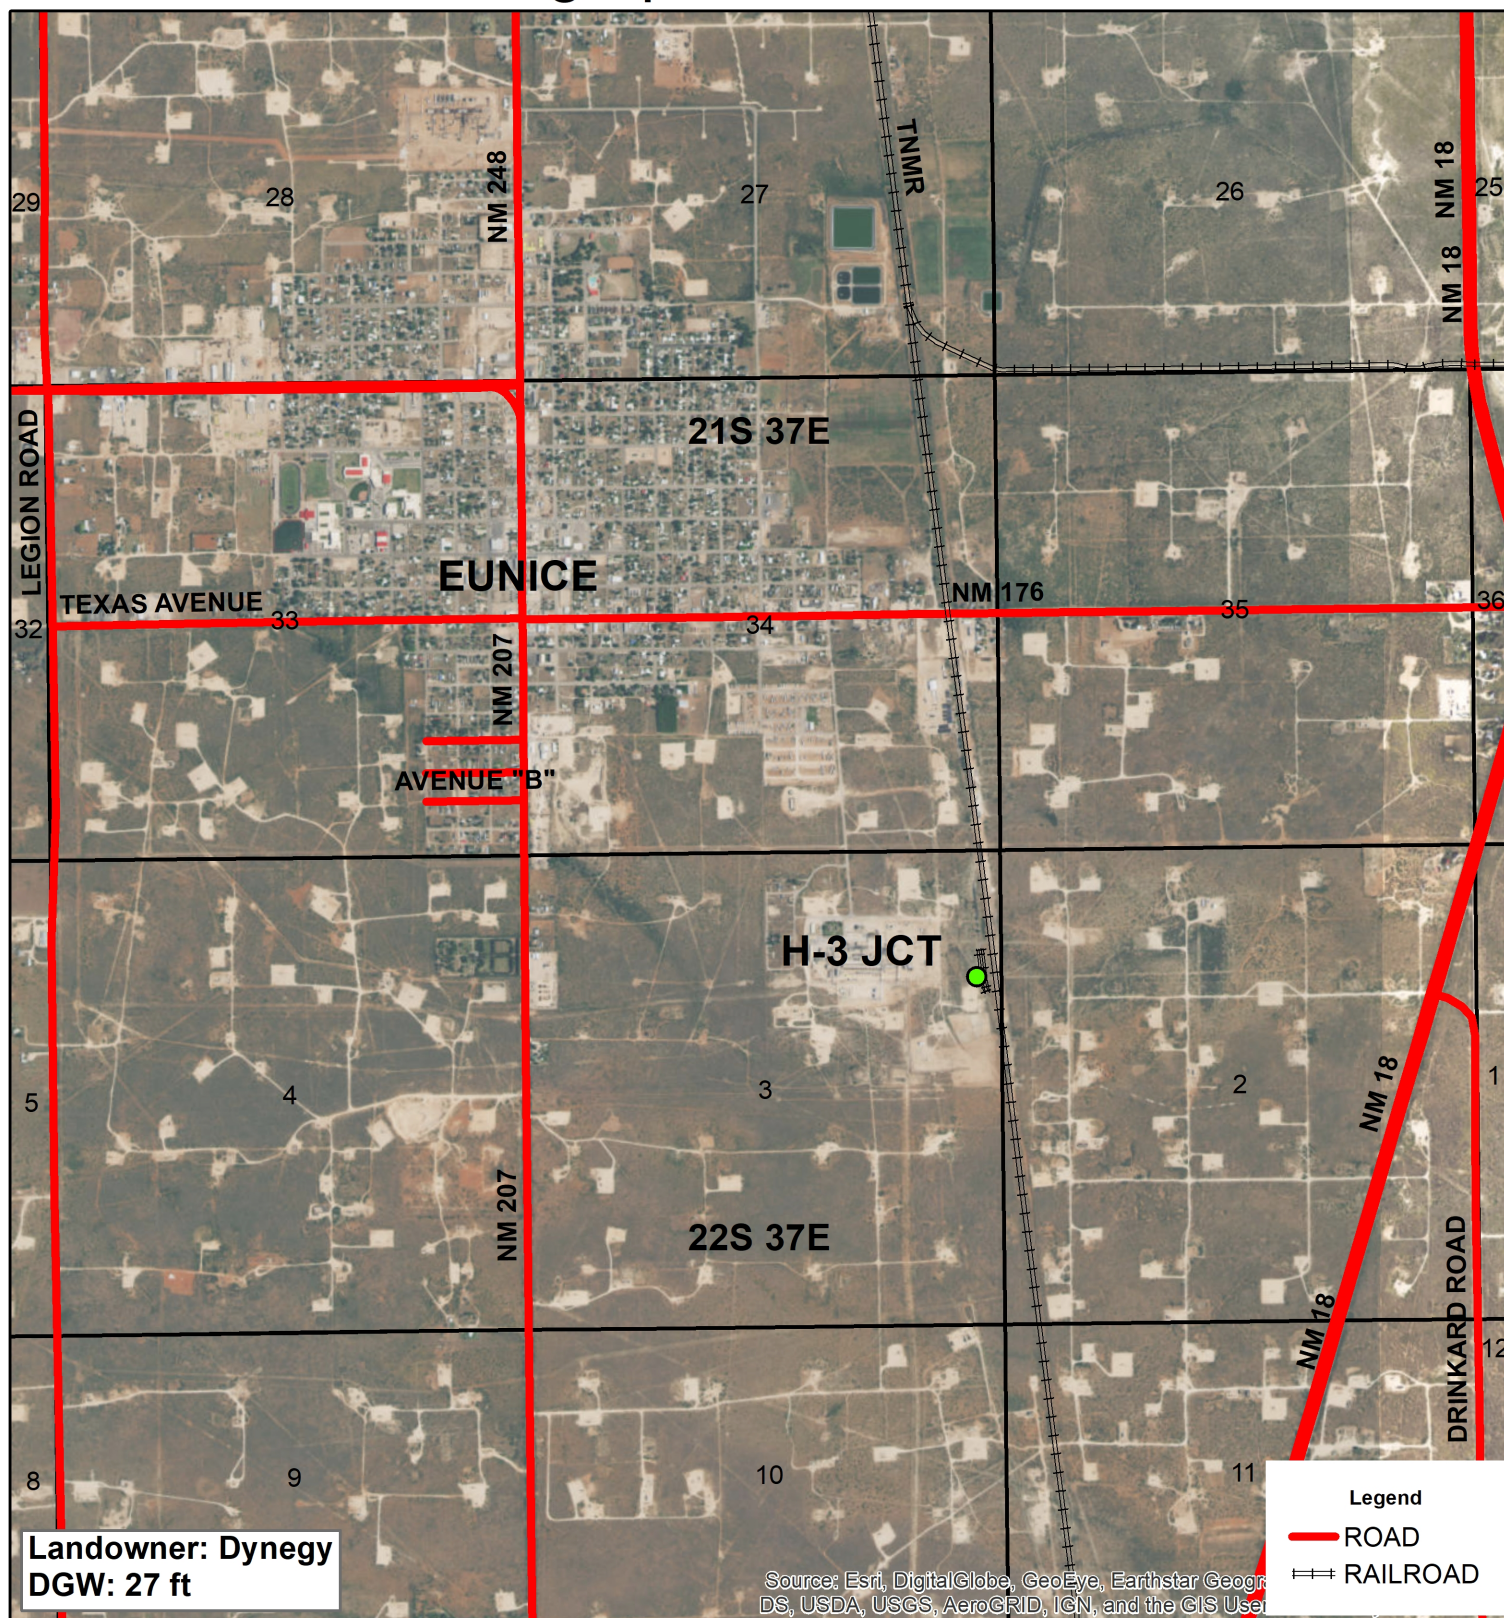
Geographic Location

BD
H-3 JCT
1R426-32

UL H3 SECTION 3
T-22-S R-37-E
LEA COUNTY, NM

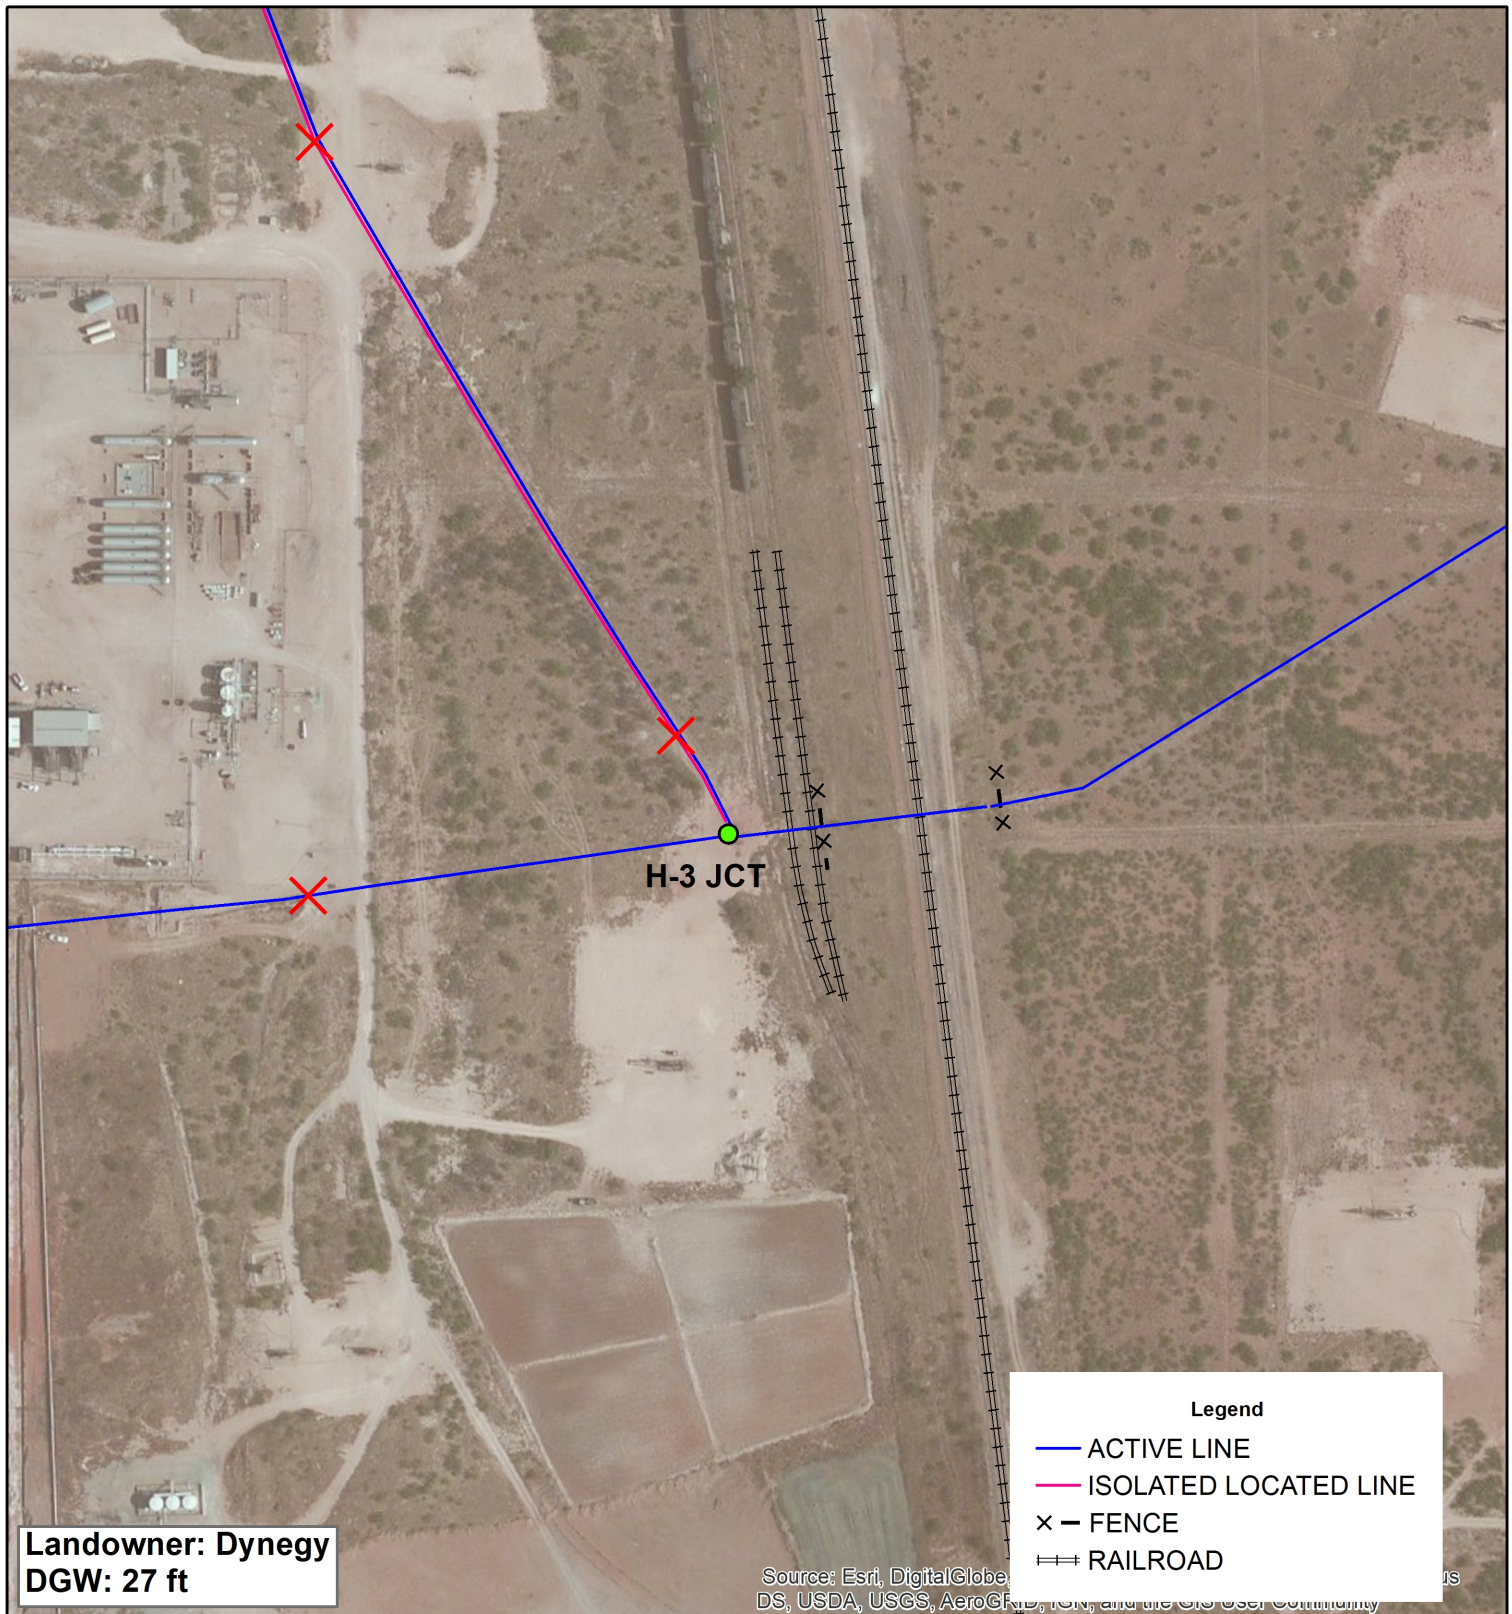
BD
H-3 JCT
1R426-32

UL H3 SECTION 3
T-22-S R-37-E
LEA COUNTY, NM

Underground facilities are
spatially projected
and need to be field verified.

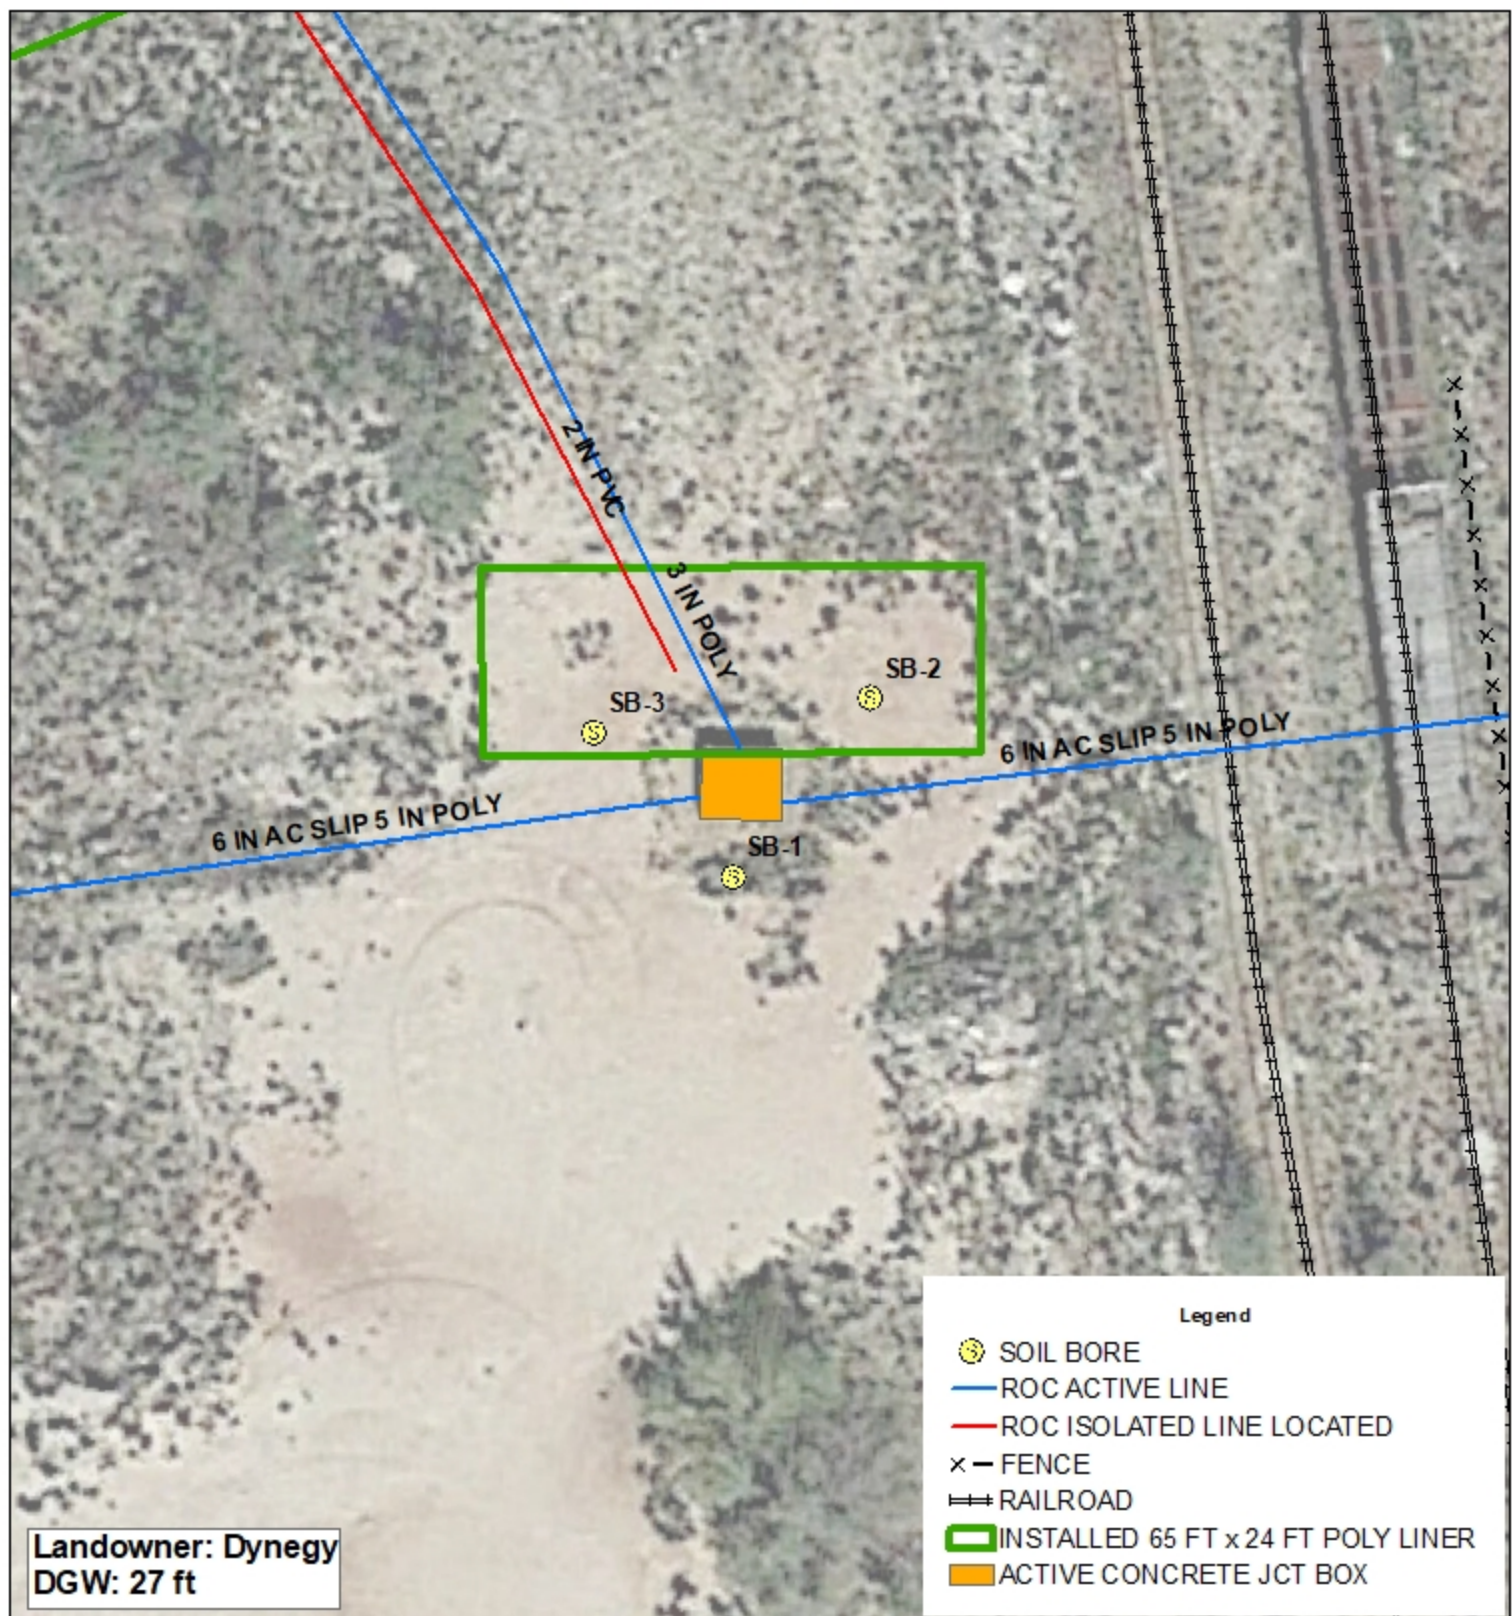
Excavation and Liner Installation

BD
H-3 JCT
1R426-32

GPS date: 6/30/17, 9/7/17, 7/19/19
8/12/19 TG
Drawing date: 4/6/20
Drafted by: T. Grieco

In order to inhibit the downward migration of residual constituents through the vadose zone, ROC excavated a 57x22-ft area to a depth of 4.5 ft bgs. A representative composite sample was collected from the 4-walls and was analyzed by a commercial laboratory for chloride and hydrocarbon. The composite sample resulted in a chloride concentration of 672 mg/kg, GRO/DRO/EXT-DRO concentrations below detectable limit, and BTEX concentrations below detectable limit. Based on the 4-wall composite, ROC excavated the site further to dimension of 65x24-ft. A representative composite sample was collected from the 4-walls and was analyzed by a commercial laboratory for chloride and hydrocarbon. The composite sample resulted in a chloride concentration of 416 mg/kg, GRO/DRO/EXT-DRO concentrations below detectable limit, and BTEX concentrations below detectable limit. A total of 456 cubic yards of excavated soil were taken to a NMOCD approved facility for disposal. The top of the liner was padded

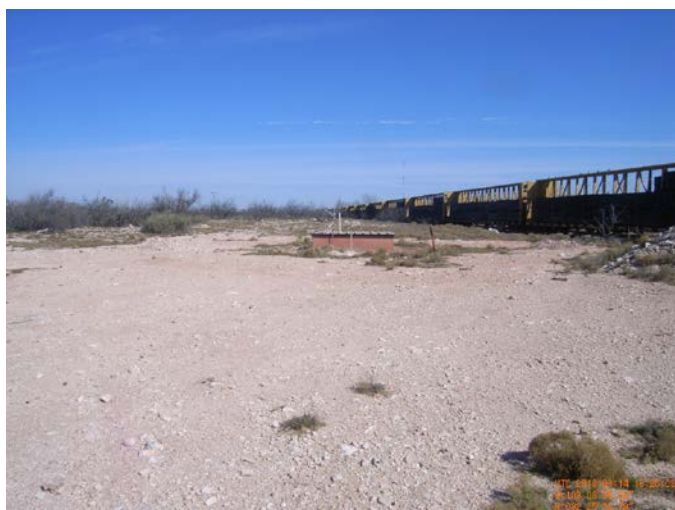
Initial photo, facing north

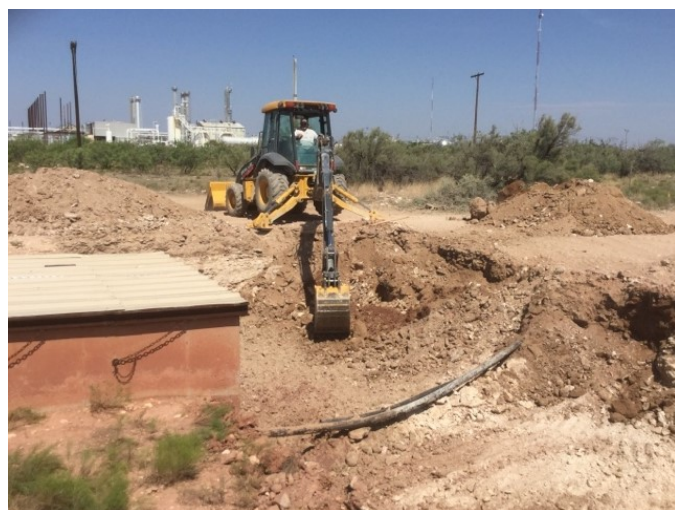
E5 excavating site, facing northwest

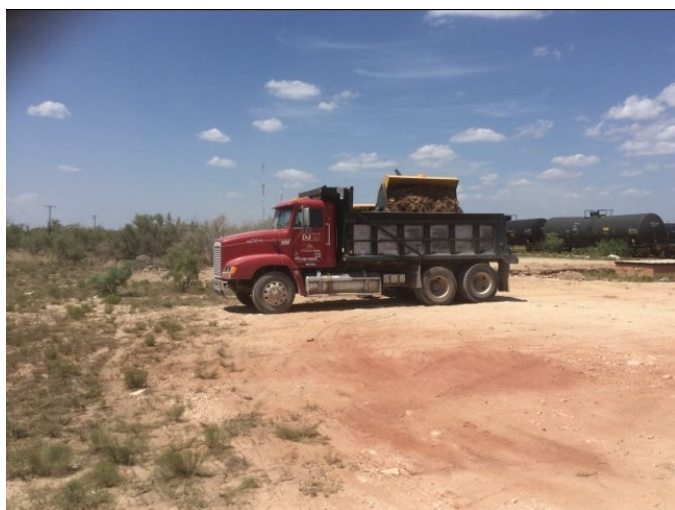
Exporting excavated soil, facing north

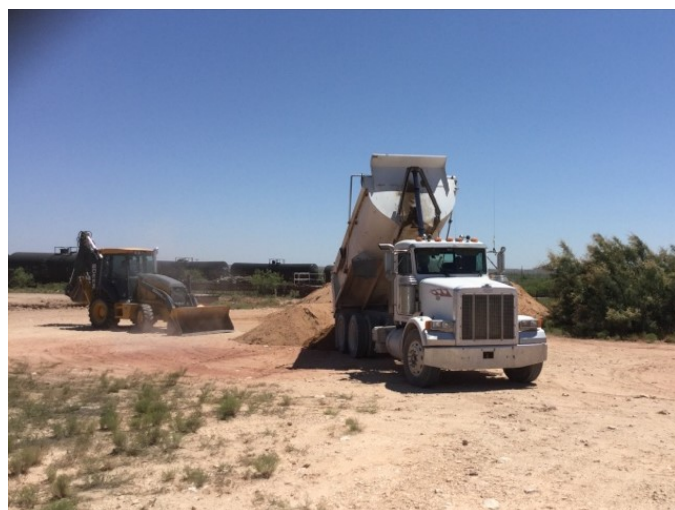
Importing blowsand, facing east

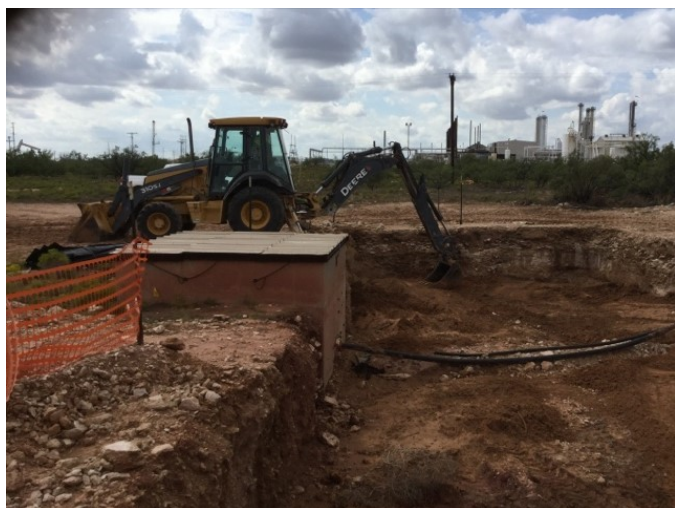
Padding excavation with imported blow sand, facing southeast

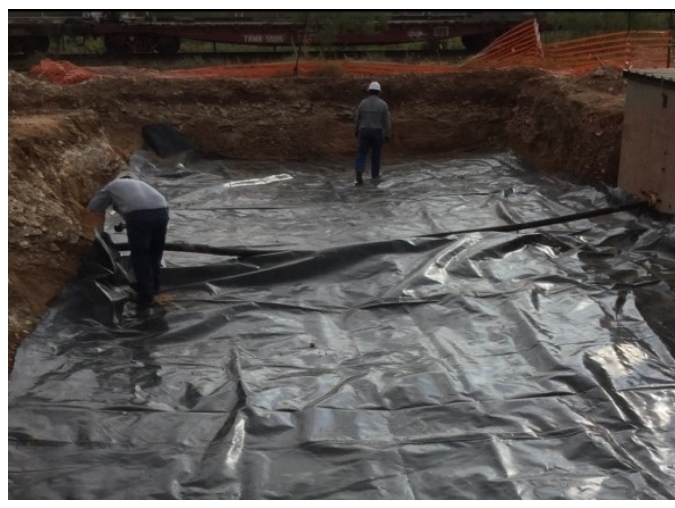
Installing and properly seating a 20-mil reinforced liner at 4.5 ft bgs, facing east

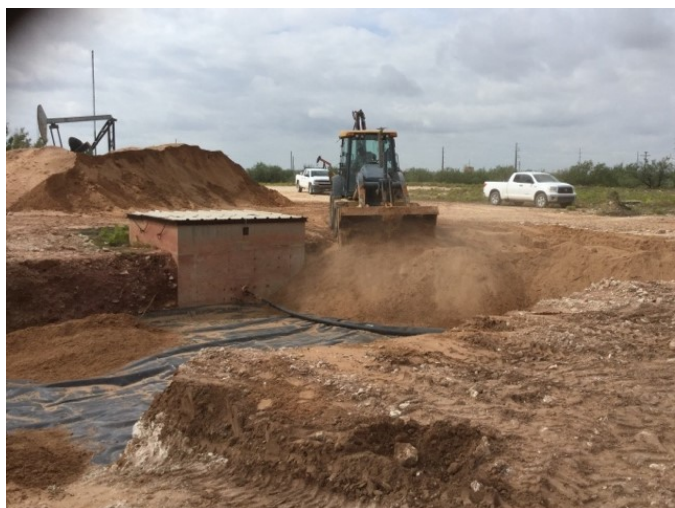
Padding above liner, facing southwest 10/1/2019

with imported soil, and the excavation was backfilled to ground surface and contoured to the surrounding area. Four samples of the imported soil were analyzed by a commercial laboratory for chloride and hydrocarbon, resulting in a concentration of chloride of 16 mg/kg, <16 mg/kg, 16 mg/kg, and <16, respectively. Hydrocarbon concentrations, GRO/DRO/EXT-DRO and BTEX, were below detectable limits in each sample. The backfilled site was seeded with a blend of native vegetation. Vegetation above the liner will also provide a natural infiltration barrier for the site, since plants capture water through their roots thereby reducing the volume of water moving through the vadose zone.

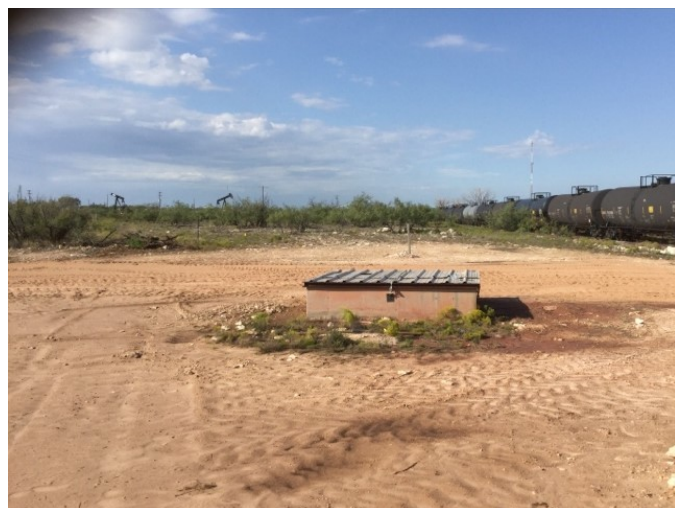
Backfill complete, facing north 10/2/2019

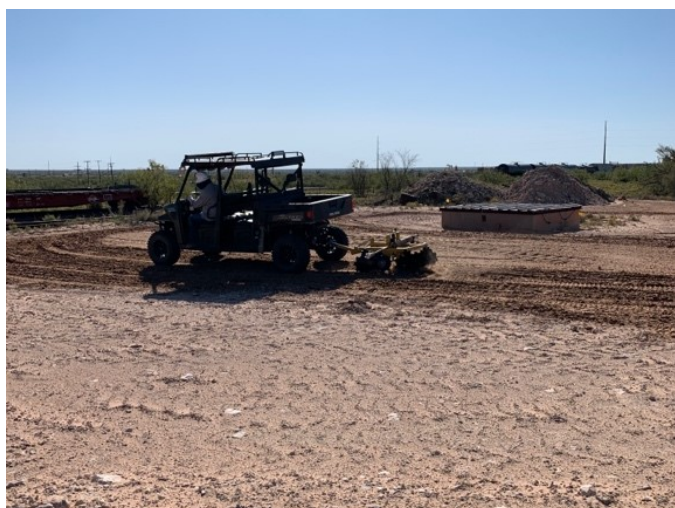
Tilling, facing southeast 10/25/2019

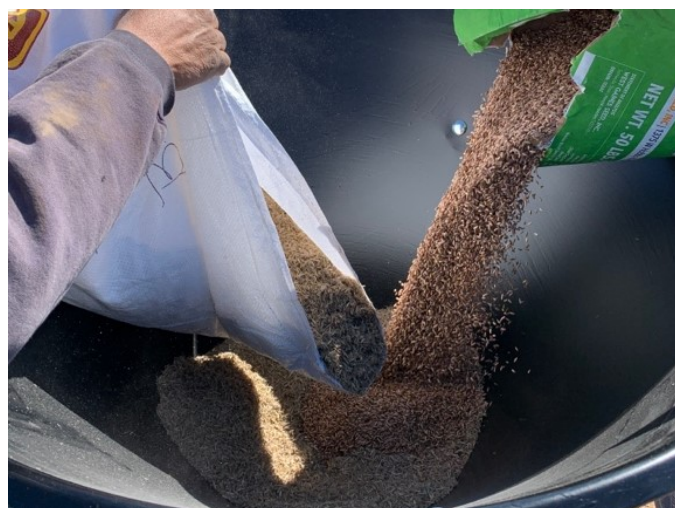
Adding seed to the spreader, facing east 10/25/2019

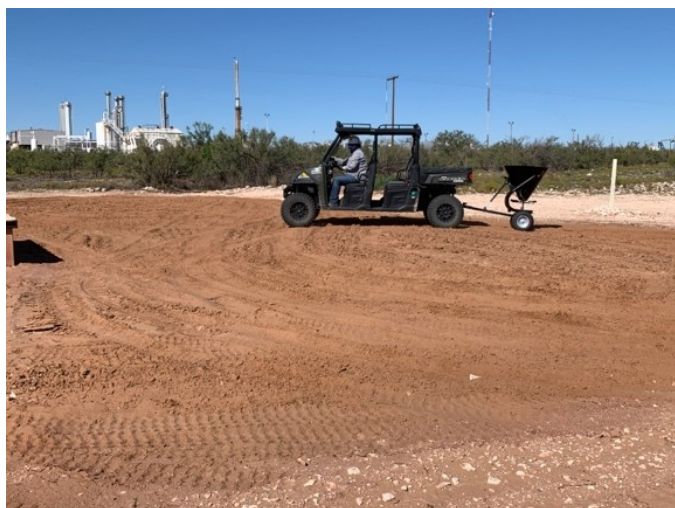
Seeding the backfilled site, facing northwest 10/25/2019

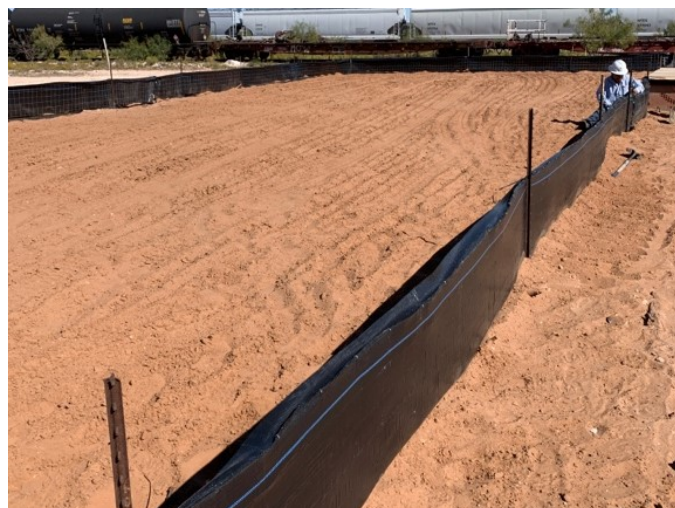
Site complete, facing northeast 10/25/2019
