Soil Assessment and Remediation Work Plan:

Nailed It Fed Com #234
Incident # nAPP2107529251

Subject: Soil Assessment and Closure Report
Nailed It Fed Com #234
Incident # nAPP2107529251

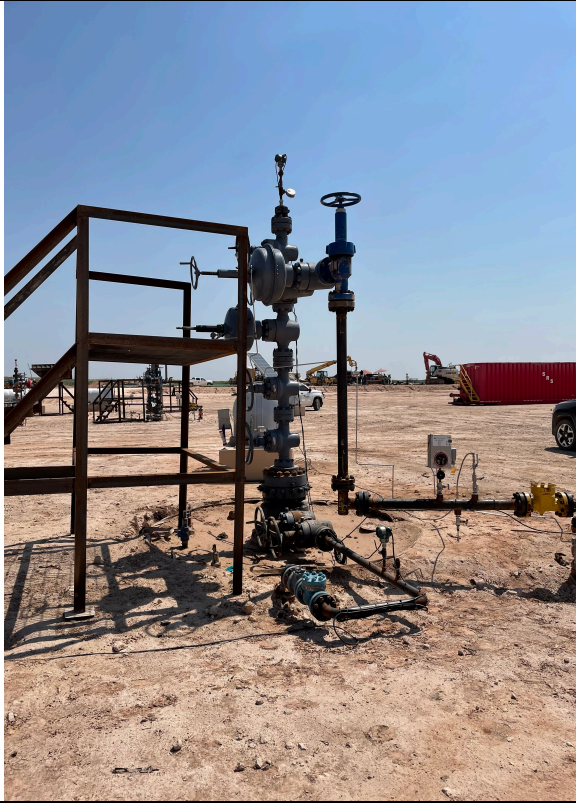
Viewing Direction: Southeast

Sample Site, West of wellhead

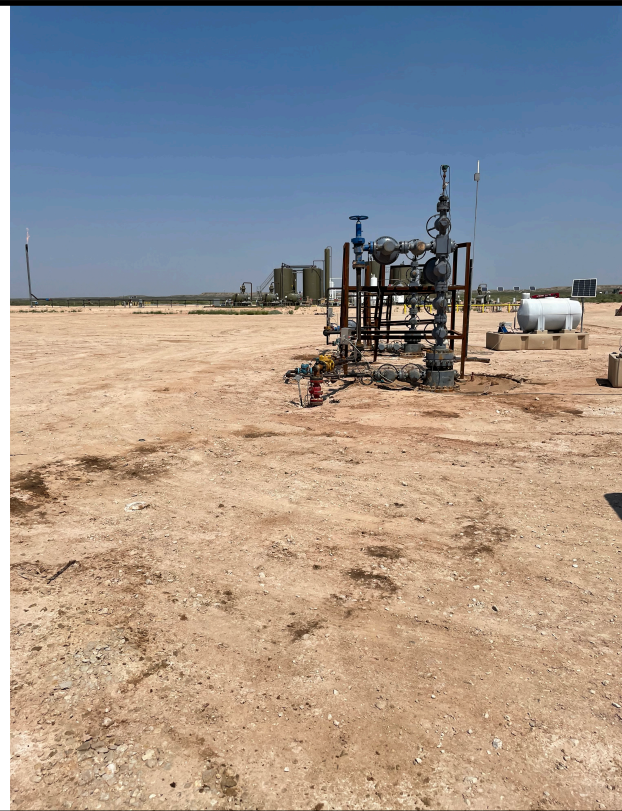
Viewing Direction: North

Samples taken slightly to the West of wellhead

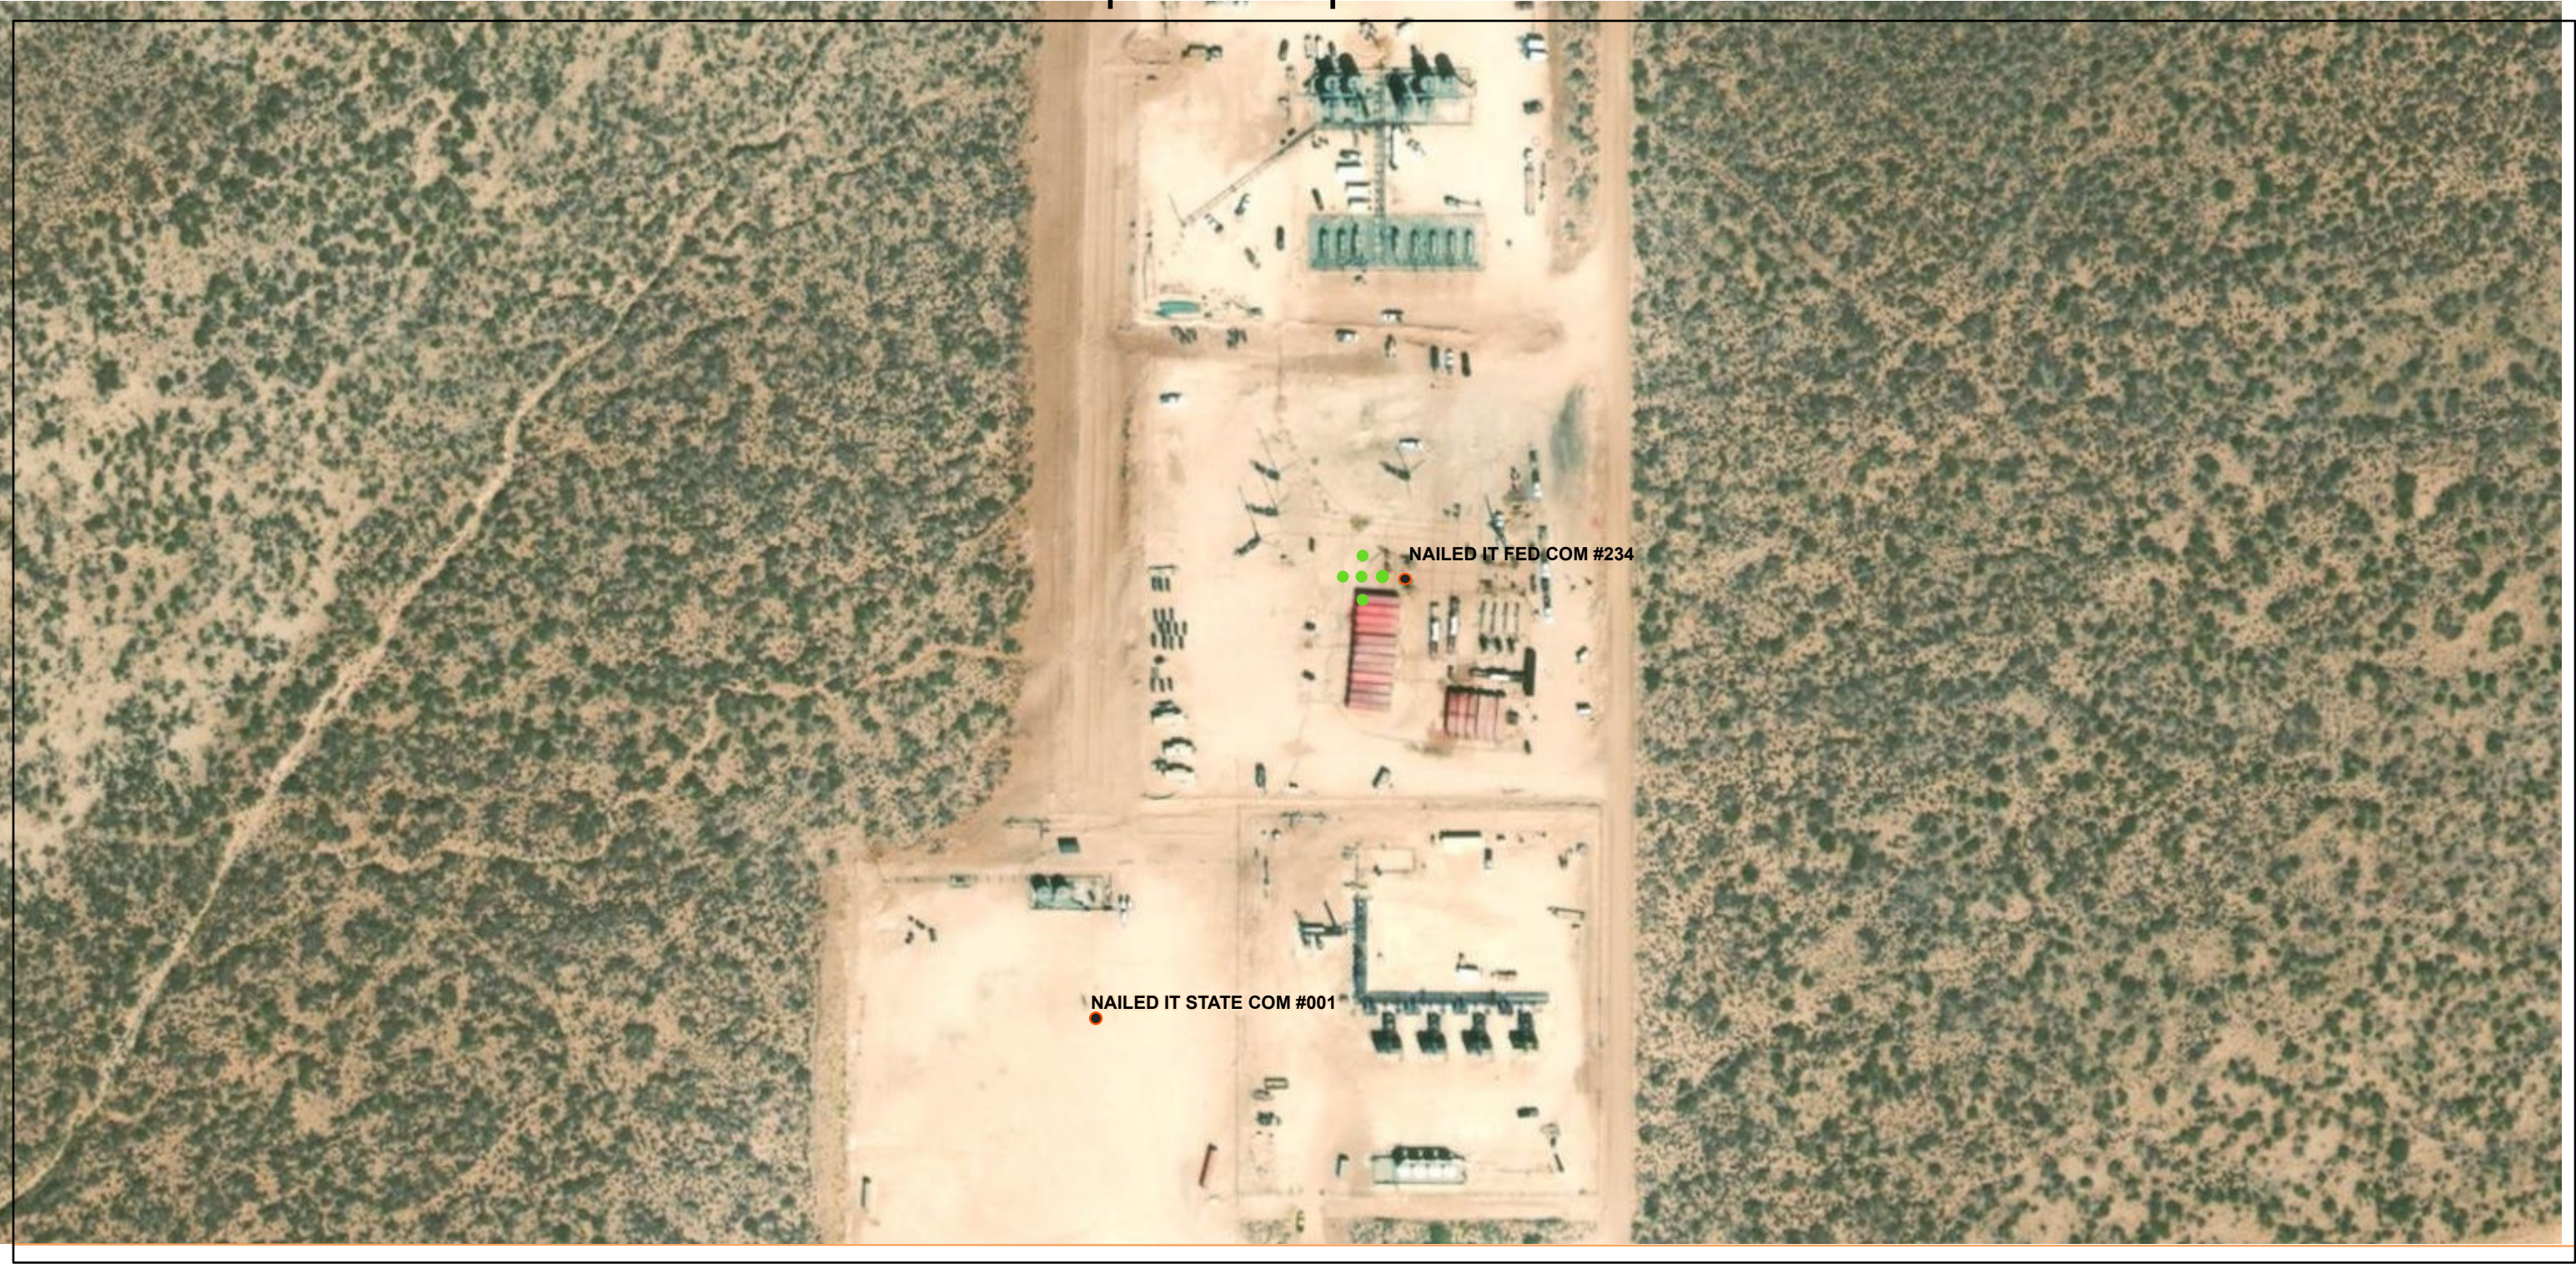
FIGURE 1

On March 8, 2021, a flowline failed, resulting in the release of 2 barrels (bbls) of crude oil and 7 bbls of produced water onto the surrounding well pad. The location of the release is shown on Figure 1. Upon discovery, crews arrived onsite to recover and freestanding fluids. Approximately 2 bbls of crude oil and 7 bbls of produced water was recovered.

A total of 5 samples were collected in the impacted area, as shown on Figure 1, and analyzed for chlorides, total petroleum hydrocarbons (TPH) including gasoline range organics (GRO), diesel range organics (DRO), and motor oil/lube organics (MRO), benzene, toluene, ethylbenzene, total xylenes (BTEX). Laboratory analytical results are summarized in Table 1 and laboratory data is included as Attachment 2. Sample results were compared to 19.15.29.12(C) (4) NMAC, Table I, Depth to ground water greater than 100 feet. At the completion of excavation, all samples were compliant with Closure Criteria. At the completion of excavation activities, no samples were above Table I standards.

The final excavation extent was approximately 209 cubic yards of impacted soil. At the completion of soil remediation efforts, all five samples were compliant with the Closure Criteria for the Site. The location has been backfilled with clean soil and graded with the rest of the production pad.
