Incident ID	nAPP2125046010
District RP	
Facility ID	
Application ID

Site Assessment/Characterization

State of New Mexico
Oil Conservation Division

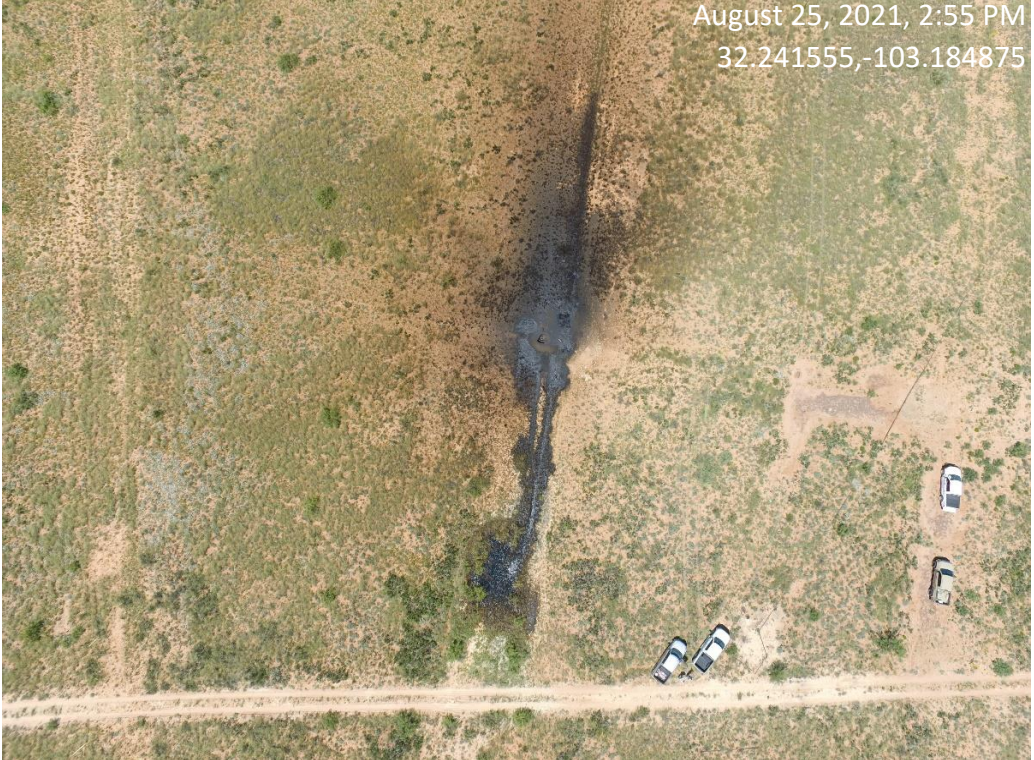
Photo Number: 1

Photo Direction: South	
Photo Description: Aerial view of the affected area.

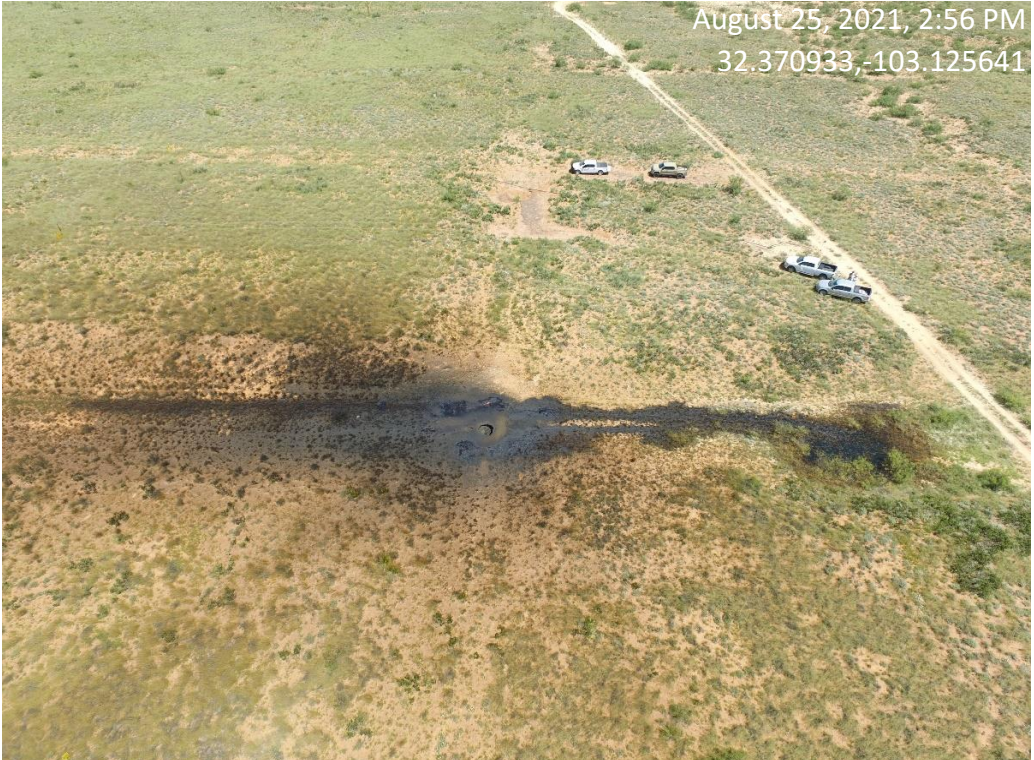
Photo Number: 2

Photo Direction: East	
Photo Description: Aerial view of the affected area.

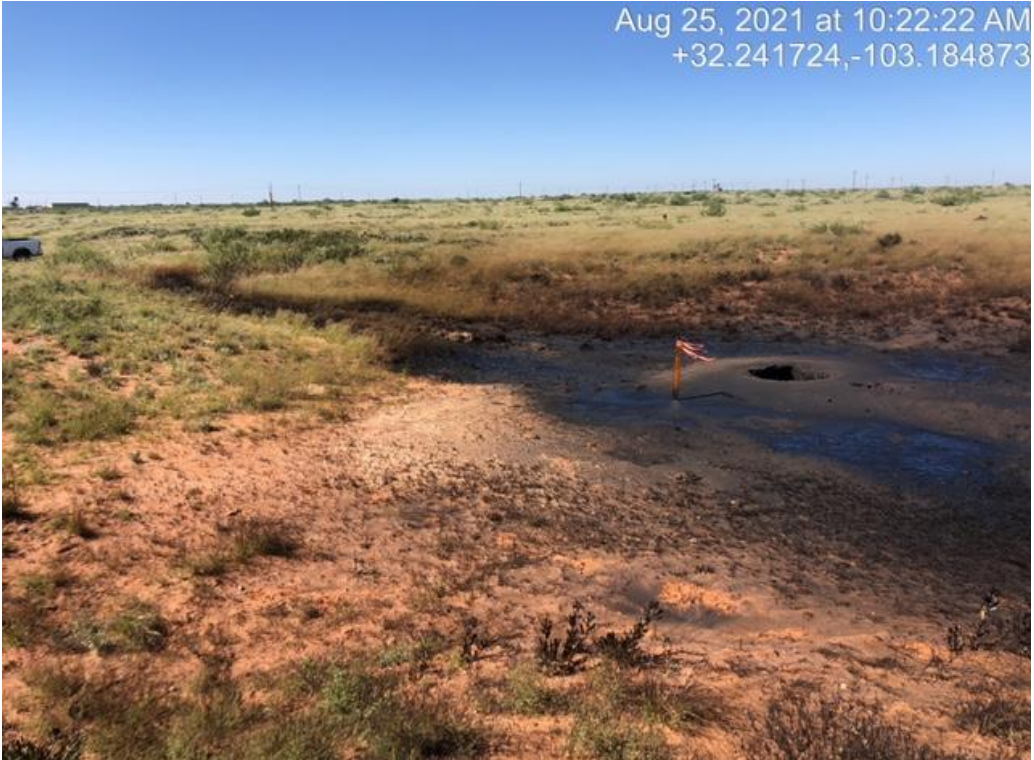
Photo Number: 4	<div>Aug 25, 2021 at 10:22:22 AM +32.241724,-103.184873</div>

Photo Direction: Southwest	
Photo Description: View of the affected area.

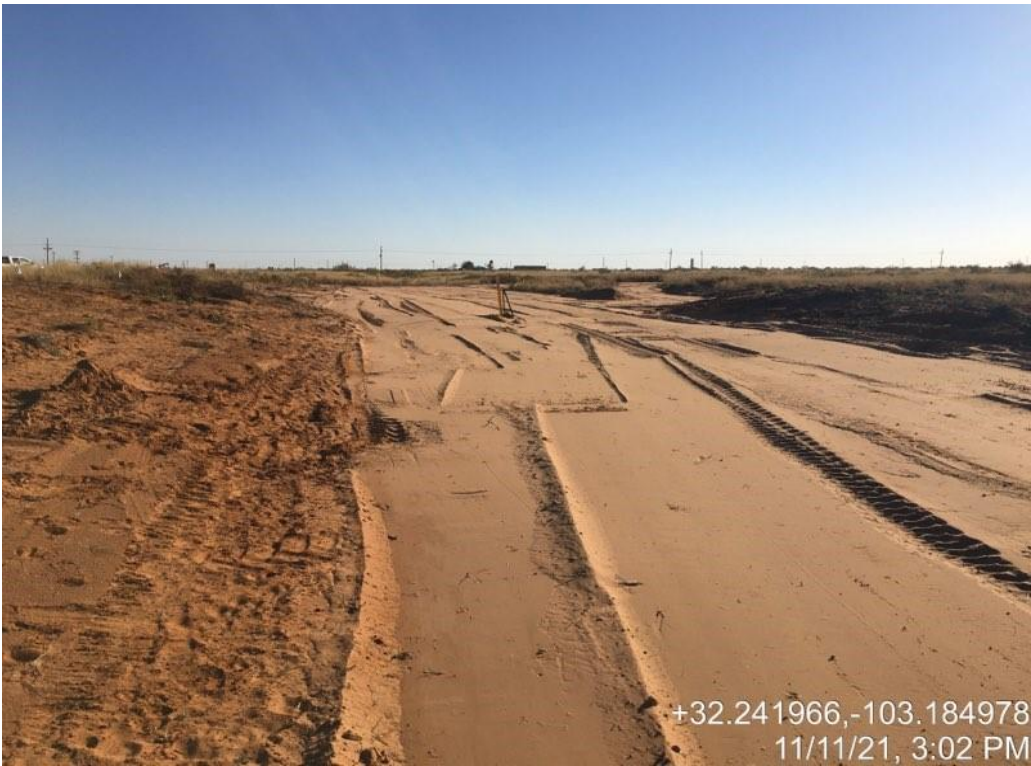
Photo Number: 10

Photo Direction: South	
Photo Description: View of the remediated area following backfill and regrading.

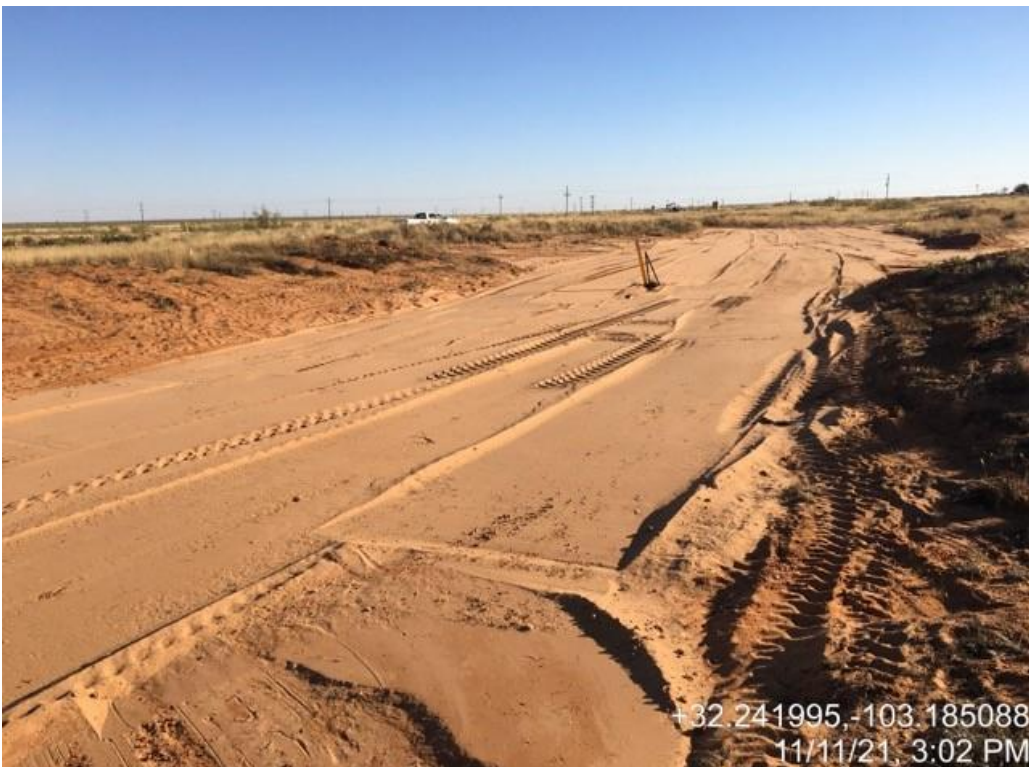
Photo Number: 11

<p>+32.241995,-103.185088 11/11/21, 3:02 PM</p>
Photo Direction: South-Southeast	
Photo Description: View of the remediated area following backfill and regrading.
