Remediation Summary & Soil Closure Request

COG Operating, LLC

Merlin State Com 1

NMOCD Reference No. nAPP2125030589

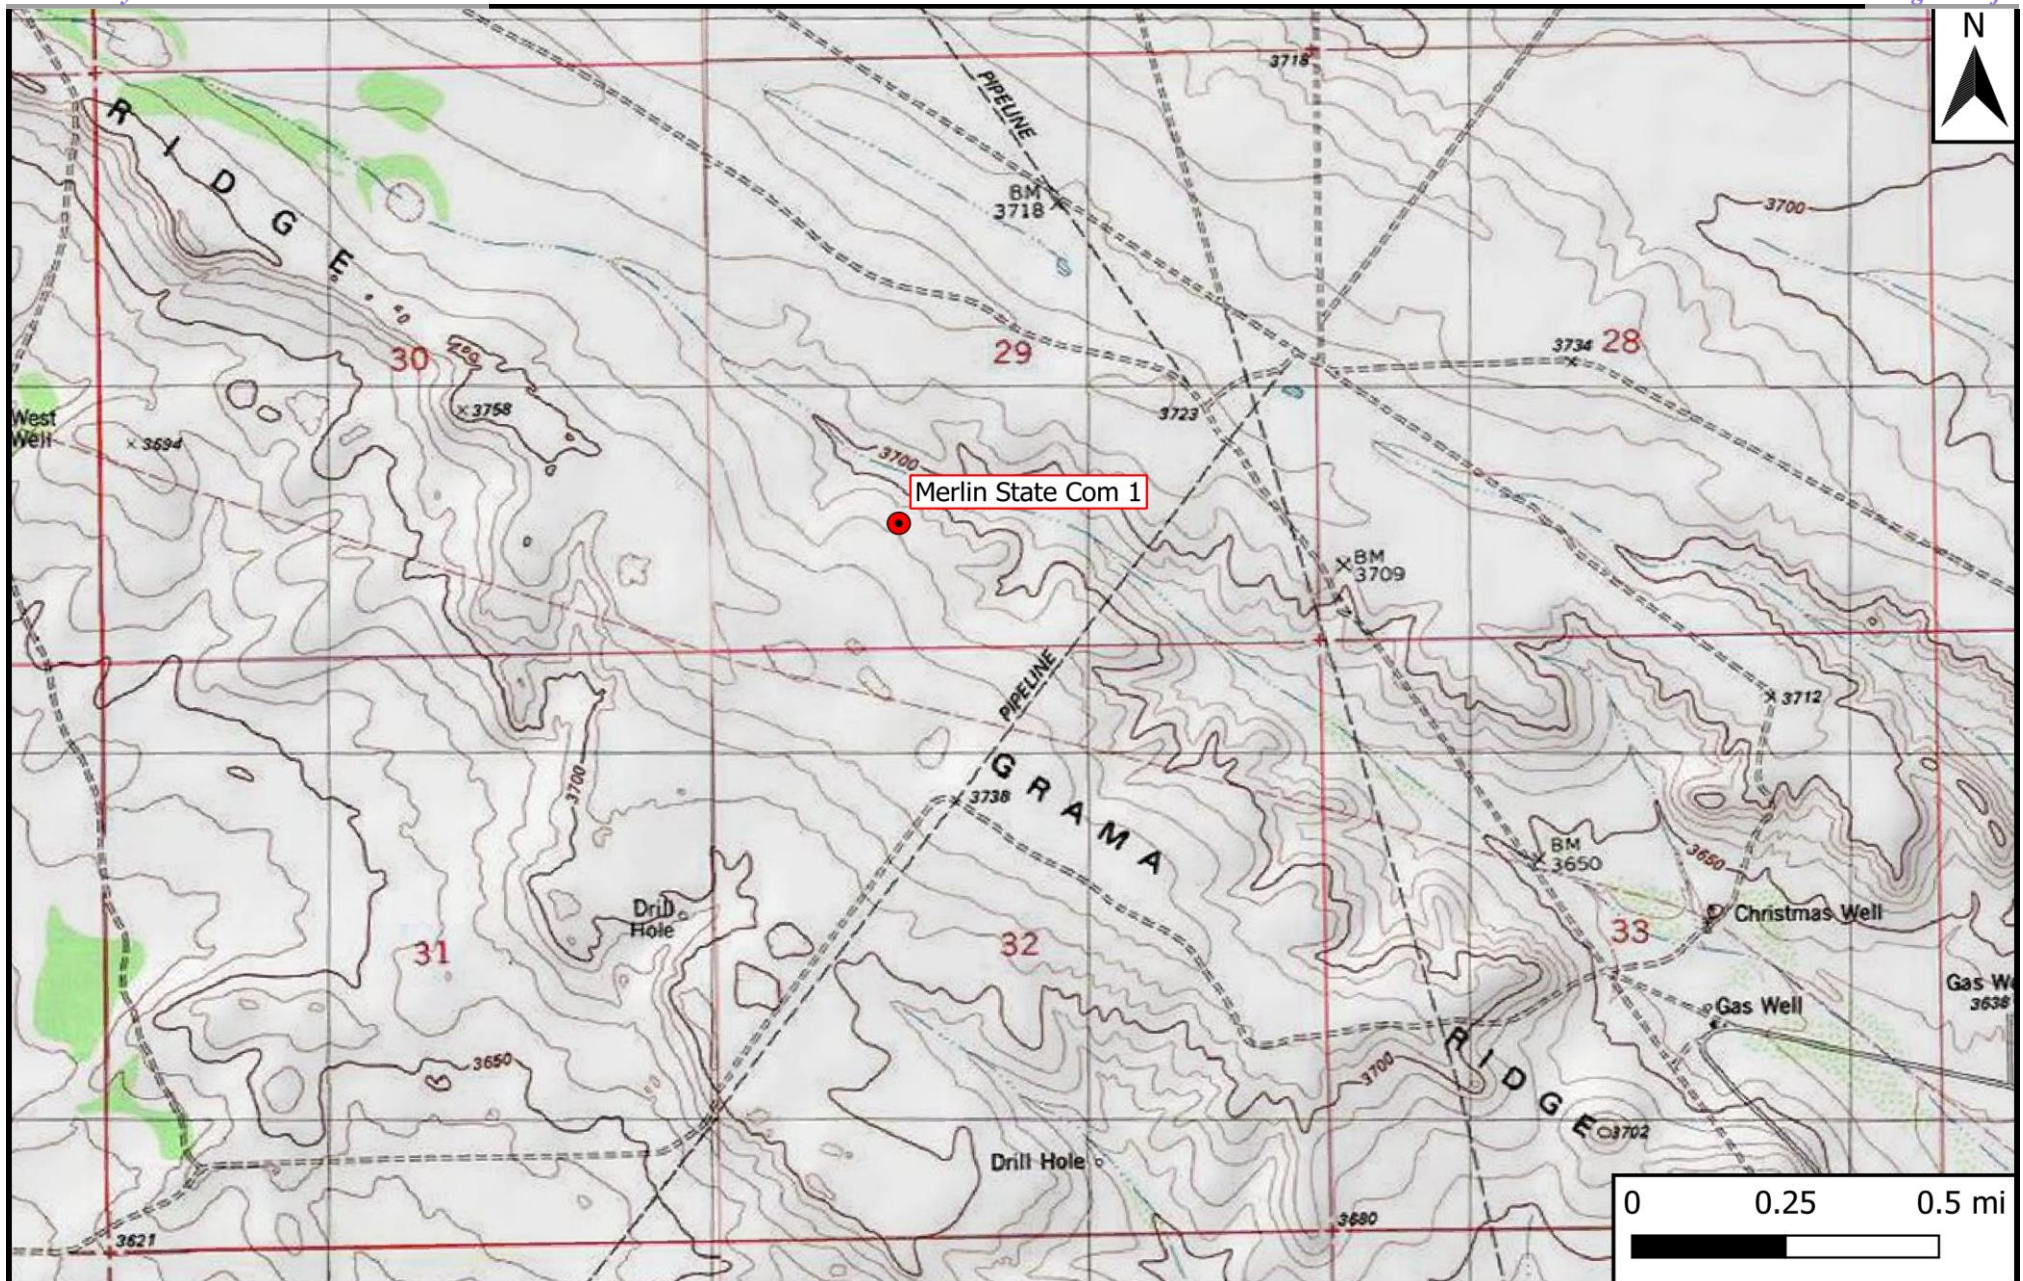
Figure 1

Topographic Map

NMOCD Siting Criteria data was gathered from available resources including Bureau of Land Management (BLM) and Fish & Wildlife Services (FWS) shapefiles; topographic maps; NMOSE and USGS databases; and aerial imagery. The results are depicted in Figures 1, 2, 4, and 5.

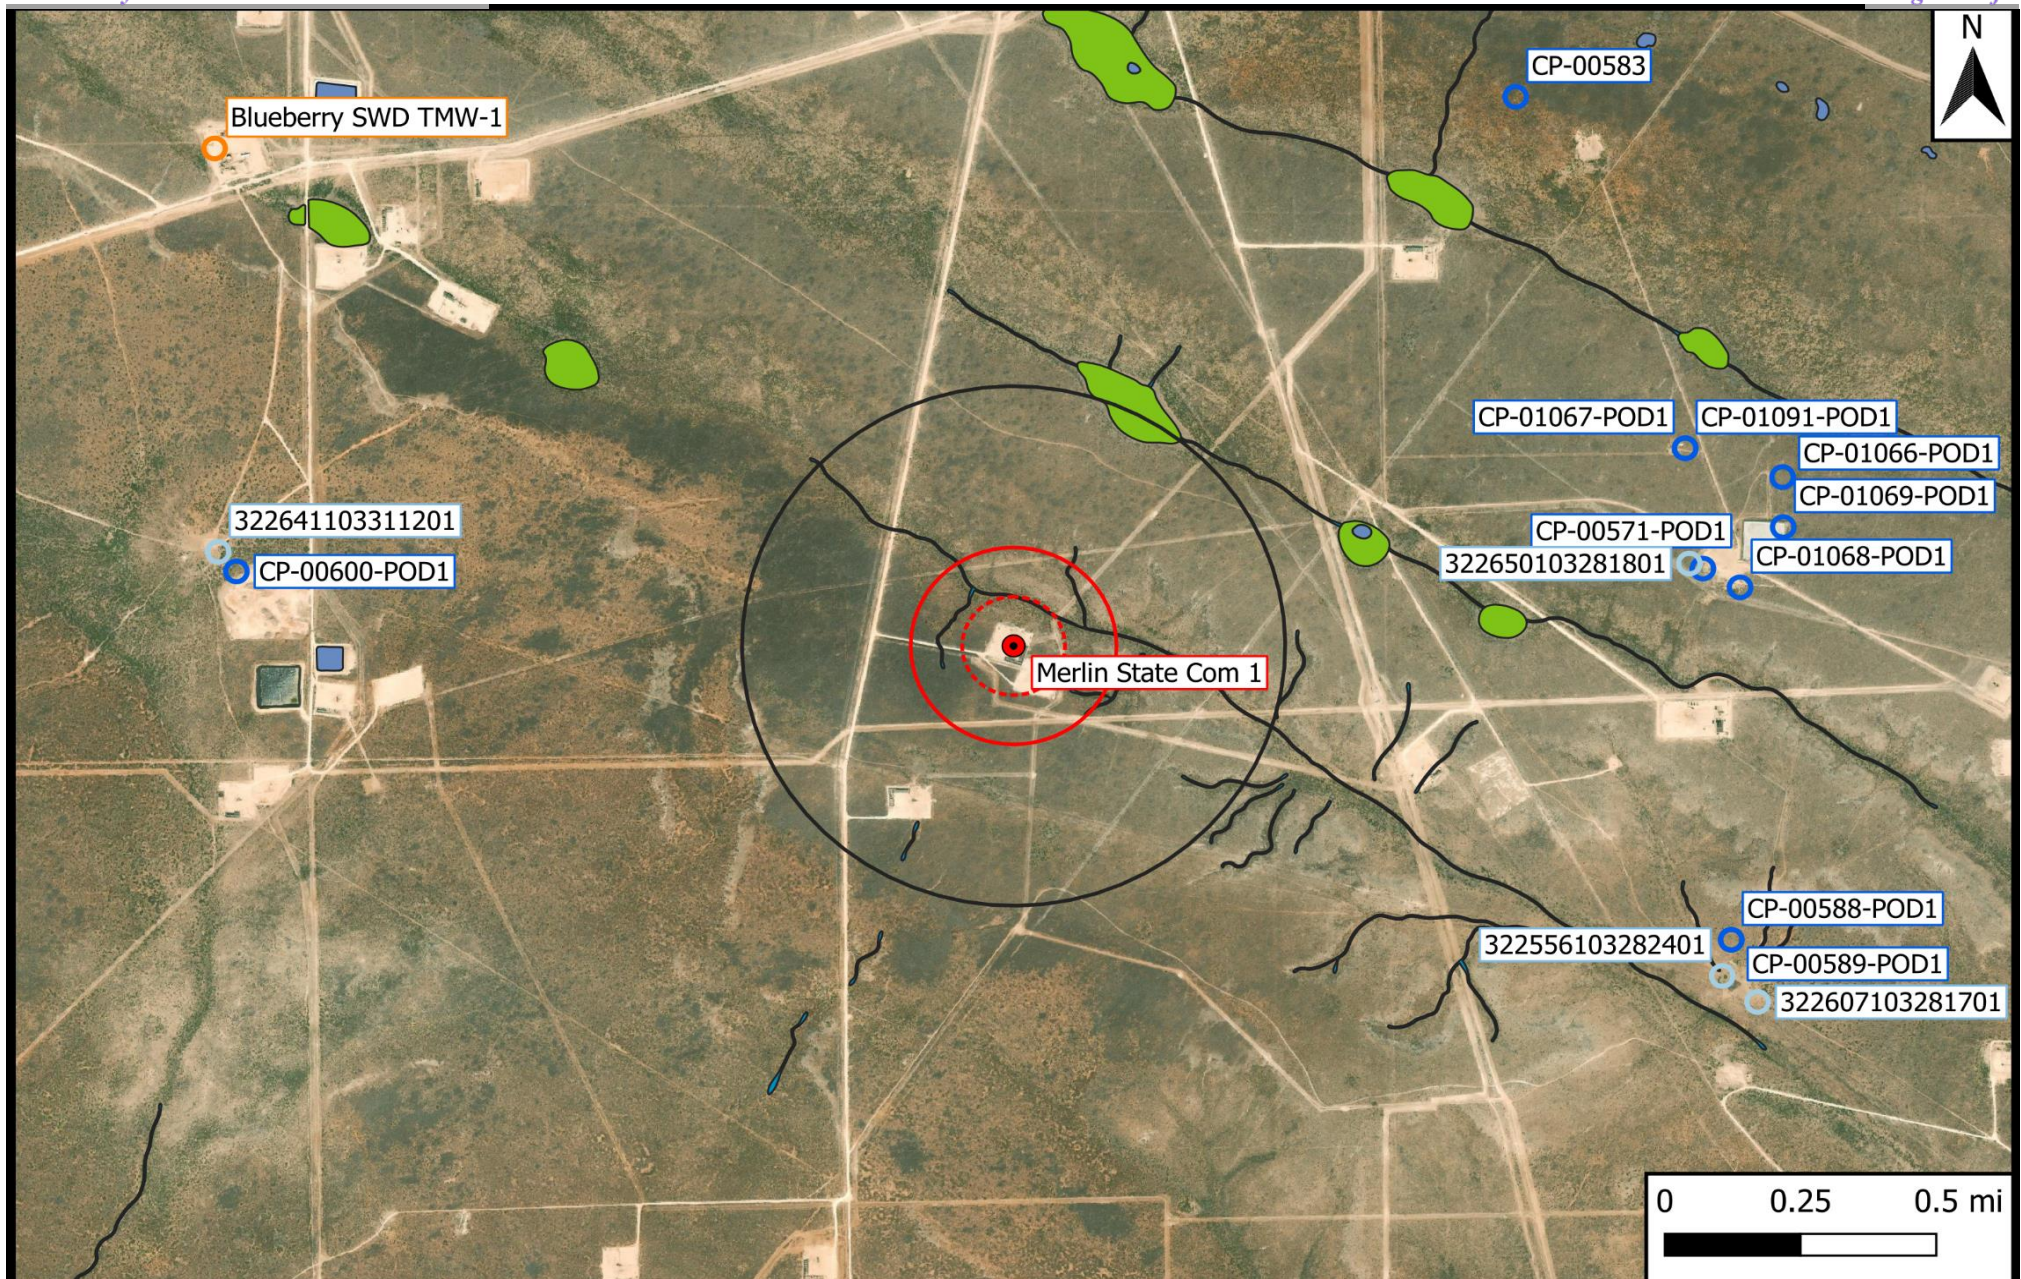
Figure 2

Aerial Proximity Map

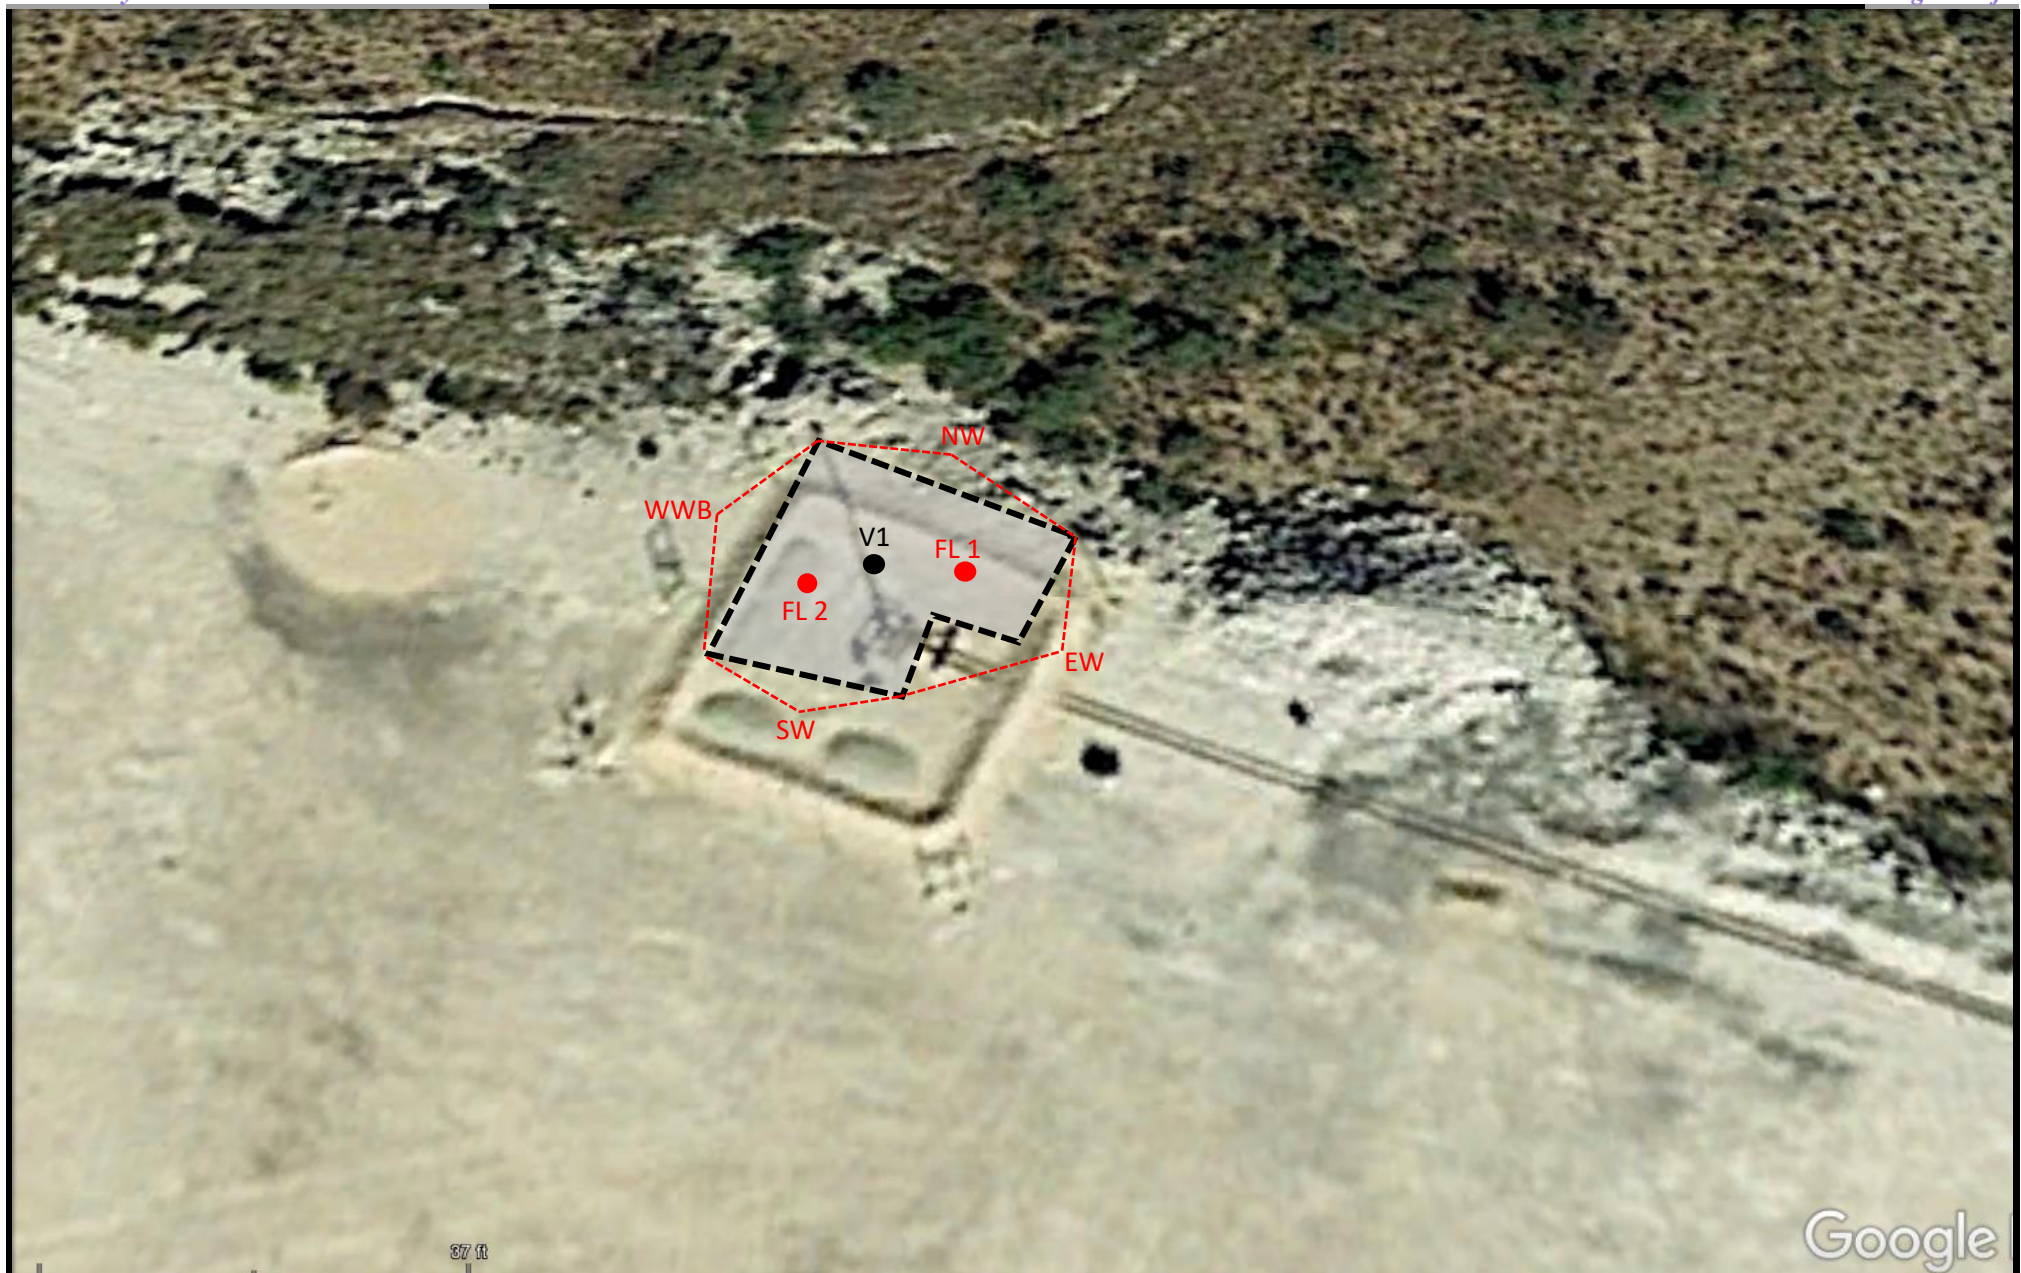
Figure 3

Site & Sample Location Map

The final dimensions of the excavated area were approximately 46 feet in length, 14 to 32 feet in width, and two (2) feet in depth. During the course of remediation activities, approximately 36 cubic yards of impacted soil was transported to an NMOCD-permitted surface waste facility for disposal. Approximately 36 cubic yards of locally sourced, non-impacted material was imported to the Site for use as backfill.

Soil sample locations and the extent of the excavated area are depicted in Figure 3, "Site & Sample Location Map". Soil chemistry data is summarized in Table 1. Laboratory analytical reports are provided in Appendix B. General photographs of the Site are provided in Appendix C.

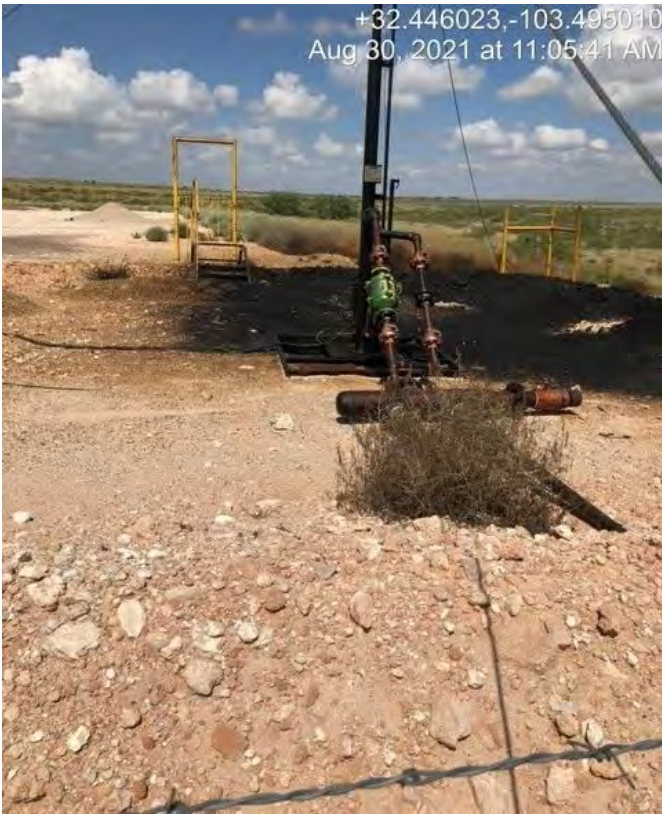
Photo Number: 1

Photo Direction: Northwest	
Photo Description: View of the affected area.

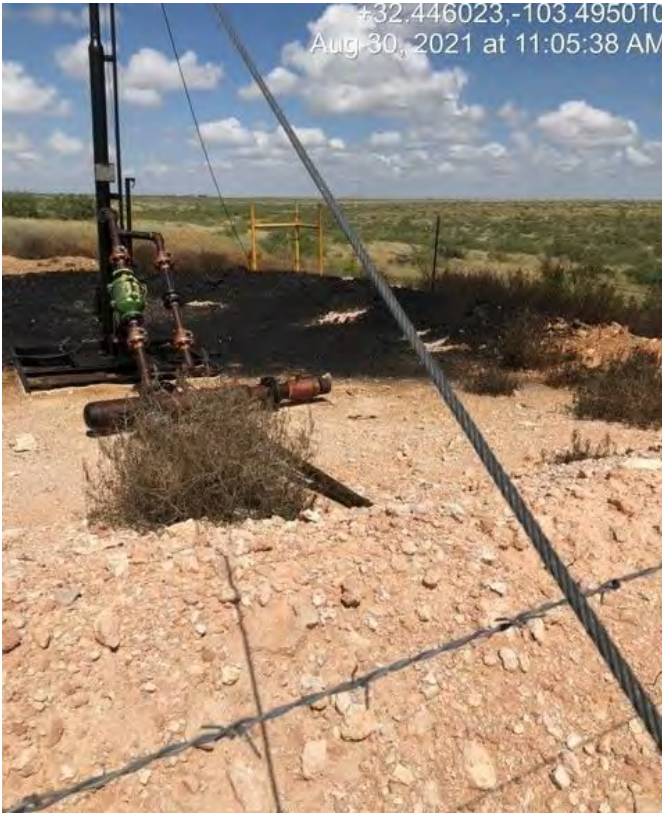
Photo Number: 2

Photo Direction: Northwest	
Photo Description: View of the affected area.

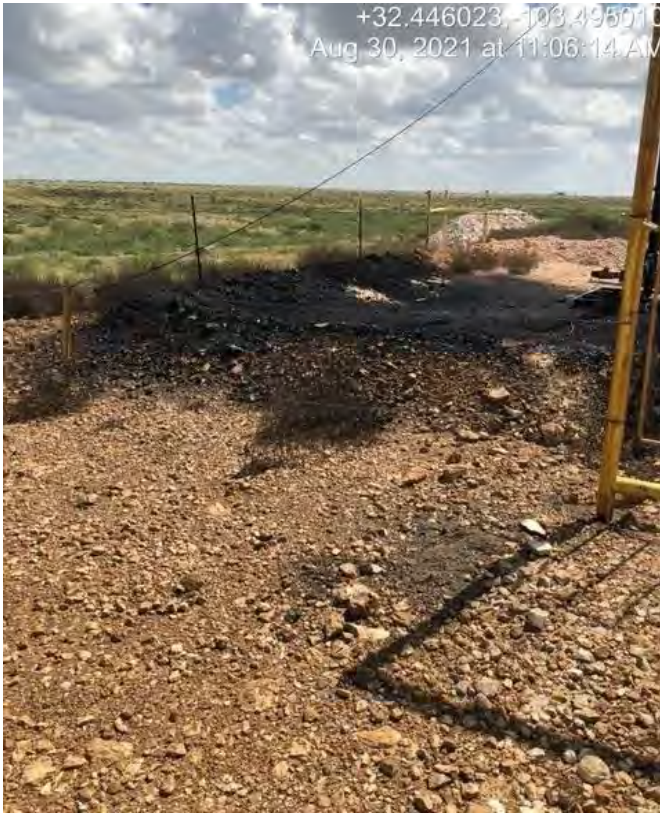
Photo Number: 4

Photo Direction: East	
Photo Description: View of the affected area.

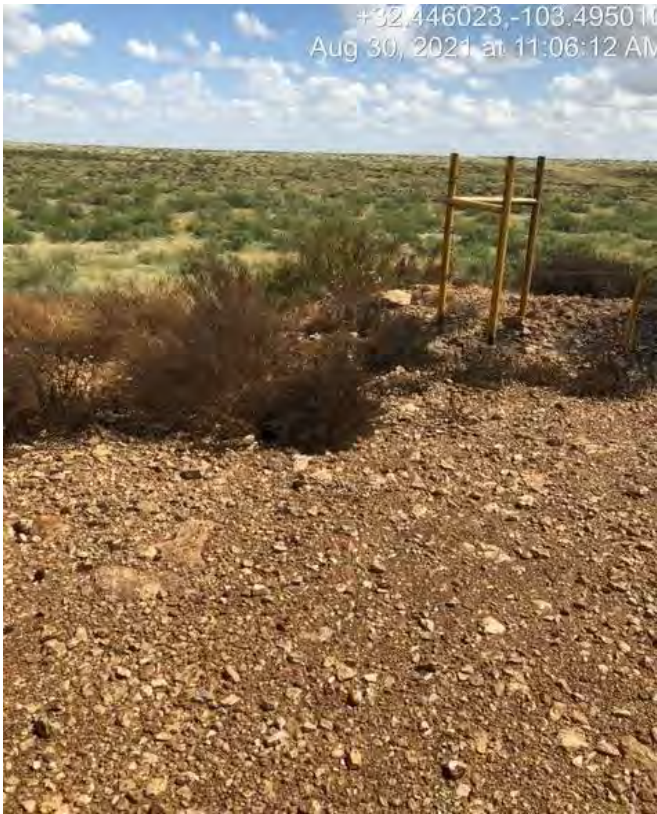
Photo Number: 5

Photo Direction: Northeast	
Photo Description: View of the affected area.

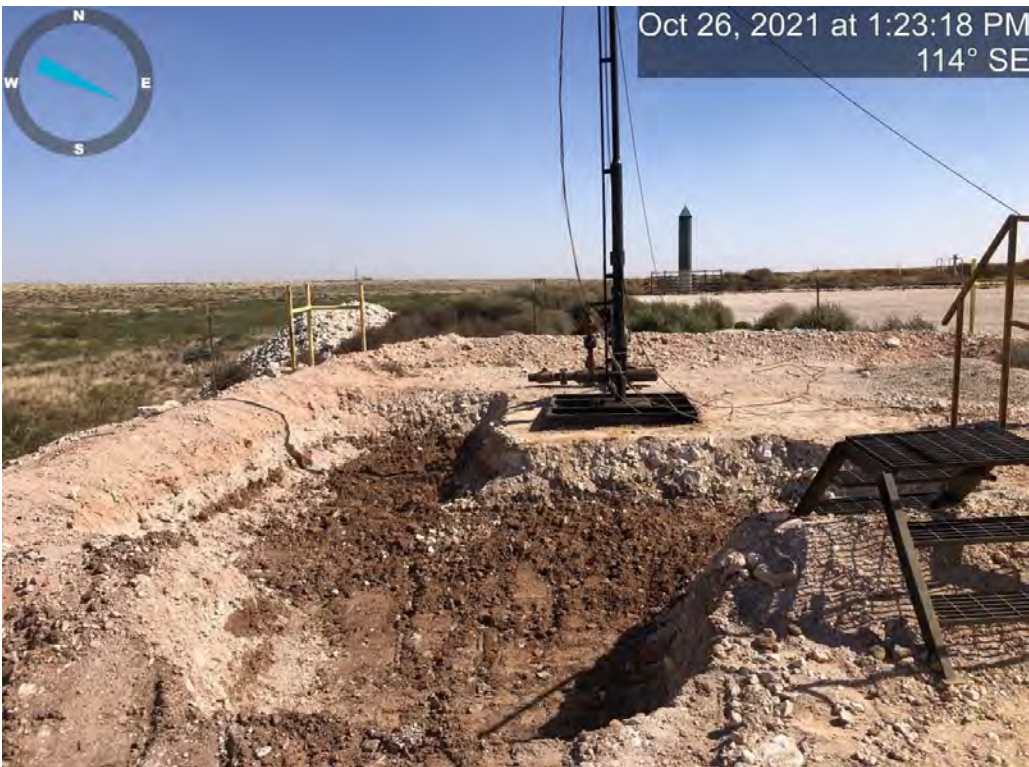
Photo Number: 7

Photo Direction: East	
Photo Description: View of the excavated area.

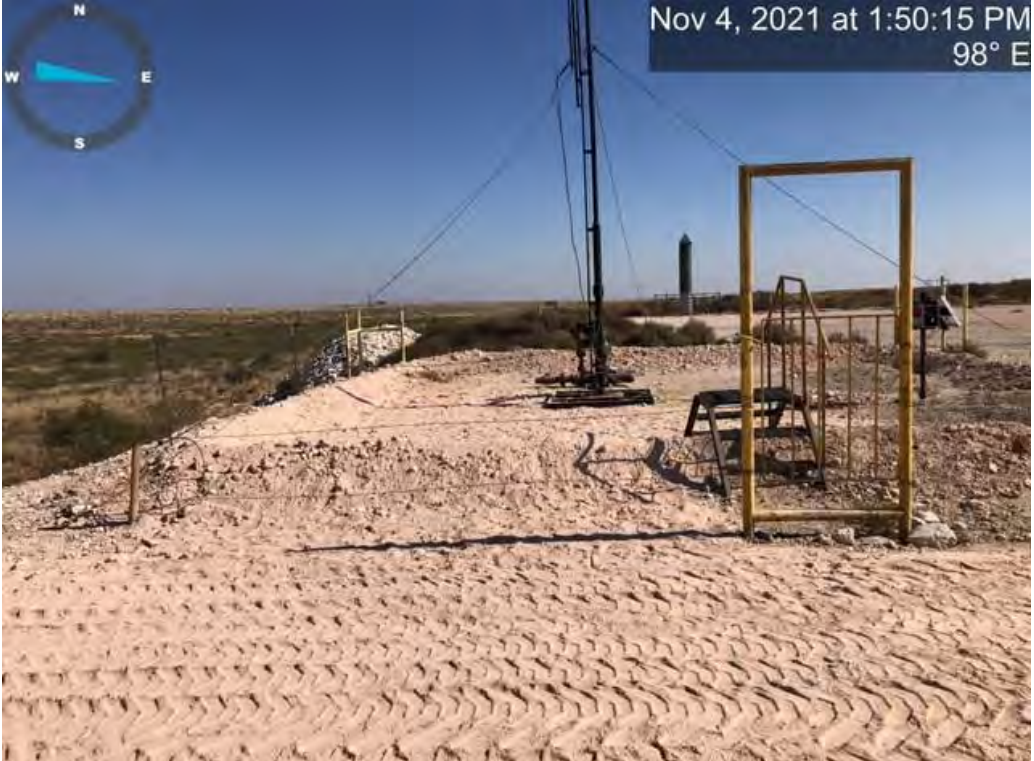
Photo Number: 9

<p>Nov 4, 2021 at 1:50:15 PM 98° E</p> <p>A photograph showing a remediated area with a sandy, textured ground surface. In the background, a tall crane or drilling rig is visible. To the right, there is a yellow metal frame structure. The sky is clear and blue. A compass rose in the top left corner indicates North (N), South (S), East (E), and West (W). The photo was taken on Nov 4, 2021 at 1:50:15 PM, facing 98° E.</p>
Photo Direction: East	
Photo Description: View of the remediated area following backfill & regrading.

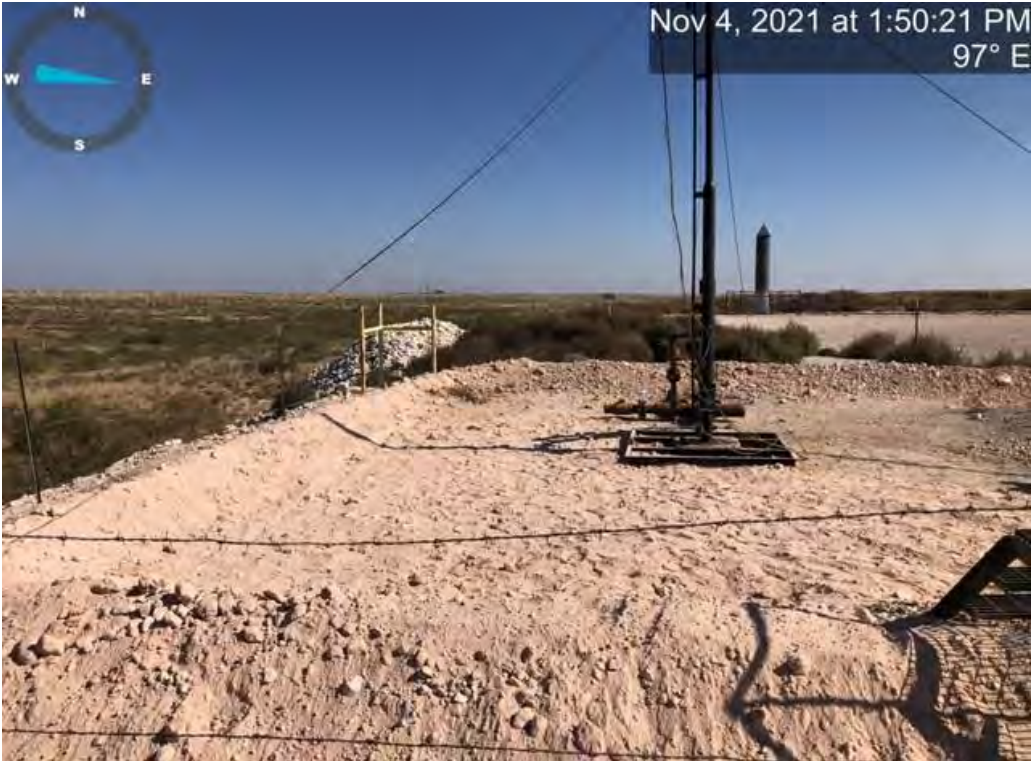
Photo Number: 10

<p>Nov 4, 2021 at 1:50:21 PM 97° E</p> <p>A photograph showing a remediated area with a sandy, textured ground surface. In the background, a tall crane or drilling rig is visible. To the right, there is a yellow metal frame structure. The sky is clear and blue. A compass rose in the top left corner indicates North (N), South (S), East (E), and West (W). The photo was taken on Nov 4, 2021 at 1:50:21 PM, facing 97° E.</p>
Photo Direction: East	
Photo Description: View of the remediated area following backfill & regrading.
