## Release Notification

Site Name San Juan 10-2 Water line (Near SJ 32-8 242A)	Site Type Pipeline
Date Release Discovered 3/12/2021 @ 11:30am	API#

## Executive Summary

On March 12, 2021, Hilcorp Energy Company (Hilcorp) had a release of 21 bbls of produced water at the San Juan 10-2 Water Line (located approximately 1,210 ft southeast of the San Juan 32-8 Unit 242A wellpad). The release was due to the 4-inch steel water pipeline developing internal corrosion and causing the release of produced water within the right-of-way (ROW). The released fluids escaped the pipeline and pooled into a low-lying surface area immediately adjacent to the pipeline location (staying within the pipeline ROW) measuring 40 ft x 10 ft. No fluids were recovered at the time of the incident. Operations isolated, blew down, and locked out/tagged out the pipeline. As a result, no excavations occurred following the release.

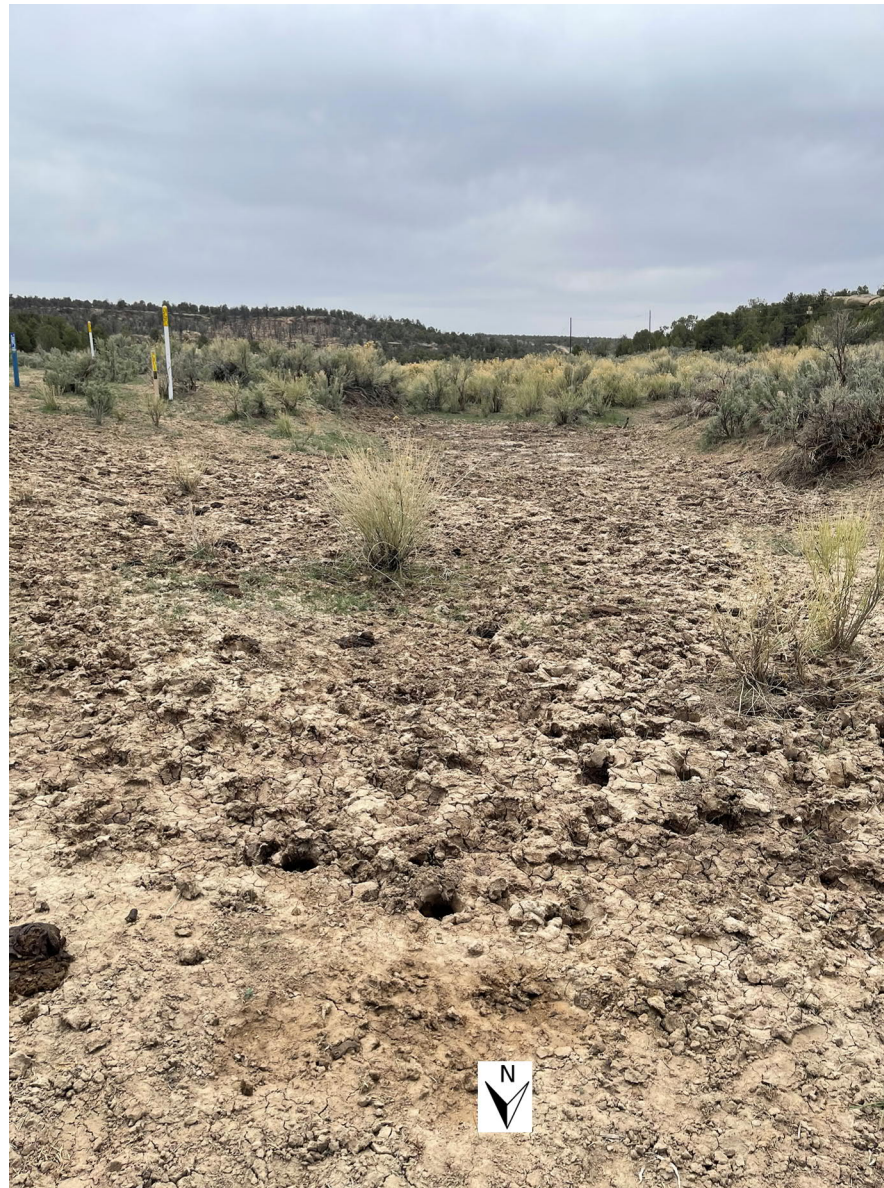
## Initial Release Photograph

A release of ~21bbls of produced water was released due to internal corrosion on the pipeline. Operations shut in waterline and turned in one call. Water was pooled approximately 20' x 20' x 4" deep. Release remained on pipeline right of way. Hilcorp will notify OCD 48 hrs prior to confirmation sampling.
