CLOSURE REPORT

**Lateral K-54 Condensate Tank Riser (4/15/21)
Unit Letter C, S22 T27N R6W
Rio Arriba County, New Mexico**

NM EMNRD OCD Incident ID No. NAPP2110632433

September 1, 2021
Ensolum Project No. 05A1226145

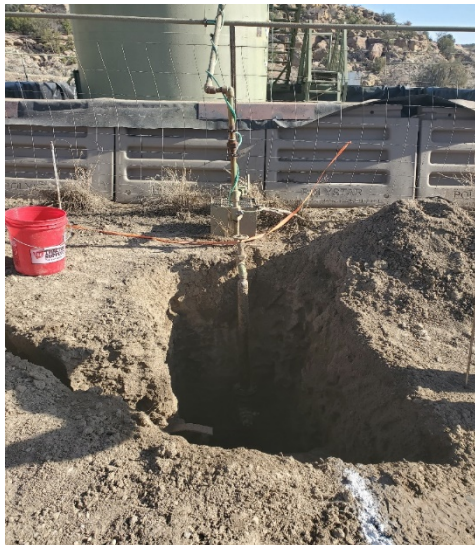
**Photograph 1**

Photograph Description: View of the release area.

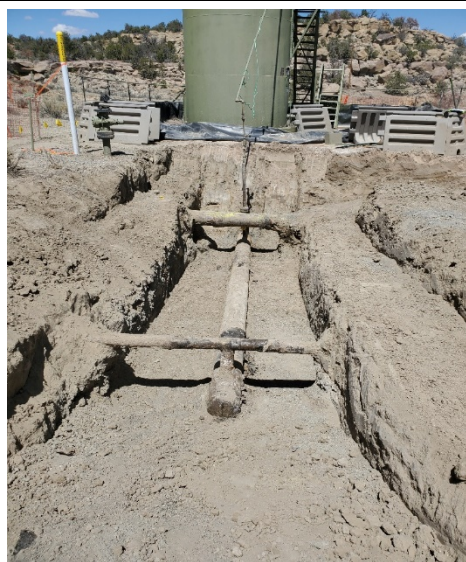
**Photograph 2**

Photograph Description: View of in-process excavation activities.

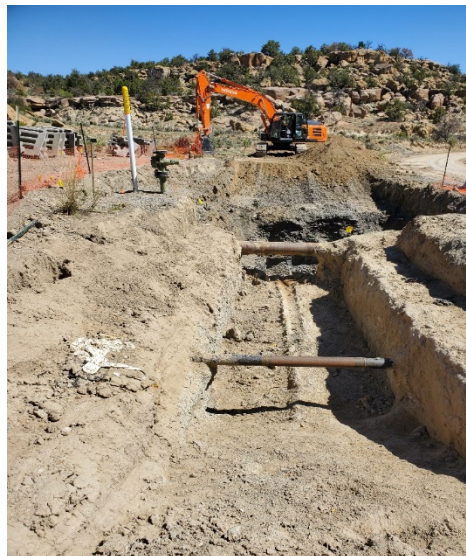
**Photograph 3**

Photograph Description: View of in-process excavation activities.

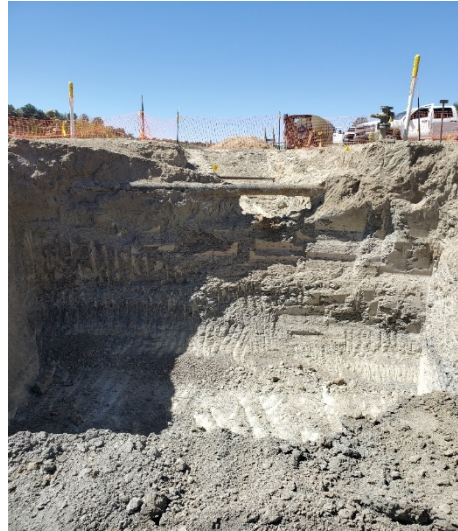
**Photograph 4**

Photograph Description: View of in-process excavation activities.

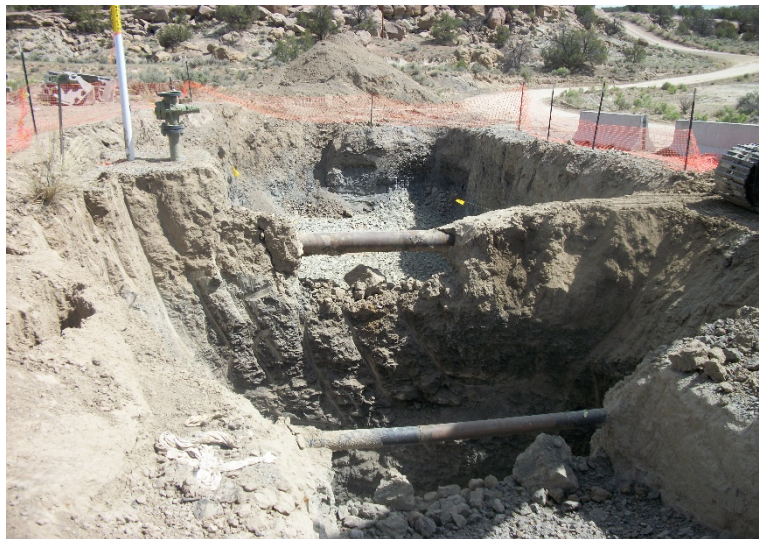
**Photograph 5**

Photograph Description: View of in-process excavation activities.

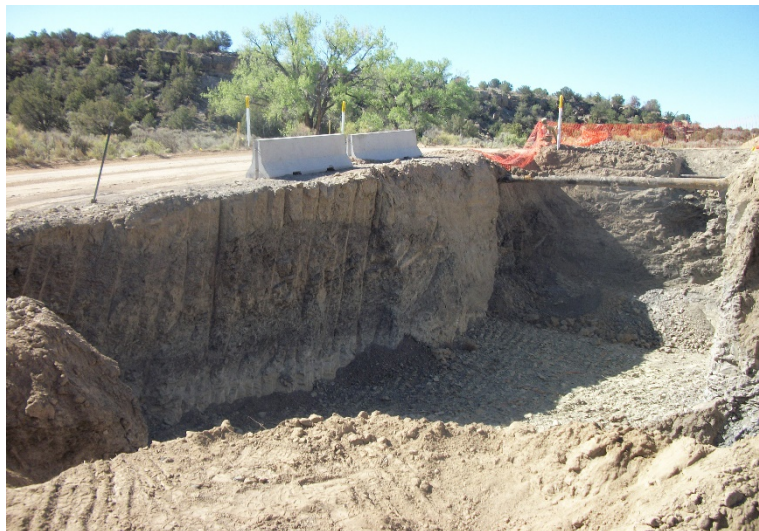
**Photograph 6**

Photograph Description: View of in-process excavation activities.

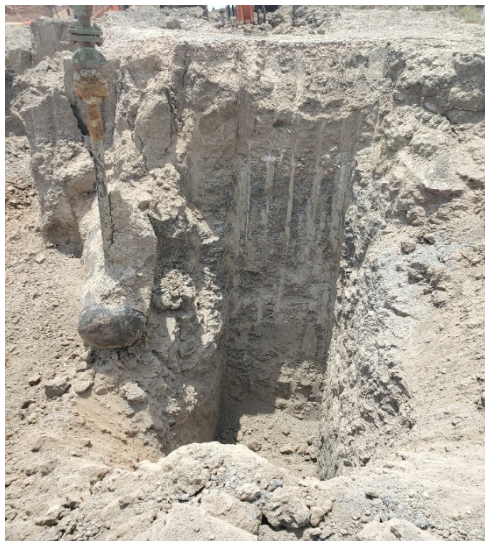
**Photograph 7**

Photograph Description: View of test pit #1

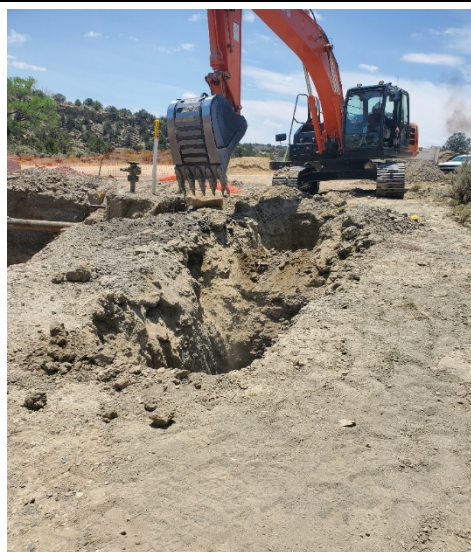
**Photograph 8**

Photograph Description: View of test pits #2 and #3.

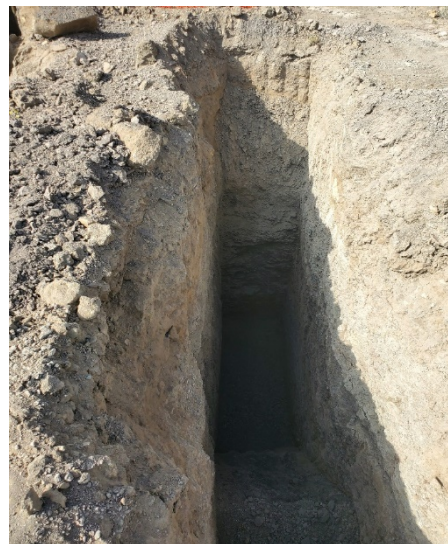
**Photograph 9**

Photograph Description: View of test pit #3.

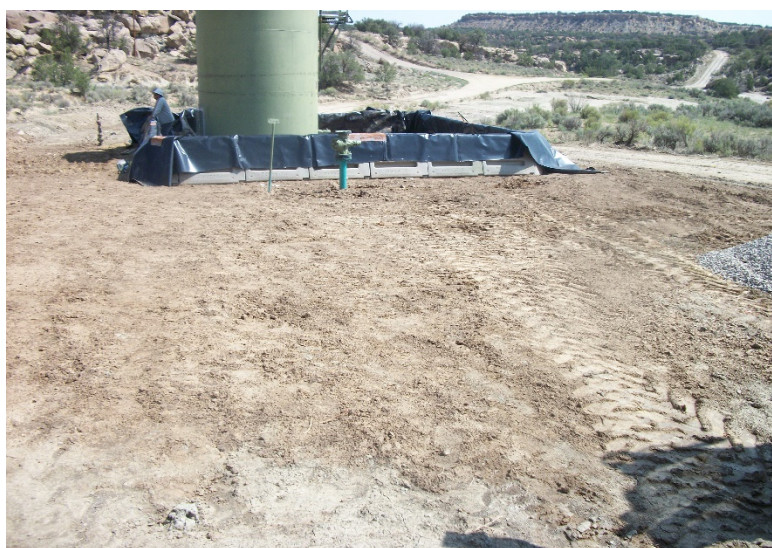
**Photograph 10**

Photograph Description: View of the excavation after initial restoration.

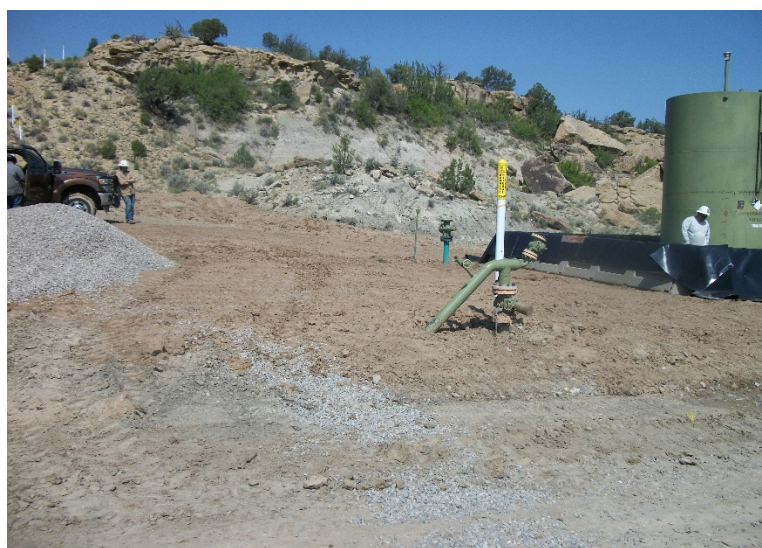
**Photograph 11**

Photograph Description: View of the excavation after initial restoration.
