Re: Remediation Plan

Pearsall SWD Gathering Line

NMOCD Ref. No. NAPP2113148964

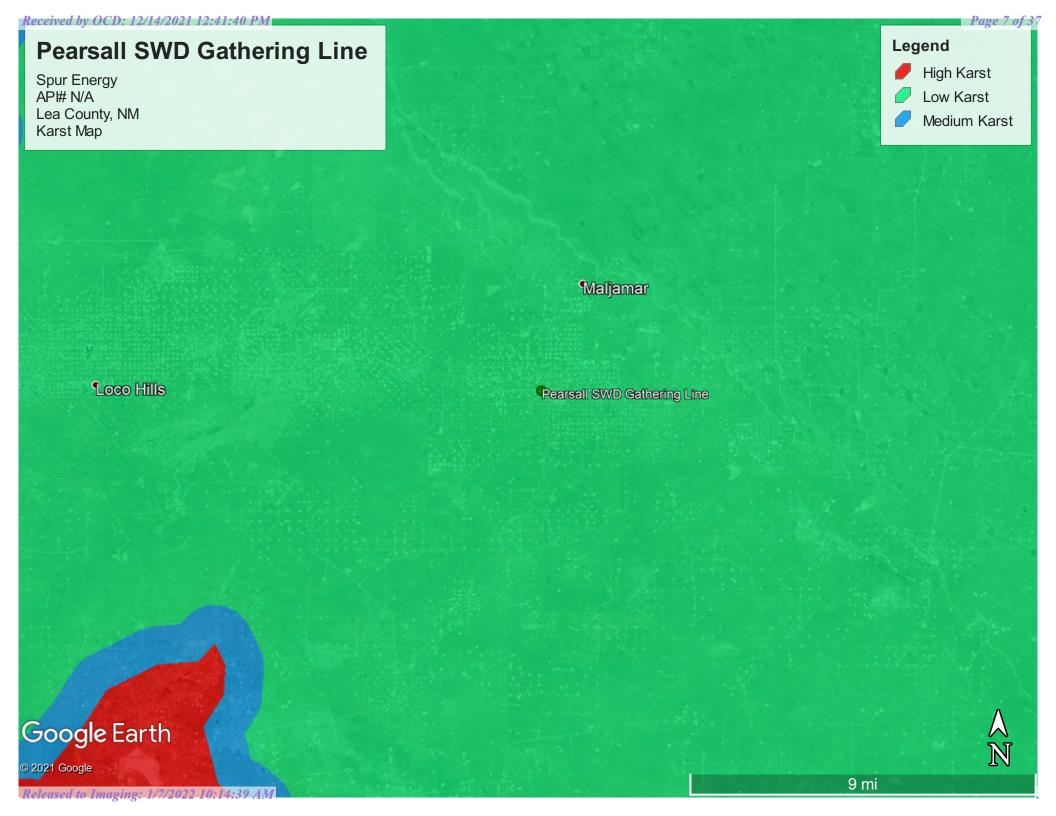
3-Karst Map

Per the New Mexico Bureau of Geology and Mineral Resources, the geology is in the Quaternary Formation-Eolian and piedmont deposits. Interlayered eolian sands and piedmont-slope deposits along the eastern flank of the Pecos River valley, primarily between Roswell and Carlsbad. Typically capped by thin eolian deposits. The soil in this area is made up of Kermit soils and Dune land, 0 to 12 percent slopes, according to the United States Department of Agriculture Natural Resources Conservation Service soil survey (Appendix B). The drainage courses in this area are excessively drained. There is a low potential for karst geology to be present around the Pearsall (Figure 3).

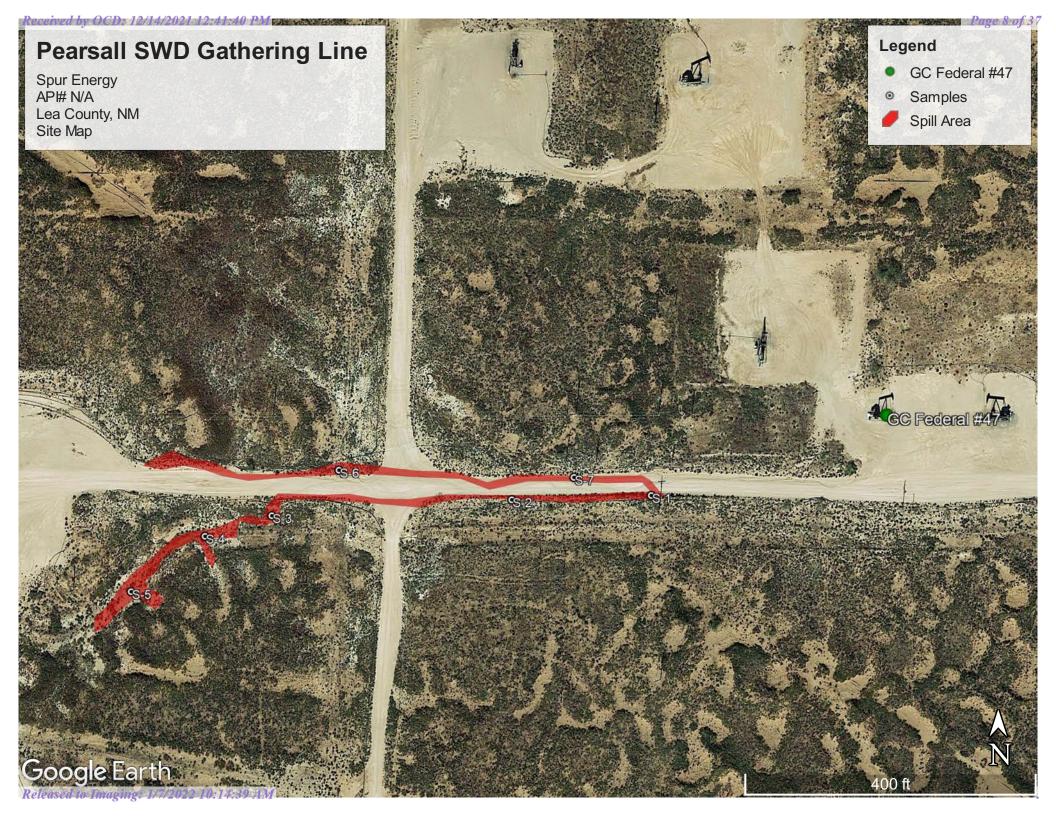
4-Site Map

On May 6th, 2021, Pima Environmental mobilized personnel to the site to assess the area. We sampled the affected areas along the road and in the pasture. Laboratory results of this sampling event can be found in the following data table.

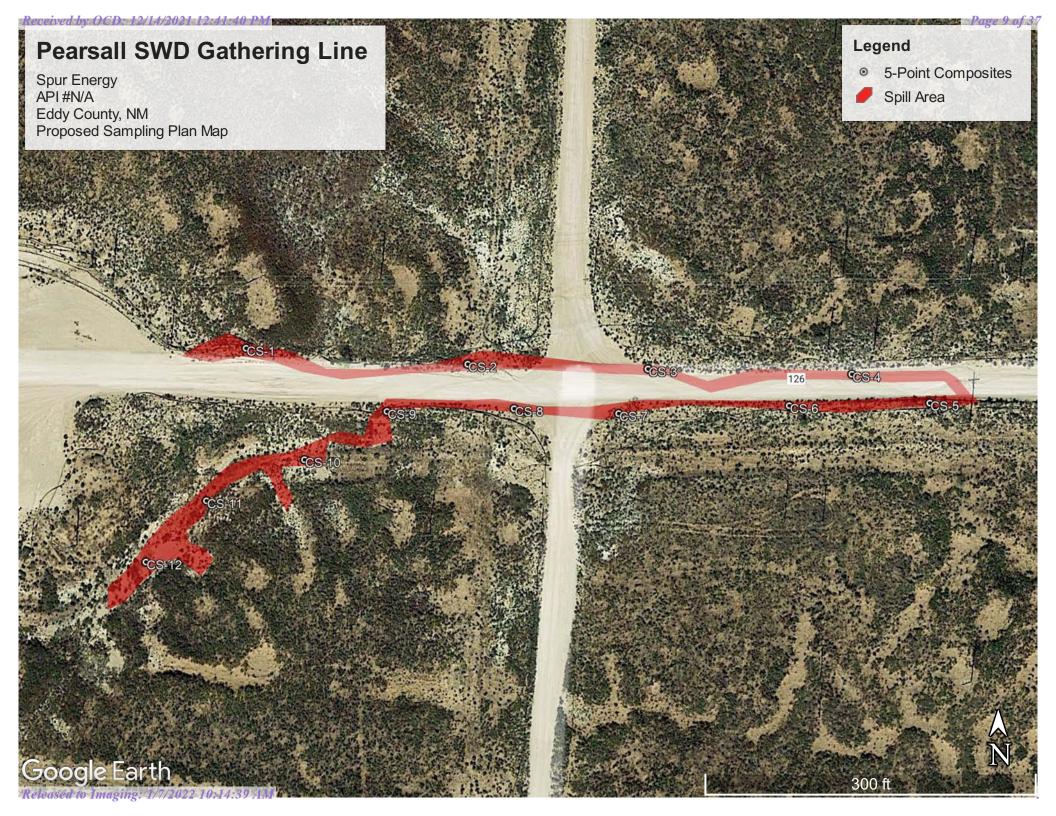
5-Proposed Sampling Plan Map

Pima, on behalf of Spur, would like to respectfully request a variance from the sampling requirement and submit a proposed sampling plan for approval. Each 5-point composite sample will be taken from a depth of 6" bgs. This Proposed Sampling Plan Map can be found in Figure 5.

Created By	Condition	Condition Date
chensley	SA-1000 application approved for sample points S-1,2,3, and S-7. The OCD request S-6 be remediated with alternative method.	1/7/2022

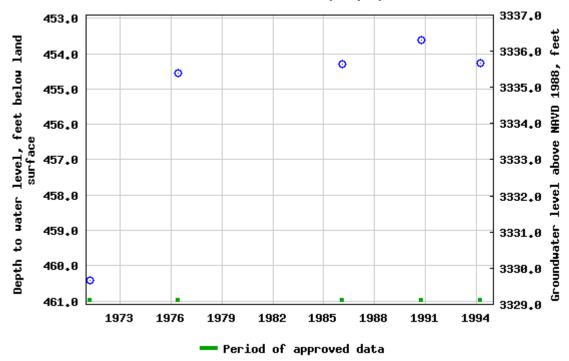
USGS 324600103484601 18S.31E.01.44432

Breaks in the plot represent a gap of at least one year between field measurements. <u>Download a presentation-quality graph</u>

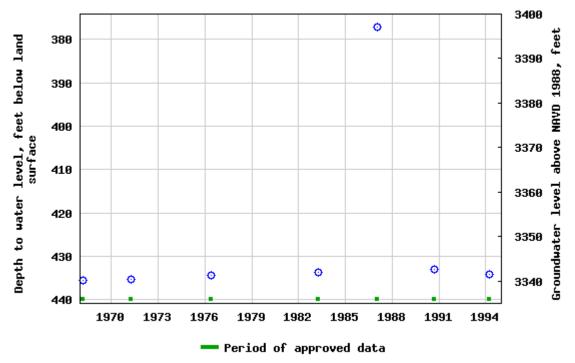
USGS 324539103490501 185,31E,12,23144

Breaks in the plot represent a gap of at least one year between field measurements. <u>Download a presentation-quality graph</u>
