**RE: Closure Request  
Jazz Bass 34 Federal 003H  
Incident Number NAPP2130844927  
Lea County, New Mexico**

WSP USA Inc. (WSP) on behalf of COG Operating, LLC (COG), presents the following Closure Request detailing site assessment and soil sampling activities at the Jazz Bass 34 Federal 003H (Site) in Unit O, Section 34, Township 25 South, Range 35 East, in Lea County, New Mexico (Figure 1). The purpose of the site assessment and soil sampling activities was to assess for the presence or absence of impacts to soil following a release of crude oil and produced water within lined containment at the Site. Based on field observations, field screening activities, and soil sample laboratory analytical results, COG is submitting this Closure Request and requesting no further action (NFA) for Incident Number NAPP2130844927.

PHOTOGRAPHIC LOG		
COG Operating, LLC	Jazz Bass 34 Federal 003H Lea County, New Mexico	NAPP2130844927

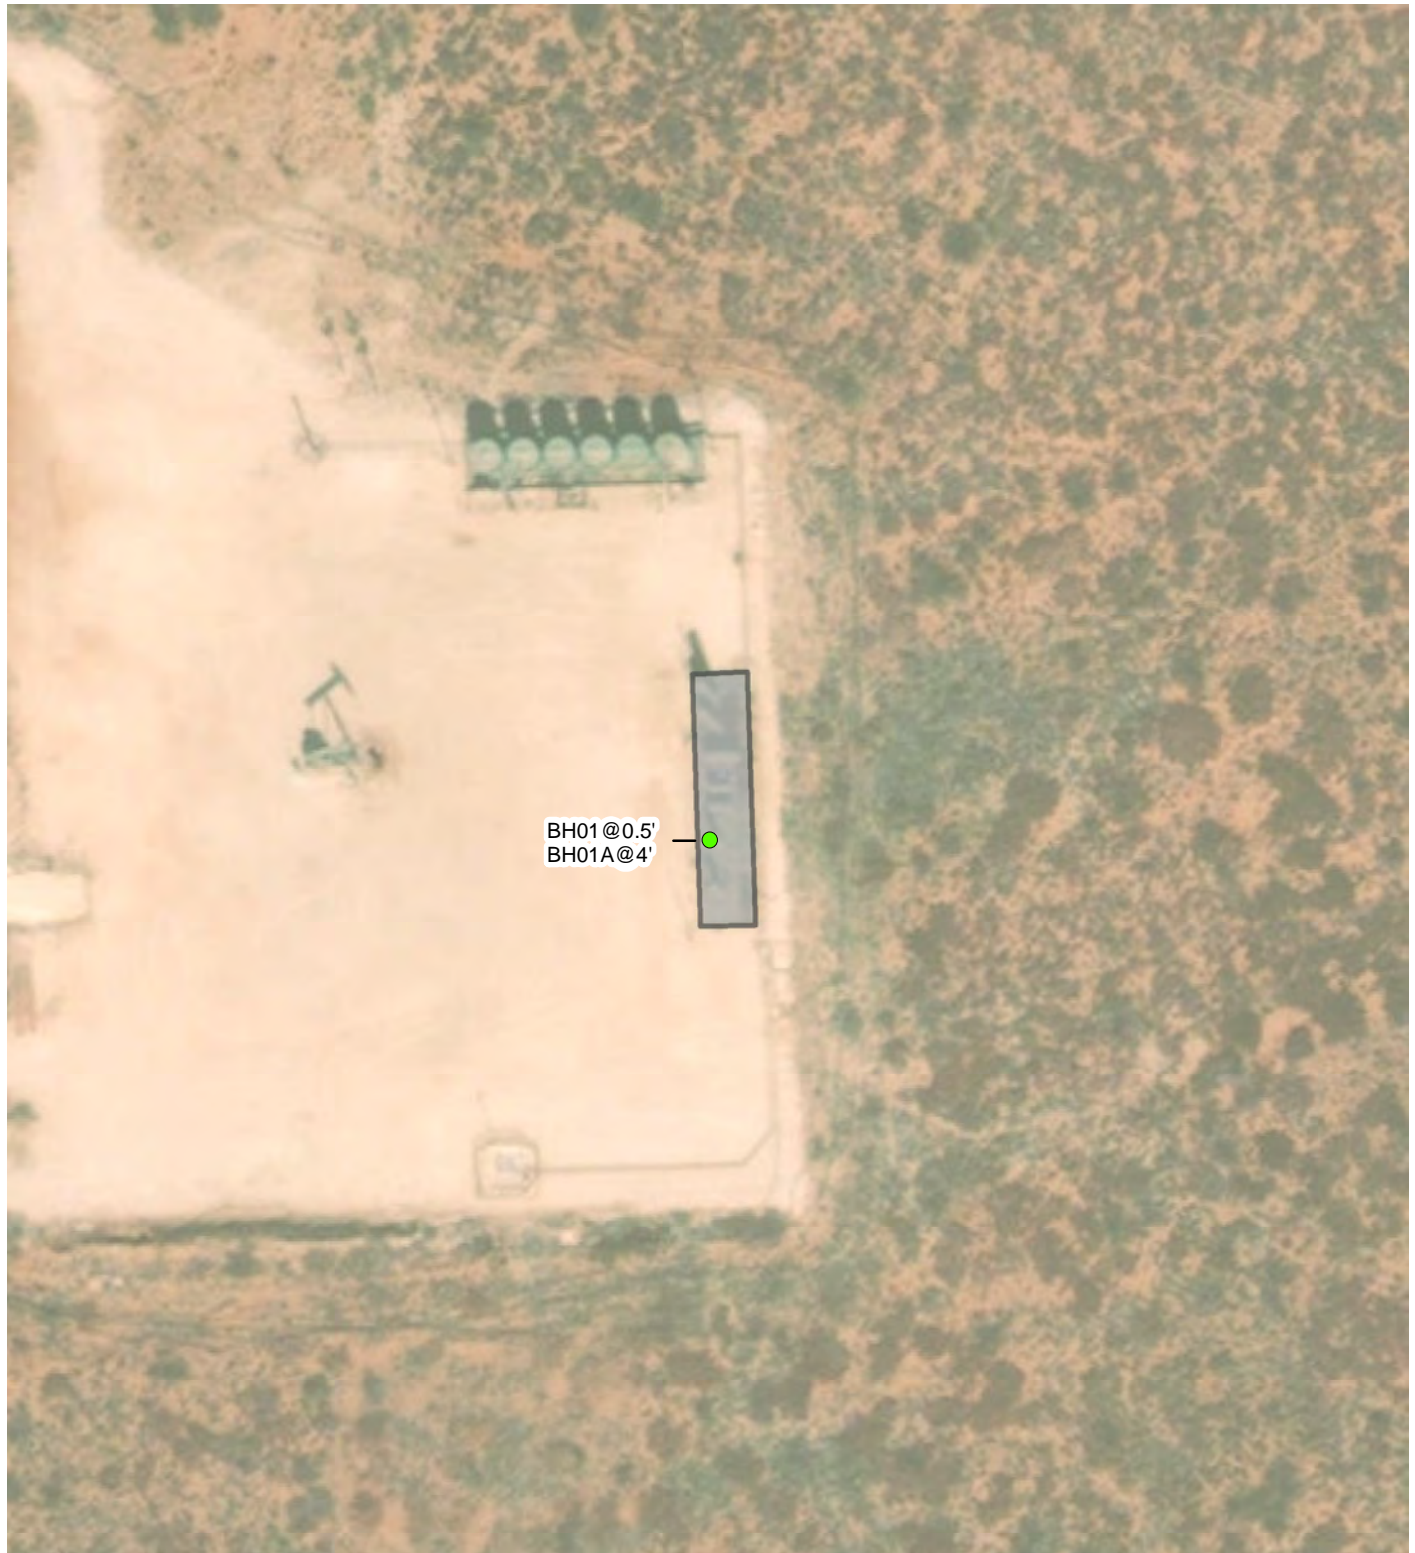
**FIGURE 2**  
**DELINEATION SOIL SAMPLE LOCATIONS**  
JAZZ BASS 34 FEDERAL 003H  
UNIT O SEC 34 T25S R35E  
LEA COUNTY, NEW MEXICO  
**COG OPERATING, LLC**

NOTE: INCIDENT NUMBER NAPP2130844927  
SAMPLE ID@DEPTH BELOW GROUND SURFACE (FEET)

Laboratory analytical results for delineation soil samples BH01 and BH01A indicated that benzene, BTEX, TPH-DRO/TPH-GRO, TPH, and chloride concentrations were compliant with the Closure Criteria. In addition, all delineation soil samples were compliant with the most stringent Table 1 Closure Criteria. Laboratory analytical results are summarized in Table 1 and the complete laboratory analytical report is included as Attachment 4.

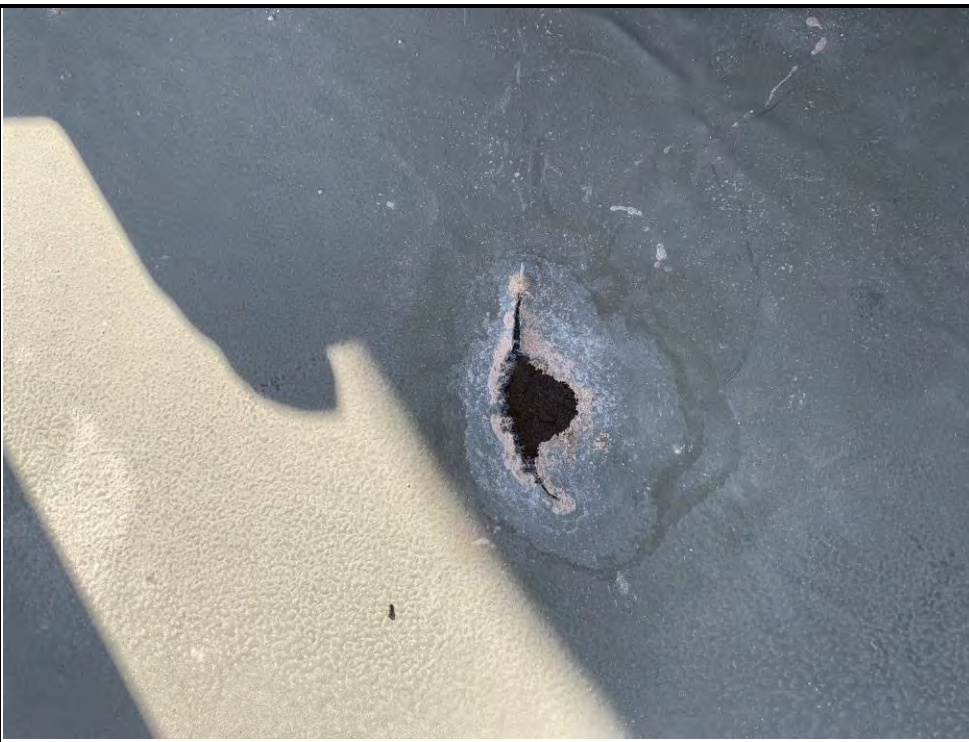
Photo No.	Date

1	November 8, 2021	
View of hole identified in tank battery liner during inspection.

Following the failed liner integrity inspection at the Site, WSP personnel advanced one borehole, (BH01), within the lined containment to assess for the presence or absence of soil impacts resulting from the October 21, 2021 crude oil and produced water release within the lined containment. Two delineation soil samples were collected from borehole BH01, at depths of approximately 0.5 feet and 4 feet bgs. Laboratory analytical results for the delineation soil samples indicated that benzene, BTEX, TPH-DRO/TPH-GRO, TPH and chloride concentrations were compliant with the Closure Criteria. In addition, all delineation soil samples were compliant with the most stringent Table 1 Closure Criteria. The release was contained laterally by the lined containment and all released fluids were recovered during initial response activities. The tear in the liner was subsequently repaired.

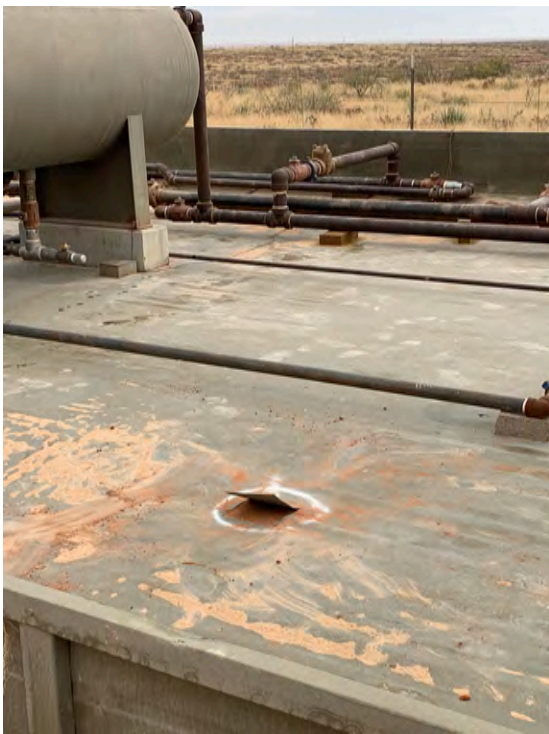
Photo No.	Date

2	November 24, 2021	
View of BH01 location inside tank battery containment.

On November 24, 2021, WSP personnel visited the Site to evaluate the release and conduct site assessment activities. WSP personnel advanced one borehole (BH01) via hand-auger at the location of the tear in the liner identified during the liner integrity inspection. Two soil samples (BH01 and BH01A) were collected from the borehole at depths of approximately 0.5 feet and 4 feet bgs. Soil from the borehole was field screened for volatile aromatic hydrocarbons and chloride utilizing a calibrated photo-ionization detector (PID) and Hach® chloride QuanTab® test strips, respectively. Field screening results and observations from the borehole were documented on a lithologic/soil sampling log, which is included as Attachment 2. The borehole was backfilled with the soil removed and a COG contractor repaired the tear in the liner. The borehole delineation soil sample location is depicted on Figure 2. Photographic documentation was conducted during the Site visit. A photographic log is included in Attachment 3.
