Release Notification

Site Name: Jicarilla 95 6A	Site Type: Well
Date Release Discovered: 12/2/2020	API# (if applicable): 30-039-25442

Incident # nAPP2035757045

Well Name: Jicarilla 95 6A Located in Section 36, Township 27 North, Range 3 West, Rio Arriba, New Mexico.

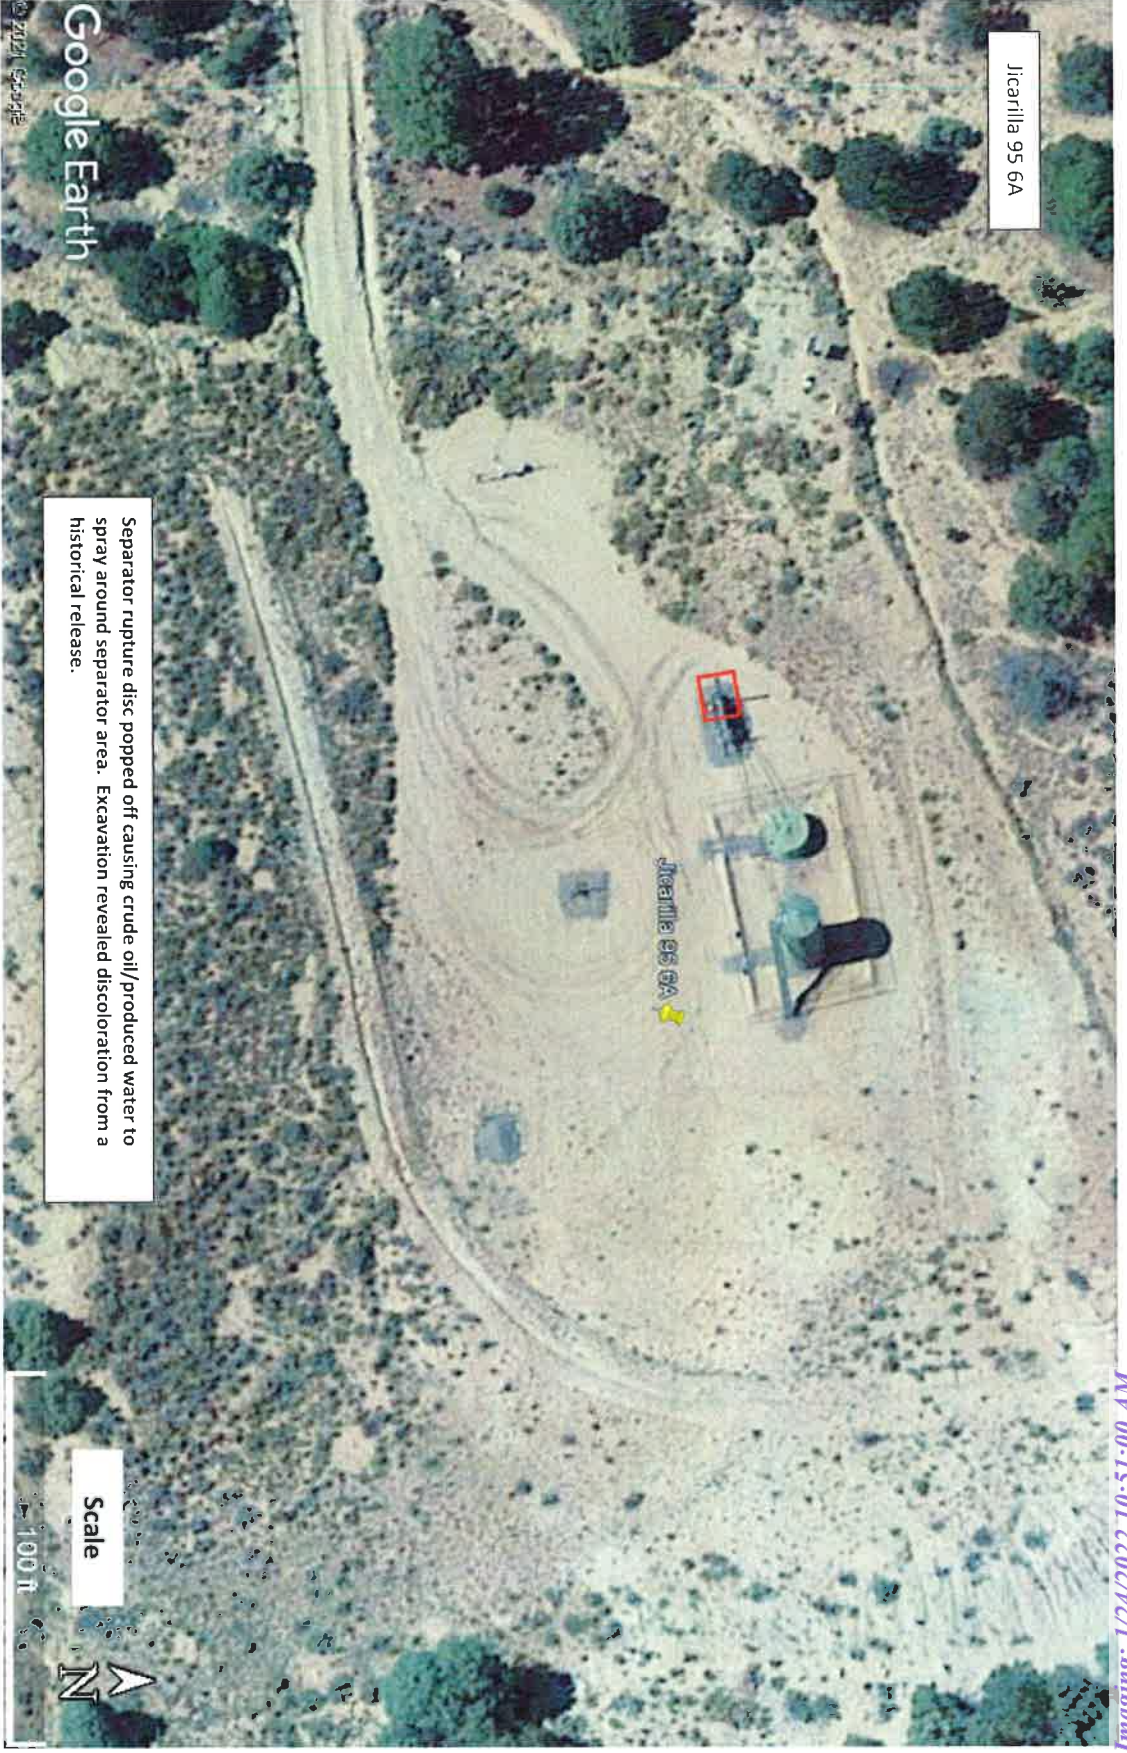
Aerial Site Map

Separator rupture disc popped off causing crude oil/produced water to spray around separator area. Excavation revealed discoloration from a historical release.

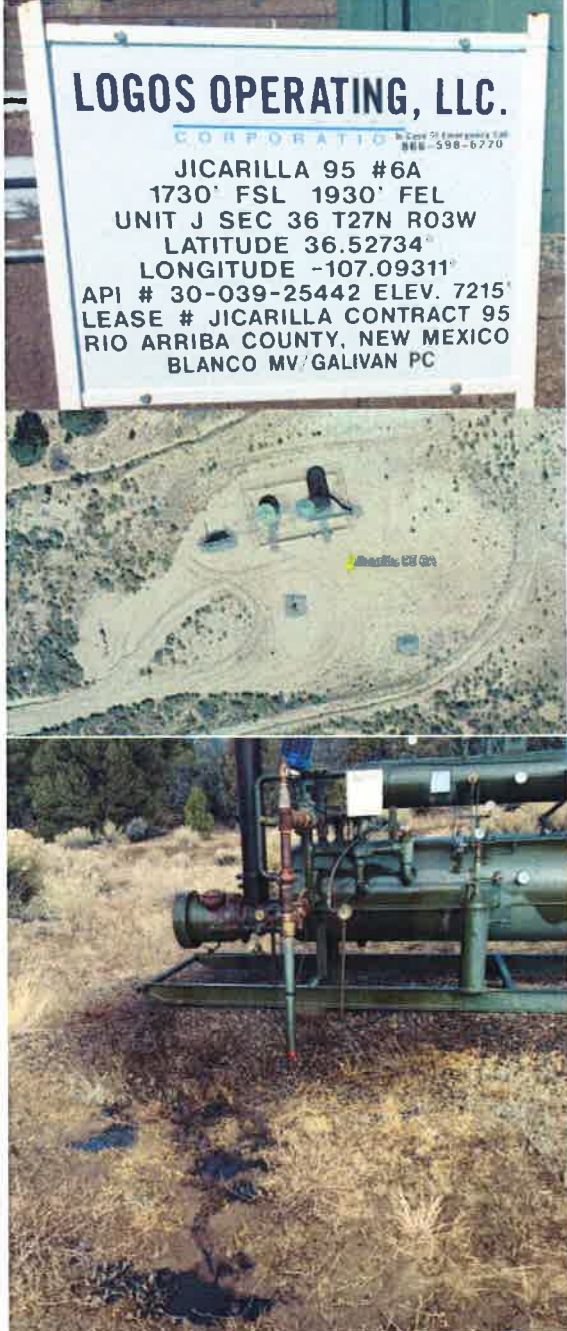
JICARILLA 35 8 – 11/12/20 SITE AREA SPILL

The separator had a ruptured disc pop off on location and sprayed +/- 20 gals of mixed oil and water. The affected area sprayed on the separator and the ground around the separator.

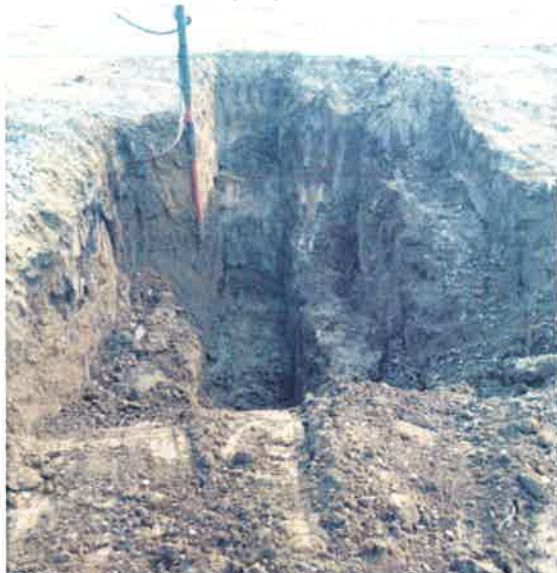
JICARILLA 35 8 – 12/02/2020 SITE AREA REMEDIATING

On December 2, 2020, we dug approximately 12 cu yds of contaminated soil, which appears to be a historic stain from previous ruptured disc on the separator.

On November 30, 2020 Jicarilla was notified that Kelley Oilfield Services was scheduled to remove contaminated soil and Envirotech to do confirmation sampling. On December 2, 2020 Kelley Oilfield Services removed the separator, as Keith Manwell had requested, started digging and hauled off 16 yards, approximate 8' x 8' x 5' deep at the separator of contaminated soil and disposed of at Envirotech Landfarm. Envirotech took field confirmation samples at 1:37pm with Keith Manwell on location – samples passed. After samples were taken, Kelley Oilfield Services back-filled area with approved dirt located by Keith Manwell. Backfill was completed on December 2, 2020.

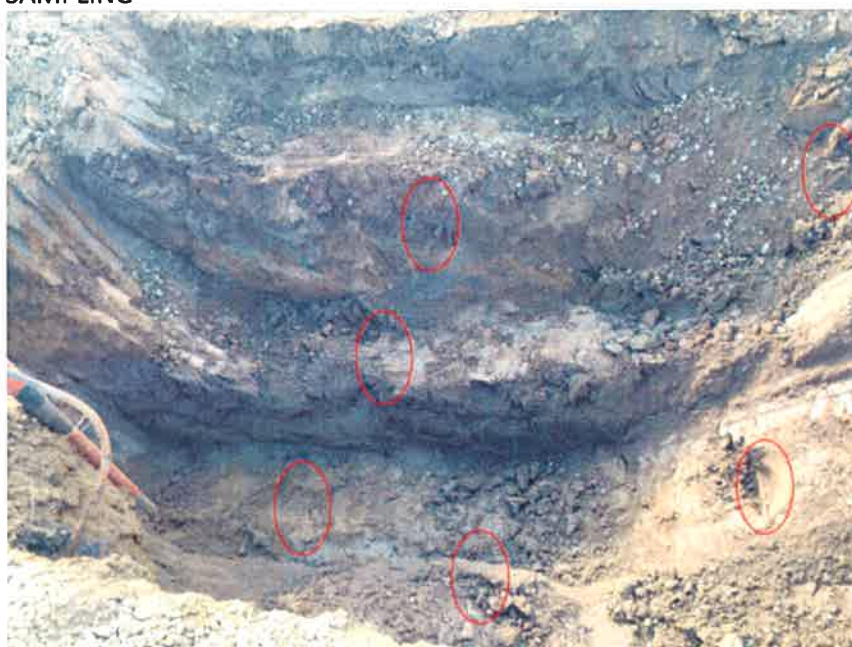
SAMPLING

On December 2, 2020 Jicarilla and OCD were notified and Envirotech performed the confirmation sampling. One 5-point composite sample was collected, as documented in the enclosed Aerial Site map. The sample testing report was received on 12/10/20, the sample passed.
