SITE CHARACTERIZATION AND PROPOSED REMEDIATION PLAN

MOBIL CI #12 (FLOWLINE TIE IN)
UNIT H, SECTION 16, TOWNSHIP 19S, RANGE 25E
EDDY COUNTY, NEW MEXICO
32.69017, -104.51728
RANGER REFERENCE NO. 5375

DECEMBER 6, 2021

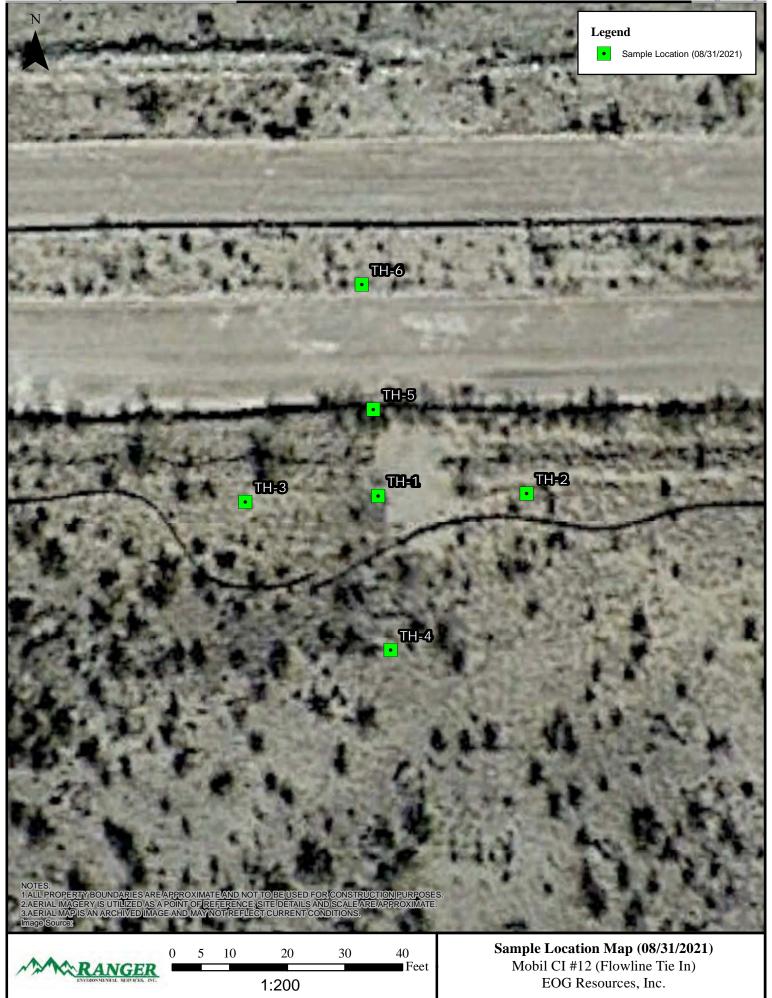
The initial test excavation location ("TH-1") was completed in the approximate midpoint of the reported area of concern. Based on the observed field chloride readings, the excavation was completed to approximately 14 feet bgs (the maximum extent of the on-site equipment). Test excavations "TH-2" through "TH-5" were subsequently completed in each cardinal direction moving outward from the "TH-1" location to assist in delineating the elevated field chloride readings. During the installation of test excavation "TH-5", which was located north of the "TH-1" location, elevated field chloride readings were still found to be present. Therefore, an additional test excavation ("TH-6") was installed further to the north. Due to the proximity of the "TH-6" test excavation to a caliche ranch road, the depth of this test excavation was limited to one-foot bgs for safety purposes. However, no elevated field chloride readings were obtained in this test excavation.

As summarized above, during the test excavation installation process, field chloride titrations indicated that elevated soil chloride concentrations were present in test excavations TH-1 and TH-5. However, none of the test excavation soils were found to contain discoloration or elevated OVM readings.

A site map depicting the test excavation/sample locations is attached.

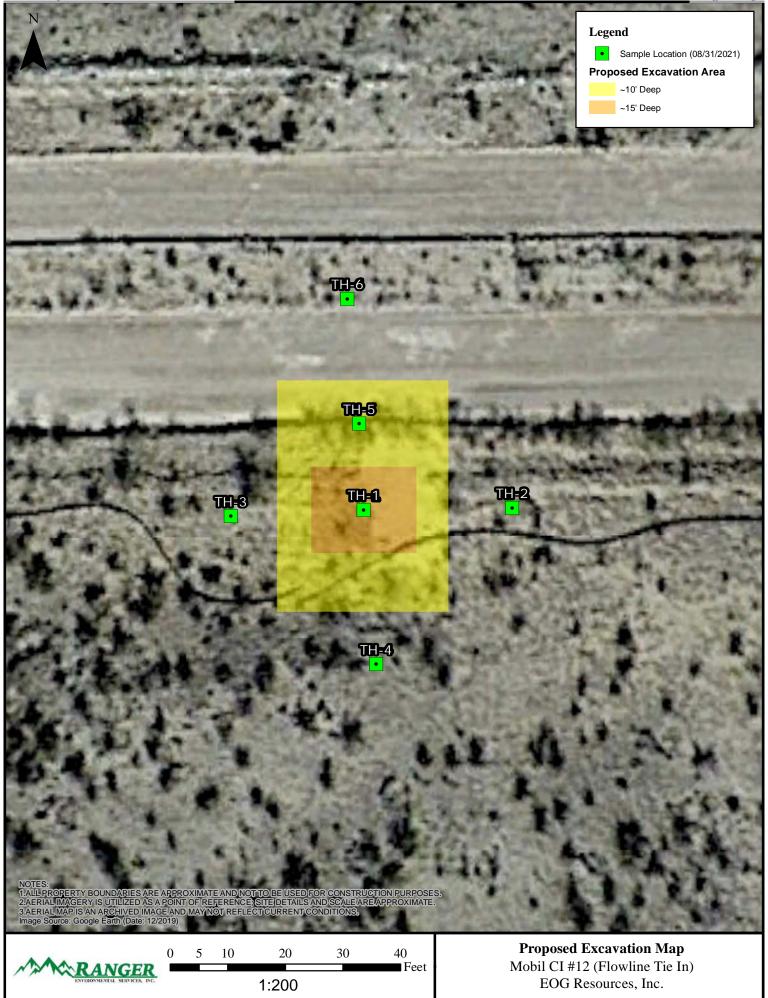
To address the elevated soil chloride concentrations at the Site, soil excavation is proposed. Based on the samples collected during the assessment activities, soil excavation activities will be completed to boundaries and depths anticipated to be within the applicable regulatory criteria. The initial proposed excavation area is anticipated to have maximum dimensions of approximately 40 feet long by 30 feet wide and will be completed to a depth of approximately 15 feet bgs. A site map depicting the proposed excavation area is attached.

Based on the proposed excavation boundaries and depths, it is anticipated that approximately 700 cubic yards of material will be generated during the site remediation process. The excavated material will be transported off-site for disposal at an approved disposal facility.

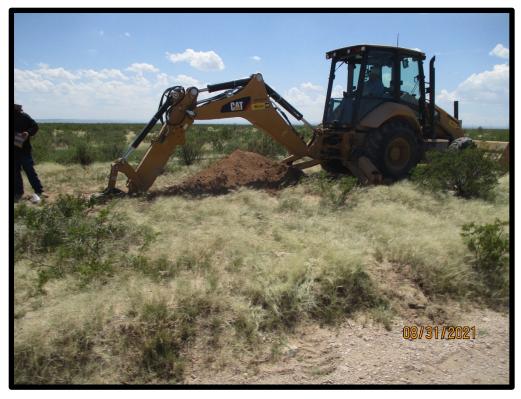
PHOTOGRAPH NO. 1 – A view of the assessment activities on August 31, 2021 in the vicinity of test excavation "TH-3". The view is towards the southwest.

(Approximate GPS: 32.690224, -104.517336)

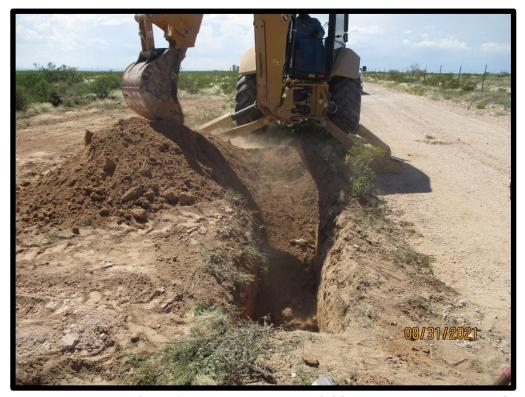
PHOTOGRAPH NO. 2 – A view of the assessment activities on August 31, 2021 in the vicinity of test excavation "TH-5". The view is towards the west.

(Approximate GPS: 32.690210, -104.517273)
