**Re: Closure Request Report
Federal BA 001 (1.8.21)
Tracking # nAPP2102141155
GPS: 32.428955, -103.76284
Unit Letter O Section 34, Township 21 South, Range 31 East
Eddy County, New Mexico**

COG Operating, LLC (COG) is pleased to submit the following closure report in response to a release that occurred at the Federal BA 001 located in Unit Letter O Section 34, Township 21 South, Range 31 East in Eddy County, New Mexico. The spill site coordinates are 32.428955, -103.76284.

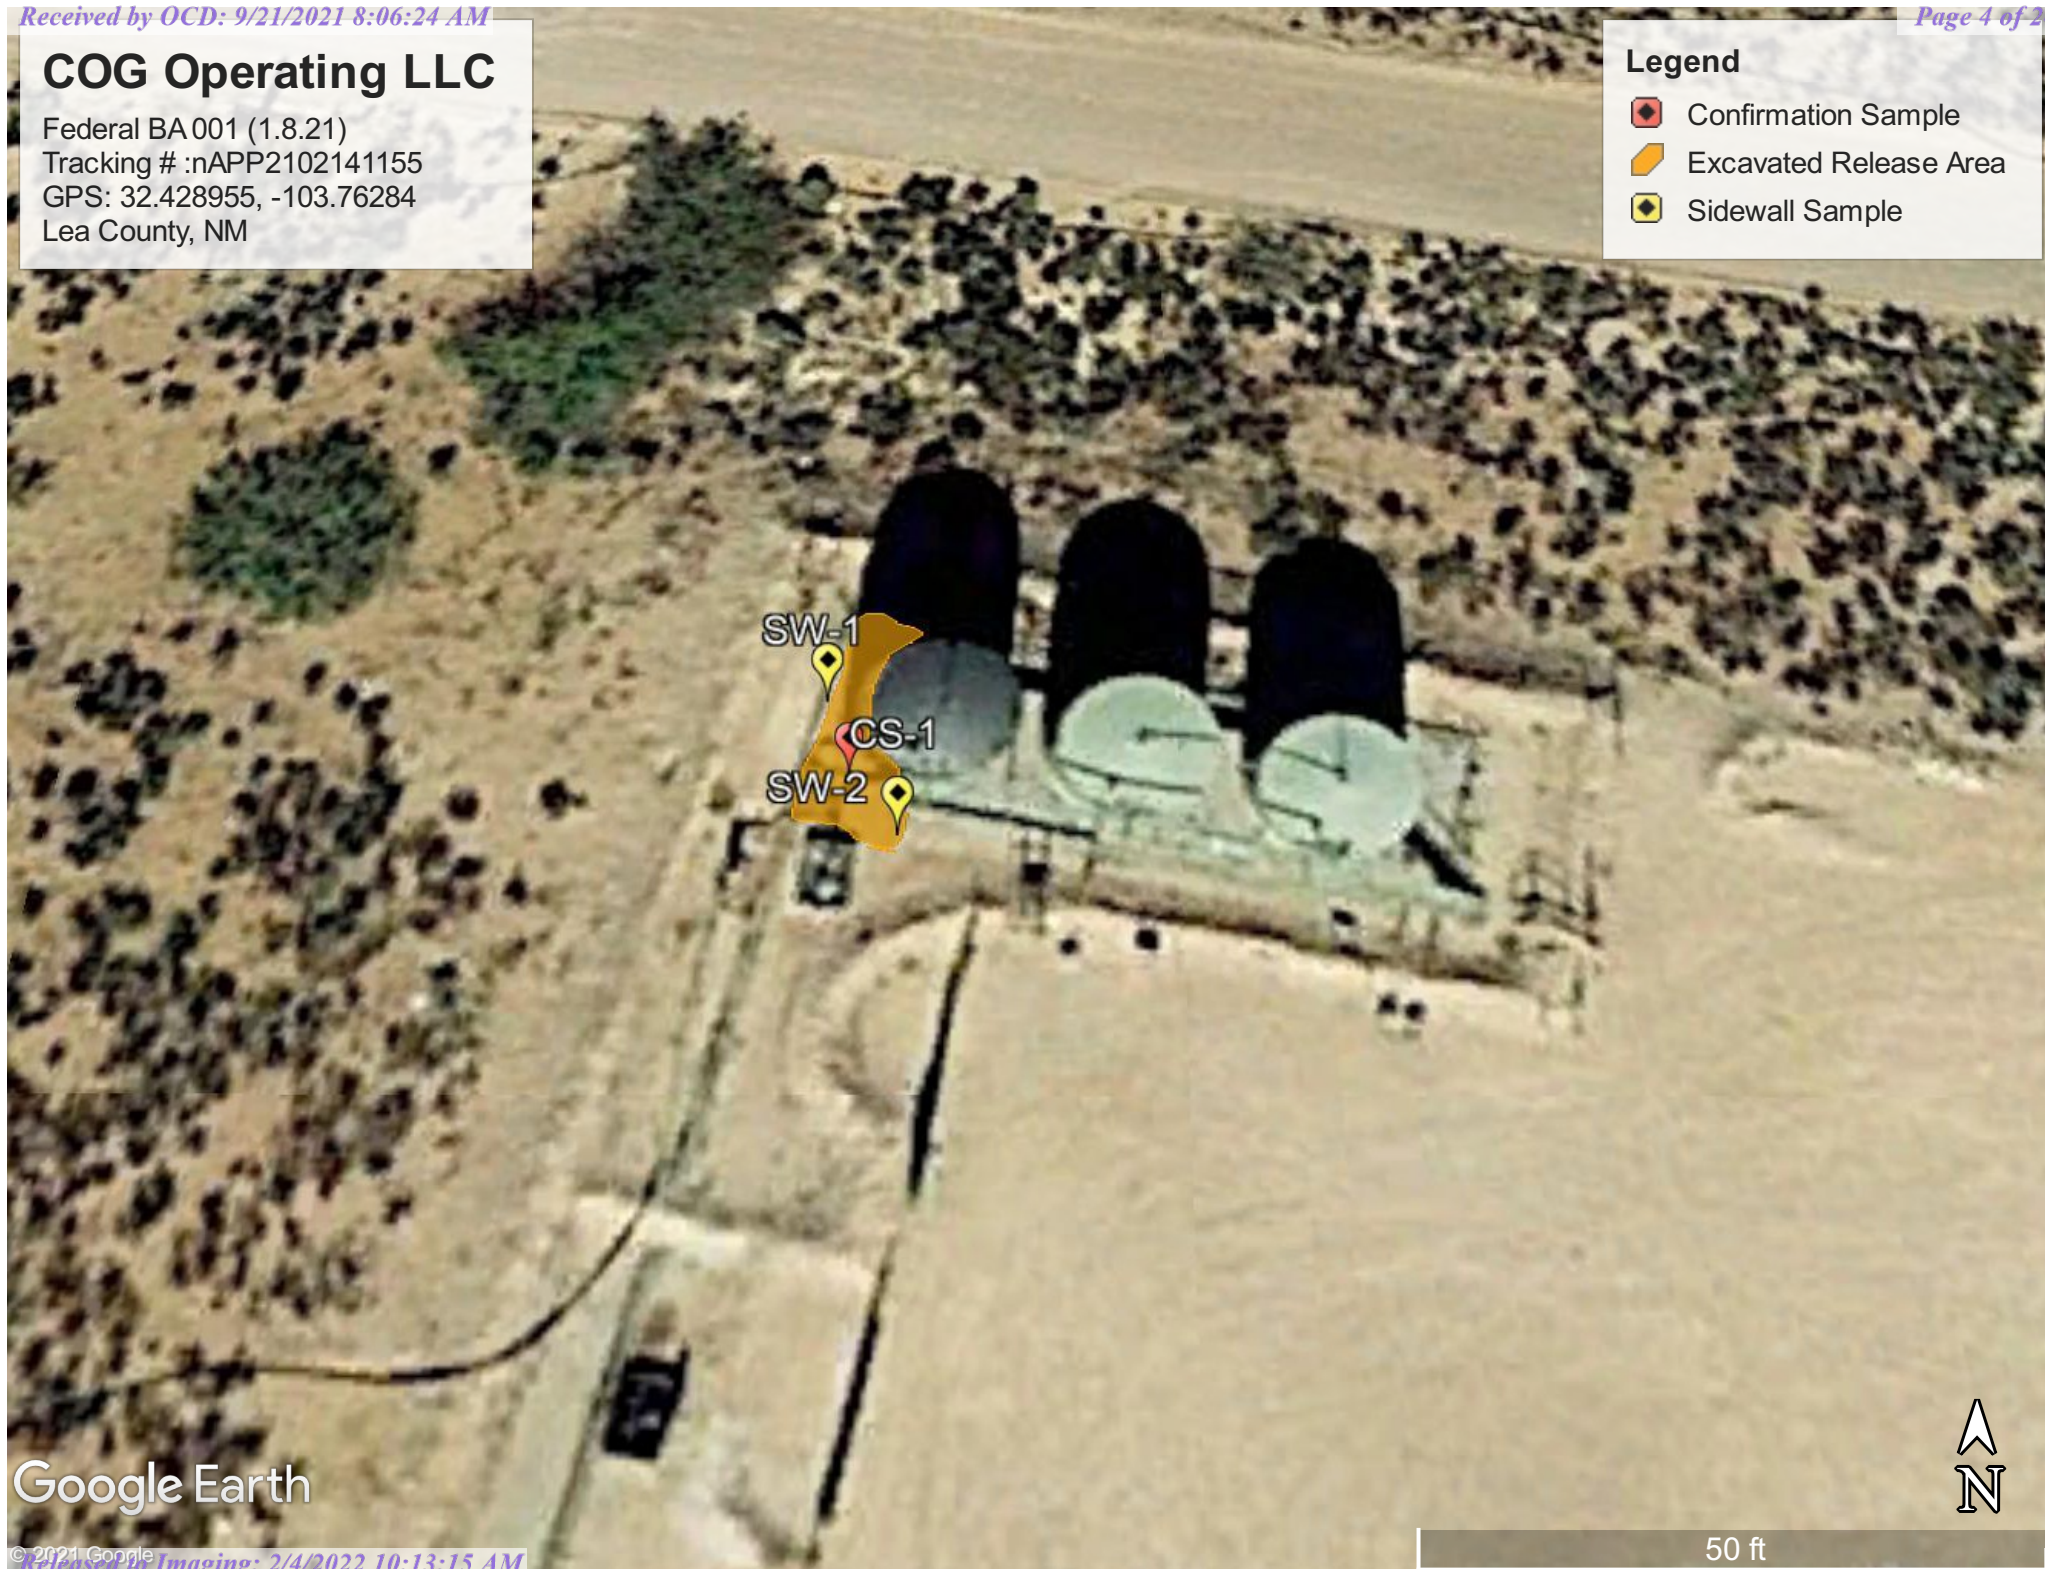
Maps

Confirmation Sample
-

Excavated Release Area
-

Sidewall Sample

- The impacted area was excavated to a depth of two (2) to two feet bgs. A composite sample (BH-1) and two sidewall samples (SW-1, SW-2) were taken on March 17, 2021. The results showed elevated DRO. The sidewalls results were below NMOCD closure criteria. An additional half (0.5) ft bgs was excavated and an additional confirmation sample was taken. The results indicated NMOCD closure criteria was met due to the Depth to water being greater than 100 ft.
- Table 1 shows the sample depths and analytical results.
- All the excavated material was hauled to an NMOCD approved solid waste disposal facility.
- Confirmation soil samples were taken from bottom and sidewalls of the excavation per NMAC 19.15.29.
- The analytical data shown in Table 1 show that the release area meets NMOCD closure criteria (NMAC 19.15.29.12(E) Table I).

Once excavated, soil samples were collected from the sidewalls to confirm the removal of impacted soil greater than 600 mg/kg of chlorides. Composite bottom and sidewall samples were collected every 200 square feet, to be representative of the release area. The confirmation sample (CS-1) and sidewall samples (SW-1 & SW-2) results meet NMOCD closure criteria.

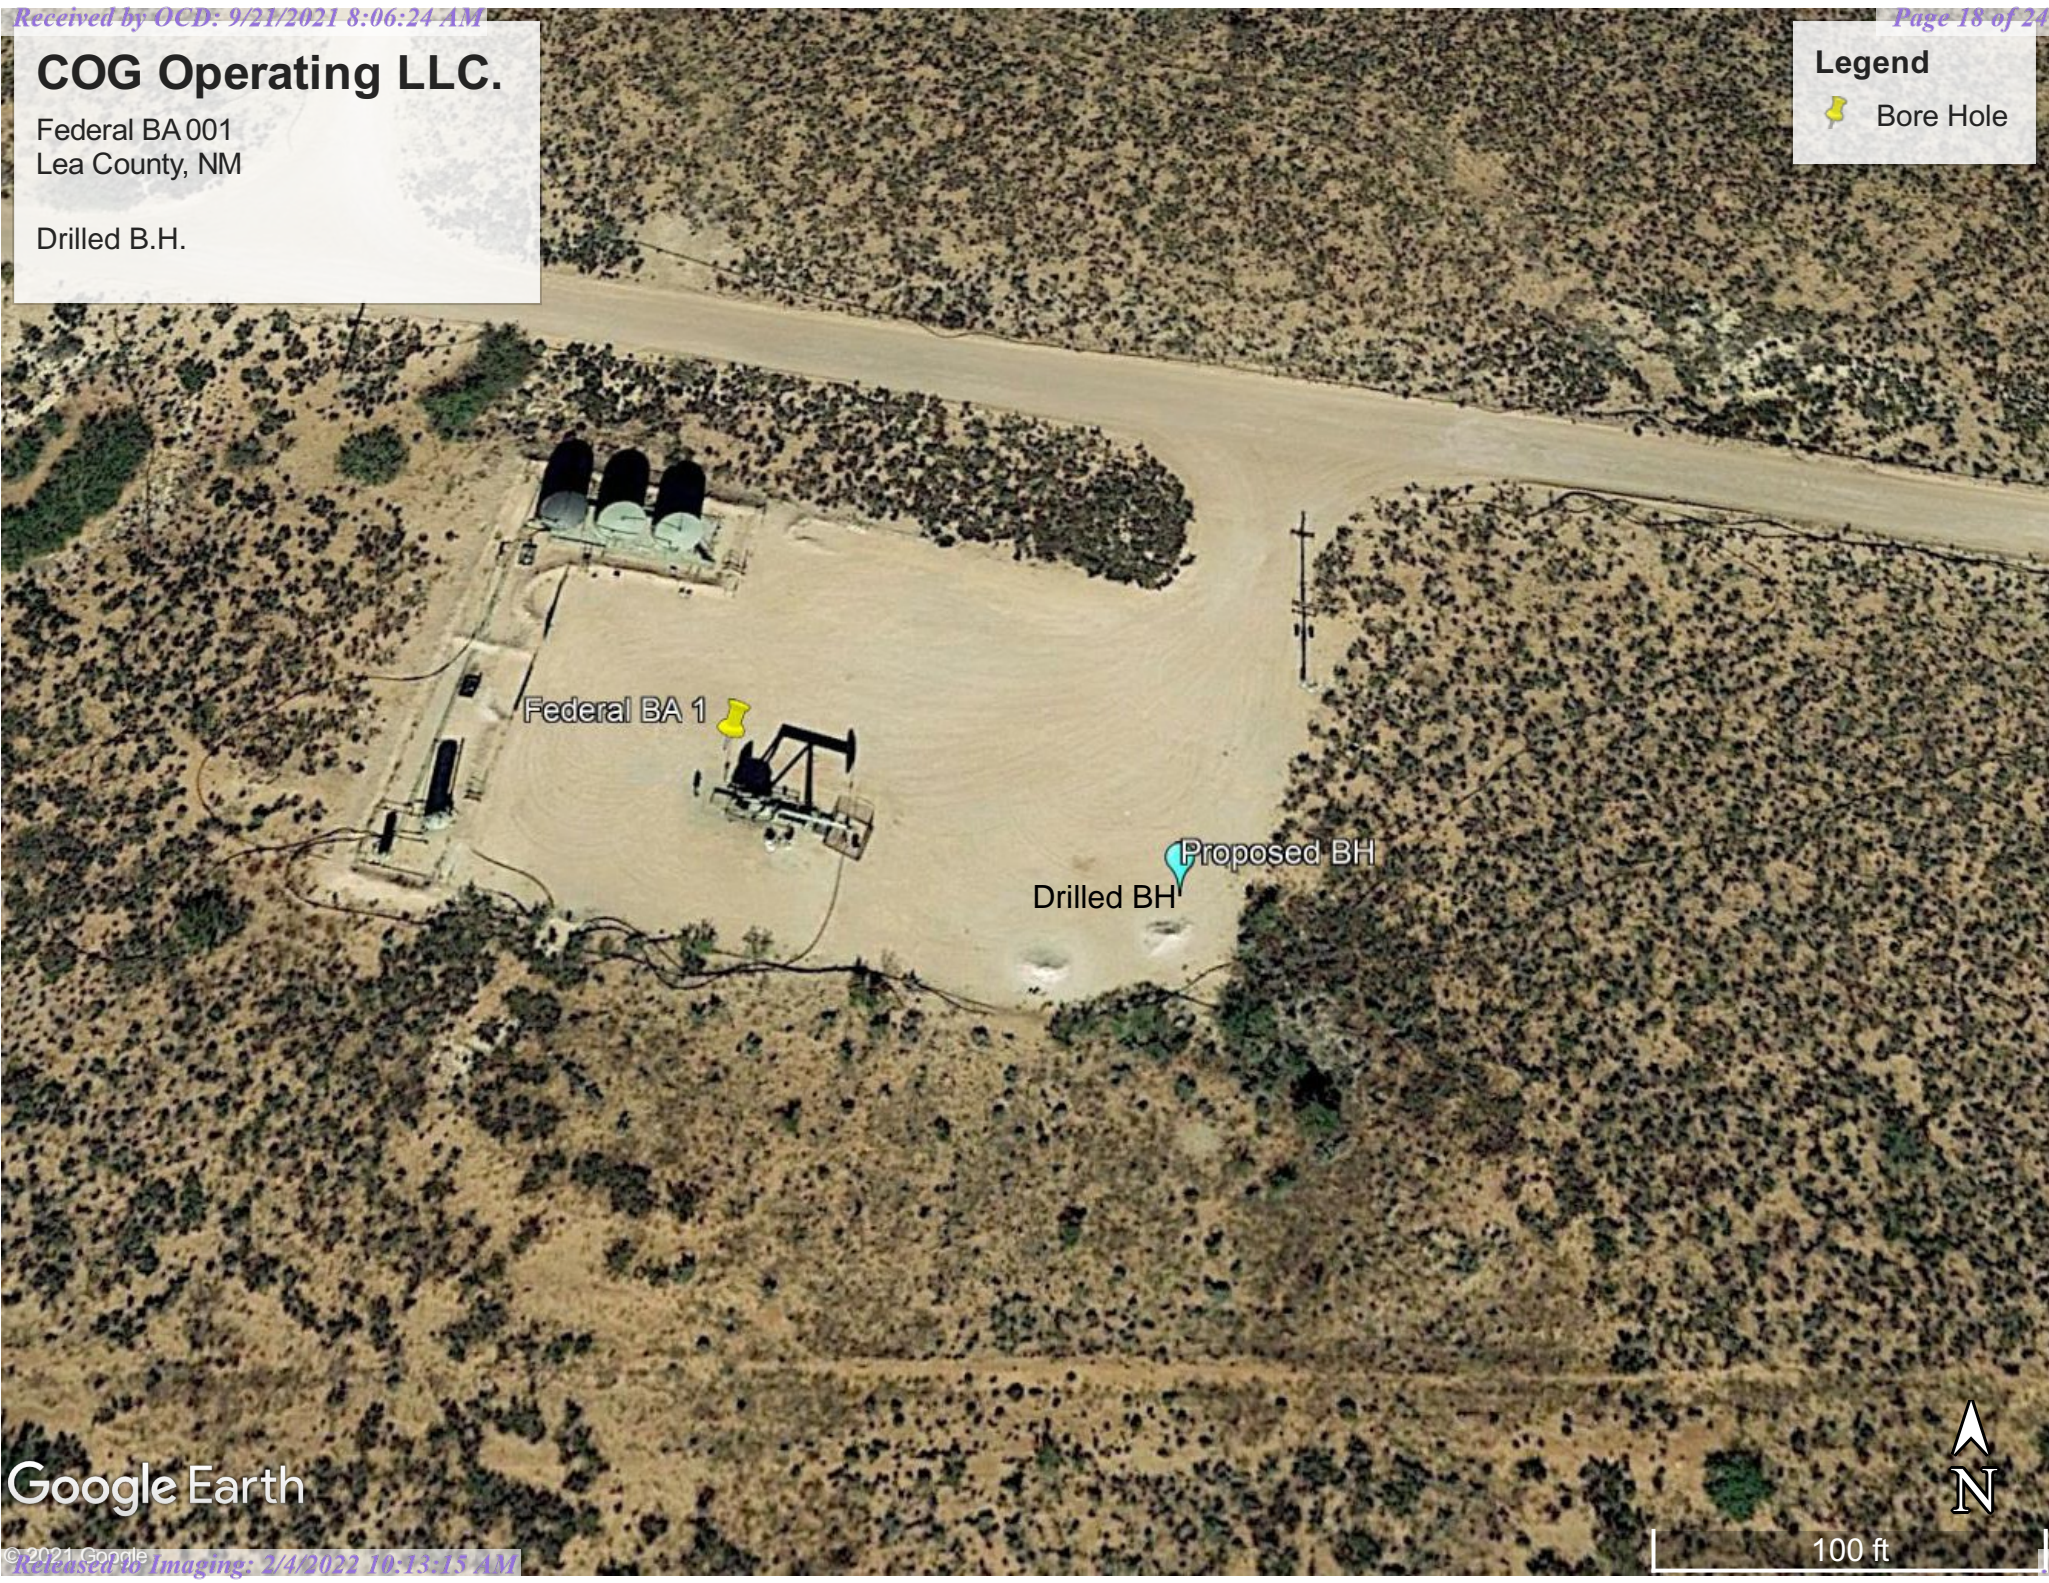
Drilled B.H.

Bore Hole

A borehole was drilled within a ½ mile of the release to a depth of one hundred and five (105) feet below surface and open for 72 hrs. After 72 hours, the borehole was gauged for presence of groundwater and no water was present. (Drilling log and map of location in Appendix B).
