RICE *Operating Company*

**RE: 2020 Annual Groundwater Report
Rice Operating Company – BD SWD System
BD F-29 (1R426-16) and F-29-1 (1R426-15): UL/F, Sec. 29, T21S, R37E**

appendix

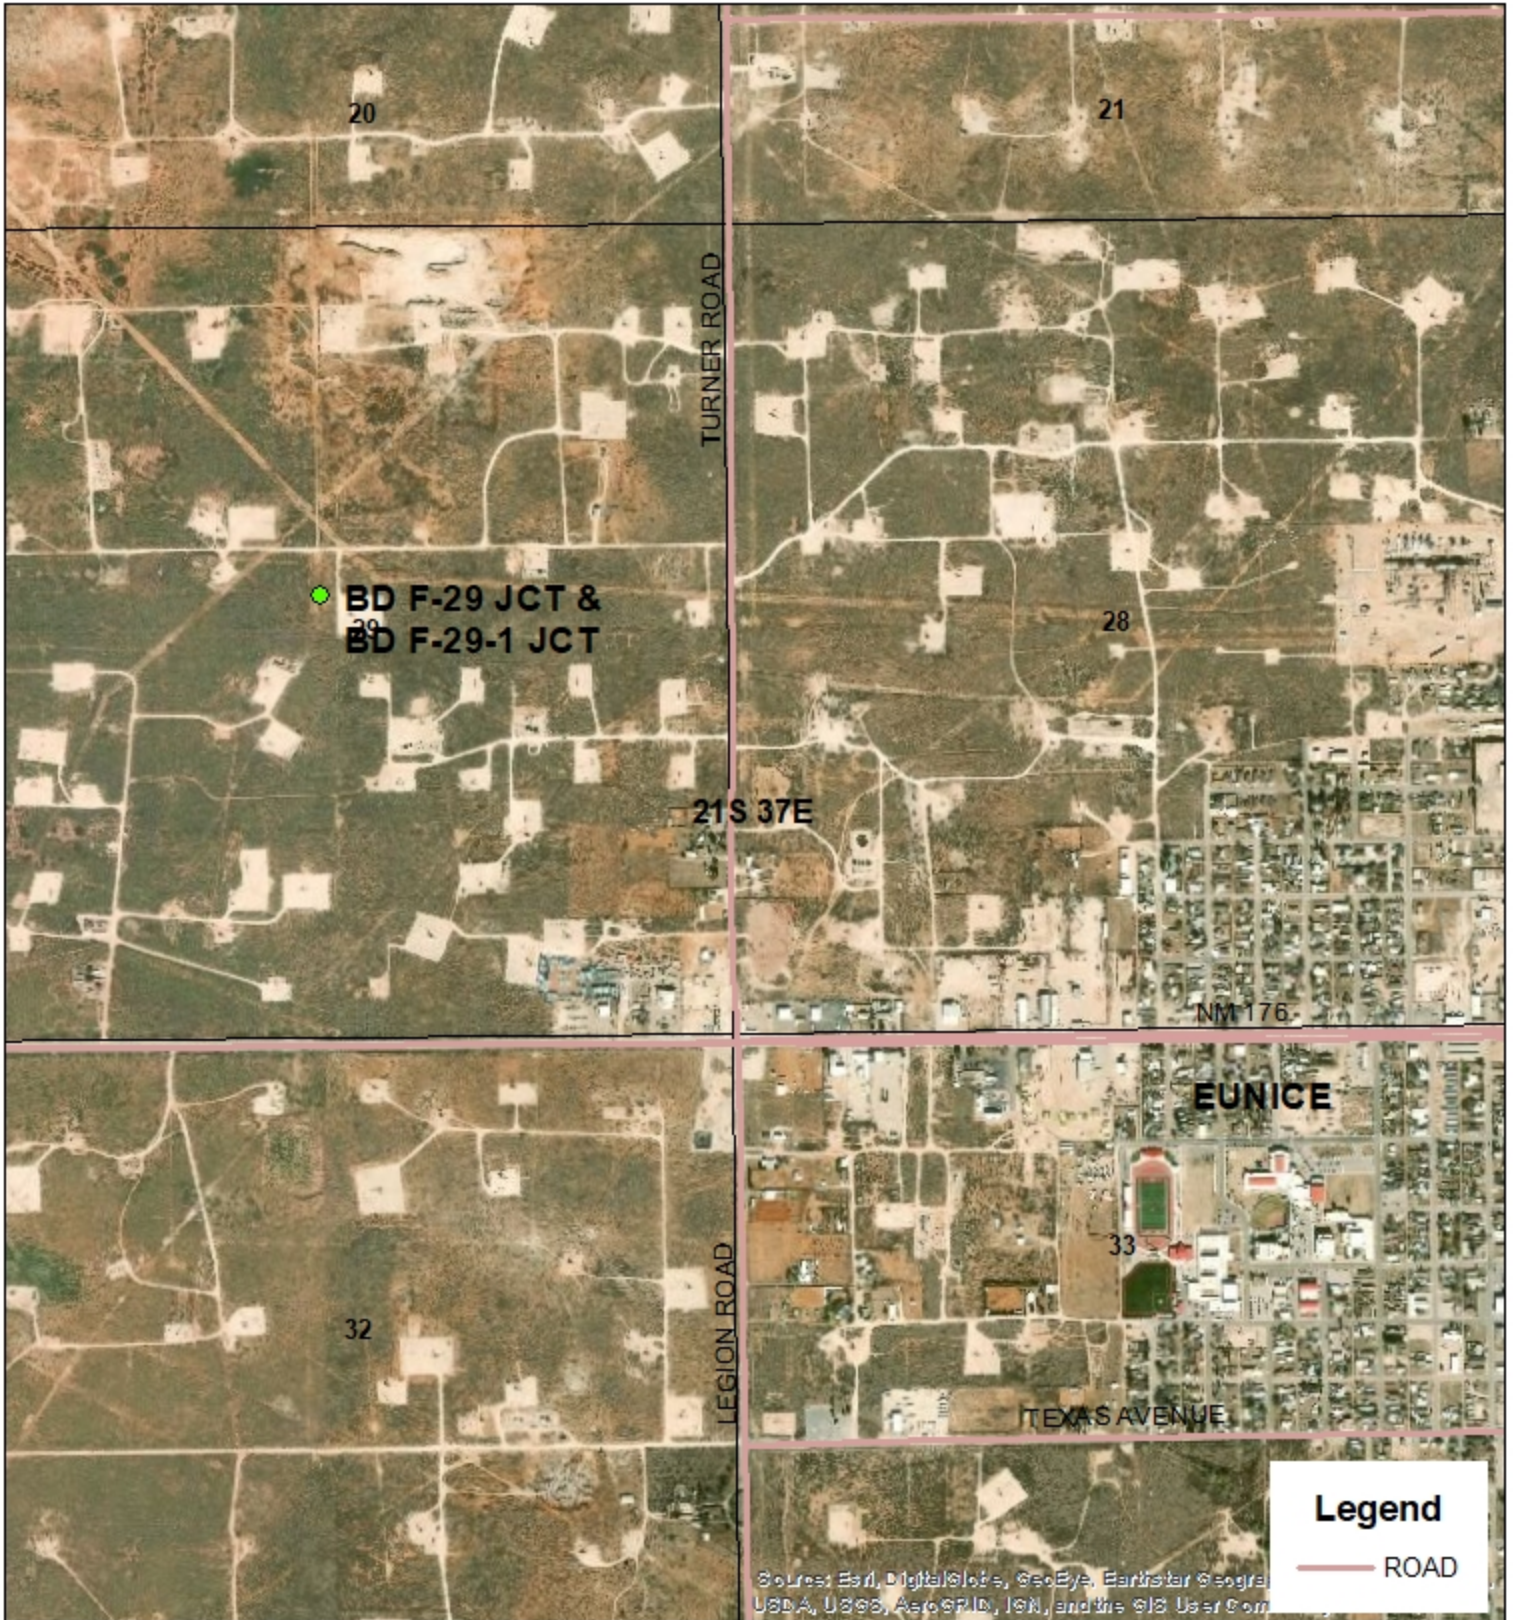
Geographical Location Map

BD F-29 JCT
 1R426-16
BD F-29-1 JCT
 1R426-15
 UL F SECTION 29
 T-21-S R-37-E
 LEA COUNTY, NM

GPS:
 F-29 JCT: 32.450545 -103.185153
 F-29-1 JCT: 32.450619 -103.185157
 NAD 83 STATE PLANE PROJ.
 NM EAST ZONE

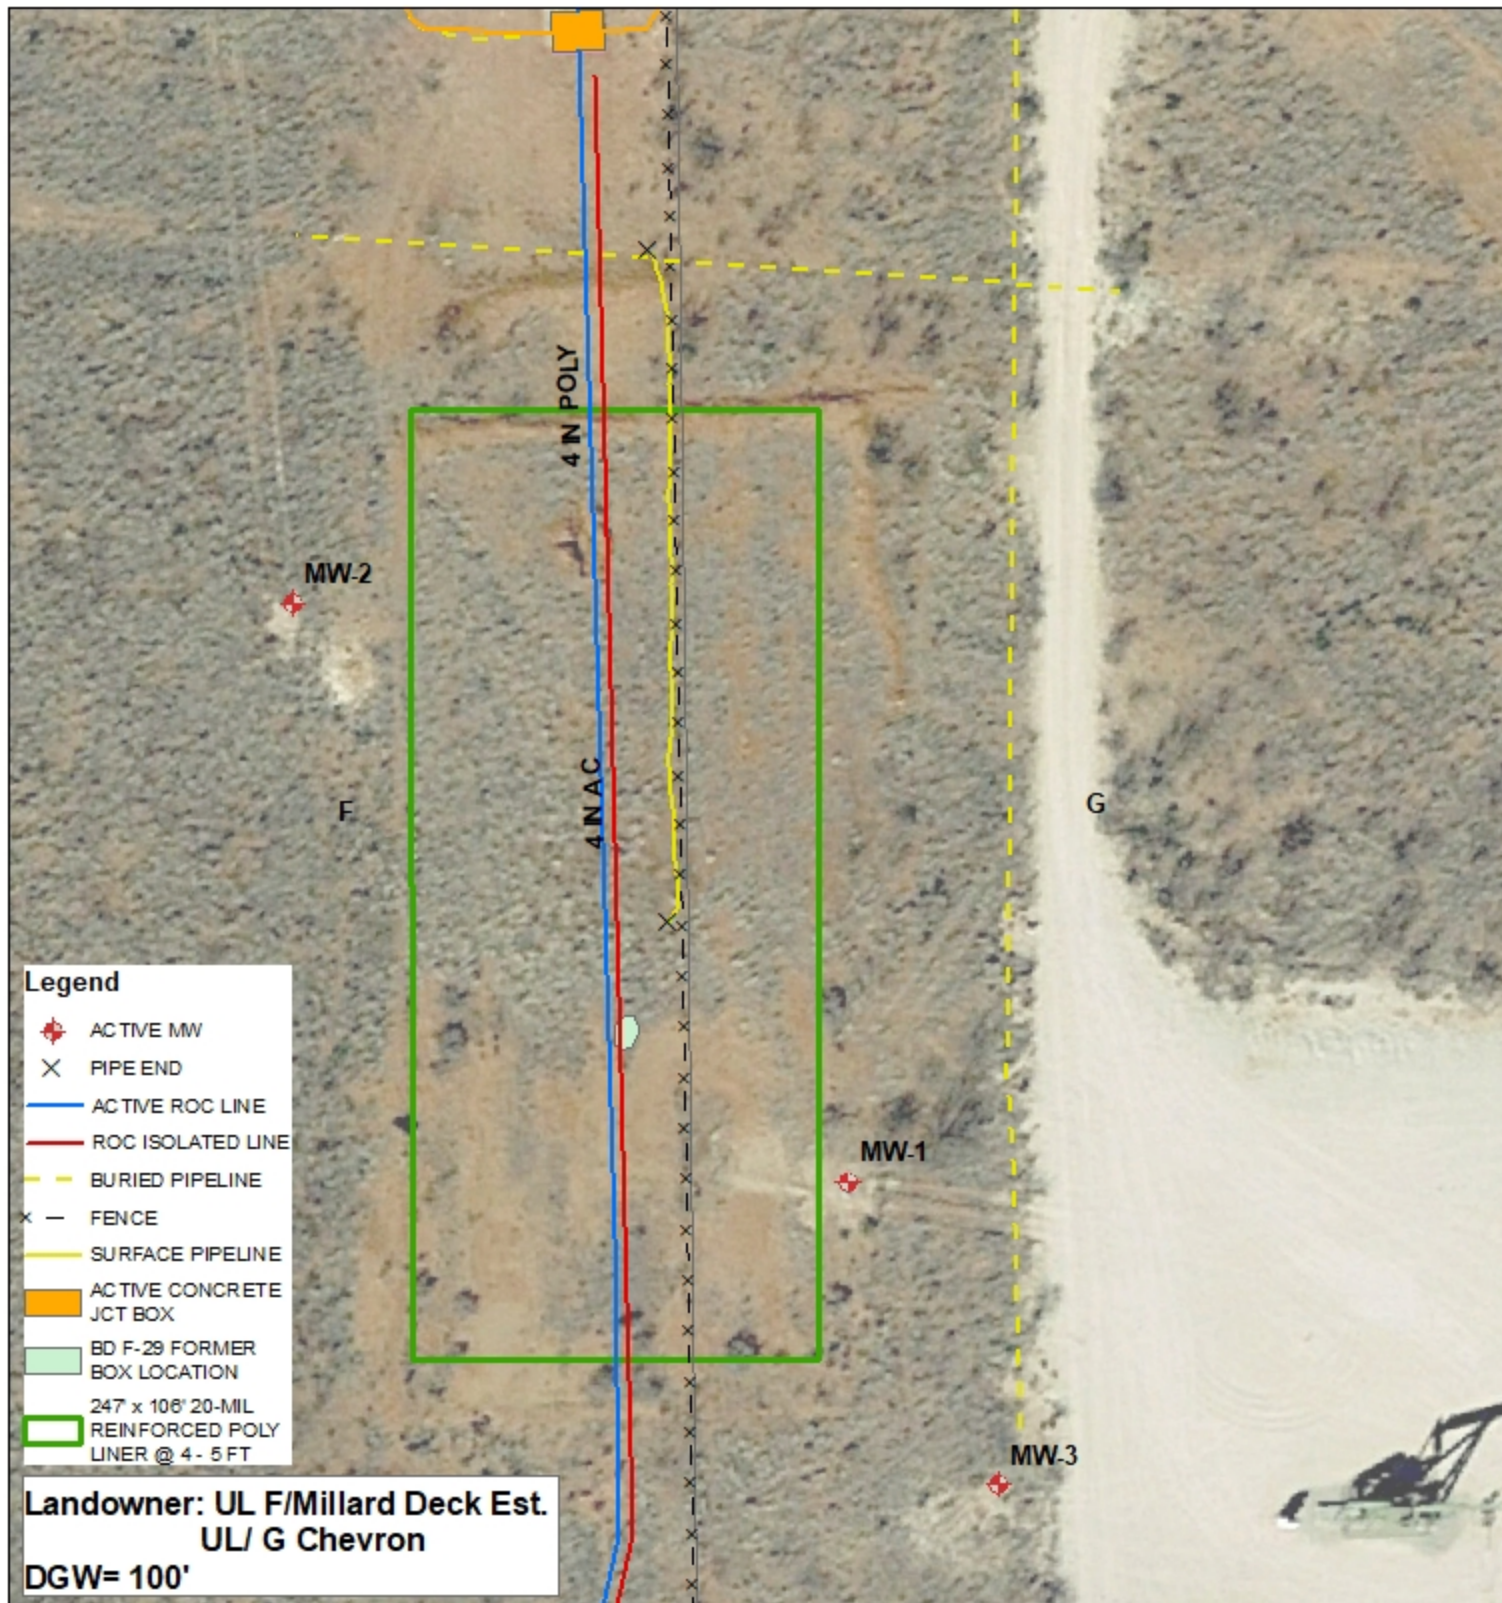
Monitor Well Location

BD
F-29 & F-29-1 JCT
 1R426-16 & 1R426-15
 UL F & G SECTION 29
 T-21-S R-37-E
 LEA COUNTY, NM

GPS: 32.450619 -103.185159
 NAD83 STATE PLANE PROJECTION
 NEW MEXICO EAST ZONE

On November 13th, 2018, a near-source monitor well (MW-1) was installed approximately 70 ft southeast of the former junction boxes. On December 10th, 2018, an up-gradient well (MW-2) was installed approximately 133 ft northwest and a down-gradient well (MW-3) was installed approximately 170 ft southeast of the former junction boxes. These wells were developed and have been sampled regularly. The most recent sampling event resulted in a chloride concentration of 440 mg/L in MW-1, 104 mg/L in MW-2, and 240 mg/L in MW-3. BTEX concentrations remained below detectable limits since the wells were installed. In 2020, ROC received NMOCD approval to cease BTEX sampling, and approval to temporarily reduce the sampling interval to semi-annual. ROC will begin quarterly sampling in 2021.

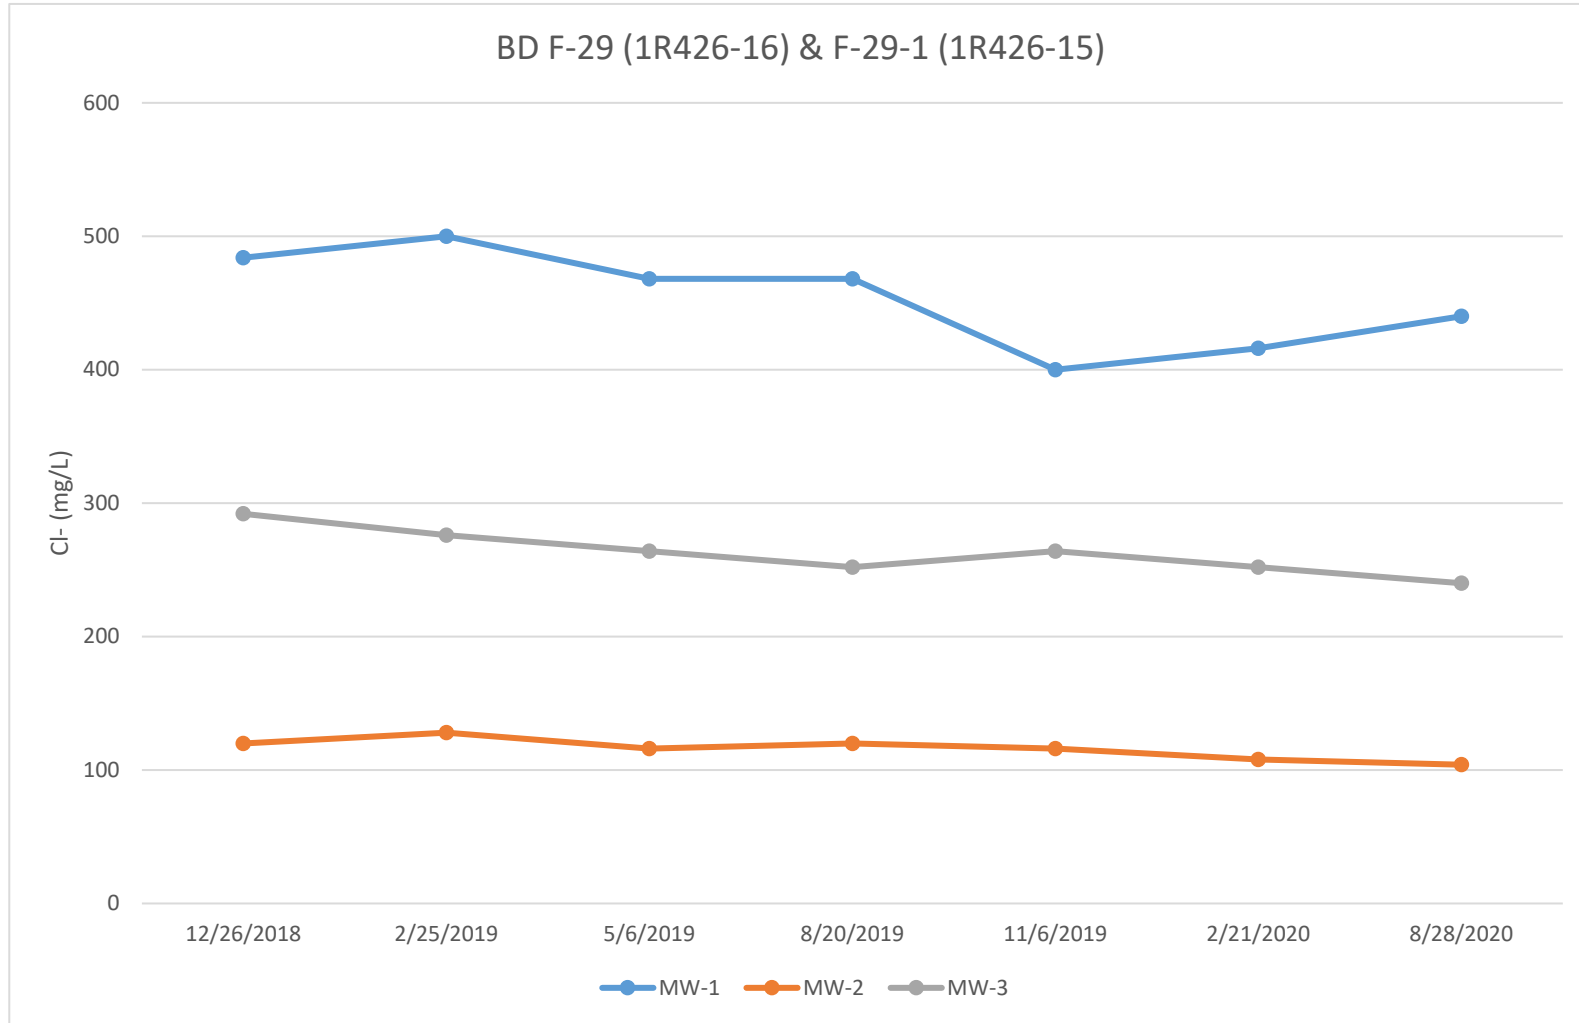
MW	Depth to Water	Total Depth	Well Volume	Volume Purged	Sample Date	Cl	TDS	Benzene	Toluene	Ethyl Benzene	Total Xylenes	Sulfate	Comments
1	99.48	116.15	10.9	35	12/26/2018	484	1,300	<0.001	<0.001	<0.001	<0.003	278	Clear No odor
1	99.45	116.15	10.9	35	2/25/2019	500	1,230	<0.001	<0.001	<0.001	<0.003	251	Clear No odor
1	99.44	116.15	10.9	35	5/6/2019	468	976	<0.001	<0.001	<0.001	<0.003	238	Clear No odor
1	99.42	116.15	10.9	35	8/20/2019	468	1,300	<0.001	<0.001	<0.001	<0.003	211	Clear No odor
1	99.44	116.15	10.9	35	11/6/2019	400	1,200	<0.001	<0.001	<0.001	<0.003	208	Clear No odor
1	99.43	116.15	10.9	35	2/21/2020	416	1,140	<0.0005	<0.0005	<0.0005	<0.002	125	Clear No odor
1	99.4	116.15	10.9	35	8/28/2020	440	1,290	XXX	XXX	XXX	XXX	218	Clear No odor

MW	Depth to Water	Total Depth	Well Volume	Volume Purged	Sample Date	Cl	TDS	Benzene	Toluene	Ethyl Benzene	Total Xylenes	Sulfate	Comments
2	98.22	102.98	0.7	3	12/26/2018	120	550	<0.001	<0.001	<0.001	<0.003	153	Clear No odor
2	98.2	102.98	0.7	3	2/25/2019	128	470	<0.001	<0.001	<0.001	<0.003	134	Clear No odor
2	98.18	102.98	0.7	3	5/6/2019	116	616	<0.001	<0.001	<0.001	<0.003	116	Clear No odor
2	98.13	102.98	0.7	3	8/20/2019	120	570	<0.001	<0.001	<0.001	<0.003	119	Clear No odor
2	98.19	102.98	0.7	3	11/6/2019	116	596	<0.001	<0.001	<0.001	<0.003	121	Clear No odor
2	98.16	102.48	0.7	3	2/21/2020	108	538	<0.0005	<0.0005	<0.0005	<0.002	146	Clear No odor
2	98.14	102.48	0.7	3	8/28/2020	104	617	XXX	XXX	XXX	XXX	109	Clear No odor

MW	Depth to Water	Total Depth	Well Volume	Volume Purged	Sample Date	Cl	TDS	Benzene	Toluene	Ethyl Benzene	Total Xylenes	Sulfate	Comments
3	99.88	108.83	1.4	5	12/26/2018	292	978	<0.001	<0.001	<0.001	<0.003	298	Clear No odor
3	99.87	108.83	1.4	5	2/25/2019	276	991	<0.001	<0.001	<0.001	<0.003	245	Clear No odor
3	99.88	108.83	1.4	5	5/6/2019	264	936	<0.001	<0.001	<0.001	<0.003	240	Clear No odor
3	99.9	108.83	1.4	5	8/20/2019	252	964	<0.001	<0.001	<0.001	<0.003	227	Clear No odor
3	100.03	108.83	1.4	3	11/6/2019	264	871	<0.001	<0.001	<0.001	<0.003	238	Clear No odor
3	99.99	108.83	1.4	3	2/21/2020	252	1,080	<0.0005	<0.0005	<0.0005	<0.002	242	Clear No odor
3	99.97	108.83	1.4	3	8/28/2020	240	1,080	XXX	XXX	XXX	XXX	219	Clear No odor

1. A Geographical Location Map.
2. A map showing well locations.
3. A table presenting all laboratory results and depth to groundwater for each well at the site, and a graph showing laboratory results.
4. The laboratory analytical results for 2020.
