Release Confirmation Sampling Report

Jicarilla 95-7B

API #30-039-26854

NMOCD Incident #nRM2034857931

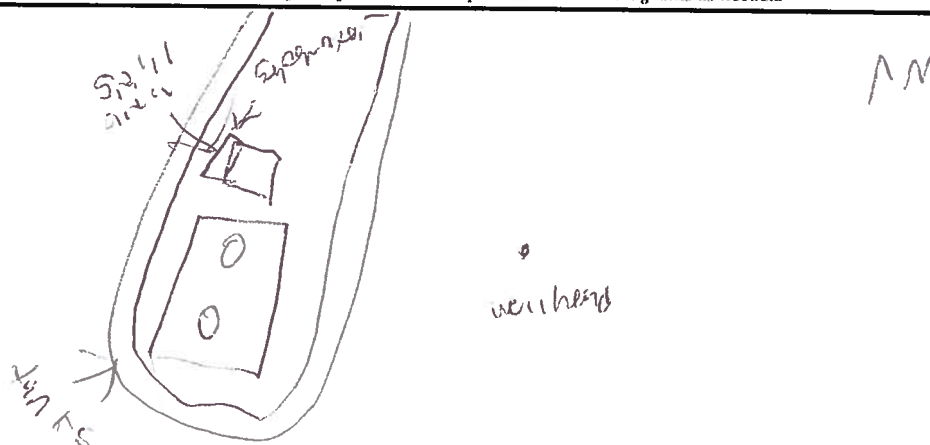
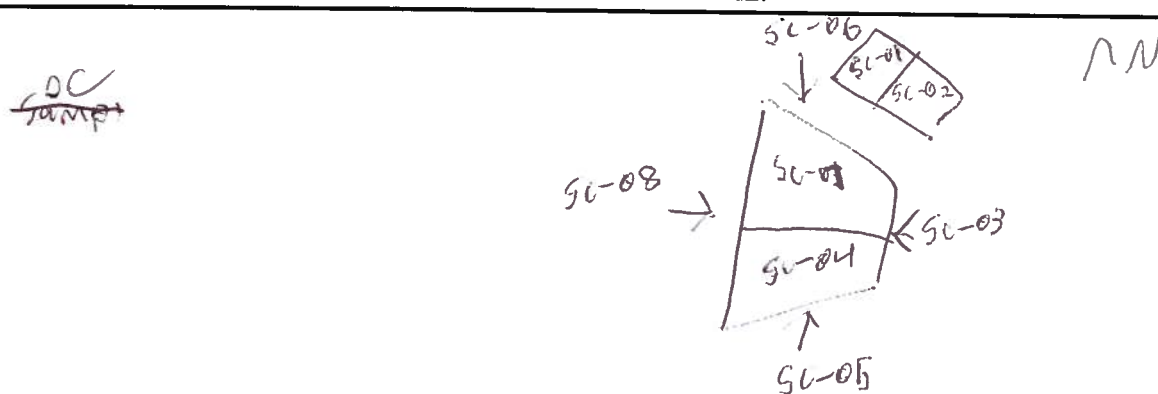
SPILL PERIMETER: Draw a schematic of the spill site. Attach photos and other diagrams as needed.

**EXCAVATION PROFILE:**

Samples taken in formation

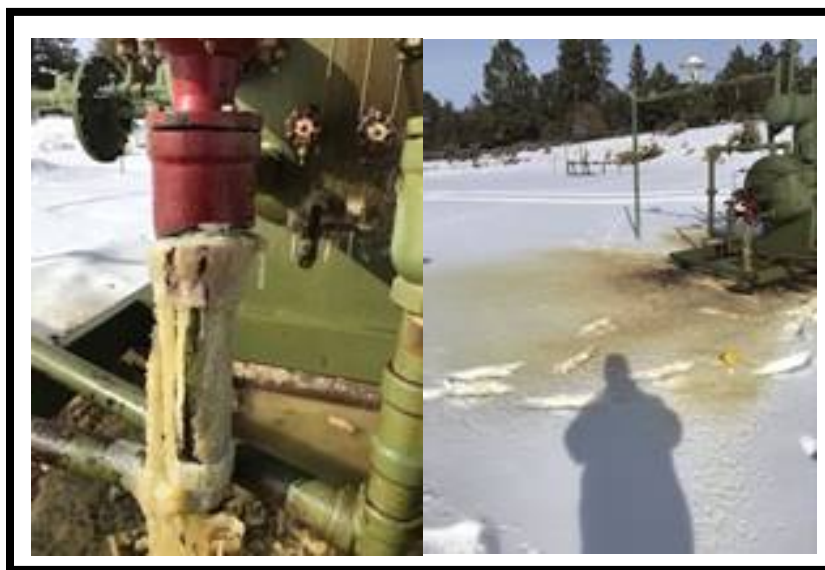
**Site Area: Spill
December 17, 2020**

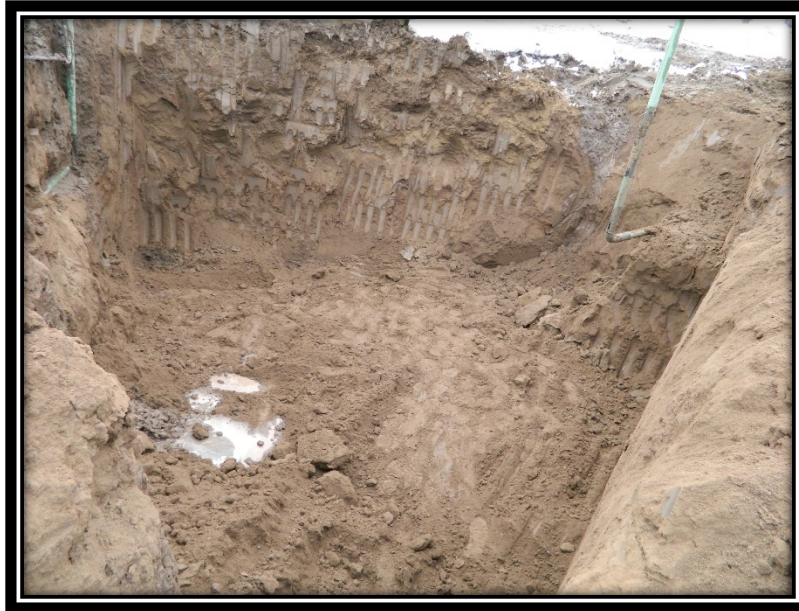
Picture 1: View of Base and West Wall

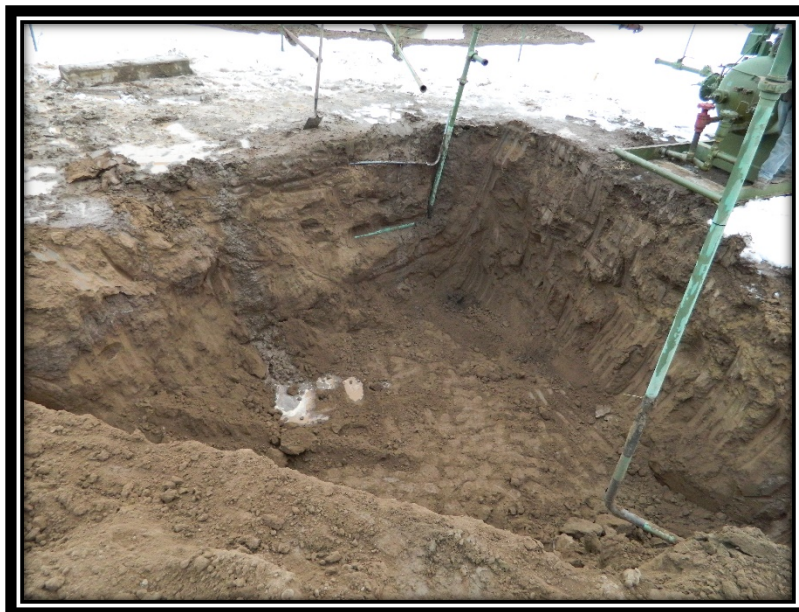
Picture 2: View of South Wall

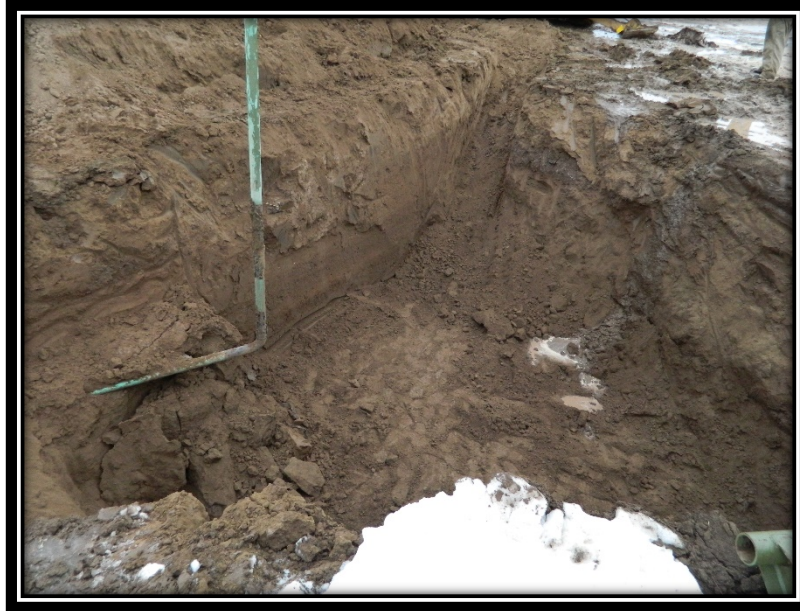
Picture 3: View of North Wall

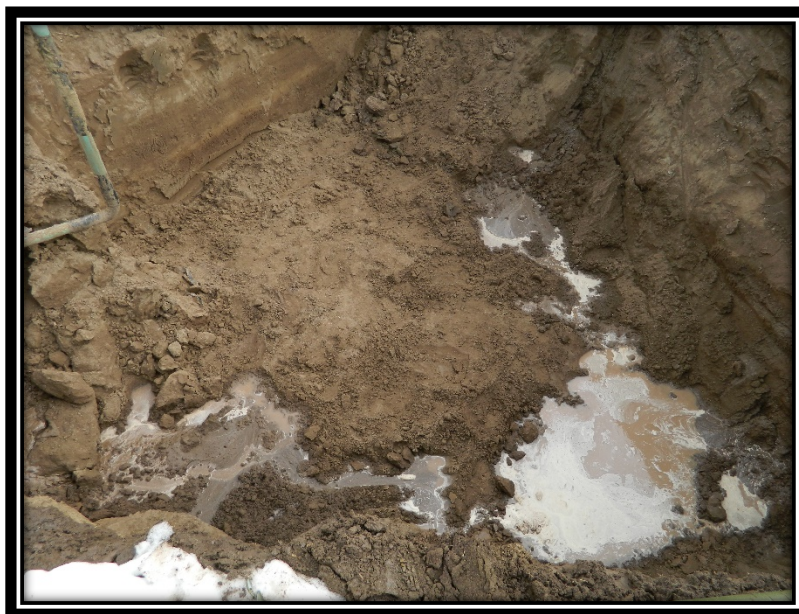
Picture 4: View of Base

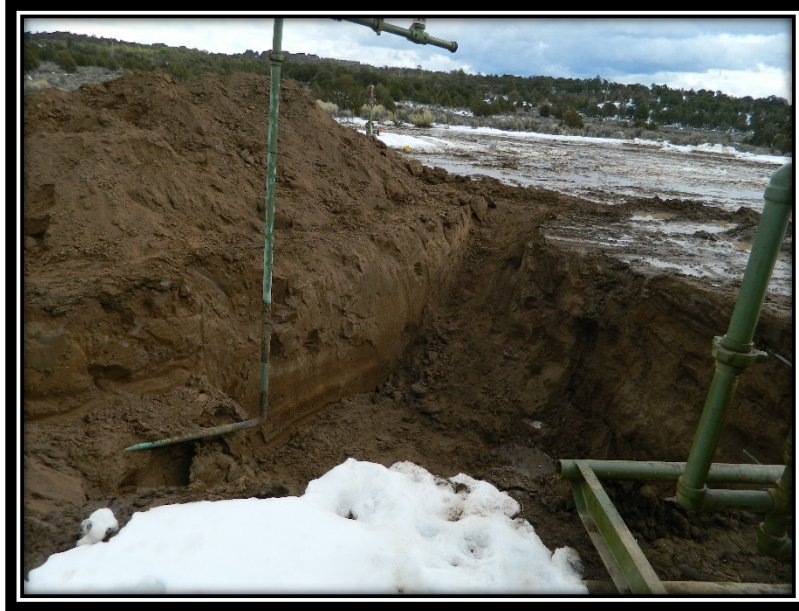
Picture 5: View of North and East Walls and Spoil Pile

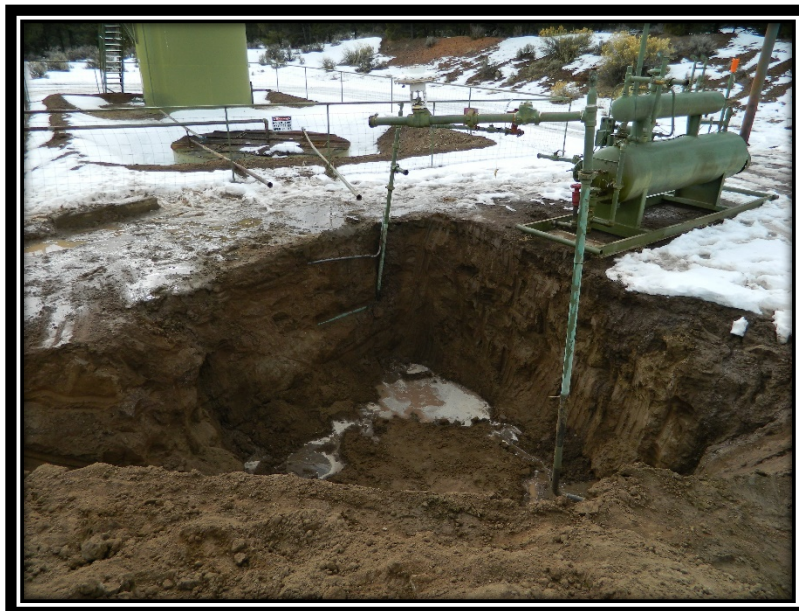
Picture 5: View of South and West Walls

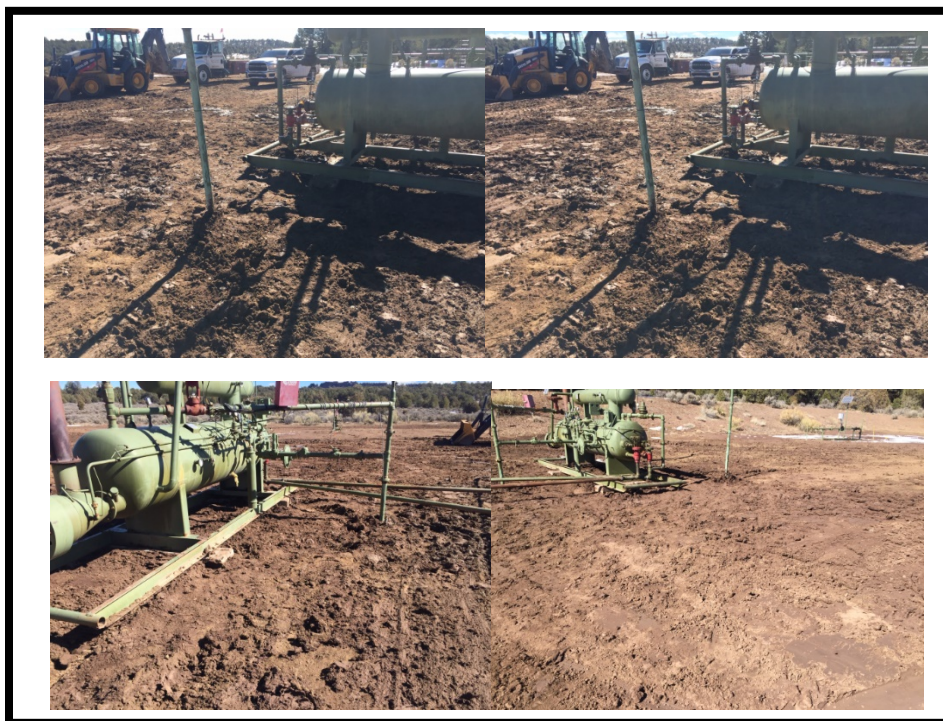
**Site Area: Backfill
February 11, 2021**
