March 1, 2022

**Re: Release Characterization and Remediation Work Plan
ConocoPhillips
Heritage Concho
Miller B Federal #003 Flowline Release
Unit Letter A, Section 23, Township 17 South, Range 32 East
Lea County, New Mexico
Incident ID# nOY1704058292
1RP-4597**

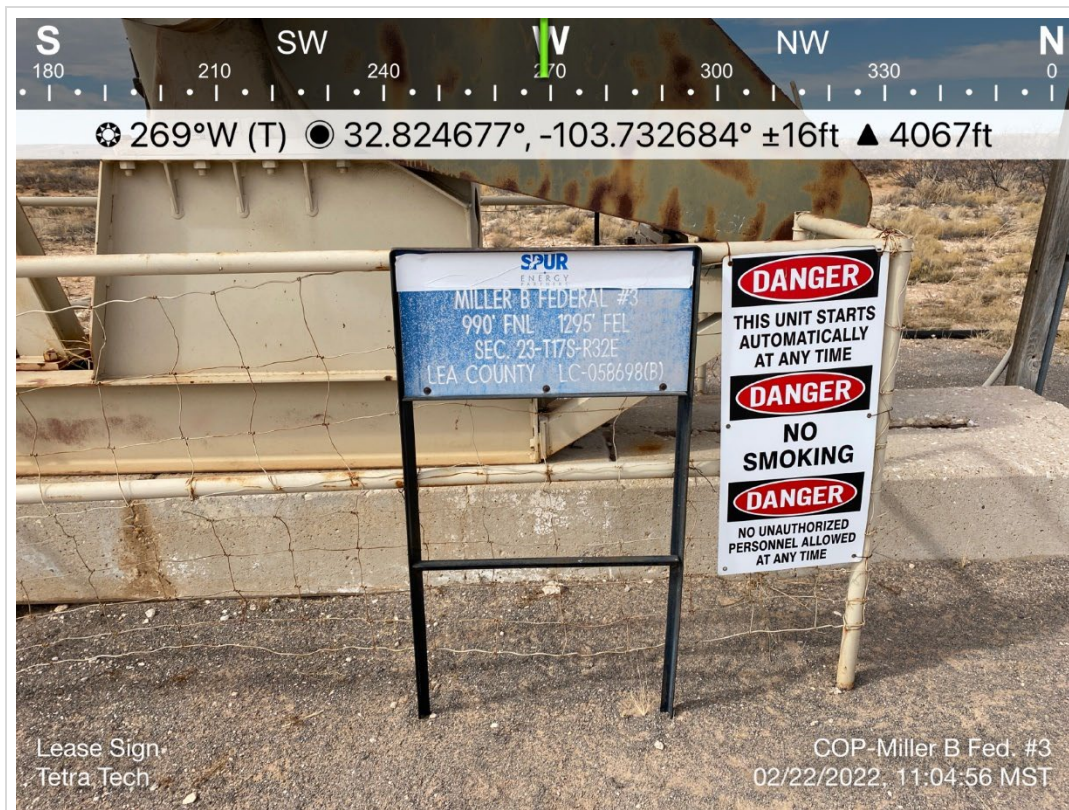
TETRA TECH, INC. PROJECT NO. 212C-MD-02672	DESCRIPTION	View west of Miller B Federal #003 signage.	1
	SITE NAME	Miller B Federal #003 Flowline Release	2/22/2022

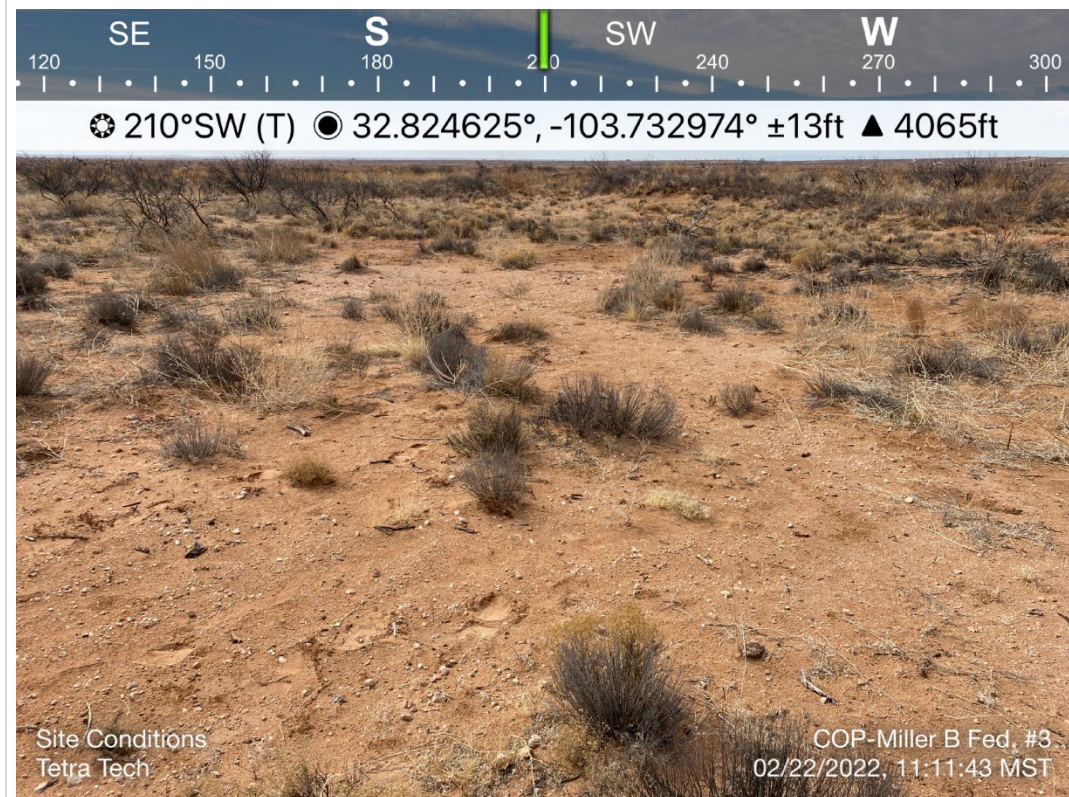
TETRA TECH, INC. PROJECT NO. 212C-MD-02672	DESCRIPTION	View southwest of the release area in the reclaimed reserve pit.	6
	SITE NAME	Miller B Federal #003 Flowline Release	2/22/2022

Additionally, ConocoPhillips proposes to conduct surface remediation in the portions of the release extent that coincide with the reclaimed reserve pit area. These areas will be hand-dug or scraped to remove visibly impacted soils and then treated with a MicroBlaze® application. Micro-Blaze® Emergency Liquid Spill Control is used to aid in the degradation of residual hydrocarbon. These activities will be conducted with caution to avoid disturbing the existing established native vegetation.

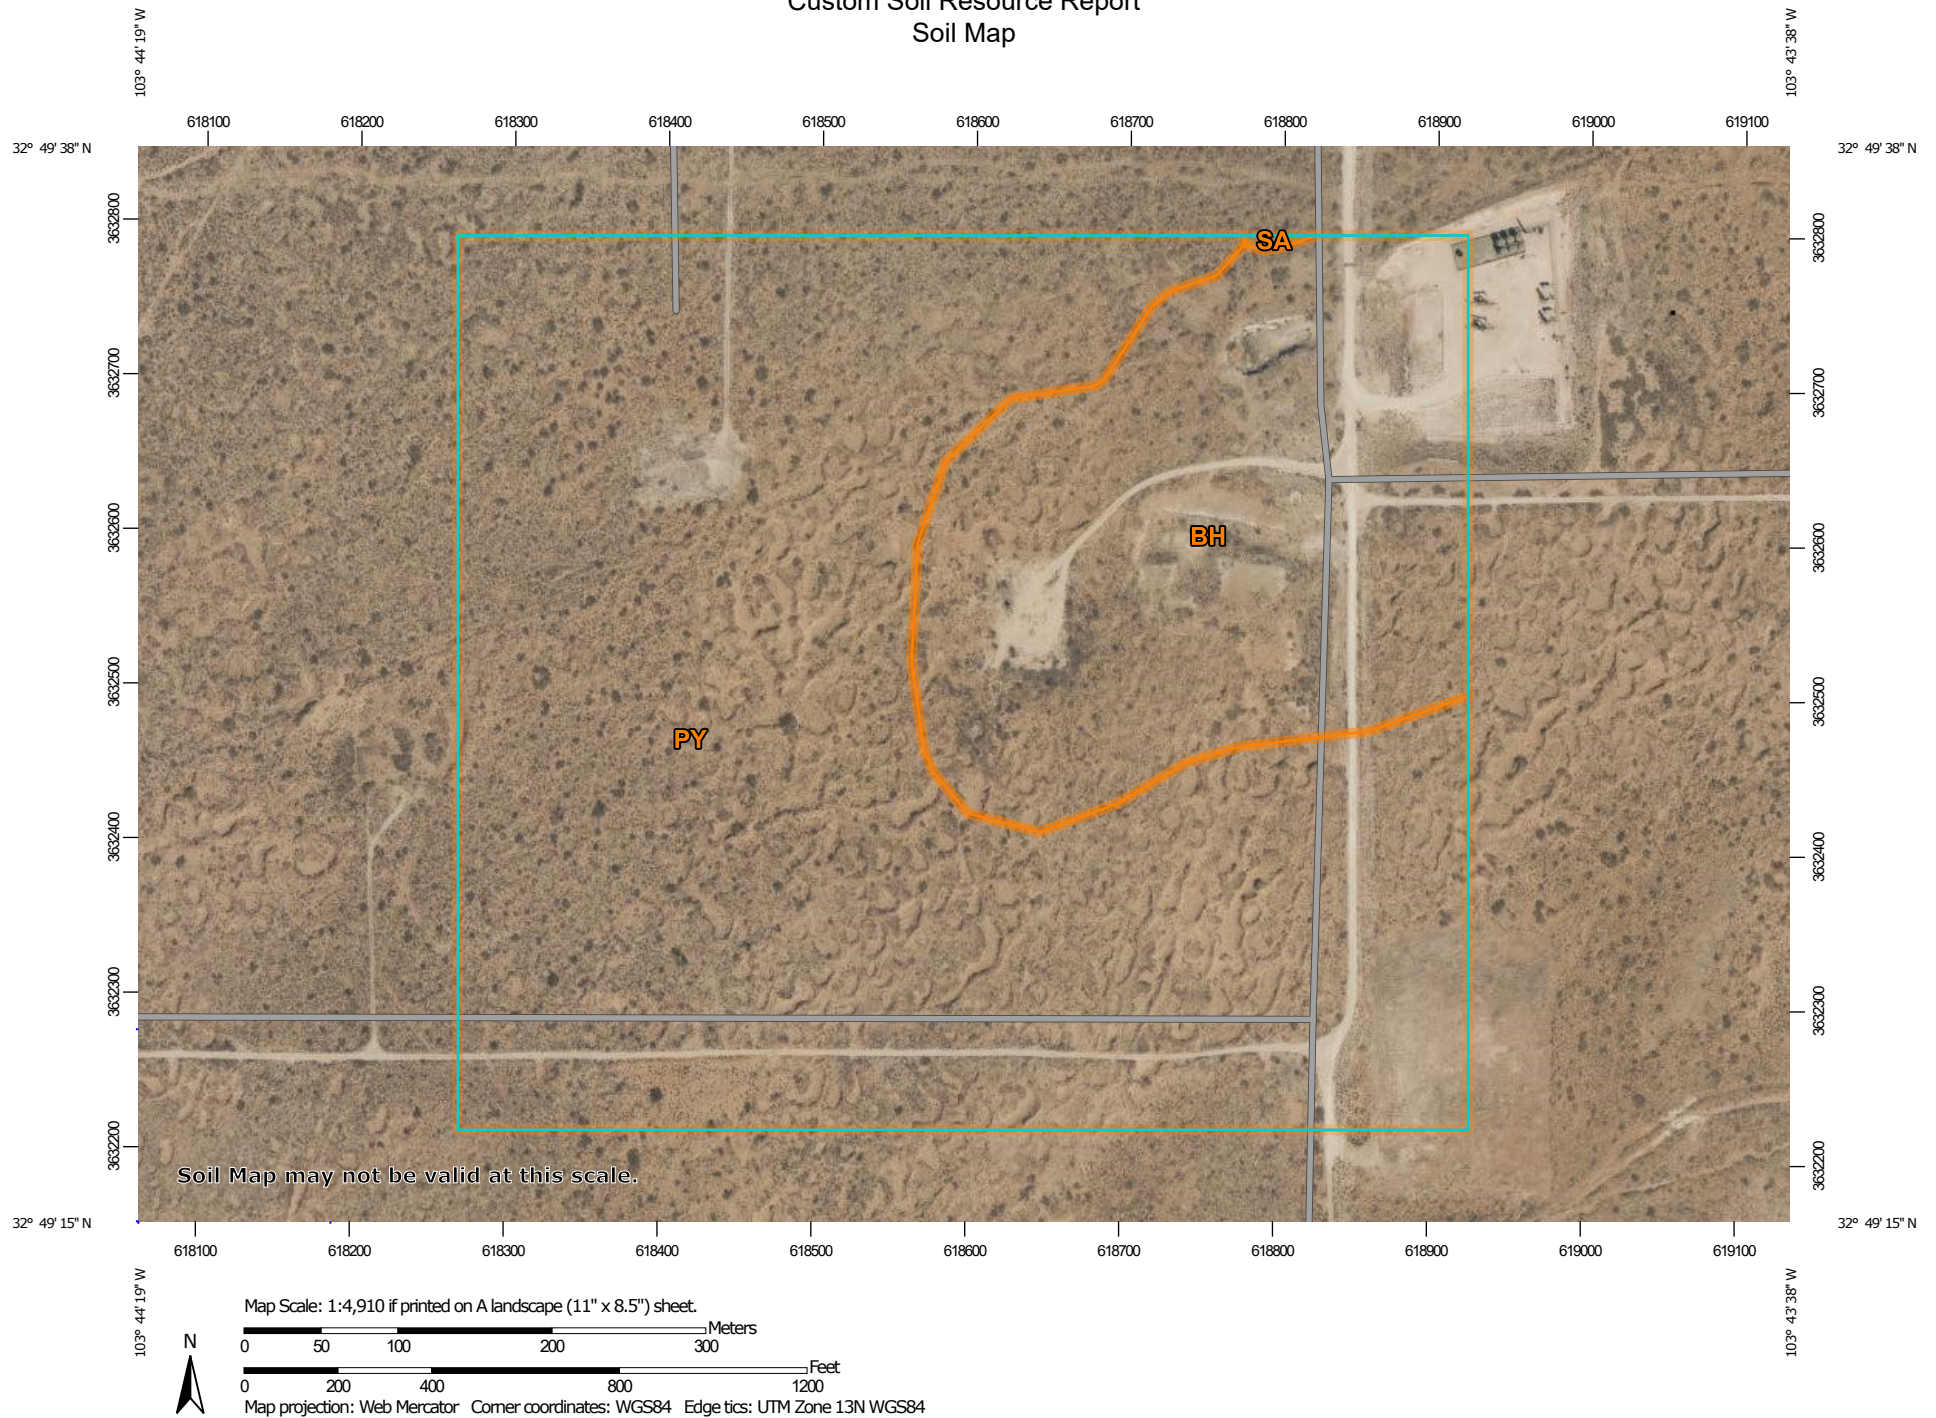
Custom Soil Resource Report
Soil Map

The soil map section includes the soil map for the defined area of interest, a list of soil map units on the map and extent of each map unit, and cartographic symbols displayed on the map. Also presented are various metadata about data used to produce the map, and a description of each soil map unit.
