Vertex Project #: 21E-00123-011

Spill Closure Report: Warren ANW Federal #6
Unit J, Section 9, Township 19 South, Range 25 East
County: Eddy
API: 30-015-28786
Incident ID: nAPP2129353745

Prepared For: **EOG Resources, Inc.**
104 S. 4th Street
Artesia, New Mexico, 88210

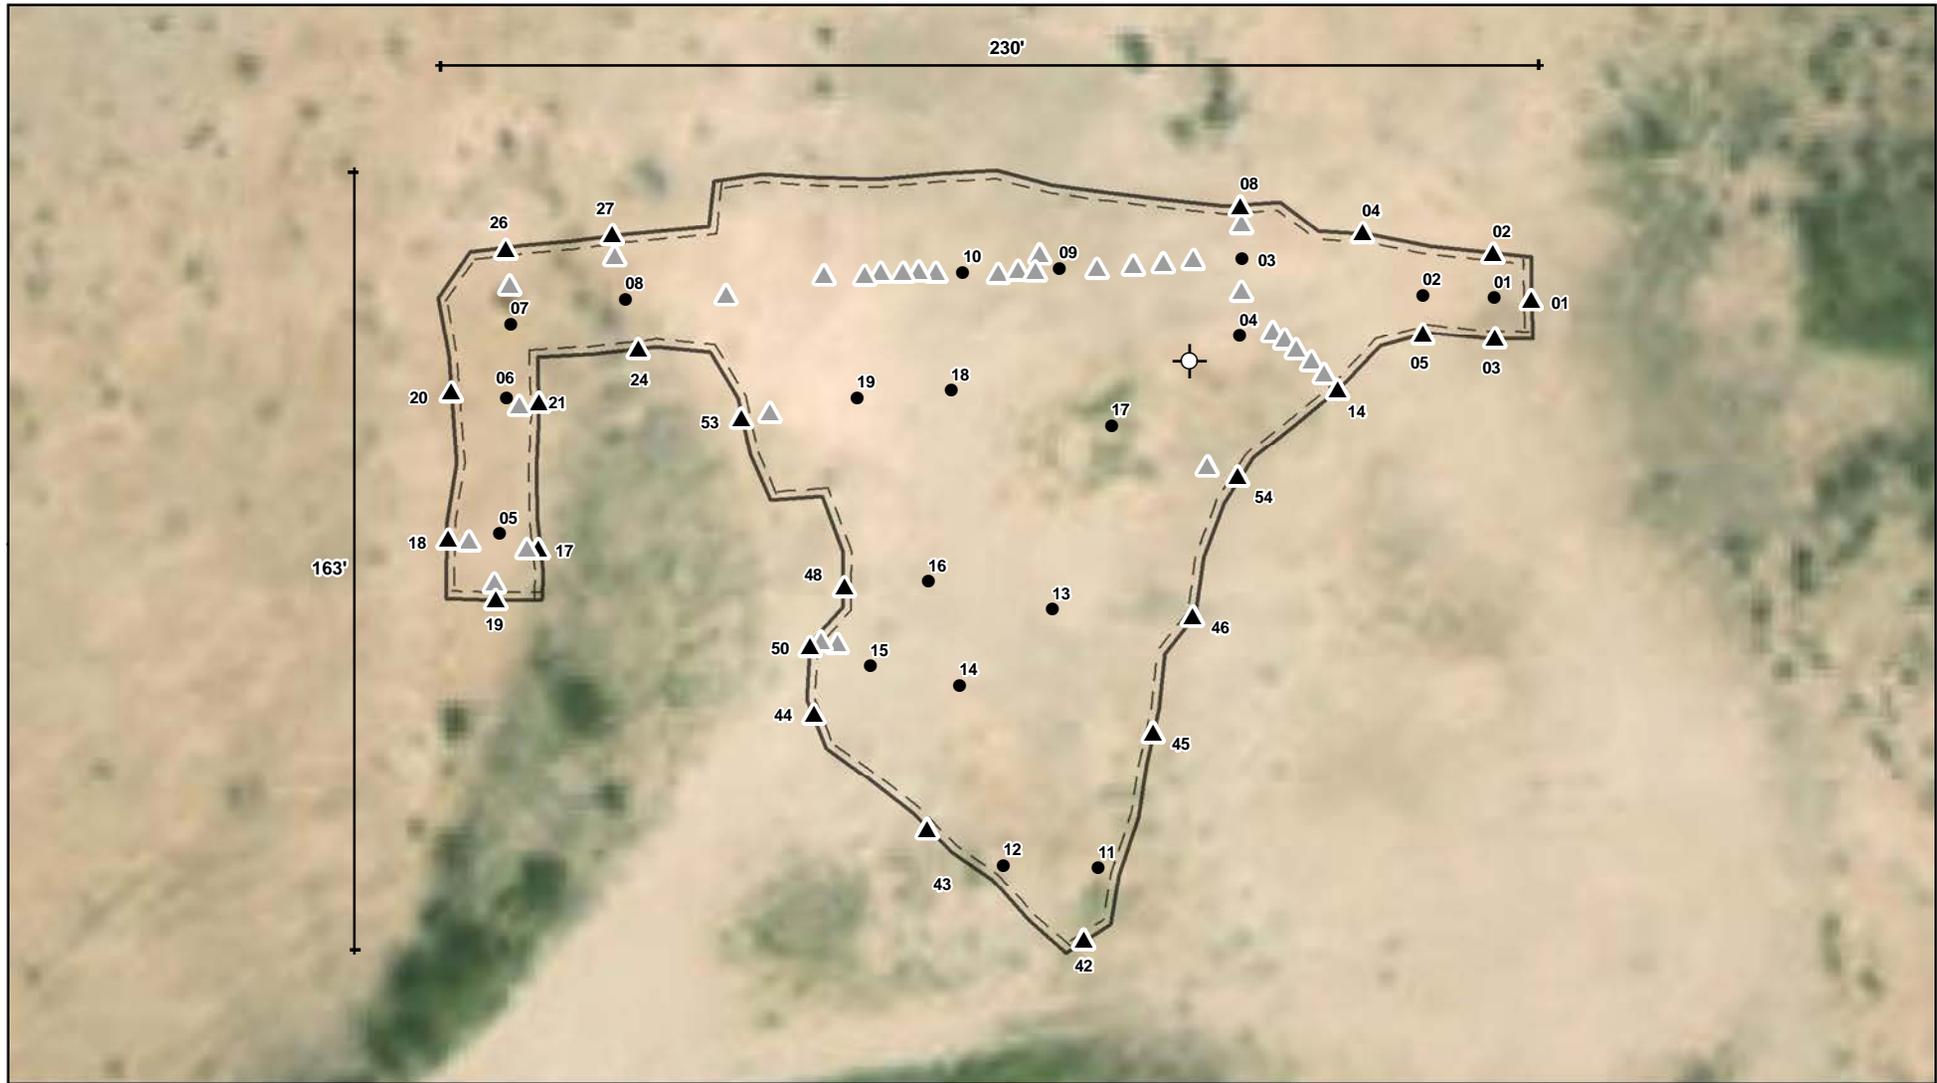
Document Path: G:\1-Projects\US PROJECTS\SEOC Resources Inc\22E-00123011 - Warren ANW Federal #6\Figure 1 Characterization Schematic Warren ANW Federal #6.mxd

- Base Sample (Prefixed by "BES21-")
- ▲ Wall Sample (Prefixed by "WES21-")
- ▲ Wall Sample (Excavated)
- ⊕ Wellhead
- ⊞ Approximate Excavation Area (16,261 sq. ft.)

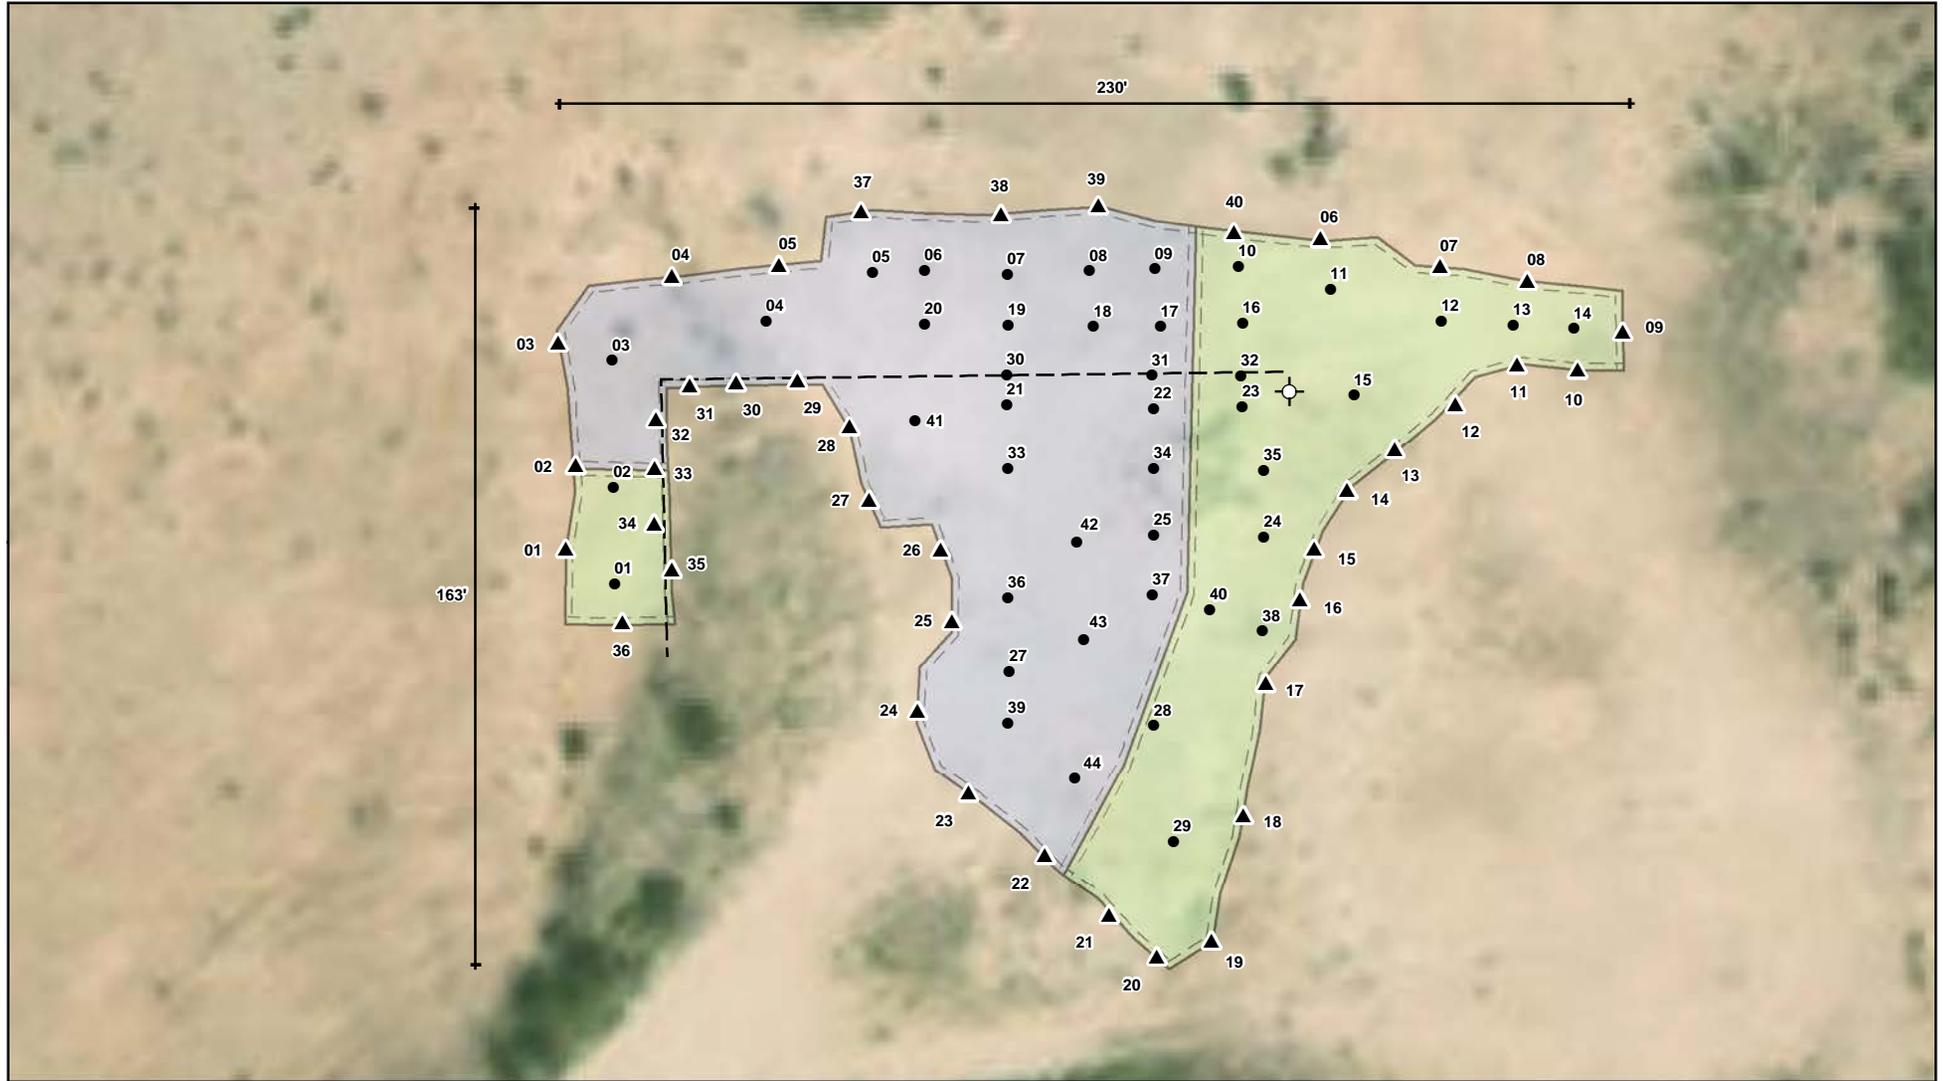
Document Path: G:\1-Projects\US PROJECTS\SEOC Resources Inc\22E-00123011 - Warren ANW Federal #6\Figure 2 Confirmation Schematic Warren ANW Federal #6.mxd

- Excavated Base Sample (Prefixed by "BES21-" or "BES22-")
- ▲ Excavated Wall Sample (Prefixed by "WES21-" or "WES22-")
- ⊕ Wellhead
- Exposed Pipeline
- Approximate Excavation Area - 4' Depth (9,628 sq. ft.)
- Approximate Excavation Area - 6' Depth (6,799 sq. ft.)

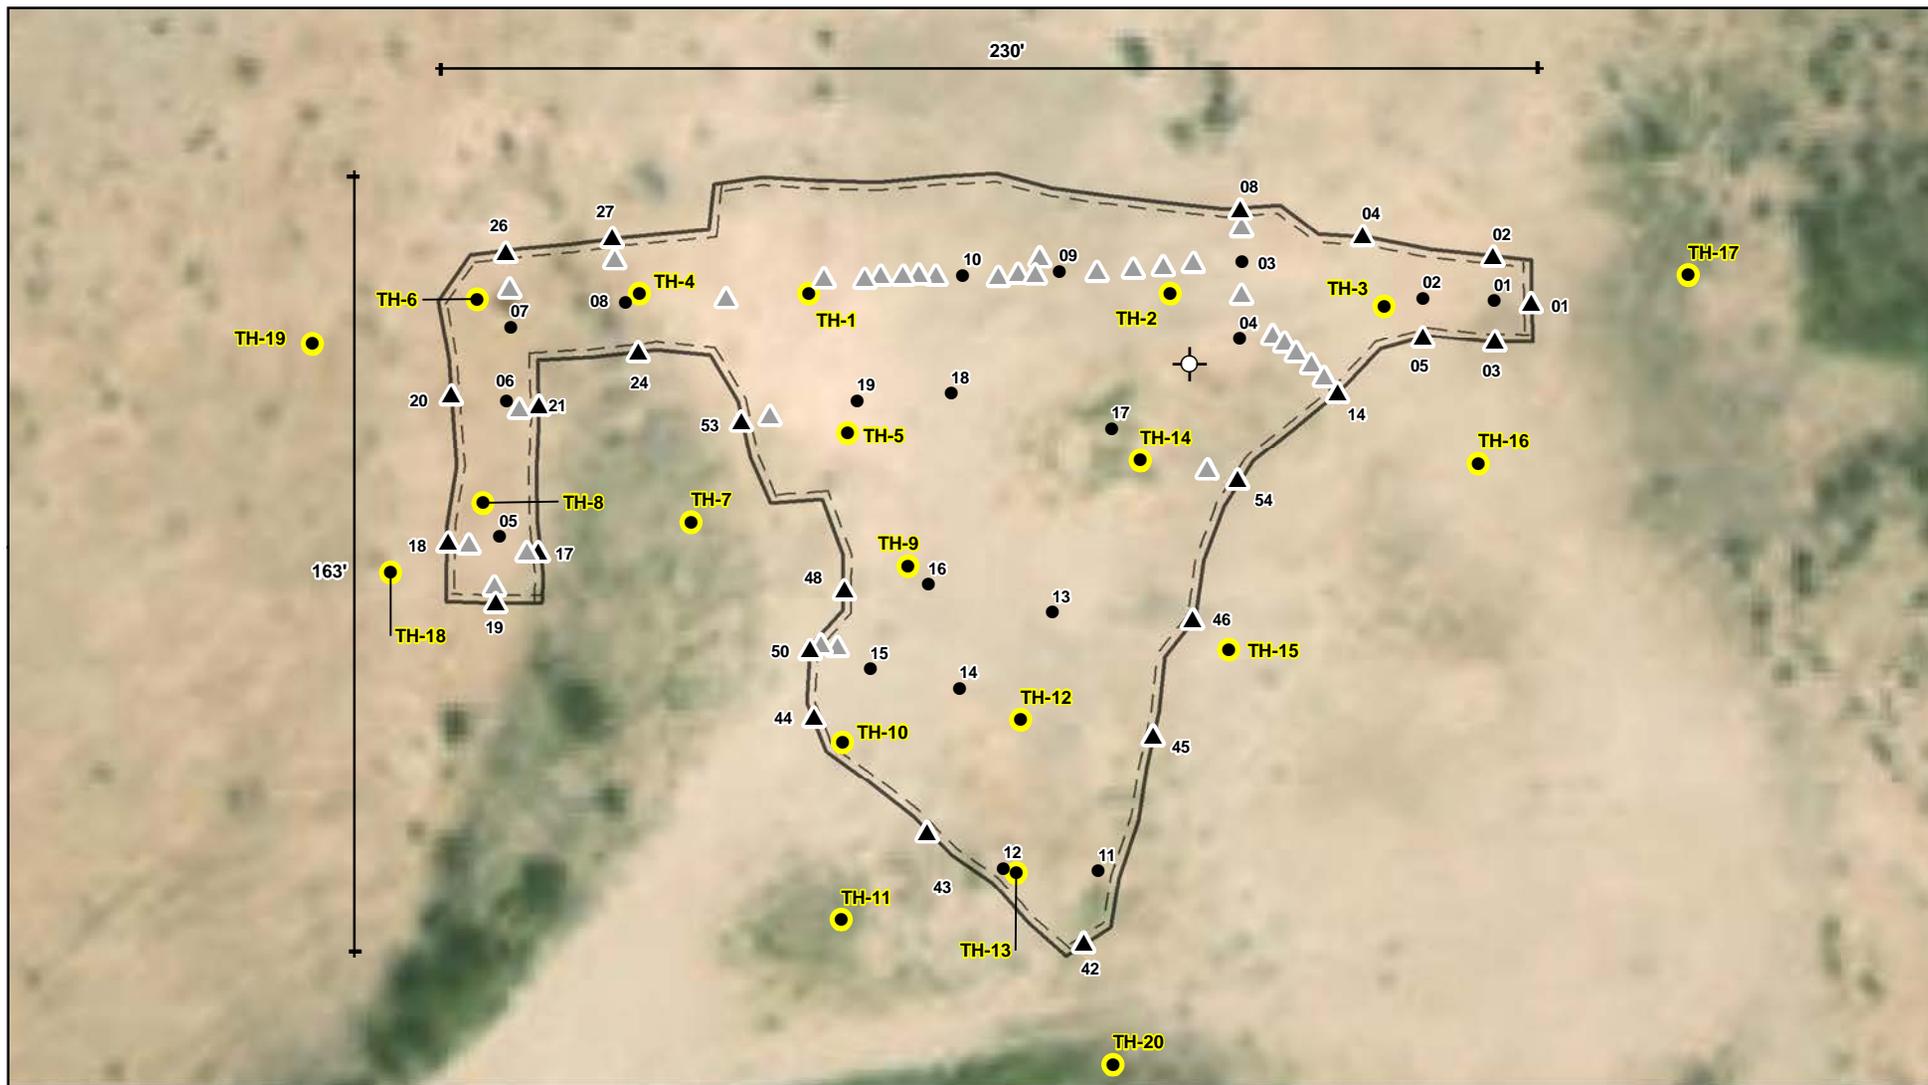
Document Path: G:\1-Projects\US PROJECTS\EOG Resources Inc\22E-00123011 - Warren ANW Federal #6\Figure 3 Characterization Schematic (Combined) Warren ANW Federal #6.mxd

- Base Sample (Prefixed by "BES21-")
- ▲ Wall Sample (Prefixed by "WES21-")
- ▲ Wall Sample (Excavated)
- ⊕ Wellhead
- Ranger Sample Points
- ⊠ Approximate Excavation Area (16,261 sq. ft.)

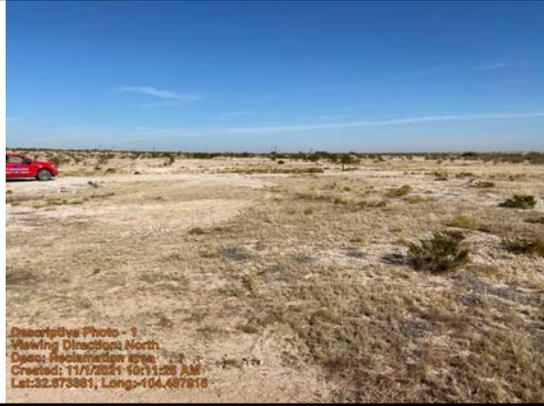
Descriptive Photo - 1
Viewing Direction: North
Date: Reclamation area
Created: 11/2/2021 10:11:28 AM
Lat:32.873861, Long:-104.487818

Reclamation area

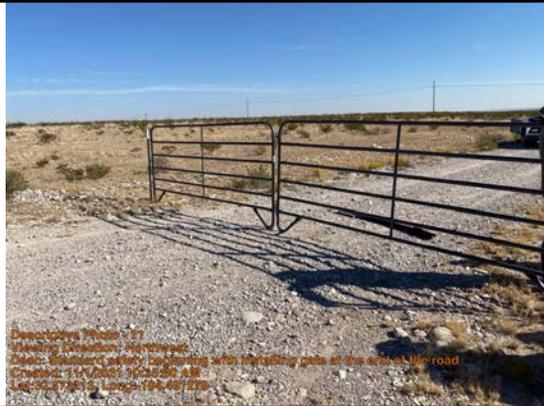
Descriptive Photo - 17
Viewing Direction: Northwest
Date: Standard safety gate being with installing gate at the end of the road
Created: 11/2/2021 10:18:30 AM
Lat:32.873861, Long:-104.487818

Standard safety beginning with installing gate at the end of the road

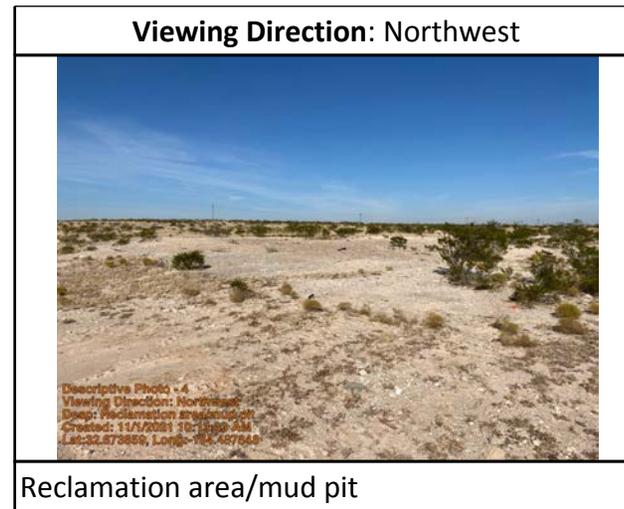
Reclamation area/mud pit

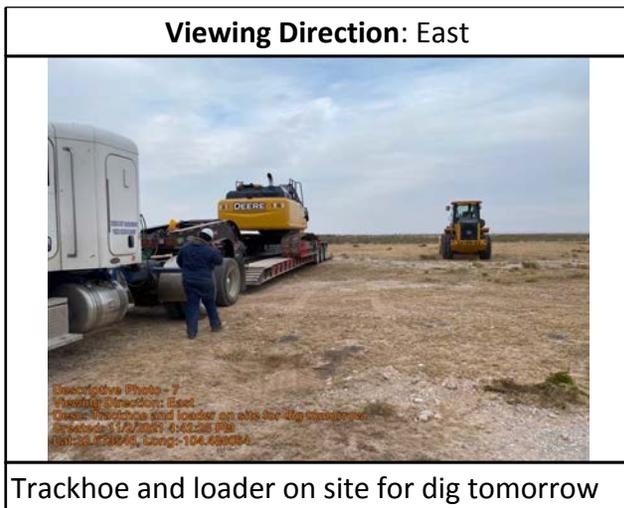
Trackhoe and loader on site for dig tomorrow

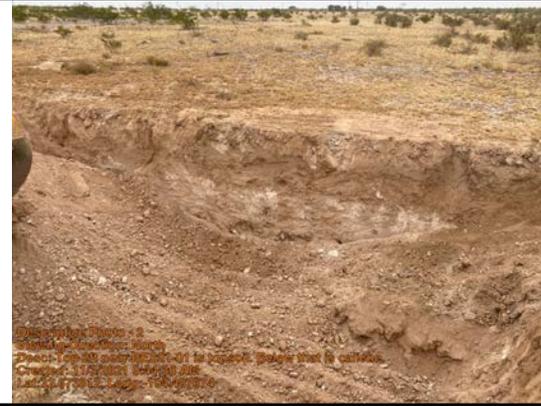
Descriptive Photo - 2
Viewing Direction: North
Desc: Top 2ft near BES21-01 is topsoil. Below that is caliche.
Created: 11/3/2021 8:41:02 AM
Lat:31.698897, Long:-104.491724

Top 2ft near BES21-01 is topsoil. Below that is caliche.

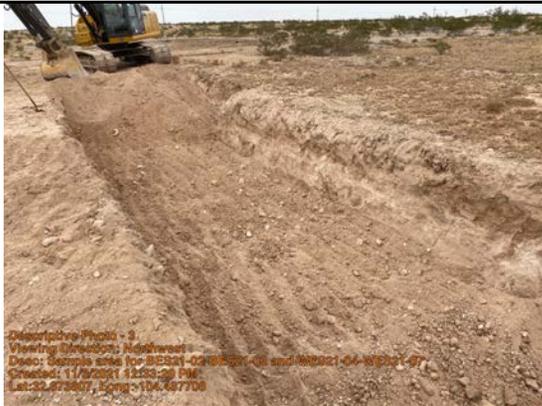
Descriptive Photo - 3
Viewing Direction: Northwest
Desc: Sample area for BES21-02-BES21-03 and WES21-04-WES21-07
Created: 11/3/2021 11:03:29 PM
Lat:31.698897, Long:-104.491724

Sample area for BES21-02-BES21-03 and WES21-04-WES21-07

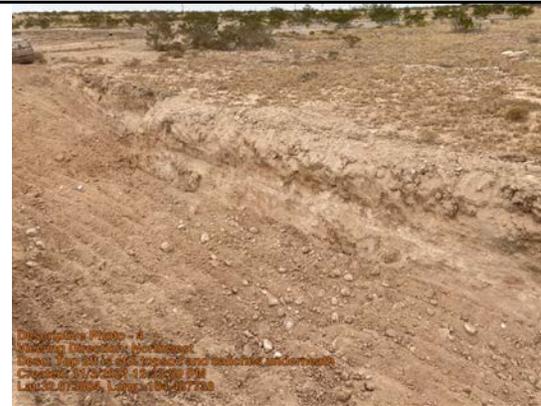
Descriptive Photo - 4
Viewing Direction: Northwest
Desc: Top 2ft is still topsoil and caliches underneath
Created: 11/3/2021 1:44:09 PM
Lat:31.698897, Long:-104.491724

Top 2ft is still topsoil and caliches underneath

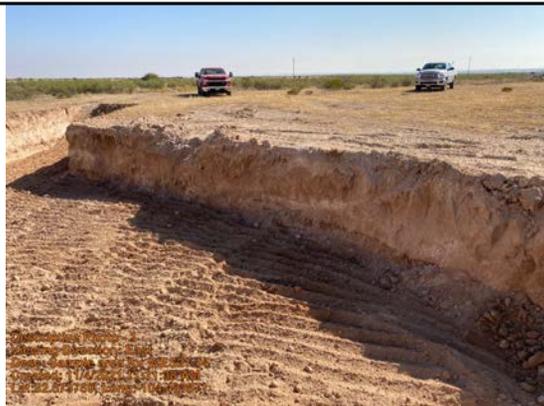
Descriptive Photo - 5
Viewing Direction: East
Date: Sample area for WES21-14
Created: 11/4/2021 12:41:39 PM
Lat:32.673768, Long:-104.488340

Sample area for WES21-14

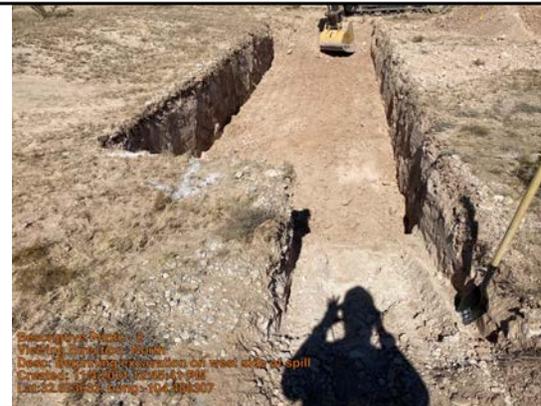
Descriptive Photo - 6
Viewing Direction: North
Date: Beginning excavation on west side of spill
Created: 11/4/2021 12:41:44 PM
Lat:32.673858, Long:-104.488307

Beginning excavation on west side of spill

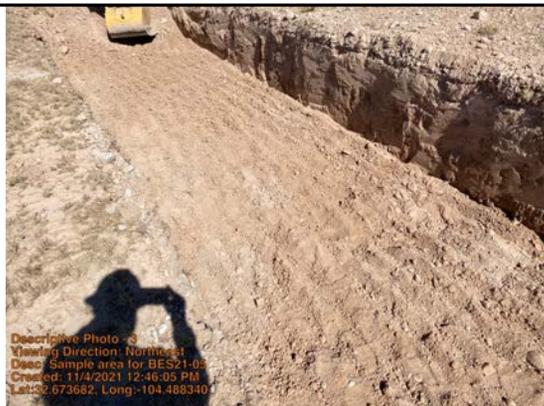
Descriptive Photo - 8
Viewing Direction: Northeast
Date: Sample area for BES21-05
Created: 11/4/2021 12:46:05 PM
Lat:32.673682, Long:-104.488340

Sample area for BES21-05

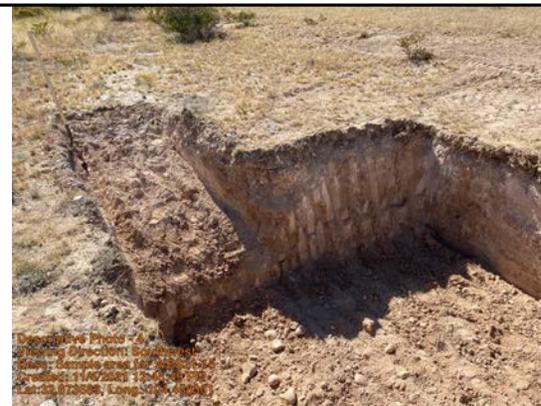
Descriptive Photo - 4
Viewing Direction: Southwest
Date: Sample area for WES21-15
Created: 11/4/2021 12:44:34 PM
Lat:32.673858, Long:-104.488307

Sample area for WES21-15

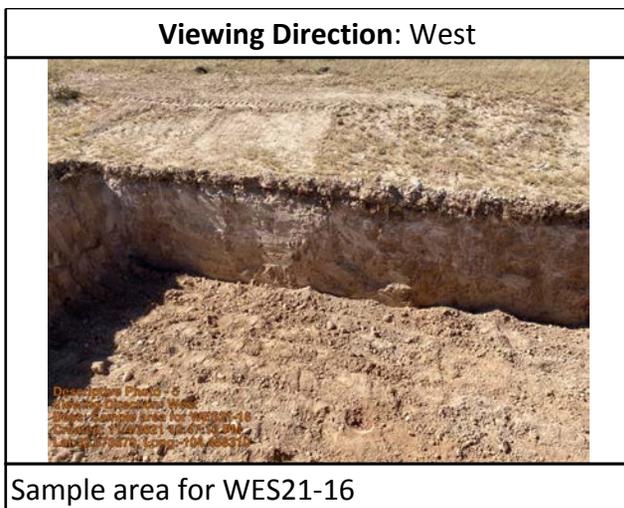
Sample area for WES21-16

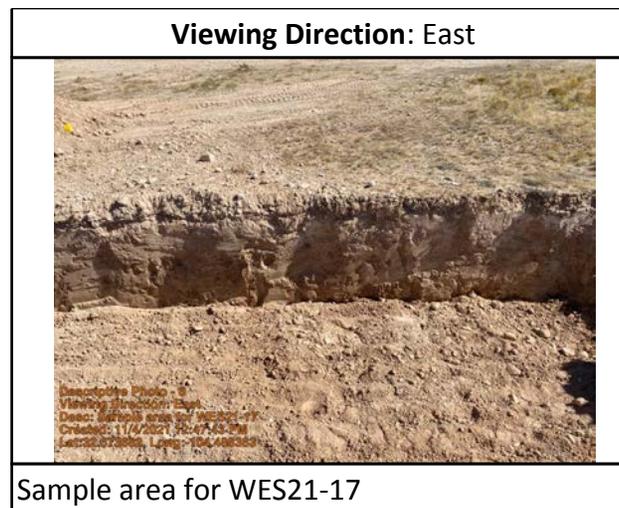
Sample area for WES21-17

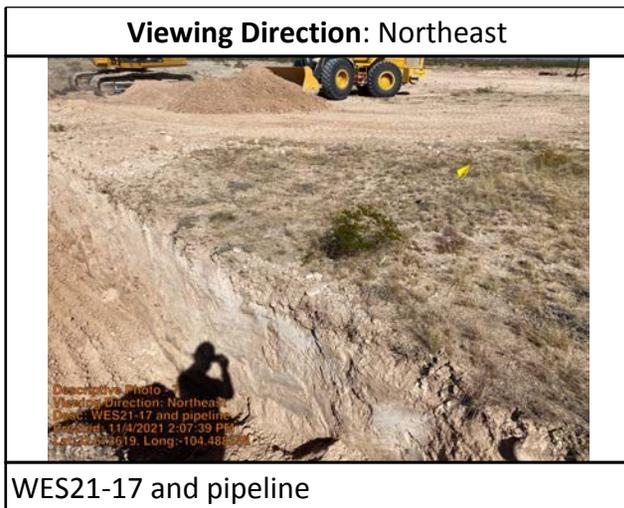
WES21-17 and pipeline

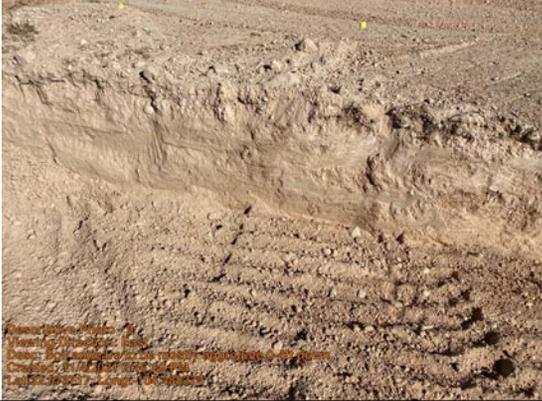
A photograph showing a cross-section of a soil profile. The soil is light brown and appears to be composed of aggregate material. There are some darker, more textured layers visible, particularly in the middle section. The top surface is relatively flat but shows some minor erosion or unevenness. The bottom of the profile is also visible, showing a similar texture to the top layer.
Soil appears to be mostly aggregate with some caliche 0-4ft down

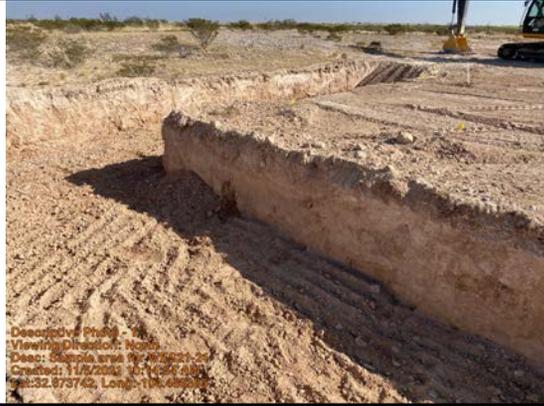
Descriptive Photo
Viewing Direction: Northeast
Desc: Sample area for WES21-21
Created: 11/5/2021 10:14:34 AM
Lat:32.673742, Long:-104.488023

Sample area for WES21-21

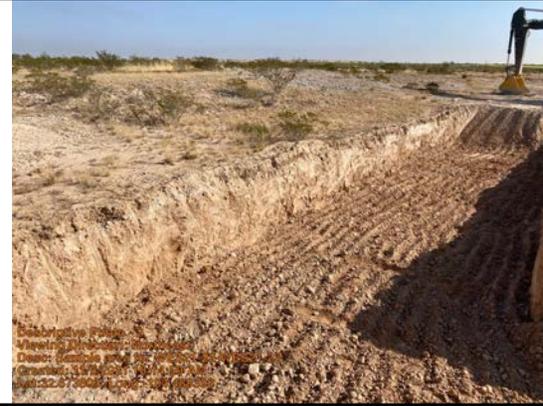
Descriptive Photo
Viewing Direction: Northeast
Desc: Sample area for WES21-22-WES21-23
Created: 11/5/2021 10:14:34 AM
Lat:32.673742, Long:-104.488023

Sample area for WES21-22-WES21-23

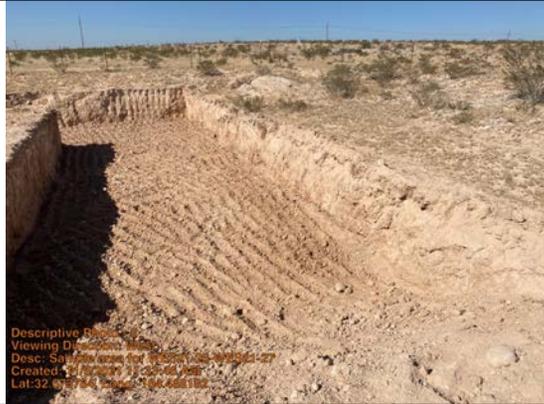
Descriptive Photo
Viewing Direction: West
Desc: Sample area for WES21-26-WES21-27
Created: 11/5/2021 11:34:43 AM
Lat:32.673351, Long:-104.488023

Sample area for WES21-26-WES21-27

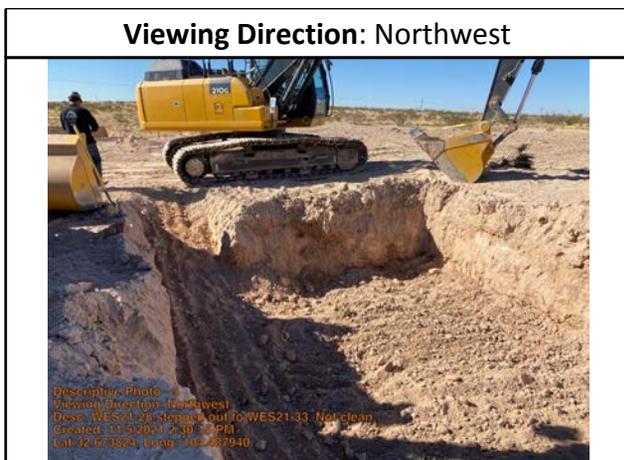
WES21-28 stepped out to WES21-33. Not clean

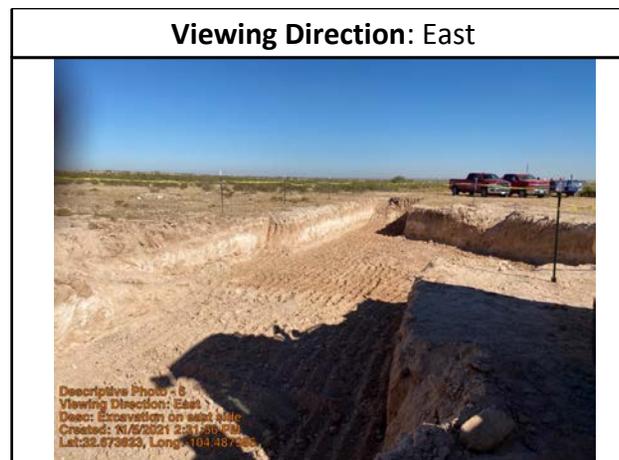
Excavation on east side

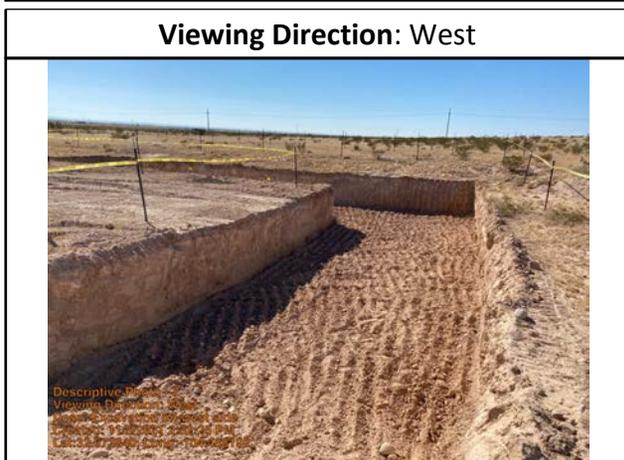
Excavation on west side

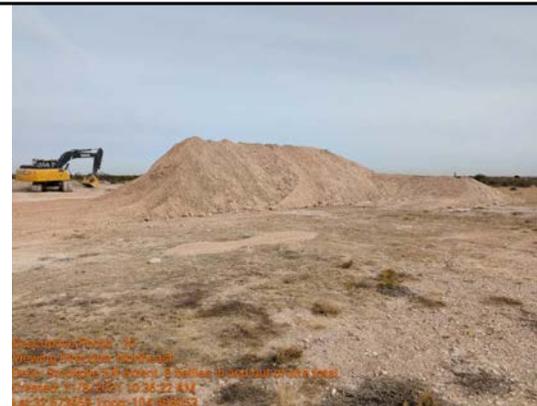
Stockpile full extent. 8 bellies in and out of site total.

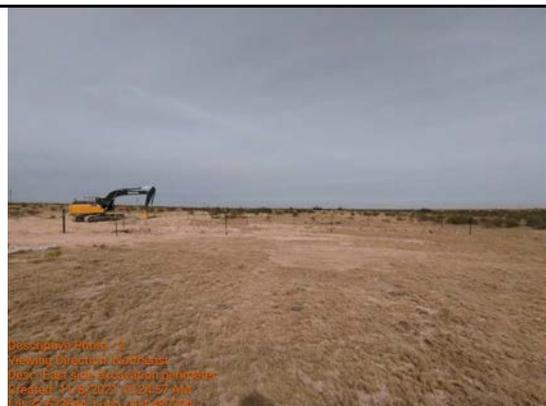
East side excavation perimeter.

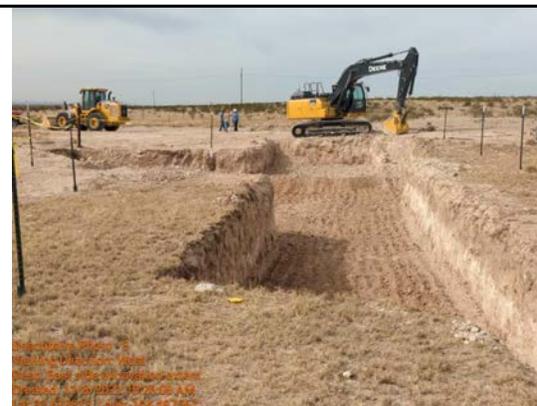
East side excavation extent.

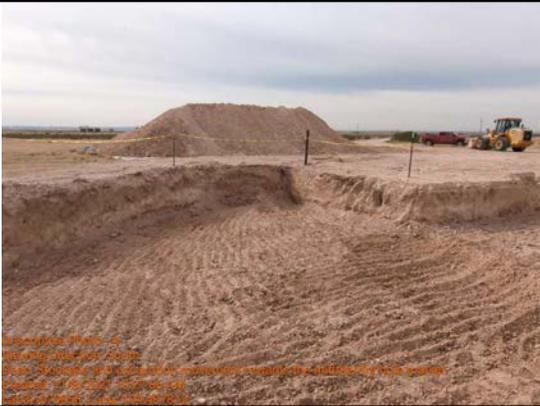
AssetName: Photo - 2
Viewing Direction: South
Desc: Stockpile and excavation movement towards the middle/dry hole marker.
Created: 11/8/2021 10:28:32 AM
Updated: 11/8/2021 10:28:32 AM

Stockpile and excavation movement towards the middle/dry hole marker.

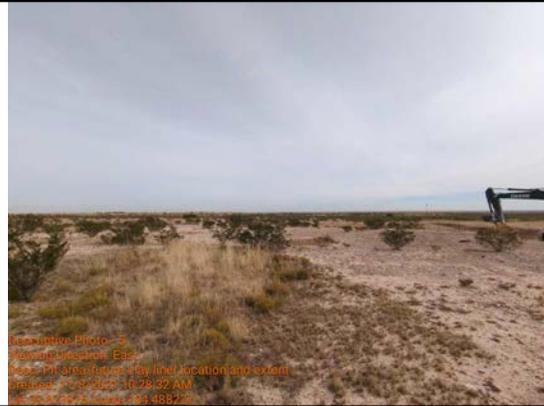
AssetName: Photo - 3
Viewing Direction: East
Desc: Pit area/future clay liner location and extent.
Created: 11/8/2021 10:28:32 AM
Updated: 11/8/2021 10:28:32 AM

Pit area/future clay liner location and extent

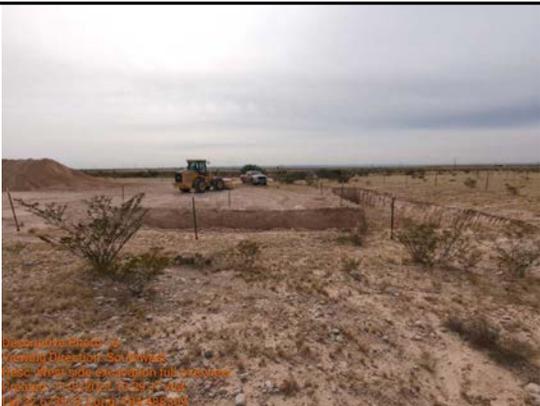
AssetName: Photo - 4
Viewing Direction: Southwest
Desc: West side excavation full overview.
Created: 11/8/2021 10:28:32 AM
Updated: 11/8/2021 10:28:32 AM

West side excavation full overview.

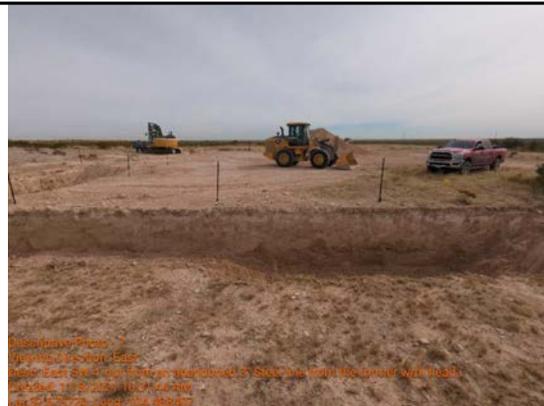
AssetName: Photo - 5
Viewing Direction: East
Desc: East SW 4' out from an abandoned 3" Steel line from the owner with load.
Created: 11/8/2021 10:28:32 AM
Updated: 11/8/2021 10:28:32 AM

East SW 4' out from an abandoned 3" Steel line from the owner with load. Waiting on approval by EOG to step out closer or have the line removed.

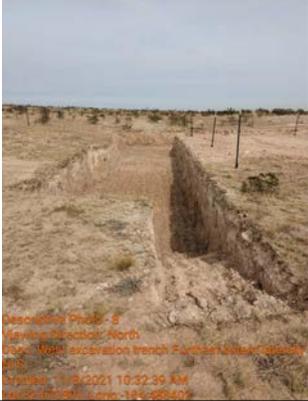
West excavation trench Furthest extent laterally N/S.

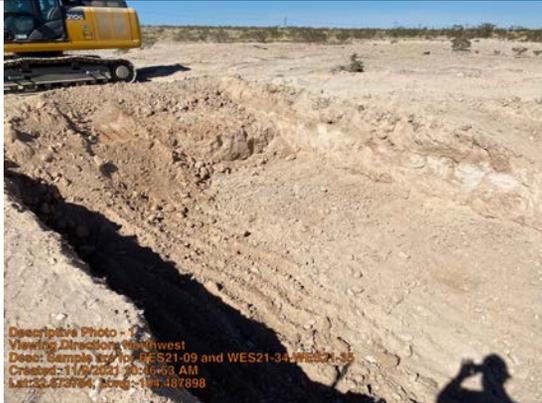
Descriptive Photo - 1
Viewing Direction: Northwest
Desc: Sample for ID: BES21-09 and WES21-34/WES21-35
Created: 11/9/2021 10:46:53 AM
Lat:32.673764, Long:-104.487898

Sample are for BES21-09 and WES21-34-WES21-35

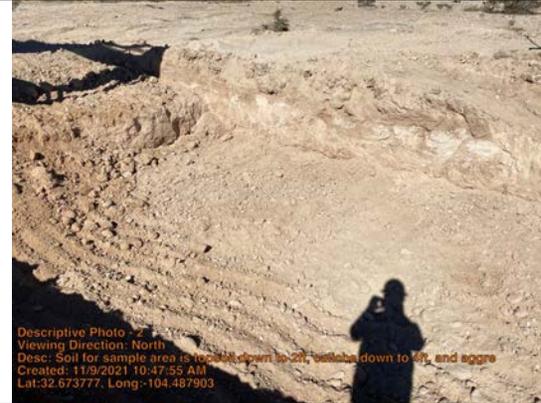
Descriptive Photo - 2
Viewing Direction: North
Desc: Soil for sample area is topsoil down to 2ft, caliche down to 4ft, and aggregate on the bottom
Created: 11/9/2021 10:47:55 AM
Lat:32.673777, Long:-104.487903

Soil for sample area is topsoil down to 2ft, caliche down to 4ft, and aggregate on the bottom

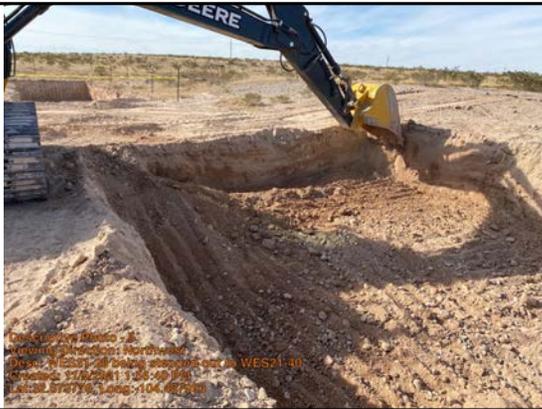
Descriptive Photo - 6
Viewing Direction: Northwest
Digs: WES21-28 being stepped out to WES21-30
Created: 11/9/2021 1:35:40 PM
Lat:32.873716, Long:-104.489281

WES21-28 being stepped out to WES21-39

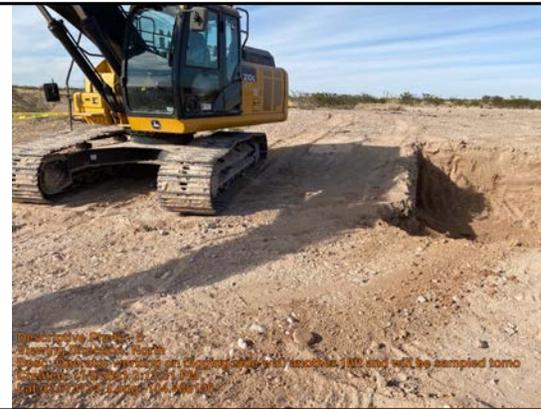
Descriptive Photo - 5
Viewing Direction: North
Digs: Operator working on digging side wall another 10ft and will be sampled tomorrow
Created: 11/9/2021 2:12:51 PM
Lat:32.873665, Long:-104.489110

Operator working on digging side wall another 10ft and will be sampled tomorrow

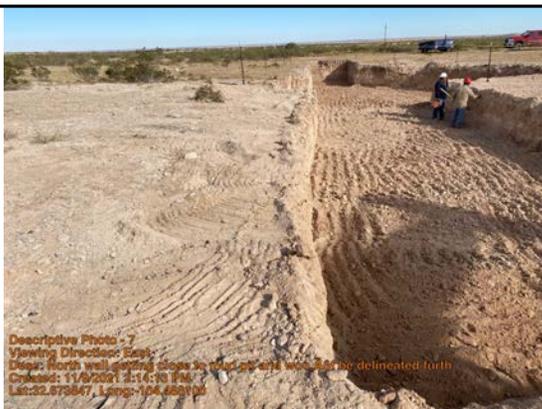
Descriptive Photo - 7
Viewing Direction: East
Digs: North wall getting close to mud pit and won't be delineated further
Created: 11/9/2021 2:14:19 PM
Lat:32.873847, Long:-104.489110

North wall getting close to mud pit and won't be delineated further

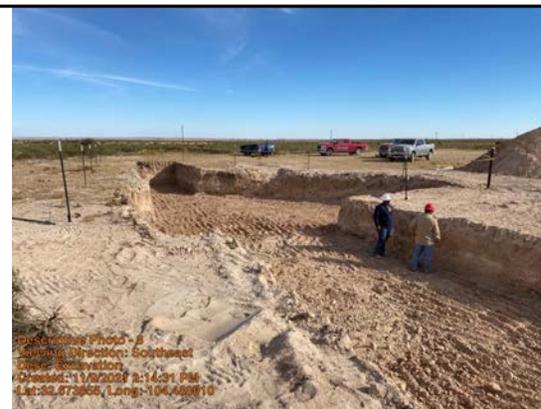
Descriptive Photo - 4
Viewing Direction: Southeast
Digs: Excavation
Created: 11/9/2021 2:14:31 PM
Lat:32.873665, Long:-104.489110

Excavation

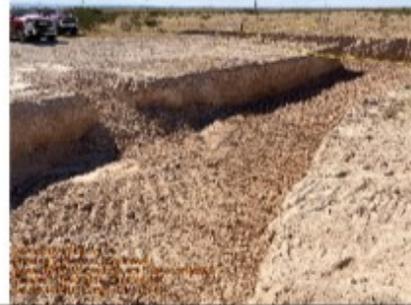
Both excavations are now connected

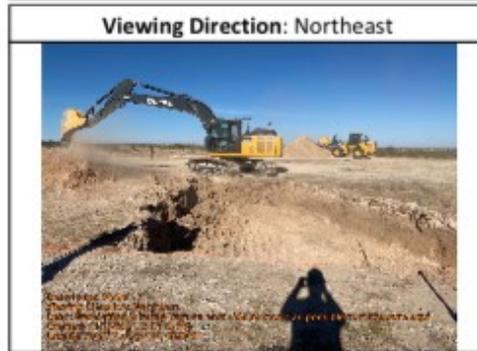
Beginning on south end working north.

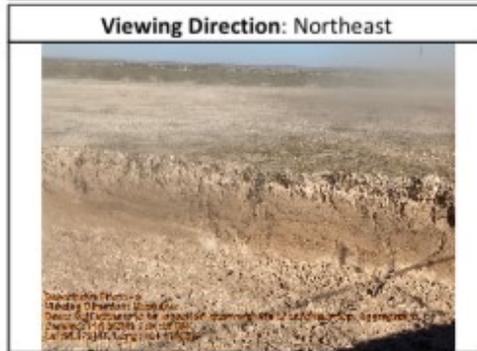
Excavation is being kept on east side as much as possible to make sure equipment can get to the pipeline when it is removed

Soil appears to be topsoil 3ft down with 6in of caliche on top. Aggregate soil at 4ft

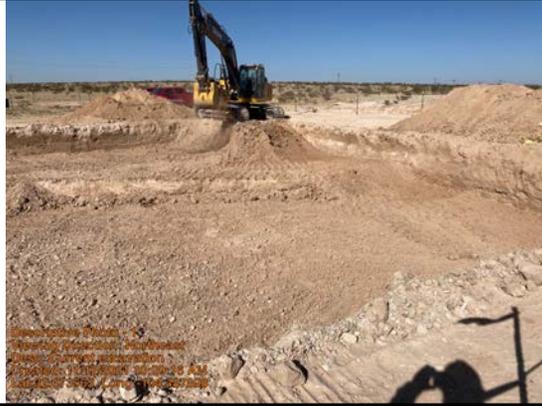
Descriptive Photo - 1
Viewing Direction: Northwest
Desc: Current excavation
Created: 11/12/2021 10:28:45 AM
Lat:32.57396, Long:-104.48786

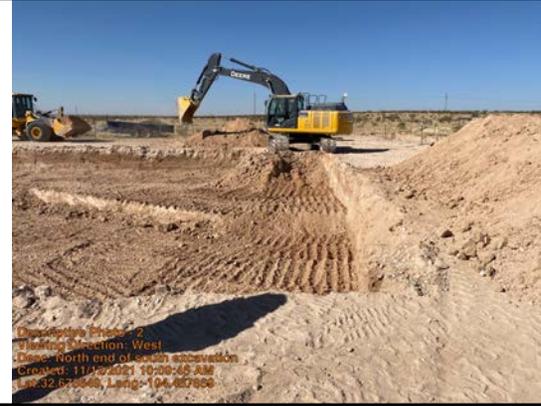
Descriptive Photo - 2
Viewing Direction: West
Desc: North end of south excavation
Created: 11/12/2021 10:28:45 AM
Lat:32.57396, Long:-104.48786

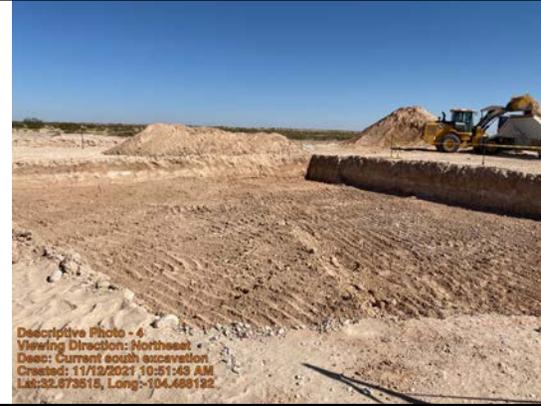
Descriptive Photo - 4
Viewing Direction: Northeast
Desc: Current south excavation
Created: 11/12/2021 10:51:43 AM
Lat:32.573515, Long:-104.489122

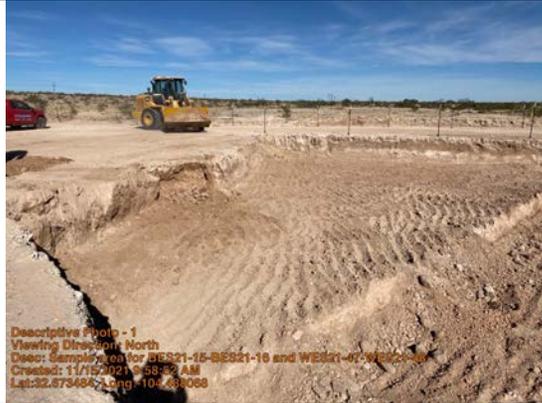
Descriptive Photo - 1
Viewing Direction: North
Desc: Sample area for BES21-15-BES21-16 and WES21-47-WES21-48
Created: 11/15/2021 9:58:39 AM
Lat:32.673464, Long: -104.488068

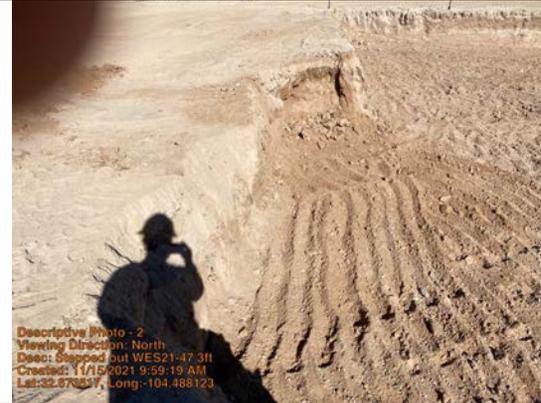
Descriptive Photo - 2
Viewing Direction: North
Desc: Stepped out WES21-47 3ft
Created: 11/15/2021 9:59:19 AM
Lat:32.673317, Long:-104.488123

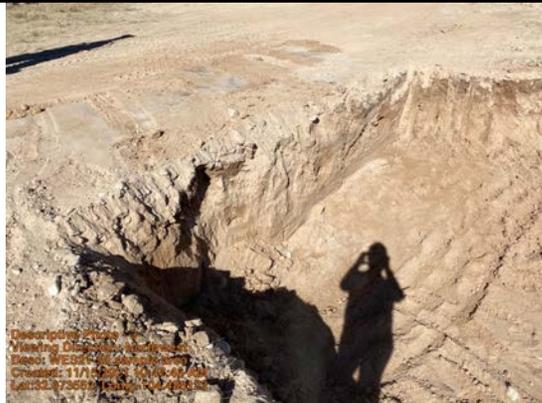
Descriptive Photo - 3
Viewing Direction: Northwest
Desc: WES21-50 sample area
Created: 11/15/2021 10:04:24 AM
Lat:32.673369, Long:-104.488123

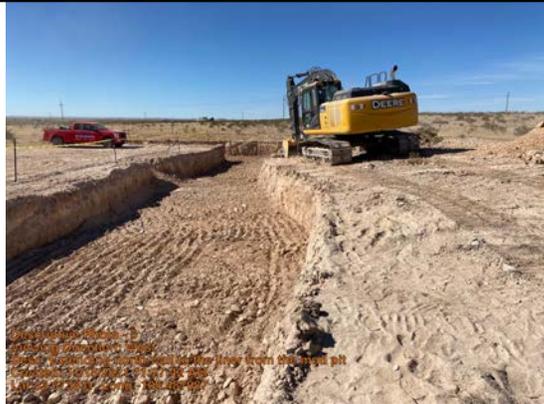
Descriptive Photo - 6
Viewing Direction: West
Desc: Extending north wall to the liner from the mud pit
Created: 11/15/2021 11:32:05 AM
Lat:32.673398, Long:-104.487757

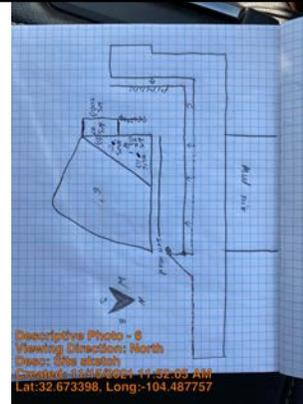
Descriptive Photo - 6
Viewing Direction: North
Desc: Site sketch
Created: 11/15/2021 11:32:05 AM
Lat:32.673398, Long:-104.487757

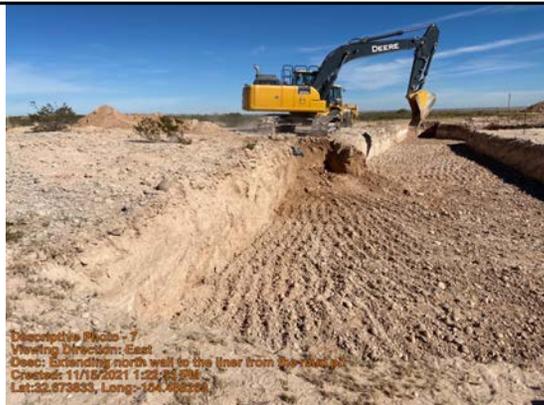
Descriptive Photo - 7
Viewing Direction: East
Desc: Extending north wall to the liner from the mud pit
Created: 11/15/2021 1:36:54 PM
Lat:32.673398, Long:-104.487757

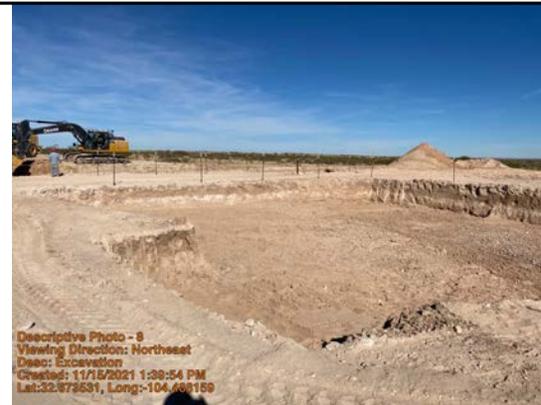
Descriptive Photo - 8
Viewing Direction: Northeast
Desc: Excavation
Created: 11/15/2021 1:36:54 PM
Lat:32.673398, Long:-104.487757

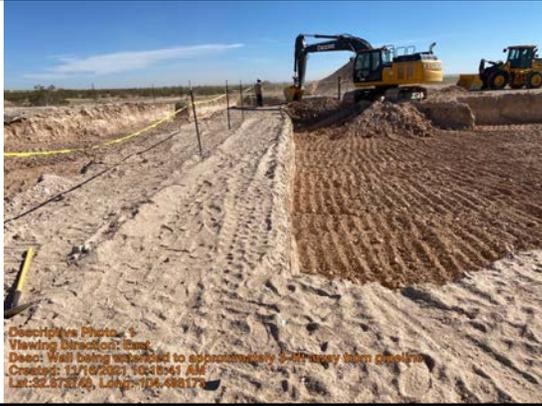
Descriptive Photo - 4
Viewing Direction: East
Desc: Wall being extended to approximately 3-4ft away from pipeline
Created: 11/16/2021 10:48:41 AM
Lat:32.573746, Long:-104.488178

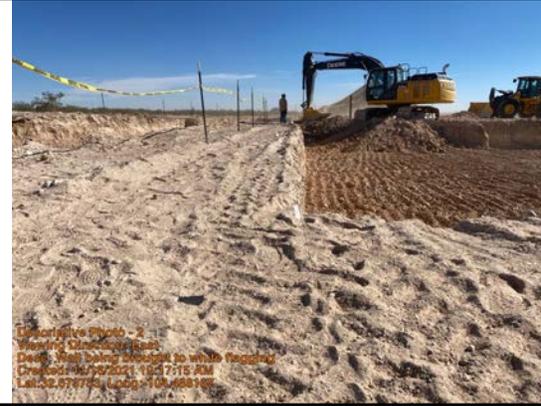
Descriptive Photo - 5
Viewing Direction: East
Desc: Wall being brought to white flagging
Created: 11/16/2021 10:17:18 AM
Lat:32.573746, Long:-104.488178

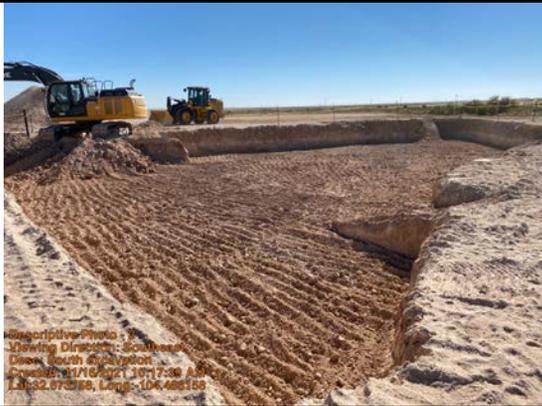
Descriptive Photo - 6
Viewing Direction: Southeast
Desc: South excavation
Created: 11/16/2021 10:17:00 AM
Lat:32.573746, Long:-104.488178

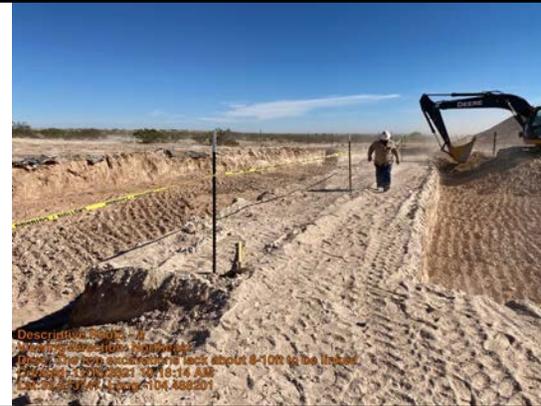
Descriptive Photo - 7
Viewing Direction: Northeast
Desc: The two excavations lack about 8-10ft to be linked
Created: 11/16/2021 10:16:14 AM
Lat:32.573746, Long:-104.488178

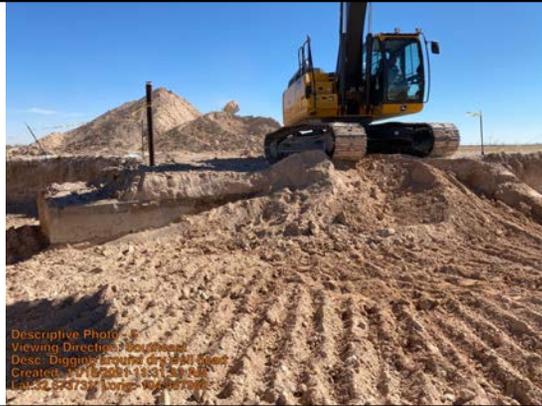
Descriptive Photo - 5
Viewing Direction: Southeast
Desc: Digging around dry well head
Created: 11/16/2021 11:31:28 AM
Lat:32.673732 Long:-104.488708

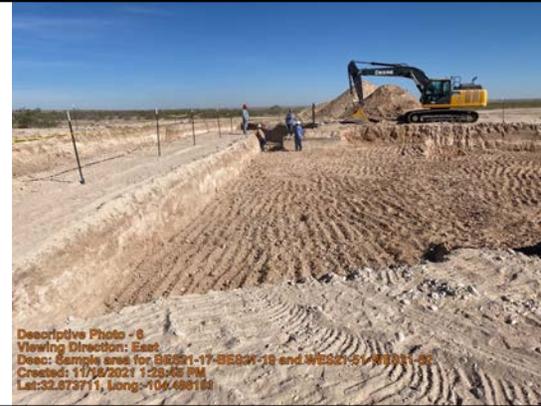
Descriptive Photo - 6
Viewing Direction: East
Desc: Sample area for BES21-17-BES21-19 and WES21-51-WES21-52
Created: 11/16/2021 1:23:45 PM
Lat:32.673711 Long:-104.488184

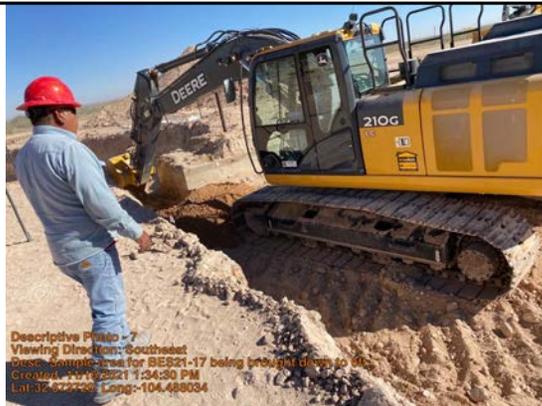
Descriptive Photo - 7
Viewing Direction: Southeast
Desc: Sample area for BES21-17 being brought down to 6ft
Created: 11/16/2021 1:34:30 PM
Lat:32.673733 Long:-104.488034

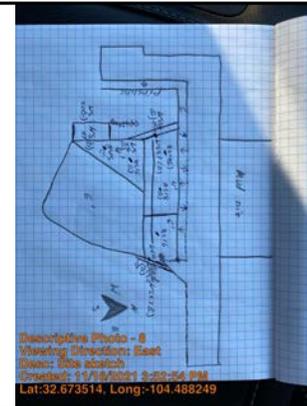
Descriptive Photo - 8
Viewing Direction: East
Desc: Site sketch
Created: 11/16/2021 1:35:54 PM
Lat:32.673514 Long:-104.488249

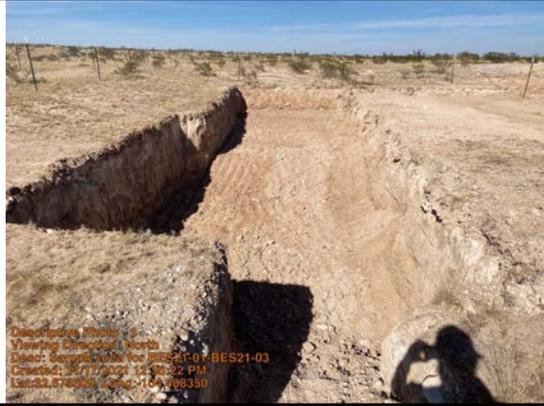
Descriptive Photo - 1
Viewing Direction: North
Desc: Sample area for BES21-01-BES21-03
Created: 11/17/2021 12:31:32 PM
Lat:32.573964, Long:-104.488350

Sample area for BES21-01-BES21-03

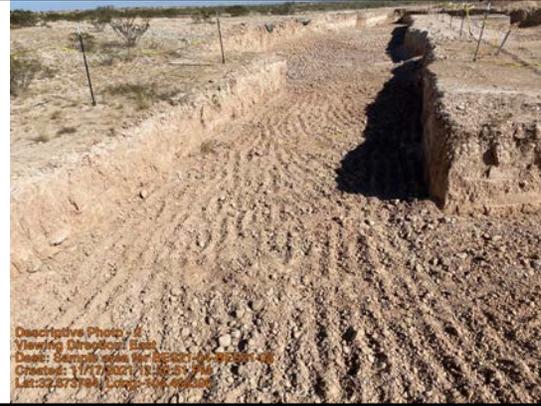
Descriptive Photo - 2
Viewing Direction: East
Desc: Sample area for BES21-04-BES21-08
Created: 11/17/2021 12:36:21 PM
Lat:32.573794, Long:-104.488350

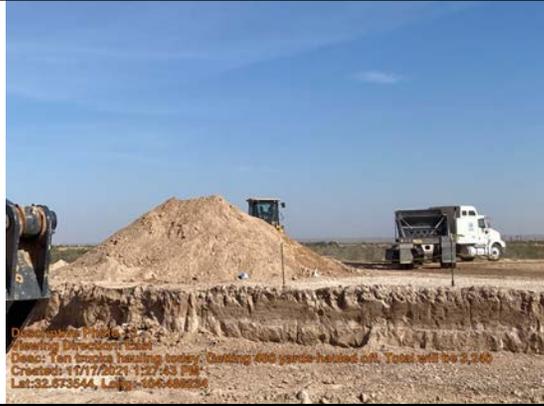
Descriptive Photo - 3
Viewing Direction: East
Desc: Ten trucks hauling today. Getting 400 yards hauled off. Total will be 3,240
Created: 11/17/2021 1:27:43 PM
Lat:32.573544, Long:-104.488350

Ten trucks hauling today. Getting 400 yards hauled off. Total will be 3,240.

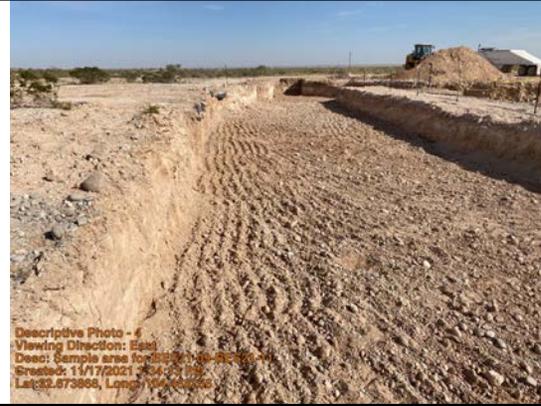
Descriptive Photo - 4
Viewing Direction: East
Desc: Sample area for BES21-09-BES21-11
Created: 11/17/2021 2:34:27 PM
Lat:32.573866, Long:-104.488350

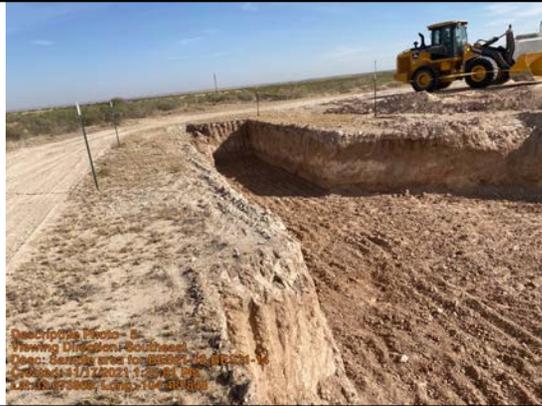
Description Photo - 1
Viewing Direction: Southeast
Date: Sample area for BES21-12-BES21-14
Created: 11/17/2021 1:25:54 PM
Lat: 37.3889, Long: 104.281889
