Vertex Project #: 21E-00123-011

Spill Closure Report: Warren ANW Federal #6
Unit J, Section 9, Township 19 South, Range 25 East
County: Eddy
API: 30-015-28786
Incident ID: nAPP2129353745

Prepared For: **EOG Resources, Inc.**
104 S. 4th Street
Artesia, New Mexico, 88210

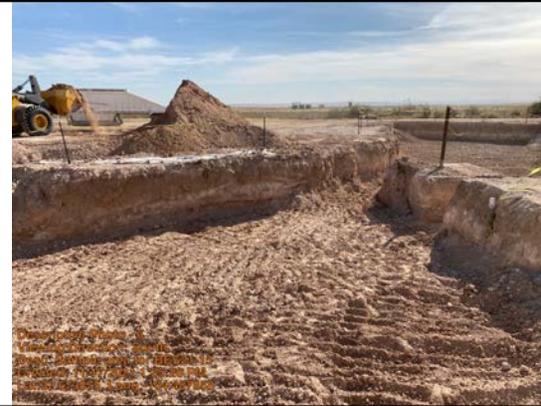
Description Photo - 2
Viewing Direction: South
Date: Sample area for BES21-15
Created: 11/17/2021 1:26:04 PM
Lat: 37.3889, Long: 104.281889

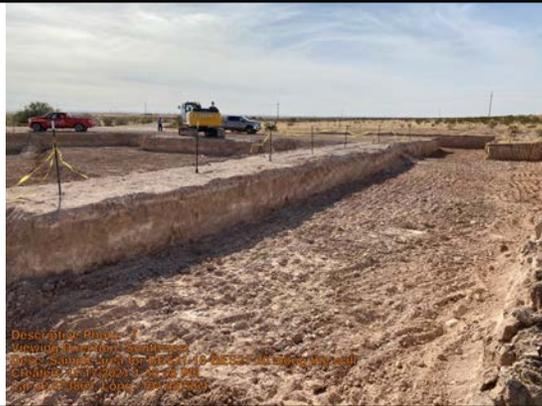
Description Photo - 3
Viewing Direction: Southwest
Date: Sample area for BES21-16-BES21-20 near the wall
Created: 11/17/2021 1:26:14 PM
Lat: 37.3889, Long: 104.281889

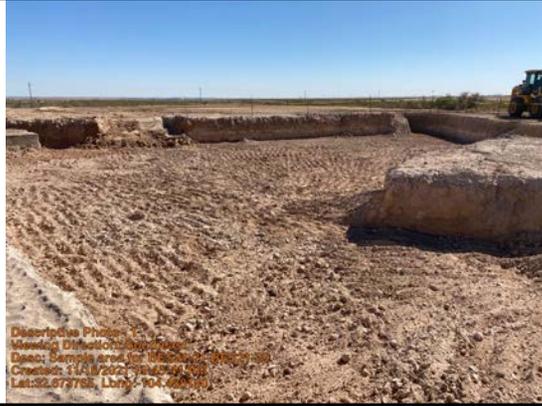
Descriptive Photo - 1
Viewing Direction: Southeast
Desc: Sample area for BES21-21-BES21-29
Created: 11/18/2021 2:44:31 PM
Lat:32.677796, Long:-104.488391

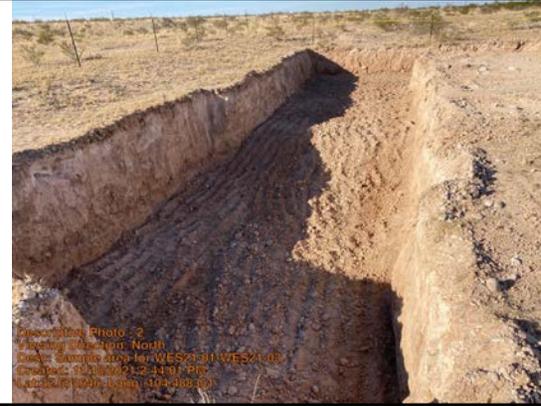
Descriptive Photo - 2
Viewing Direction: North
Desc: Sample area for WES21-01-WES21-03
Created: 11/18/2021 2:44:01 PM
Lat:32.677796, Long:-104.488391

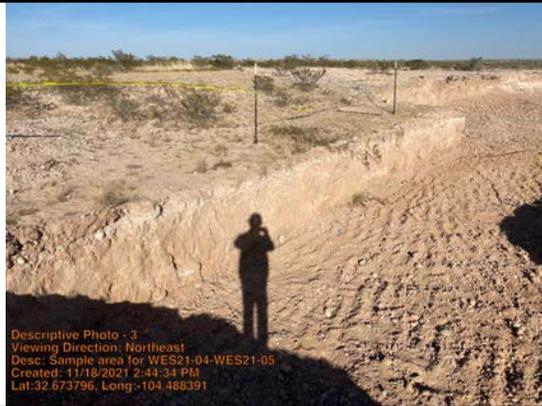
Descriptive Photo - 3
Viewing Direction: Northeast
Desc: Sample area for WES21-04-WES21-05
Created: 11/18/2021 2:44:34 PM
Lat:32.673796, Long:-104.488391

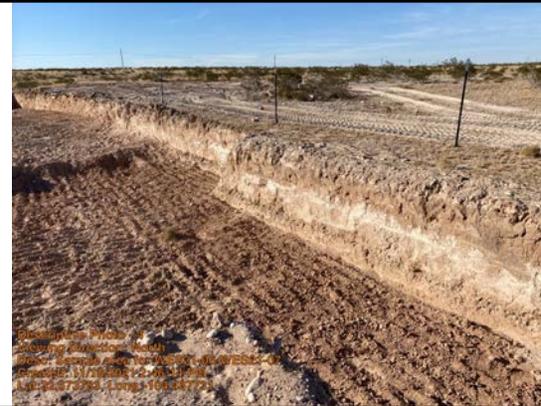
Descriptive Photo - 4
Viewing Direction: North
Desc: Sample area for WES21-06-WES21-07
Created: 11/18/2021 2:44:31 PM
Lat:32.673796, Long:-104.488391

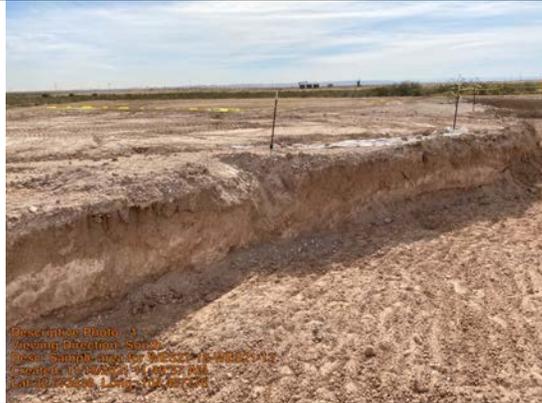
Descriptive Photo - 1
Viewing Direction: South
Desc: Sample area for WES21-12-WES21-13
Created: 11/19/2021 11:53:59 AM
Lat:32.673667 Long:104.487320

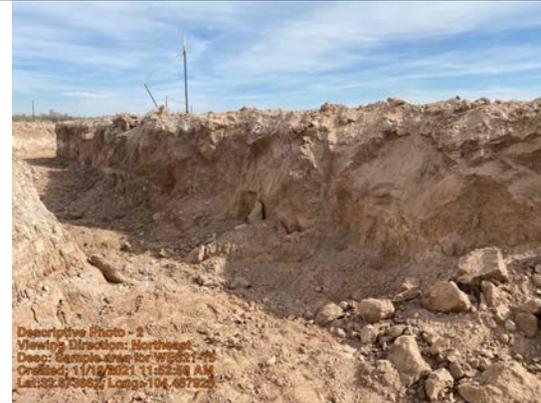
Descriptive Photo - 2
Viewing Direction: Northeast
Desc: Sample area for WES21-15
Created: 11/19/2021 11:53:59 AM
Lat:32.673667 Long:104.487320

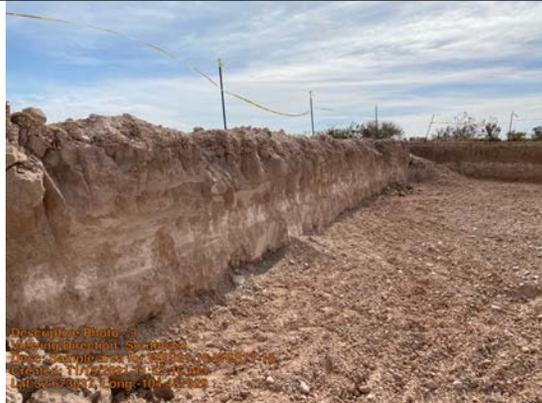
Descriptive Photo - 3
Viewing Direction: Southeast
Desc: Sample area for WES21-16-WES21-18
Created: 11/19/2021 11:53:59 AM
Lat:32.673667 Long:104.487320

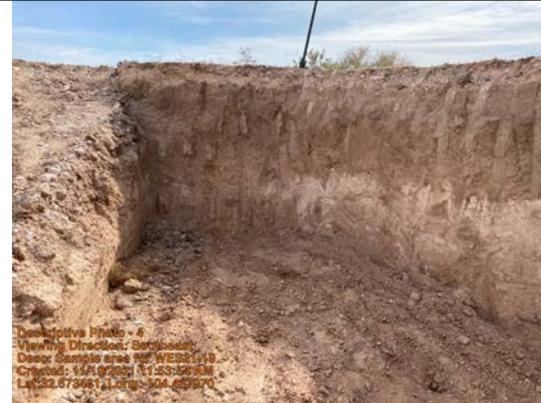
Descriptive Photo - 4
Viewing Direction: Southeast
Desc: Sample area for WES21-19
Created: 11/19/2021 11:53:59 AM
Lat:32.673667 Long:104.487320

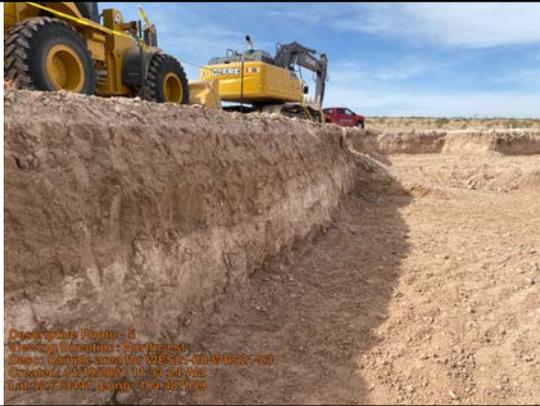
Descriptive Photo -
Viewing Direction: Northwest
Date: Sample area for WES21-20-WES21-23
Created: 11/19/2021 11:54:42 AM
Lat:32.073856, Long: -104.488110

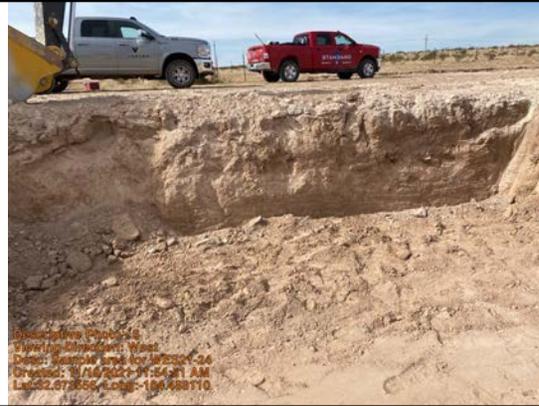
Descriptive Photo -
Viewing Direction: West
Date: Sample area for WES21-24
Created: 11/19/2021 11:54:41 AM
Lat:32.073856, Long: -104.488110

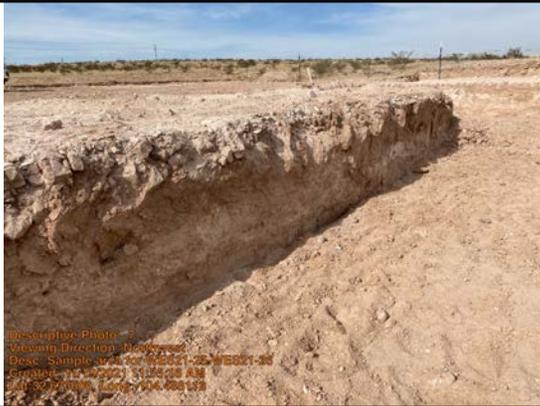
Descriptive Photo -
Viewing Direction: Northwest
Date: Sample area for WES21-25-WES21-26
Created: 11/19/2021 11:54:43 AM
Lat:32.073856, Long: -104.488110

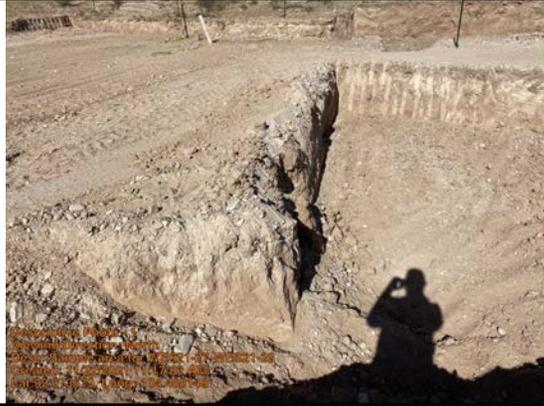
Sample area for WES21-27-WES21-28

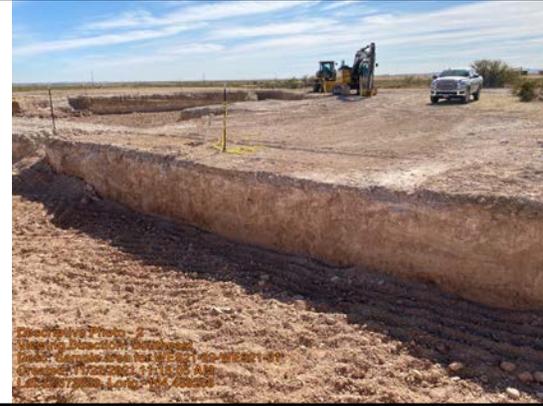
Sample area for WES21-29-WES21-31

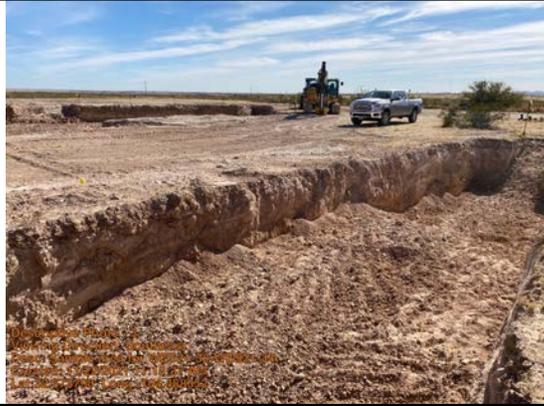
Sample area for WES21-32-WES21-34

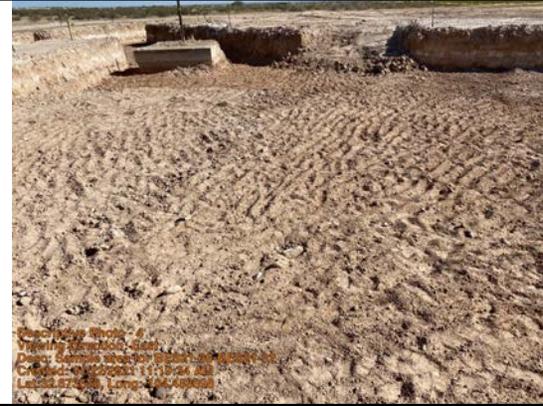
Sample area for BES21-30-BES21-32

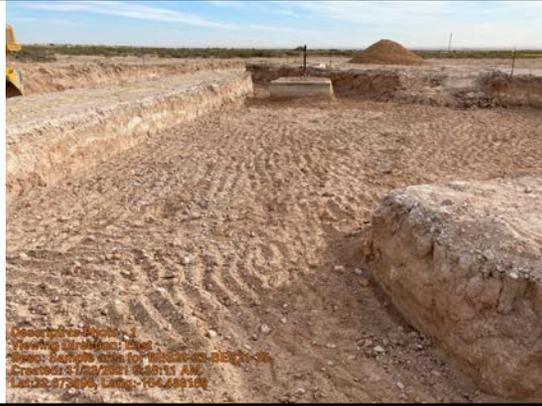
Descriptive Photo - 3
Viewing Direction: East
View: Sample area for BES21-33-BES21-35
Created: 11/23/2021 9:38:11 AM
Lat:32.87295, Long: -104.48916

Sample area for BES21-33-BES21-35

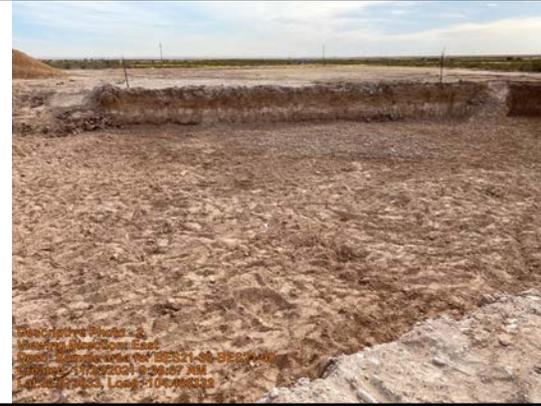
Descriptive Photo - 3
Viewing Direction: East
View: Sample area for BES21-36-BES21-40
Created: 11/23/2021 9:38:57 AM
Lat:32.87295, Long: -104.48933

Sample area for BES21-36-BES21-40

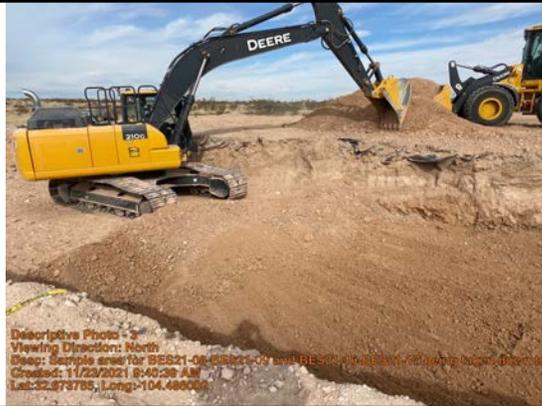
Descriptive Photo - 3
Viewing Direction: North
View: Sample area for BES21-08-BES21-09 and BES21-16-BES21-17 being taken down to 6ft
Created: 11/23/2021 9:40:39 AM
Lat:32.873785, Long: -104.48906

Sample area for BES21-08-BES21-09 and BES21-16-BES21-17 being taken down to 6ft

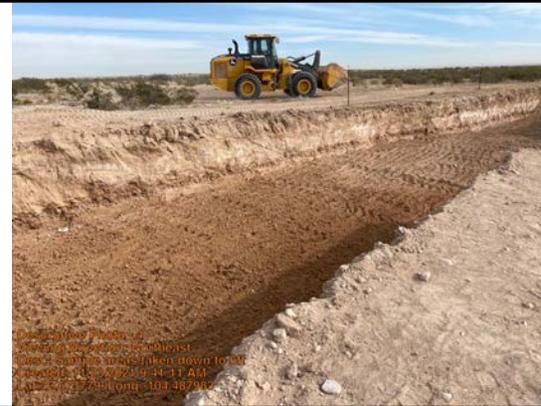
Descriptive Photo - 3
Viewing Direction: Northeast
View: Sample areas taken down to 6ft
Created: 11/23/2021 9:44:11 AM
Lat:32.87379, Long: -104.48796

Sample areas taken down to 6ft

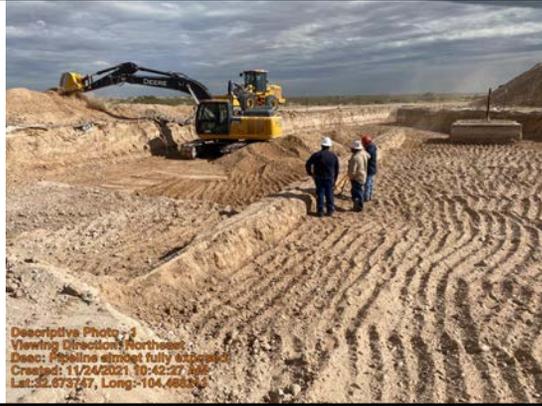
Descriptive Photo - 3
Viewing Direction: Northeast
Desc: Pipeline almost fully exposed
Created: 11/24/2021 10:42:27 AM
Lat:32.873747, Long:-104.68834

Pipeline almost fully exposed

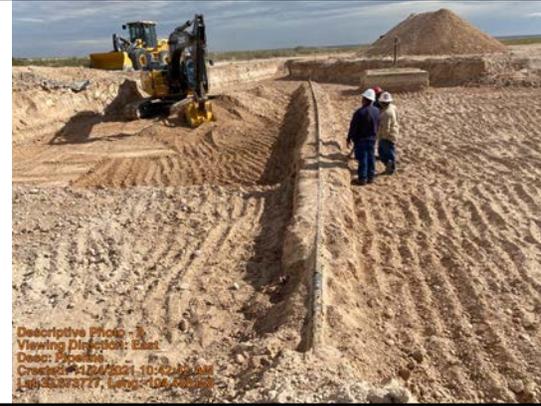
Descriptive Photo - 3
Viewing Direction: East
Desc: Pipeline
Created: 11/24/2021 10:42:46 AM
Lat:32.873777, Long:-104.68834

Pipeline

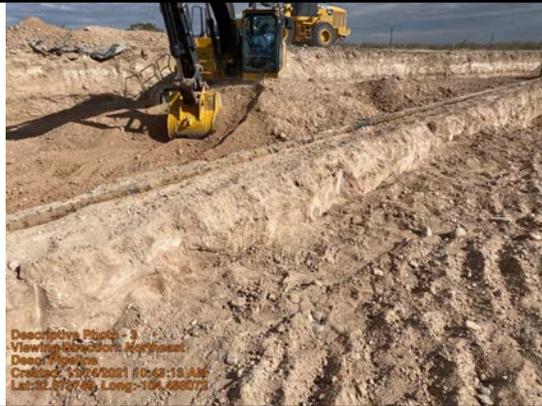
Descriptive Photo - 3
Viewing Direction: Northeast
Desc: Pipeline
Created: 11/24/2021 10:43:19 AM
Lat:32.873746, Long:-104.68872

Pipeline

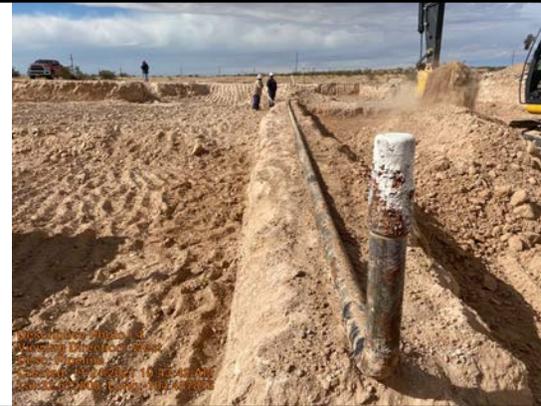
Descriptive Photo - 3
Viewing Direction: West
Desc: Pipeline
Created: 11/24/2021 10:43:41 AM
Lat:32.873746, Long:-104.68834

Pipeline

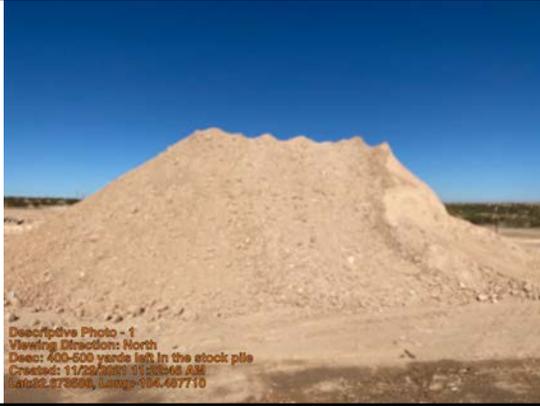
400-500 yards left in the stock pile

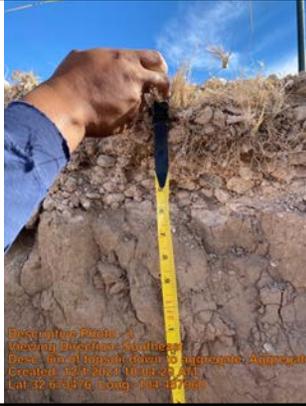
Descriptive Photo - 1
Viewing Direction: Southeast
Desc: 6in of topsoil down to aggregate. Aggregate
Created: 12/1/2021 10:08:31 AM
Lat:32.673462, Long:-104.687960

6in of topsoil down to aggregate. South side of excavation.

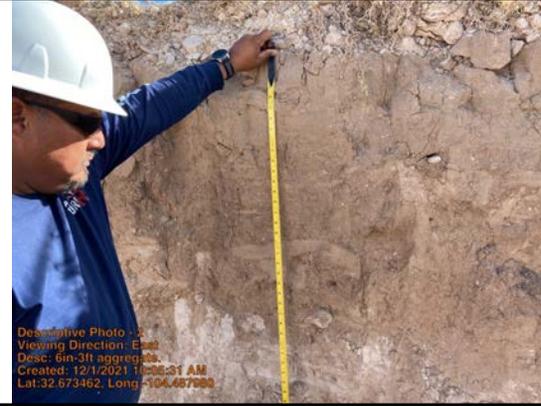
Descriptive Photo - 2
Viewing Direction: East
Desc: 6in-3ft aggregate.
Created: 12/1/2021 10:08:31 AM
Lat:32.673462, Long:-104.687960

6in-42in aggregate. South side of excavation.

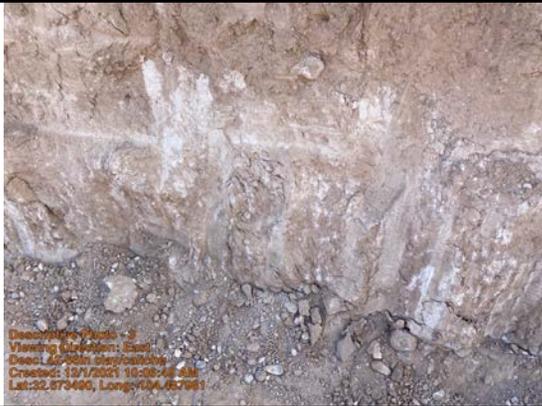
Descriptive Photo - 3
Viewing Direction: East
Desc: 42-66in clay/caliche
Created: 12/1/2021 10:08:31 AM
Lat:32.673462, Long:-104.687960

42-66in clay/caliche. South side of excavation.

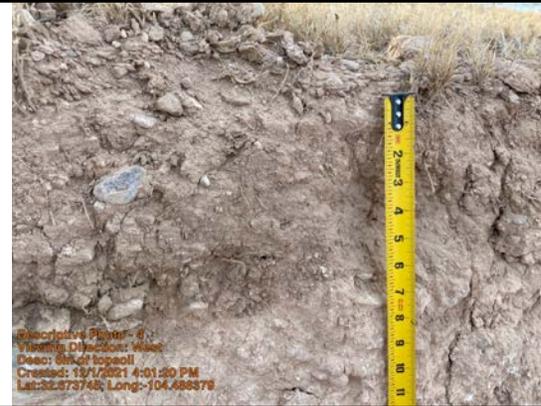
Descriptive Photo - 4
Viewing Direction: West
Desc: 6in of topsoil
Created: 12/1/2021 4:01:20 PM
Lat:32.673462, Long:-104.688378

6in of topsoil. West side of excavation.

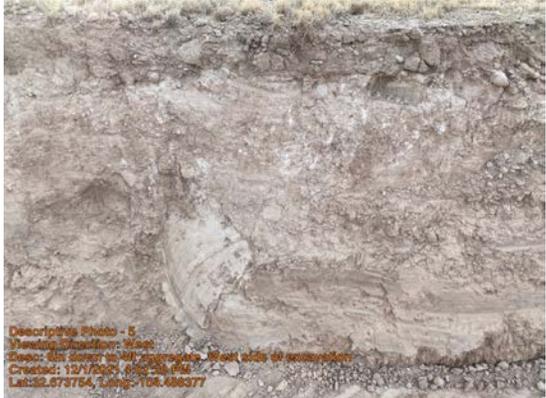
Descriptive Photo - 5
Viewing Direction: West
Desc: 6in down to 4ft aggregate. West side of excavation.
Created: 12/1/2021 4:32:30 PM
Lat:32.673754, Long:-104.486377

6in down to 4ft aggregate. West side of excavation

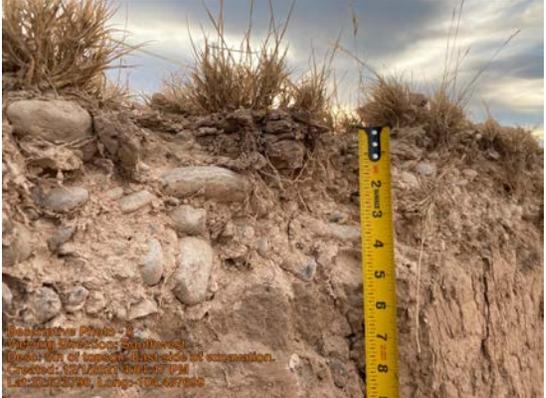
Descriptive Photo - 6
Viewing Direction: Southwest
Desc: 5in of topsoil. East side of excavation.
Created: 12/1/2021 5:04:57 PM
Lat:32.673790, Long:-104.487888

5in of topsoil. East side of excavation.

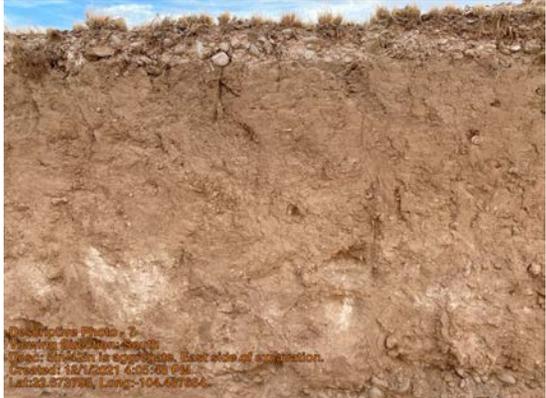
Descriptive Photo - 7
Viewing Direction: South
Desc: 5in-42in is aggregate. East side of excavation.
Created: 12/1/2021 4:32:58 PM
Lat:32.673796, Long:-104.487884

5in-42in is aggregate. East side of excavation.

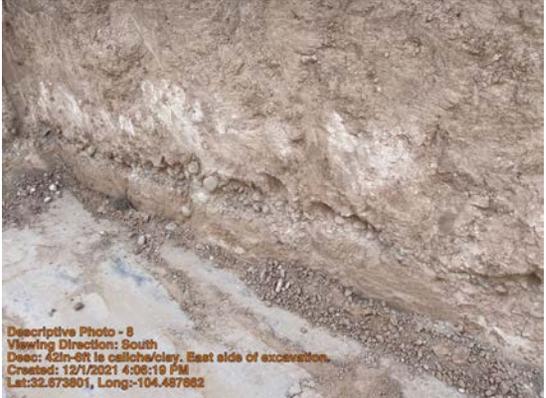
Descriptive Photo - 8
Viewing Direction: South
Desc: 42in-6ft is caliche/clay. East side of excavation.
Created: 12/1/2021 4:06:19 PM
Lat:32.673801, Long:-104.487882

42in-6ft is caliche/clay. East side of excavation.

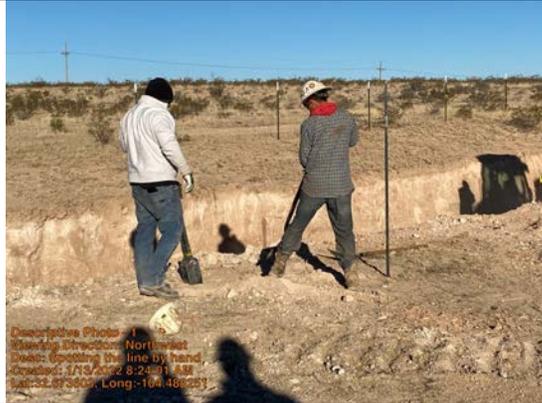
Descriptive Photo: 1
Viewing Direction: Northwest
Desc: Spotting the line by hand.
Created: 1/13/2022 8:24:01 AM
Lat: 32.873600, Long: -104.488233

Spotting the line by hand

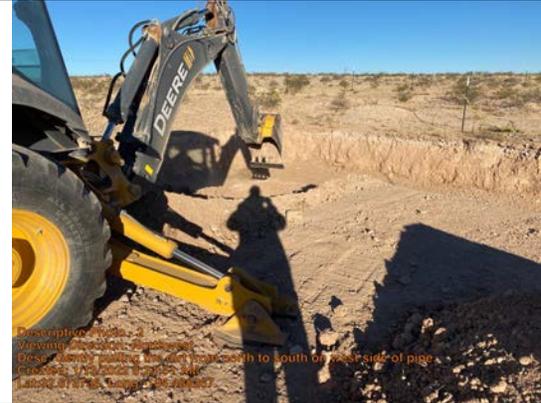
Descriptive Photo: 2
Viewing Direction: Northwest
Desc: Gently pulling the dirt from north to south on west side of pipe.
Created: 1/13/2022 8:27:52 AM
Lat: 32.873600, Long: -104.488233

Gently pulling the dirt from north to south on west side of pipe.

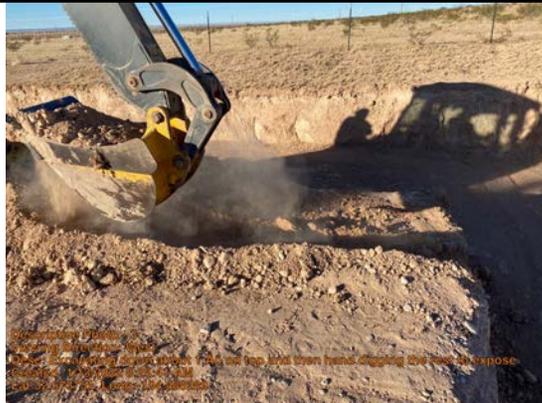
Descriptive Photo: 3
Viewing Direction: West
Desc: Excavating down about 1' on top and then hand digging the rest to expose it.
Created: 1/13/2022 8:31:12 AM
Lat: 32.873600, Long: -104.488233

Excavating down about 1' on top and then hand digging the rest to expose it

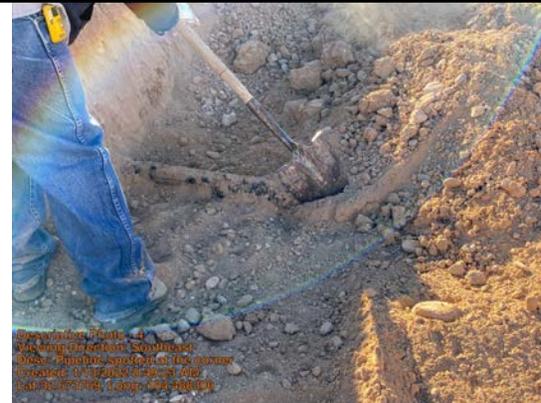
Descriptive Photo: 4
Viewing Direction: Southeast
Desc: Pipeline spotted at the corner.
Created: 1/13/2022 8:34:00 AM
Lat: 32.873600, Long: -104.488233

Pipeline spotted at the corner

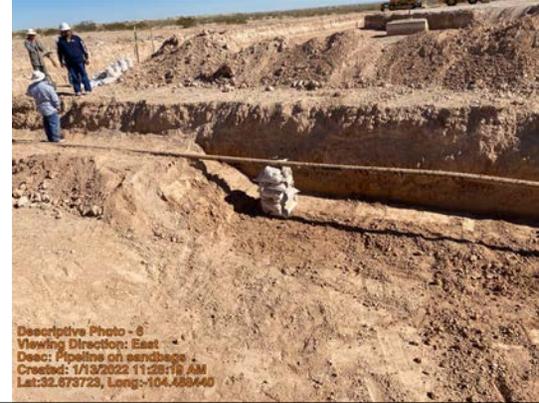
Descriptive Photo - 6
Viewing Direction: East
Desc: Pipeline on sandbags
Created: 1/13/2022 11:28:18 AM
Lat:32.673723, Long:-104.488440

Pipeline on sandbags

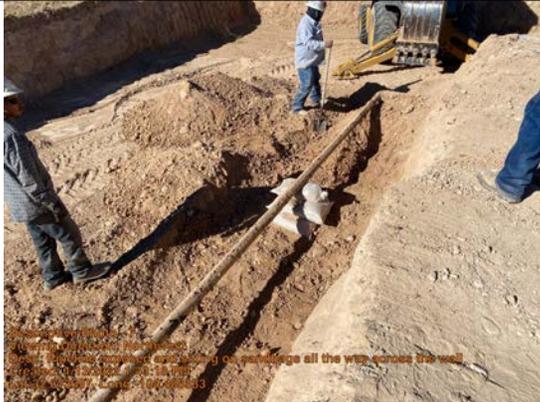
Descriptive Photo - 7
Viewing Direction: Northwest
Desc: Pipeline exposed and sitting on sandbags all the way across the wall
Created: 1/13/2022 11:28:18 AM
Lat:32.673723, Long:-104.488440

Pipeline exposed and sitting on sandbags all the way across the wall

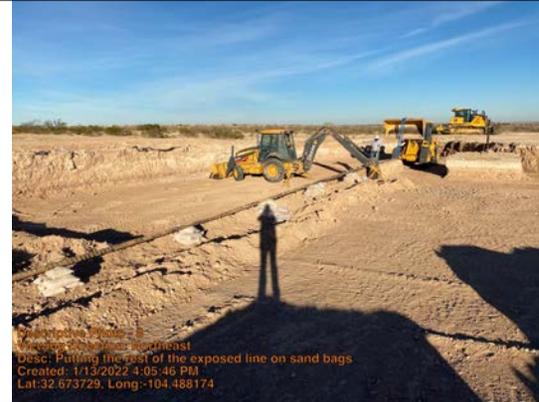
Descriptive Photo - 8
Viewing Direction: Northeast
Desc: Putting the rest of the exposed line on sand bags
Created: 1/13/2022 4:05:46 PM
Lat:32.673729, Long:-104.488174

Putting the rest of the exposed line on sand bags

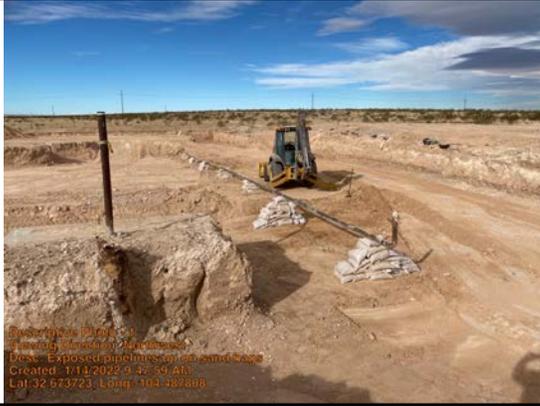
Descriptive Photo - 1
Viewing Direction: Northwest
Desc: Exposed pipelines on sand bags
Created: 1/14/2022 9:42:59 AM
Lat:32.673723, Long: -104.487888

Exposed pipelines up on sand bags

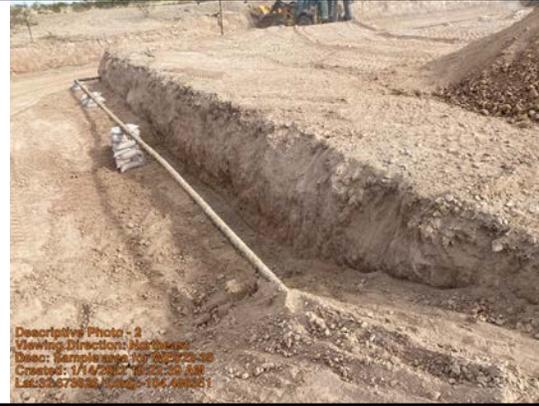
Descriptive Photo - 2
Viewing Direction: Northeast
Desc: Sample area for WES22-35
Created: 1/14/2022 10:22:28 AM
Lat:32.673840, Long: -104.488251

Sample area for WES22-35

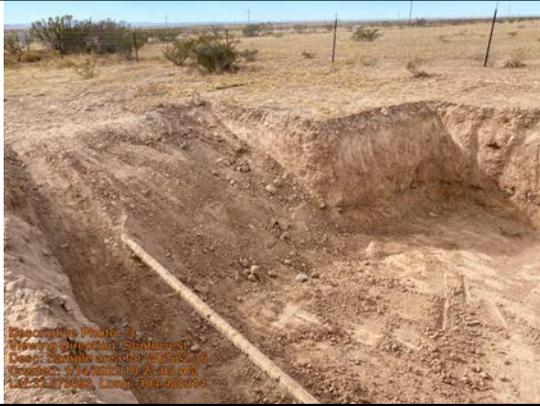
Descriptive Photo - 3
Viewing Direction: Southwest
Desc: Sample area for WES22-36
Created: 1/14/2022 10:54:18 AM
Lat:32.673840, Long: -104.488251

Sample area for WES22-36

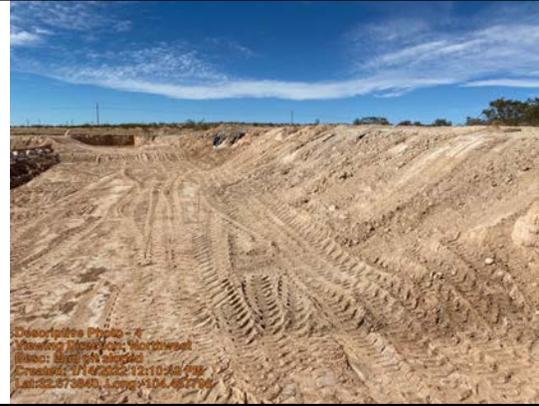
Descriptive Photo - 4
Viewing Direction: Northwest
Desc: Mud pit sloped
Created: 1/14/2022 12:10:48 PM
Lat:32.673840, Long: -104.487766

Mud pit sloped

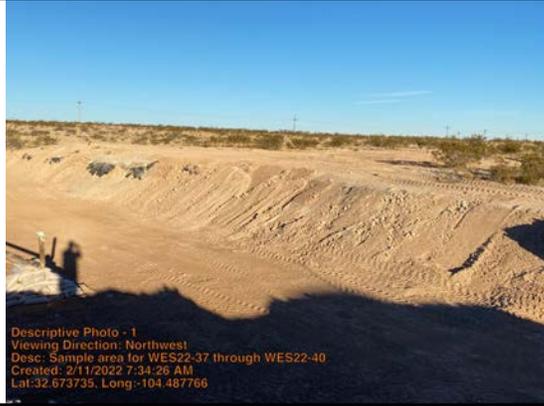
Descriptive Photo - 1
Viewing Direction: Northwest
Desc: Sample area for WES22-37 through WES22-40
Created: 2/11/2022 7:34:26 AM
Lat: 32.673735, Long: -104.487766

Sample area for WES22-37 through WES22-40

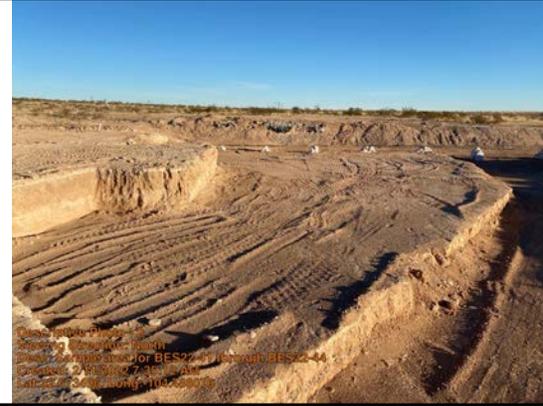
Descriptive Photo - 2
Viewing Direction: North
Desc: Sample area for BES22-41 through BES22-44
Created: 2/11/2022 7:35:17 AM
Lat: 32.673735, Long: -104.487766

Sample area for BES22-41 through BES22-44

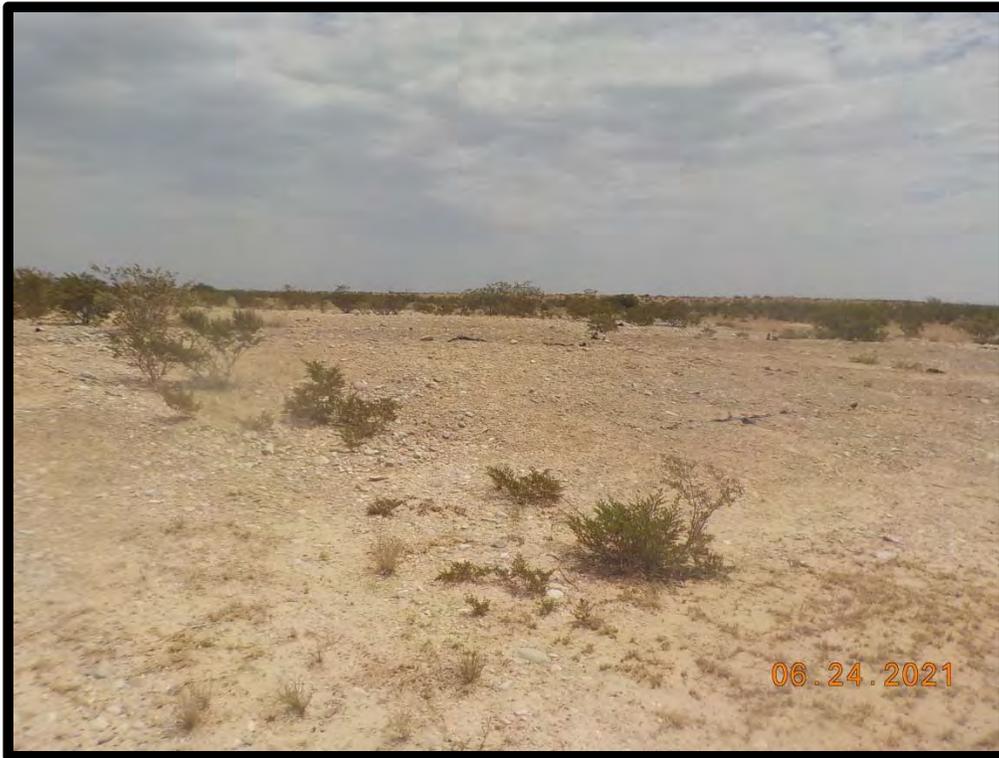
PHOTOGRAPH NO. 1 – A view of the former pit area during the June 24, 2021 site visit. The view is towards the northeast.

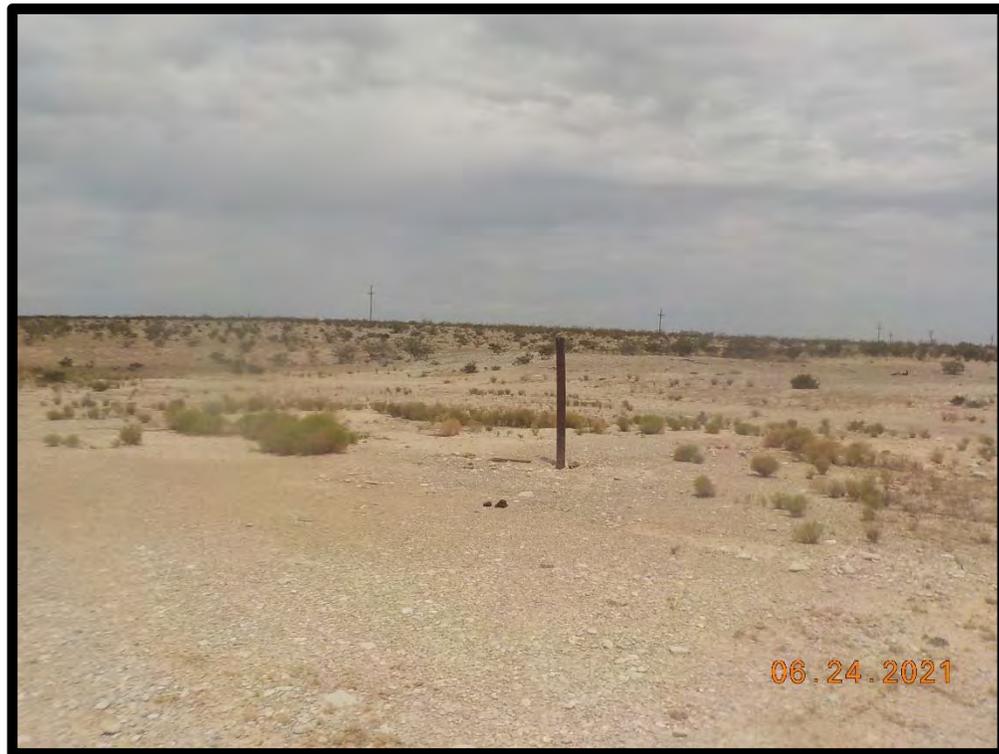
PHOTOGRAPH NO. 2 – A view of the former pit location (right) and soil cut/depression area (left) during the June 24, 2021. The view is from the well pad to the northwest.

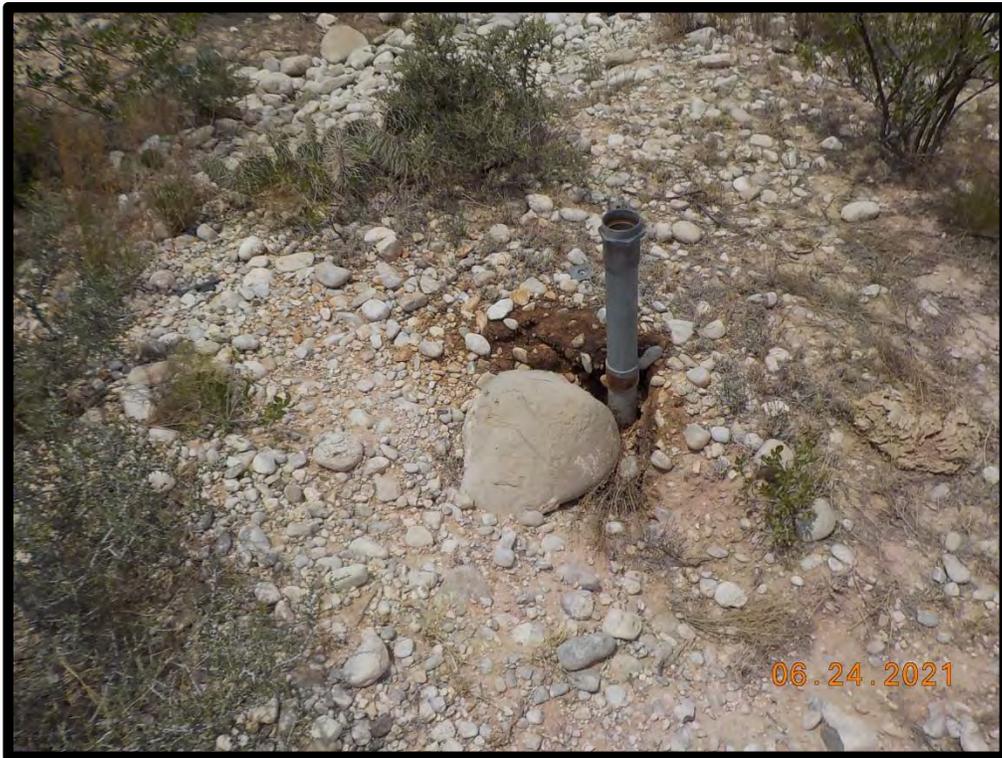
PHOTOGRAPH NO. 3 – A view of the potential impacts in the vicinity of the remaining electrical conduit.

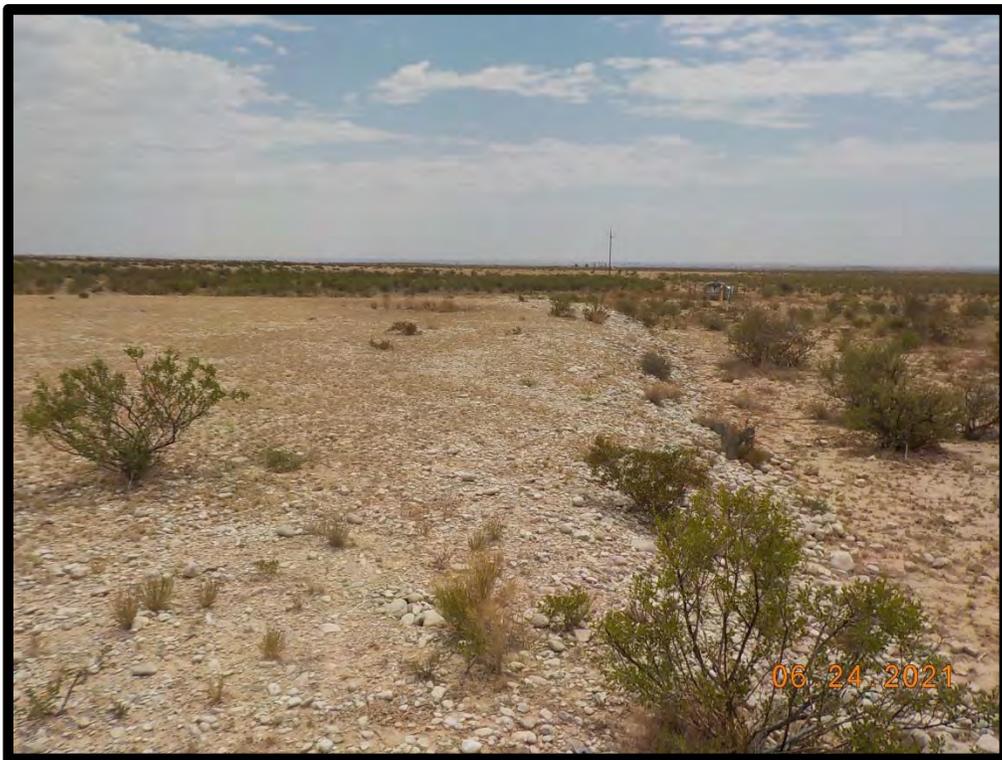
PHOTOGRAPH NO. 4 – A view of the southern pad boundary noted to be raised above the natural grade of the surrounding area. The view is towards the east.
