Vertex Project #: 21E-03819-01

Spill Closure Report: Patterson EL #1 (Section 31, Township 17 South, Range 26 East)
API: 30-015-21606
County: Eddy
Incident Report: nAPP2131355991

2022 Spill Assessment and Closure
March 2022

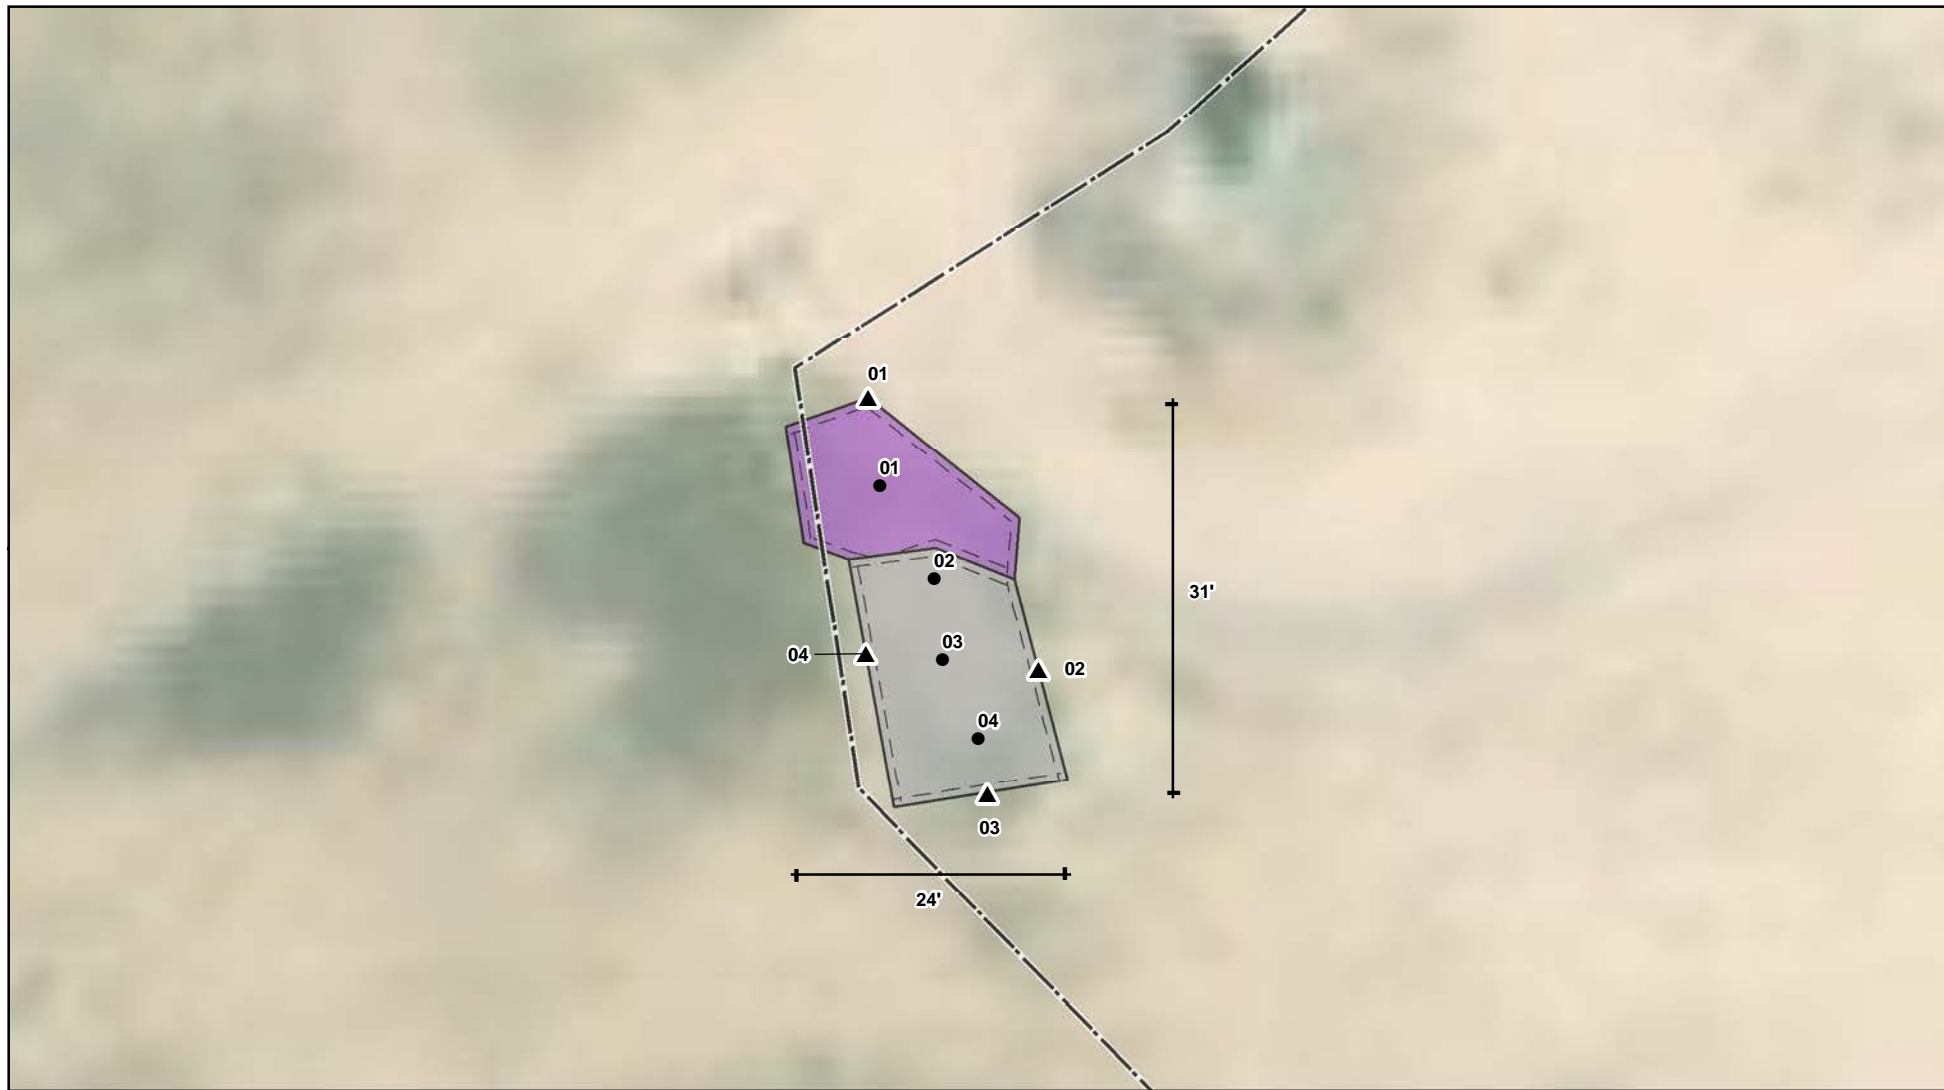
Document Path: G:\1-Projects\US PROJECTS\EOG Resources Inc\21E-03819001 - Patterson EL #1\Figure 2 Confirmatory Schematic Patterson EL #1a.mxd

- Base Sample (Prefixed by "BS21-")
- ▲ Wall Sample (Prefixed by "WS21-")
- Approximate Lease Extent
- ▭ Excavation Extent - to 3' (301 sq. ft.)
- ▭ Excavation Extent - to 3' (196 sq. ft.)

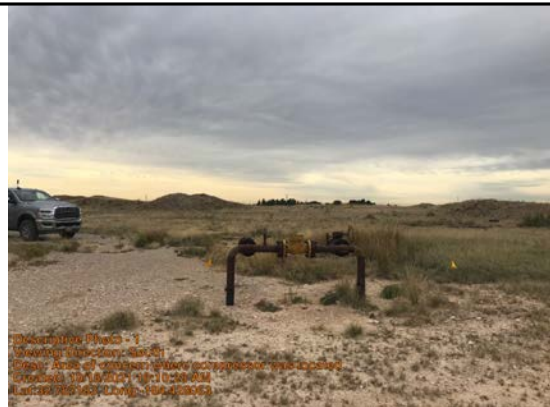
Descriptive Photo - 1
Viewing Direction: South
Dist: Area of concern where compressor was located
Created: 10/18/2021 8:14:04 AM
Lat:33.707144, Long:-104.427058

Area of concern where compressor was located

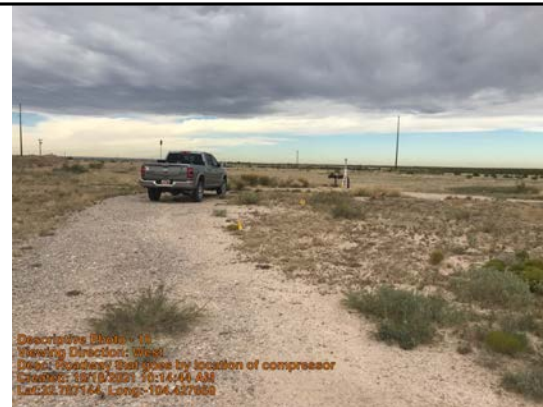
Descriptive Photo - 1a
Viewing Direction: West
Dist: Roadway that goes by location of compressor
Created: 10/18/2021 10:14:44 AM
Lat:33.707144, Long:-104.427058

Roadway that goes by location of compressor

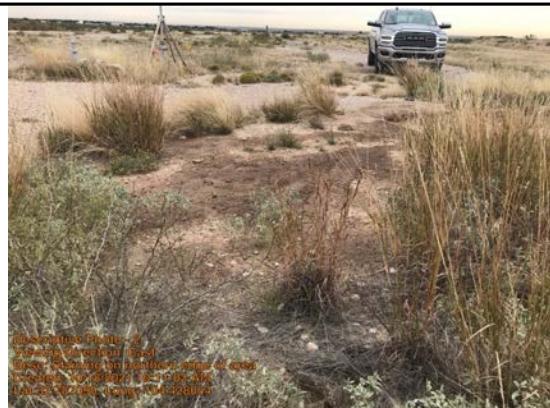
Descriptive Photo - 2
Viewing Direction: East
Dist: Staining on northern edge of area
Created: 10/18/2021 8:15:06 AM
Lat:33.707144, Long:-104.427058

Staining on northern edge of area

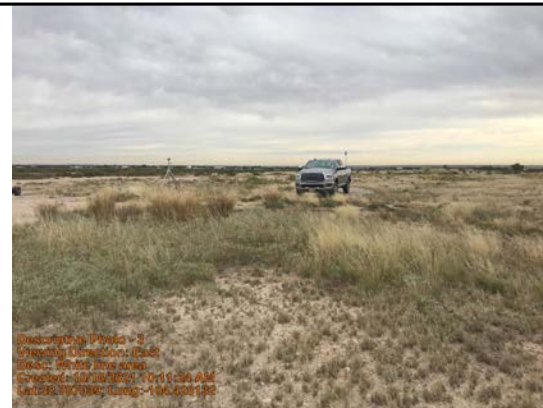
Descriptive Photo - 3
Viewing Direction: East
Dist: White line area
Created: 10/18/2021 10:15:34 AM
Lat:33.707144, Long:-104.427058

White line area

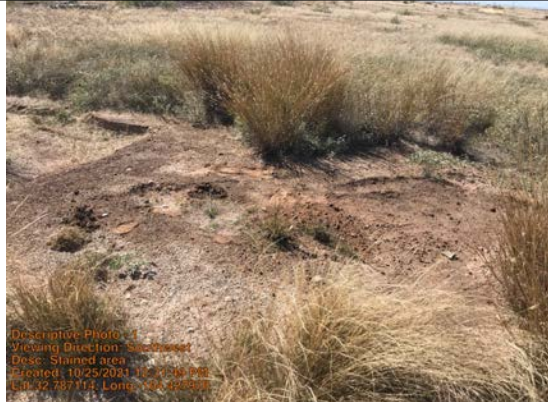
Description Photo - 1
Viewing Direction: Southwest
Desc: Stained area
Created: 10/25/2021 12:41:40 PM
Lat: 32.787114, Long: 104.427895

Stained area

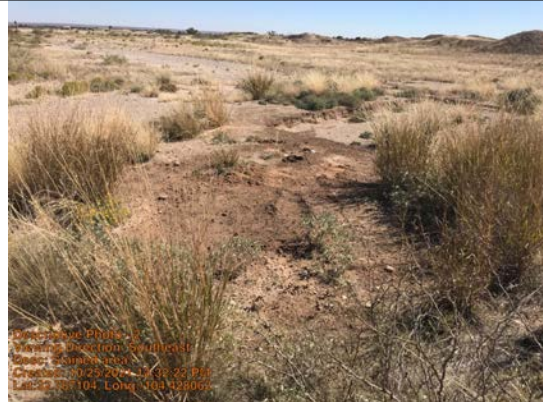
Description Photo - 2
Viewing Direction: Southeast
Desc: Stained area
Created: 10/25/2021 12:42:22 PM
Lat: 32.787104, Long: 104.428069

Stained area

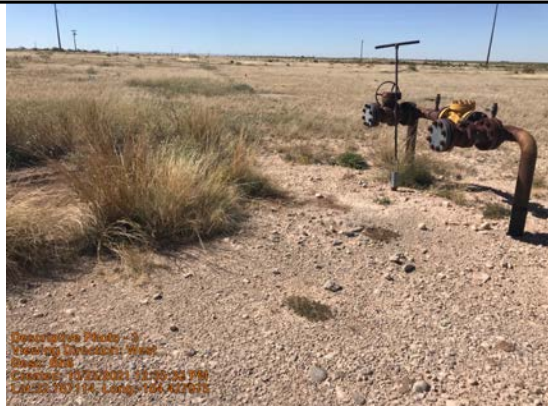
Description Photo - 3
Viewing Direction: West
Desc: BH6
Created: 10/25/2021 12:45:20 PM
Lat: 32.787114, Long: 104.427925

- 8:26** Delineation of site to determine extent of cleanup
- 12:16** Only sample to have any odor is bh5. Seems that I will have a higher reading for MRO over anything else. Stained area is very apparent. Clean up should consist of removing the stained area
- 12:40** Chlorides are not a large issue. Only sample with anything close to being high is around bh6 which could be due to being so close to a pipeline riser

Bh6

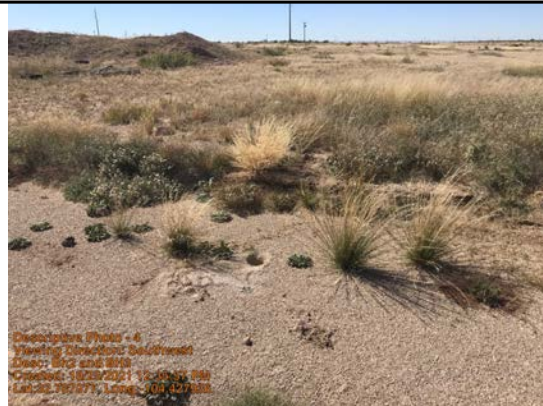
Description Photo - 4
Viewing Direction: Southwest
Desc: BH2 and BH3
Created: 10/25/2021 12:46:21 PM
Lat: 32.787077, Long: 104.427888

Bh2 and BH3

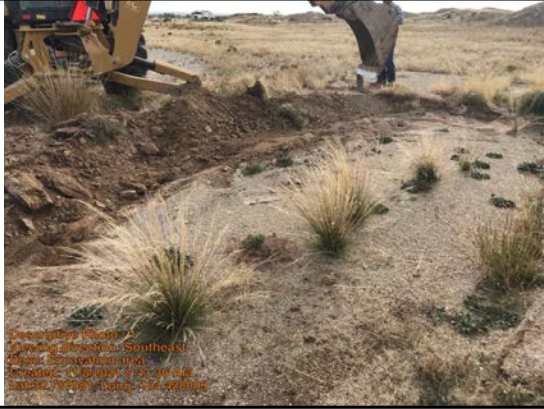
Descriptive Photo - 1
Viewing Direction: Southeast
Depth: Excavation area
Created: 11/8/2021 9:41:30 AM
Lat: 36.787025, Long: -104.481669

- 7:37** Excavation of known contamination around area where compressor was located. Visual staining will be removed and guide with field screening to clean the area
- 8:38** Scraping area to the east south and west 0.5' to remove contamination and excavating the north area where staining is very noticeable
- 10:56** Area dug down to 3 ft where BH21-05 is located and screened. Wall area taken out further due to field screen coming back high
- 11:19** Areas excavated to 0.5' each have a base sample collected to represent the areas
- 12:28** During the removal of the middle area that was clean contamination was found underneath to the north and is being taken out to clean the area. Considering the release reportable after speaking with Bob on the phone
- 13:43** Cleaning gravel out of middle area and field screening so that area will be ready for confirmation sampling

Excavation area

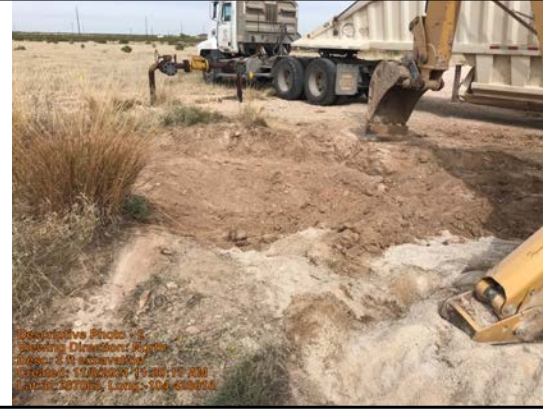
Descriptive Photo - 2
Viewing Direction: North
Depth: 3 ft excavation
Created: 11/8/2021 10:00:15 AM
Lat: 36.787025, Long: -104.481669

3 ft excavation

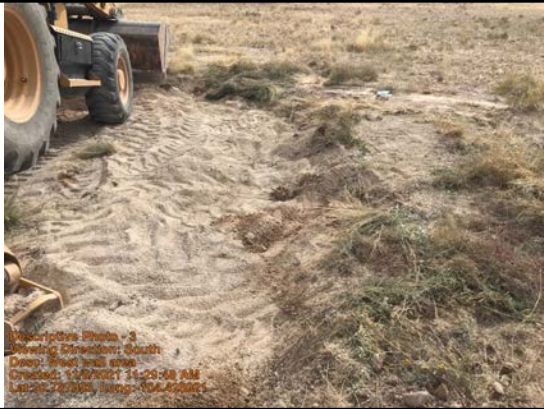
Descriptive Photo - 3
Viewing Direction: South
Depth: West wall area
Created: 11/8/2021 11:29:48 AM
Lat: 36.787025, Long: -104.481669

West wall area

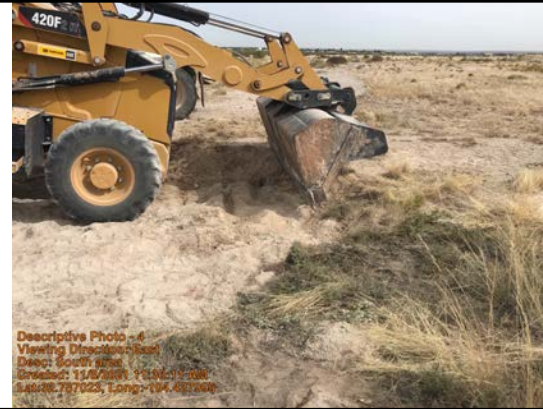
Descriptive Photo - 4
Viewing Direction: East
Depth: South area
Created: 11/8/2021 11:54:19 AM
Lat: 36.787025, Long: -104.481669

South area

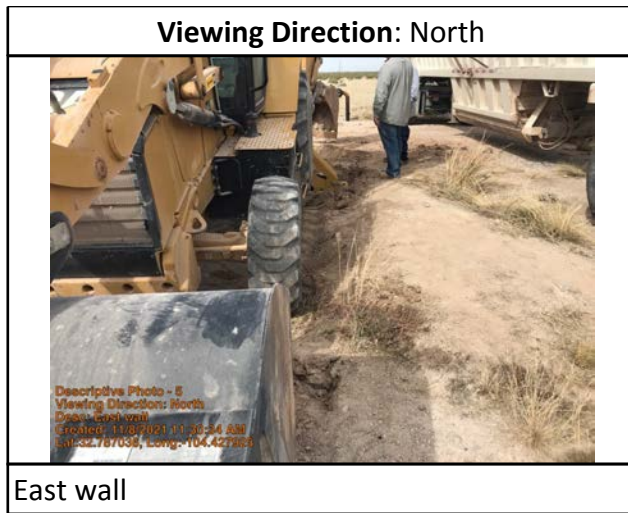
East wall

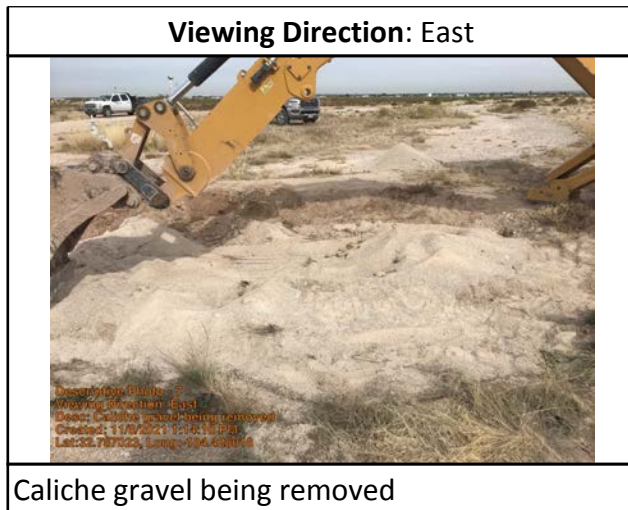
Caliche gravel being removed

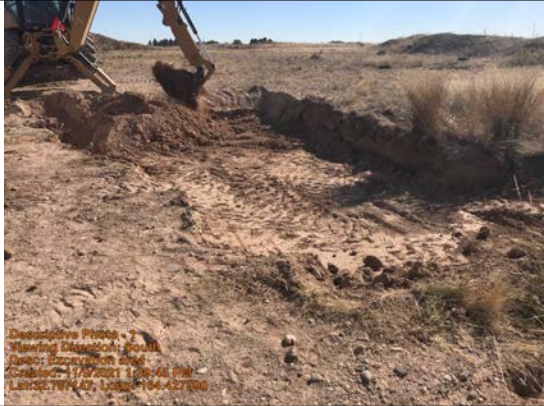
Descriptive Photo - 1
Viewing Direction: South
Desc: Excavation area
Created: 11/9/2021 1:28:46 PM
Lat:32.787047, Long:-104.427896

Excavation area

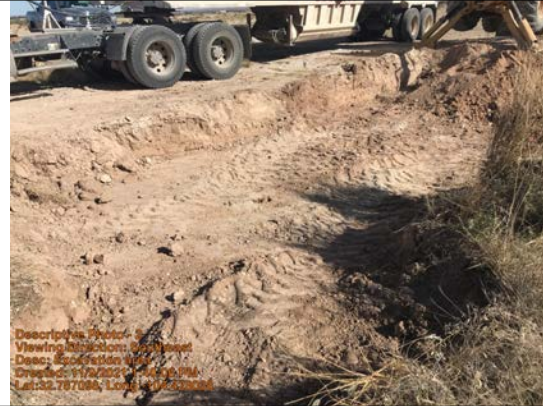
Descriptive Photo - 2
Viewing Direction: Southeast
Desc: Excavation area
Created: 11/9/2021 1:28:46 PM
Lat:32.787046, Long:-104.427896

Excavation area

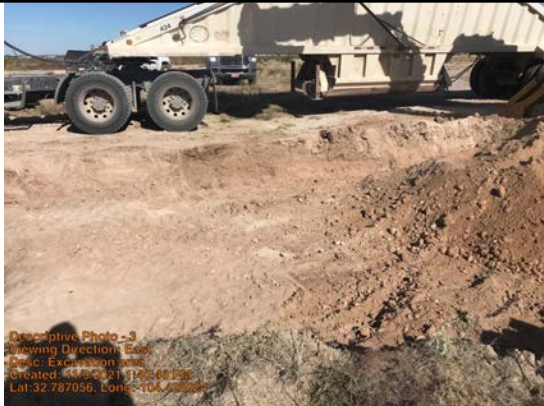
Descriptive Photo - 3
Viewing Direction: East
Desc: Excavation area
Created: 11/9/2021 1:28:46 PM
Lat:32.787056, Long:-104.427896

Excavation area

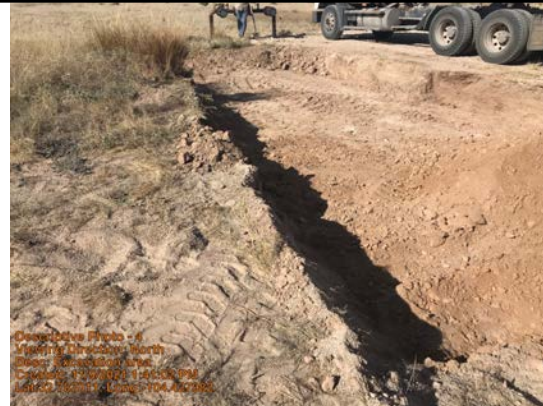
Descriptive Photo - 4
Viewing Direction: North
Desc: Excavation area
Created: 11/9/2021 1:28:46 PM
Lat:32.787047, Long:-104.427896

Excavation area

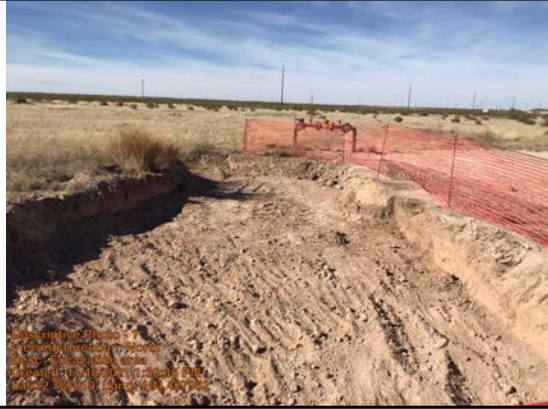
Excavation area

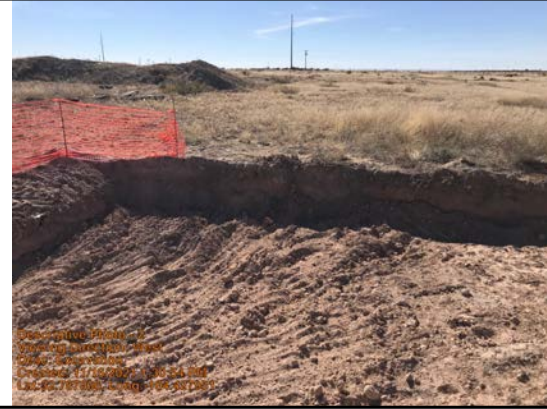
Excavation

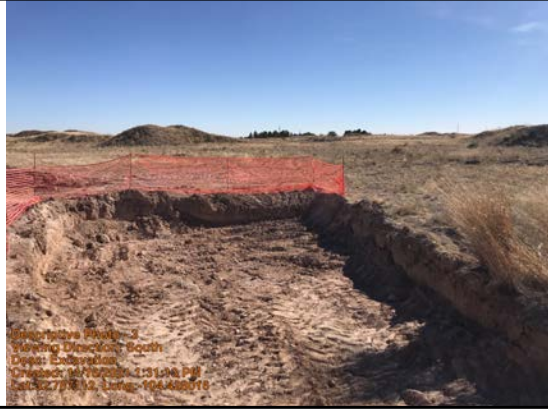
Excavation

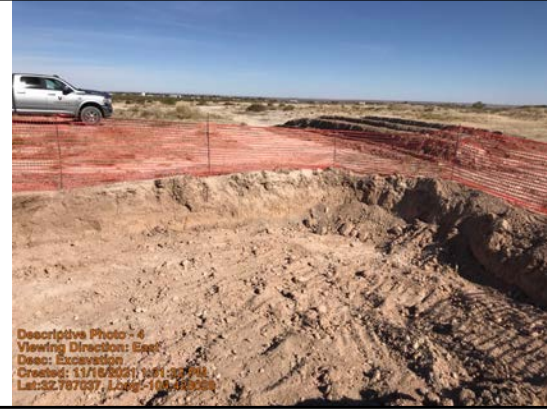
Excavation

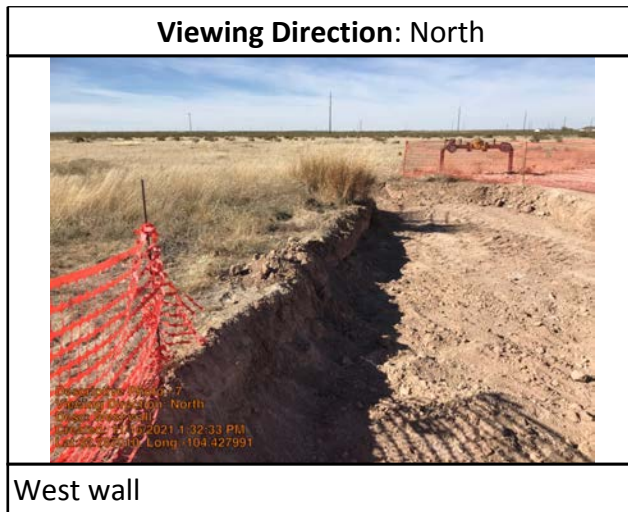
West wall

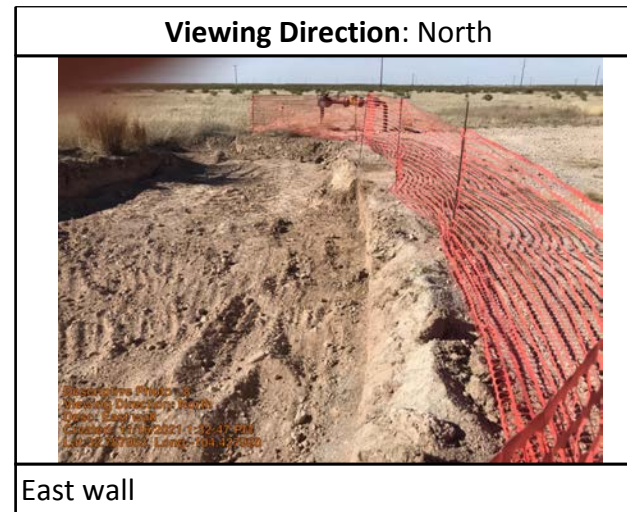
East wall

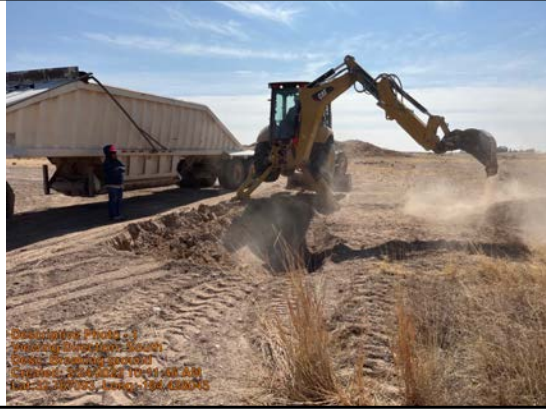
Descriptive Photo - 3
Viewing Direction: South
Date: 2/24/2022 10:34 AM
Created: 2/24/2022 10:34 AM
Lat:33.82973, Long:-105.43273

Breaking ground

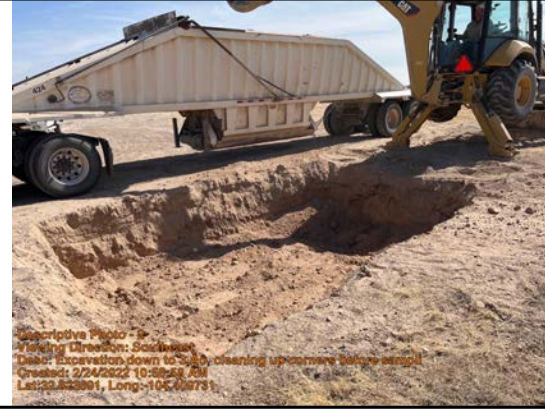
Descriptive Photo - 5
Viewing Direction: Southeast
Date: Excavation down to 3', cleaning up corners before sample
Created: 2/24/2022 10:38 AM
Lat:33.82991, Long:-105.43273

Excavation down to 3', cleaning up corners before sampling

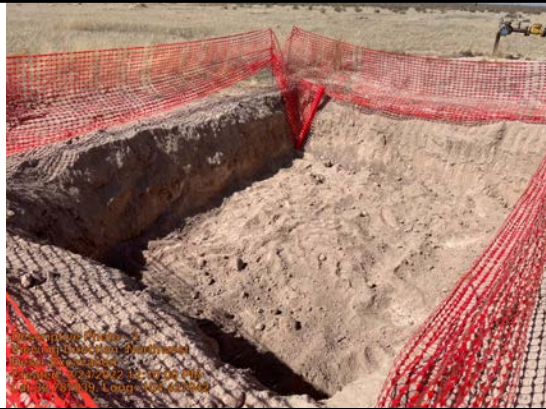
Descriptive Photo - 4
Viewing Direction: Northwest
Date: 2/24/2022 10:34 AM
Created: 2/24/2022 10:34 AM
Lat:33.82973, Long:-105.43273

Excavation

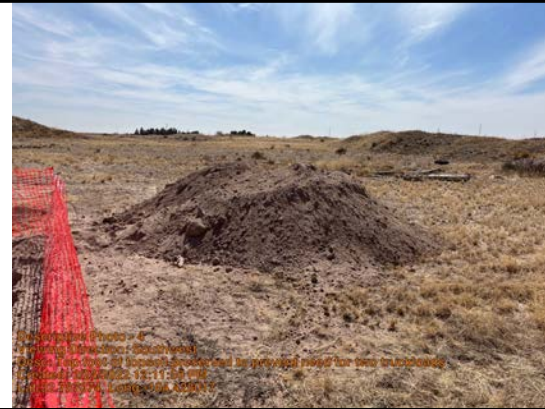
Descriptive Photo - 4
Viewing Direction: Southwest
Date: 2/24/2022 10:34 AM
Created: 2/24/2022 10:34 AM
Lat:33.82973, Long:-105.43273

Additional remediation efforts were completed on February 24, 2022 to assess the area where BS22-03 and BS22-04 were located. An additional foot was excavated to meet the strictest criteria since the area is considered pastureland and original sampling did not meet strictest criteria of the top four feet. Daily field activities can be found in Attachment 3.

Top foot of clean topsoil preserved to prevent need for additional truckloads
