Release Notification RT37G-190906-C-1410

Site Name	Juniper Pipeline release	Site Type	Natural gas gathering
Date Release Discovered	9/5/2019	API# (if applicable)

**RE: Closure Request
Juniper 8 Lateral #3
Incident Numbers nAB1927551697 and nAPP2121158260
Eddy County, New Mexico**

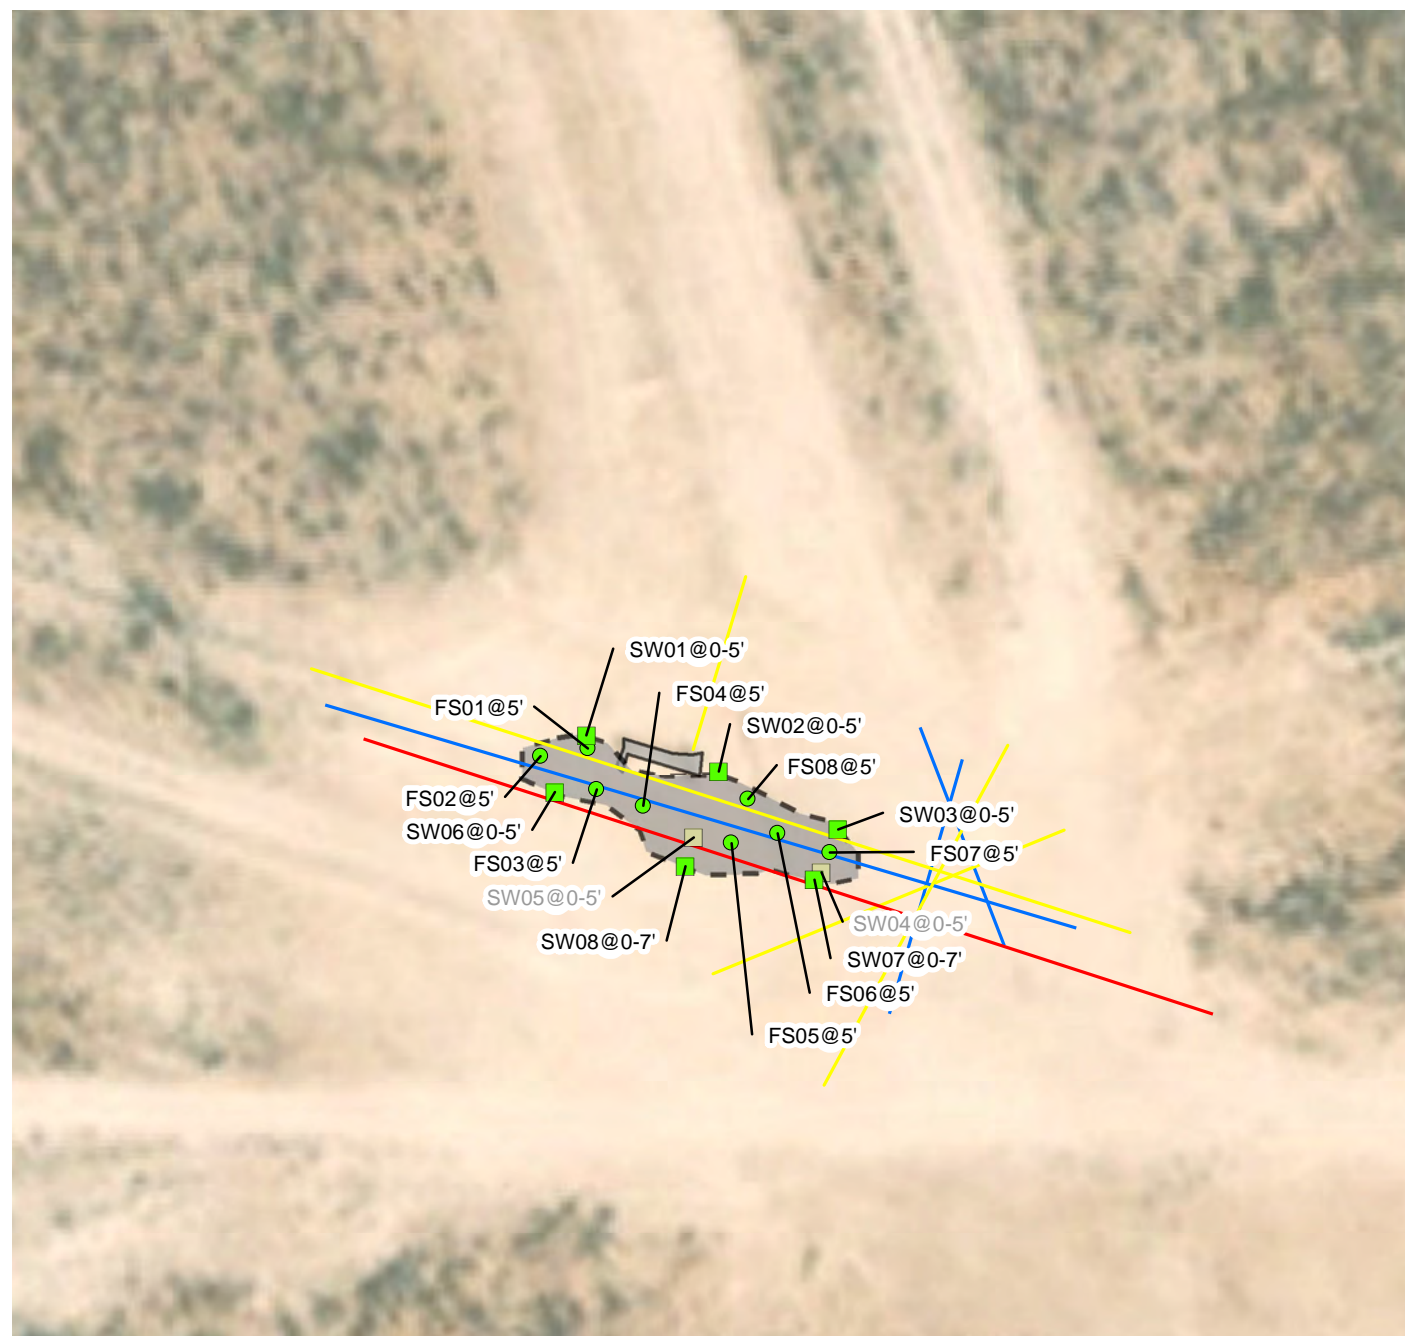
FIGURE 2
EXCAVATION SOIL SAMPLE LOCATIONS
JUNIPER 8" LATERAL #3
UNIT F SEC 3 T24S R29E
EDDY COUNTY, NEW MEXICO
LUCID ENERGY GROUP

5-point composite soil samples at least every 200 square feet from the sidewalls of the excavation. Composite soil samples SW07 and SW08 were collected from the extended sidewalls of the excavation from the ground surface to 7 feet bgs. The excavation soil samples were collected, handled, and analyzed following the same procedures as described above. The final excavation extent and excavation soil sample locations are presented on Figure 3. Photographic documentation is included in Attachment 1.

Based on laboratory analytical results for sidewall confirmation soil samples SW04 and SW05 exceeding the Closure Criteria for chloride, additional excavation appeared warranted to address residual chloride impacts.

On December 28, 2021 WSP returned to the Site to continue excavation activities in the vicinity of sample locations SW04 and SW05. To direct excavation activities, WSP screened soil for volatile aromatic hydrocarbons and chloride. Following removal of impacted soil, WSP collected

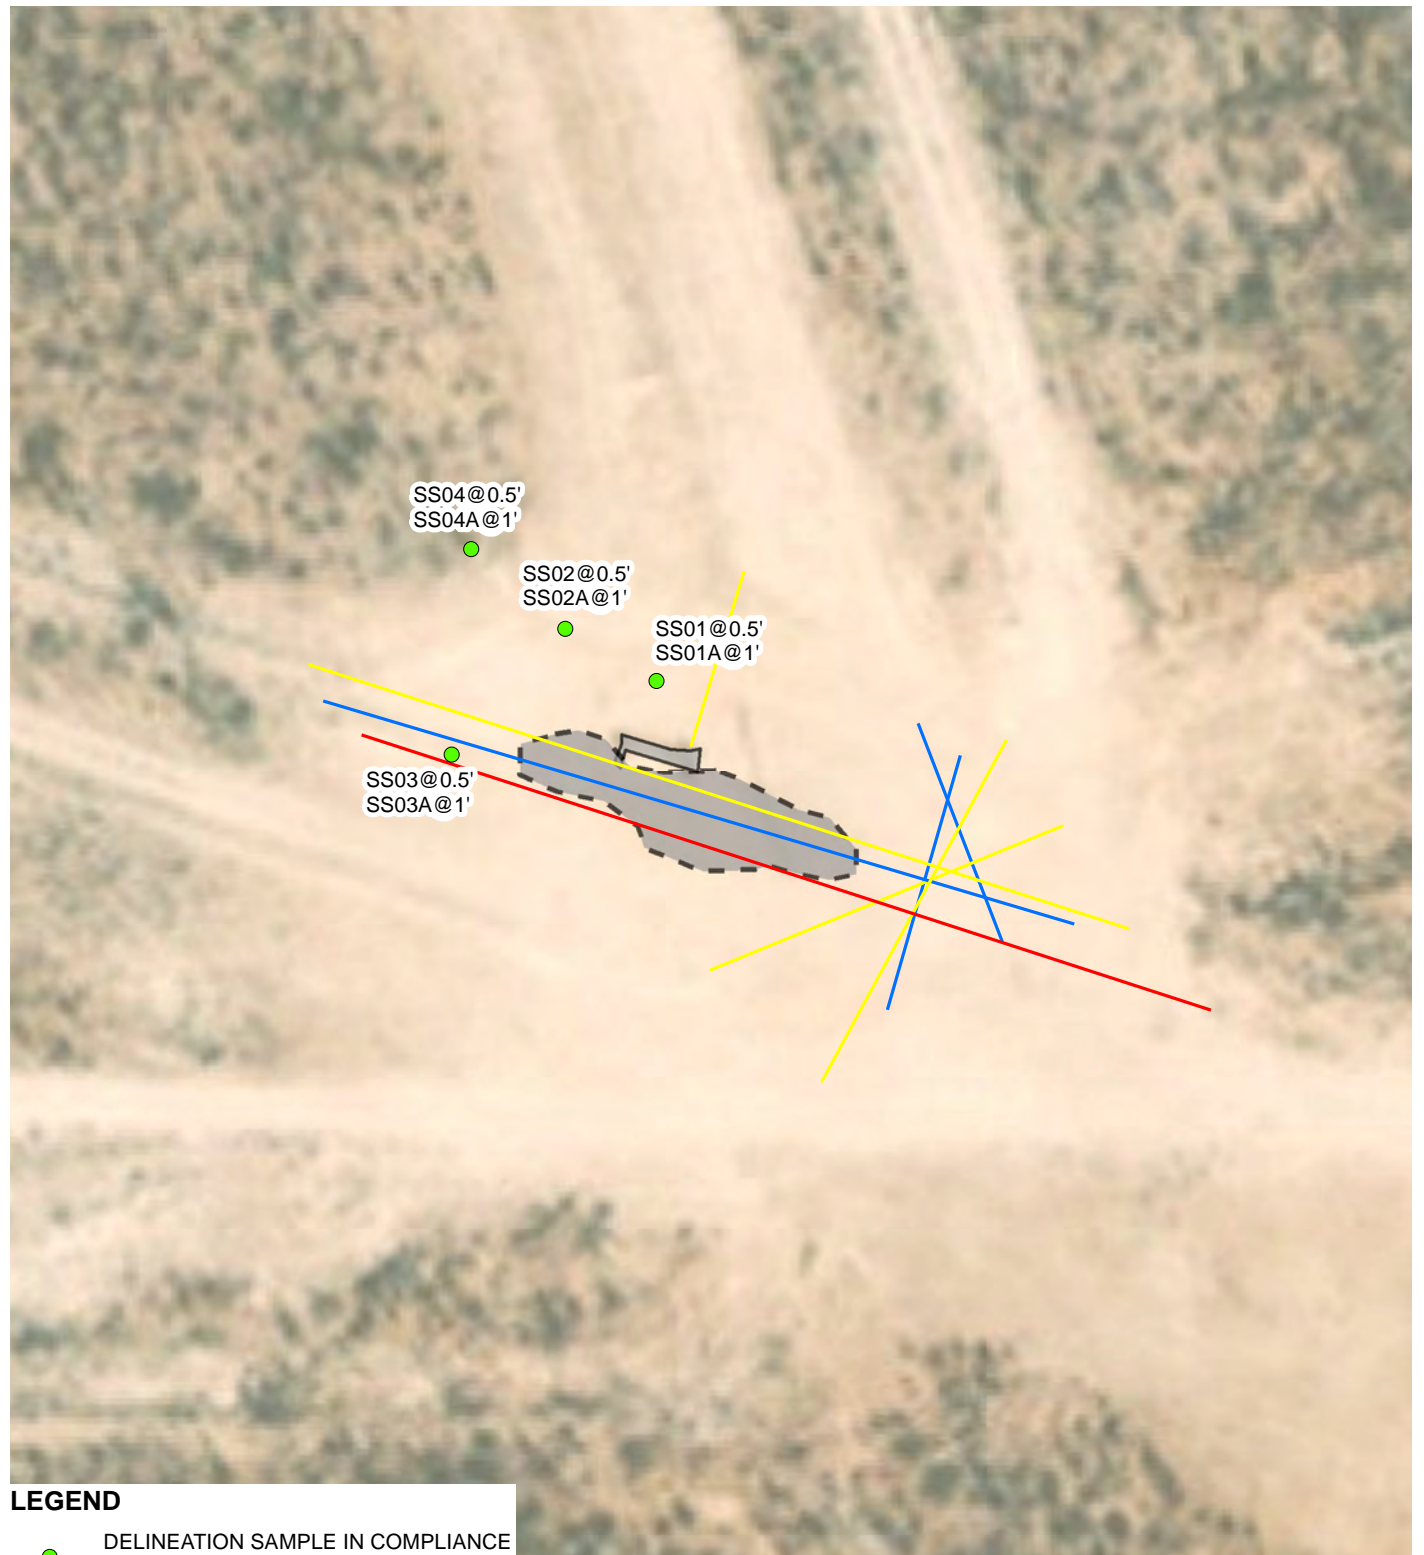
FIGURE 3
DELINEATION SOIL SAMPLE LOCATIONS
 JUNIPER 8" LATERAL #3
 UNIT F SEC 3 T24S R29E
 EDDY COUNTY, NEW MEXICO
LUCID ENERGY GROUP

To address the deficiencies addressed by NMOCD in the September 14, 2021 denial email, WSP personnel conducted delineation activities between December 29 and 30, 2021 to assess the presence or absence of impacts to soil associated with the subject release. Utilizing a hand auger, four delineation soil samples (SS01 through SS04) were advanced in close proximity to the original sample locations¹ to confirm the presence or absence of residual soil impacts from the hydrocarbon mist. Delineation activities were directed by field screening soil samples for volatile aromatic hydrocarbons and chloride. A total of two soil samples were collected from each of the borehole locations: the sample with the highest observed field screening concentrations (approximately 0.5-foot bgs) and the greatest depth (1 foot bgs). The excavation soil samples were collected, handled, and analyzed following the same procedures as described above. The delineation sample locations were mapped utilizing a handheld GPS unit and are presented on Figure 3. Field screening results and observations for the delineation soil samples were recorded on lithologic/soil sampling logs and are presented in Attachment 2.

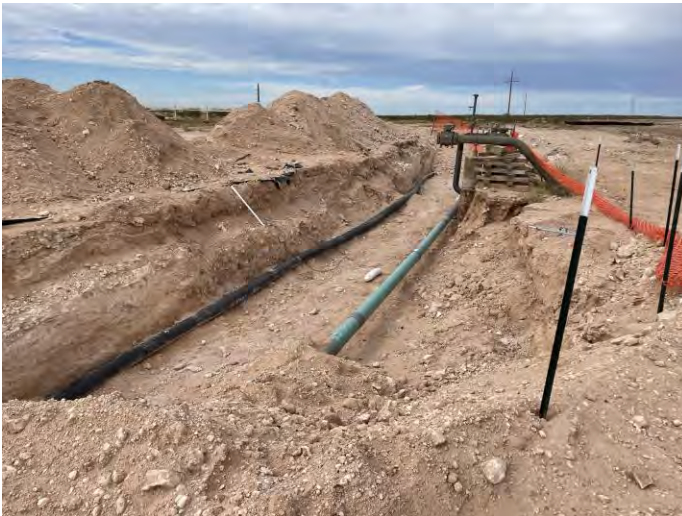
Photo No.	Date	
1	October 18, 2021	
View of the subject excavation during the site assessment

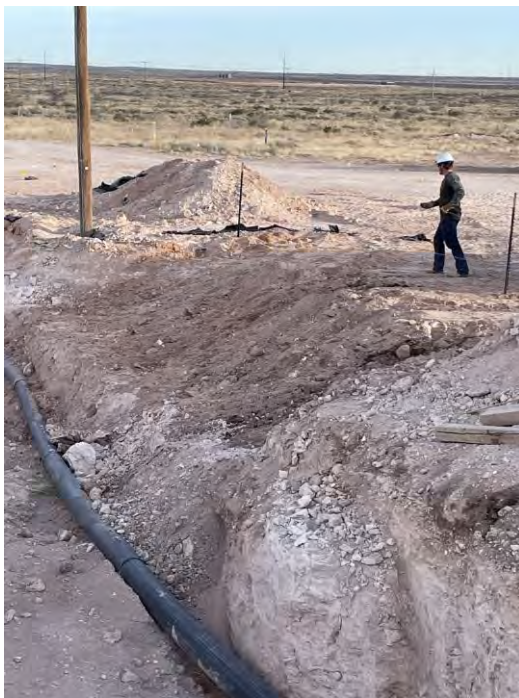
Photo No.	Date	
3	December 28, 2021	
View of the excavation during additional remediation activities.
