CLOSURE REPORT

**State Com M#9R MV (11/11/20)
Unit Letter B, S36 T32N R11W
San Juan County, New Mexico**

NM EMNRD OCD Incident ID No. NRM2032953121

August 9, 2021
Ensolum Project No. 05A1226126

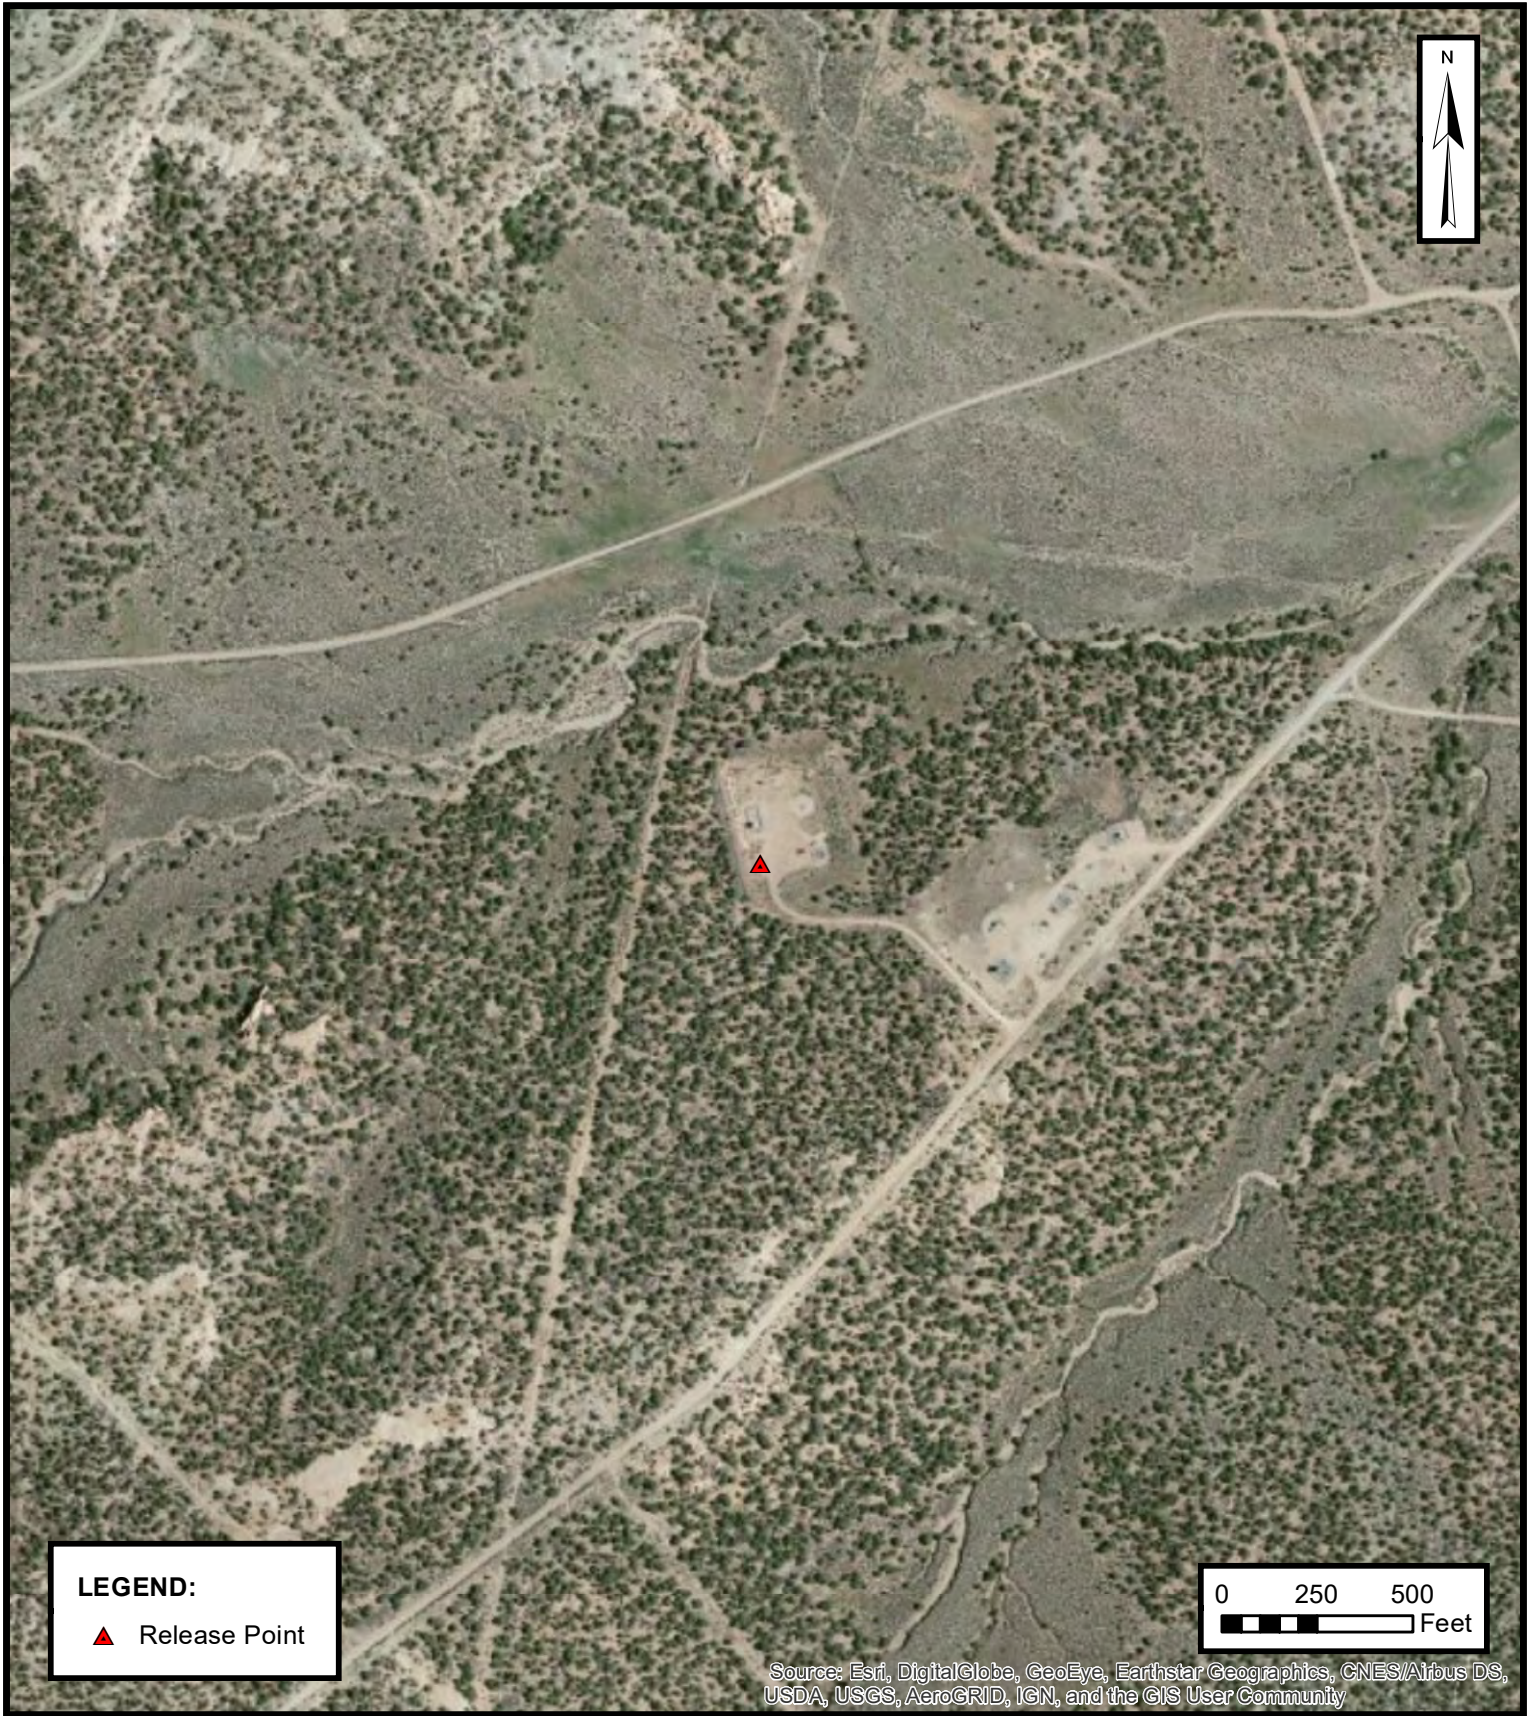
2

SITE VICINITY MAP

A **Topographic Map** depicting the location of the Site is included as **Figure 1**, and a **Site Vicinity Map** is included as **Figure 2** in **Appendix A**.

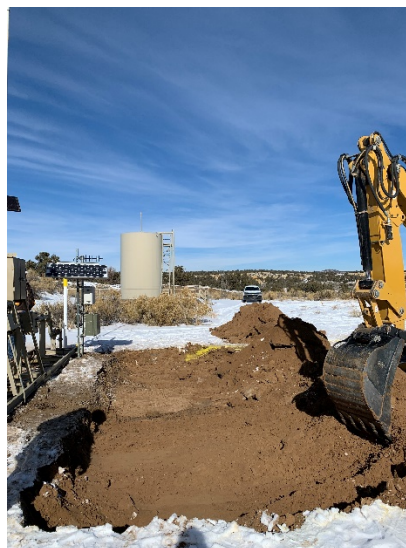
**Photograph 1**

Photograph Description: View of in-process excavation activities.

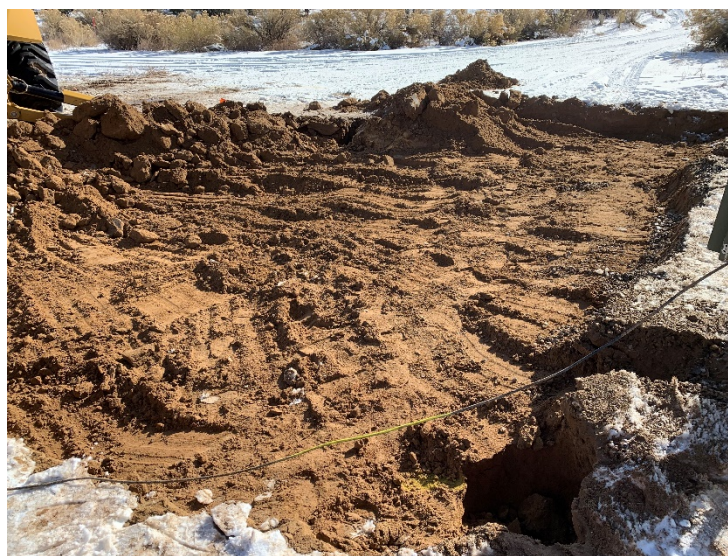
**Photograph 2**

Photograph Description: View of in-process excavation activities.

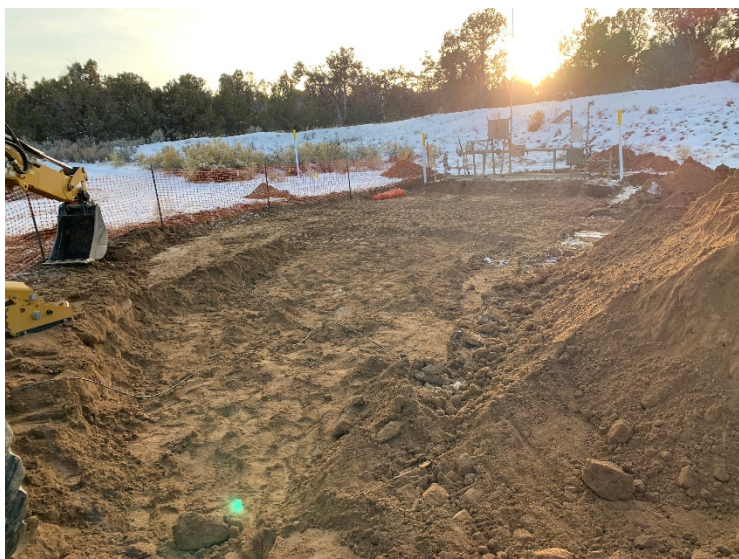
**Photograph 3**

Photograph Description: View of the excavation (first sampling event).

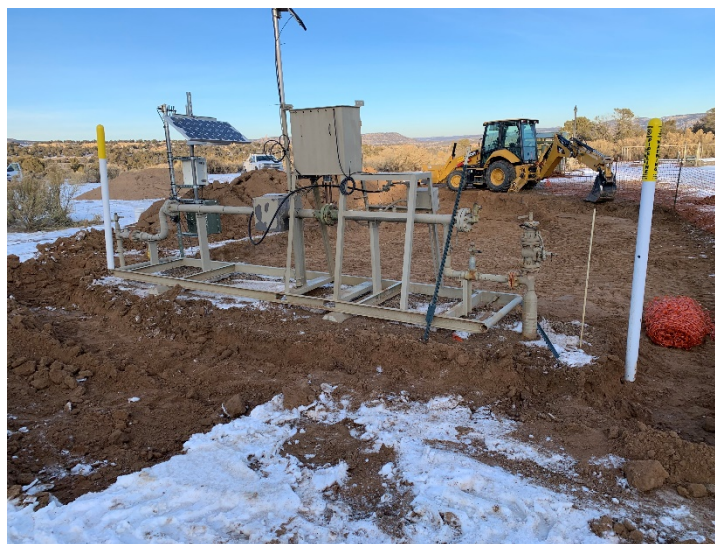
**Photograph 4**

Photograph Description: View of the excavation (first sampling event). The soil under the meter run remained in place. The NM EMNRD OCD approved Enterprise's request to postpone excavation below and surrounding the meter run until weather and ground conditions improved.

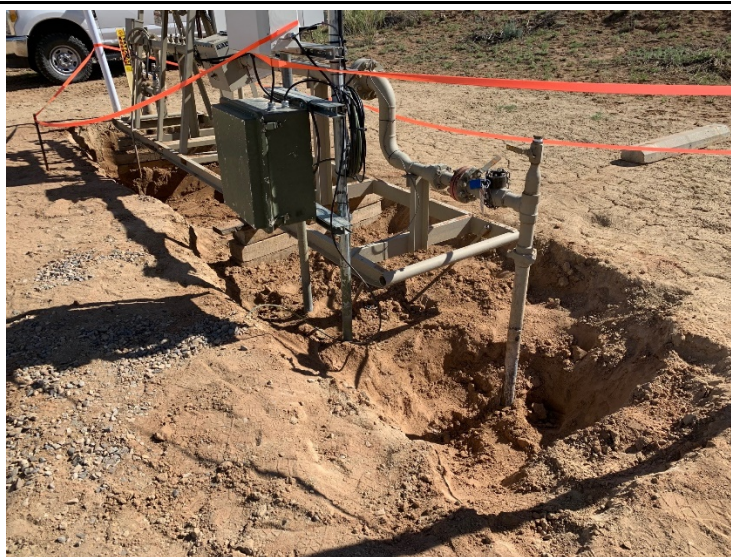
**Photograph 5**

Photograph Description: View of the excavation below and surrounding the meter run (second sampling event).

On June 9, 2021, excavation resumed below and surrounding the meter run. Hand tools were utilized to excavate the soil. After excavation, a second sampling event was performed. The NM EMNRD OCD and the NM SLO were notified of the sampling event although no representatives were present during sampling activities. In an effort to pinpoint the area of heaviest hydrocarbon impact, two composite samples were collected to replace composite soil sample S-6. Composite soil samples S-7 (0'-2') and S-8 (0'-1.5') were collected from the floor and walls of the excavation under the meter run. Subsequent soil analytical results indicated a TPH concentration that exceeded the NM EMNRD OCD closure criteria for sample S-7. In response to the data exceedance, the sample area associated with S-7 was further excavated and the soil was transported to a NM EMNRD OCD-approved landfarm for disposal/remediation.

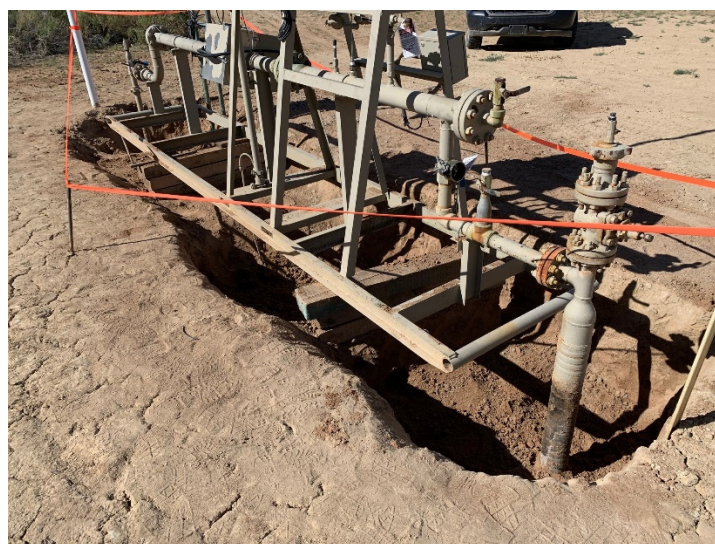
**Photograph 6**

Photograph Description: View of the excavation below and surrounding the meter run (second sampling event).

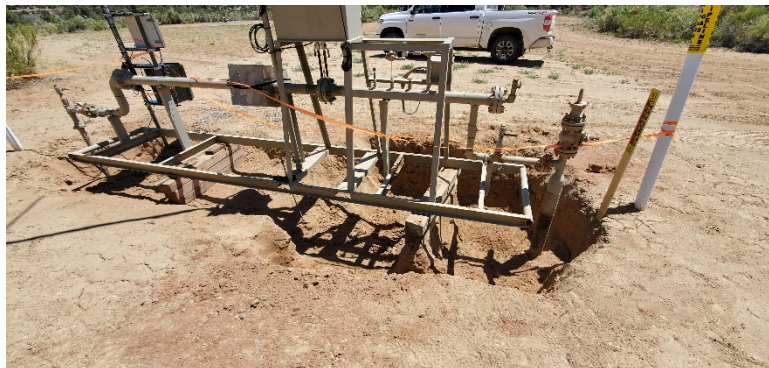
**Photograph 7**

Photograph Description: View of the excavation below and surrounding the meter run (third sampling event).

On July 1, 2021, a third sampling event was performed. The NM EMNRD OCD and the NM SLO were notified of the sampling event although no representatives were present during sampling activities. Composite soil sample S-9 (0'-3') was collected from the floor and walls of the excavation to replace composite soil sample S-7.

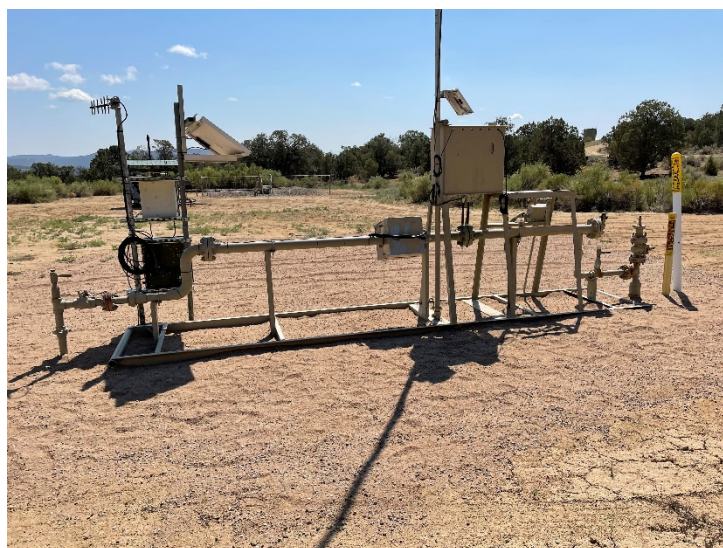
**Photograph 8**

Photograph Description: View of the excavation after initial restoration.

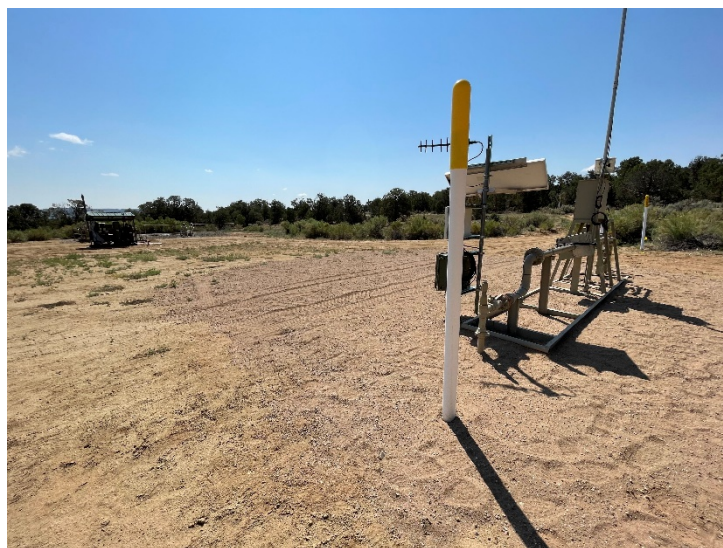
**Photograph 9**

Photograph Description: View of the excavation after initial restoration.
