**Re: Site Assessment, Remediation and Closure Report**  
**Shelby 23 #006H Battery**  
**API No. 30-015-41784**  
**GPS: Latitude 32.6367288 Longitude -104.4490816**  
**UL "A", Sec. 26, T19S, R25E**  
**Eddy County, NM**  
**NMOCD Ref. No. NAPP2113934267**

Pima Environmental Services, LLC. (Pima) has been contracted by Spur Energy Partners, LLC. (Spur) to perform a spill assessment, remediation, and submit this closure report for a produced water release that occurred at the Shelby 23 #006H Battery (Shelby). The initial C-141 was submitted on May 28<sup>th</sup>, 2021 (Appendix C). This incident was assigned Incident ID NAPP2113934267, by the New Mexico Oil Conservation Division (NMOCD).

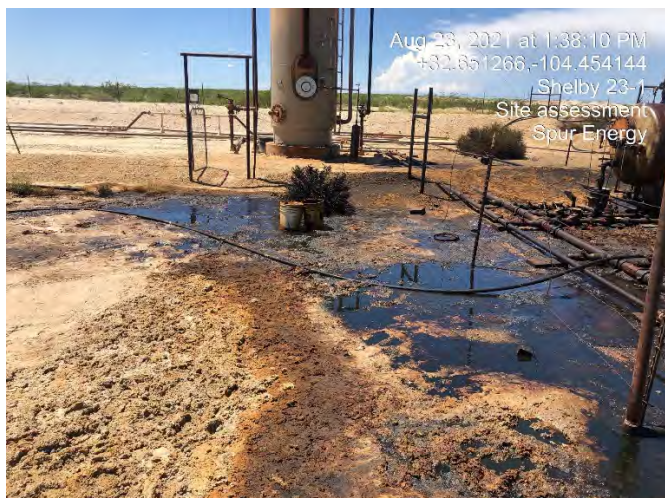
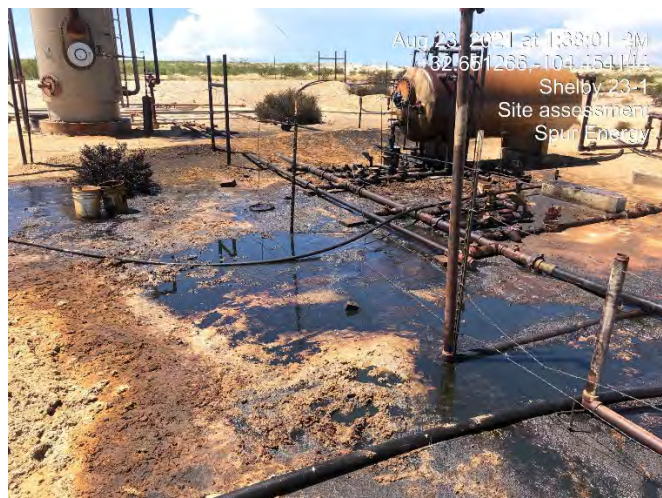
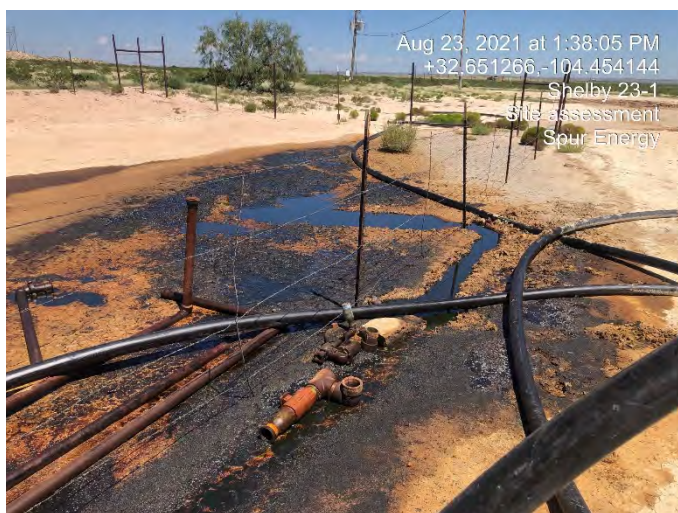
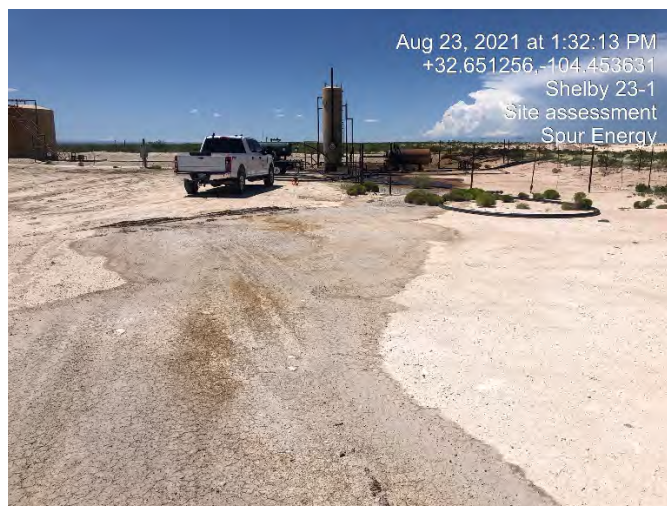
#### Site Assessment

On November 22<sup>nd</sup>, 2021, Pima mobilized personnel and equipment to conduct remedial activities. The following table represents the excavated areas and results of the sampling events at various depths BGS. Bottom and sidewall composite samples were obtained to ensure that the horizontal extents of the contamination had been removed. Photographic documentation can be found in Appendix D.
