CLOSURE REPORT

**Lateral K-51 (11/1/21)
Unit Letter O, S36 T26N R6W
Rio Arriba County, New Mexico**

New Mexico EMNRD OCD Incident ID No. NAPP2130647997

February 2, 2022
Ensolum Project No. 05A1226165

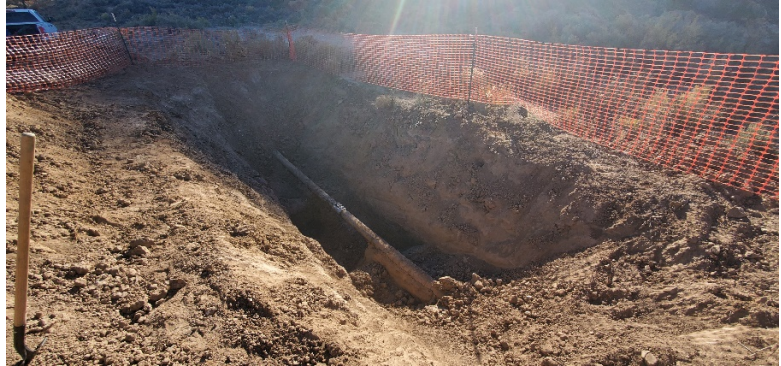
**Photograph 1**

The final excavation measured approximately 15 feet long and 4 feet wide at the maximum extents. The maximum depth of the excavation measured approximately six feet bgs. The lithology encountered during the completion of remediation activities consisted primarily of unconsolidated silty clay.

Photograph Description: View of the final excavation.

Approximately 12 cubic yards of petroleum hydrocarbon affected soil was transported to the Envirotech, Inc. (Envirotech) landfarm near Hilltop, NM for disposal/remediation. The executed C-138 solid waste acceptance form is provided in **Appendix C**. The excavation was backfilled with imported fill and laboratory-confirmed stockpiled soils and was subsequently contoured to the surrounding topography.

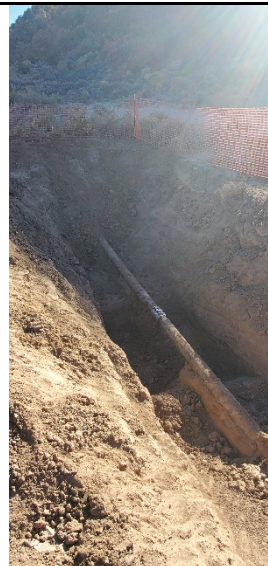
**Photograph 2**

Photograph Description: View of the final excavation.

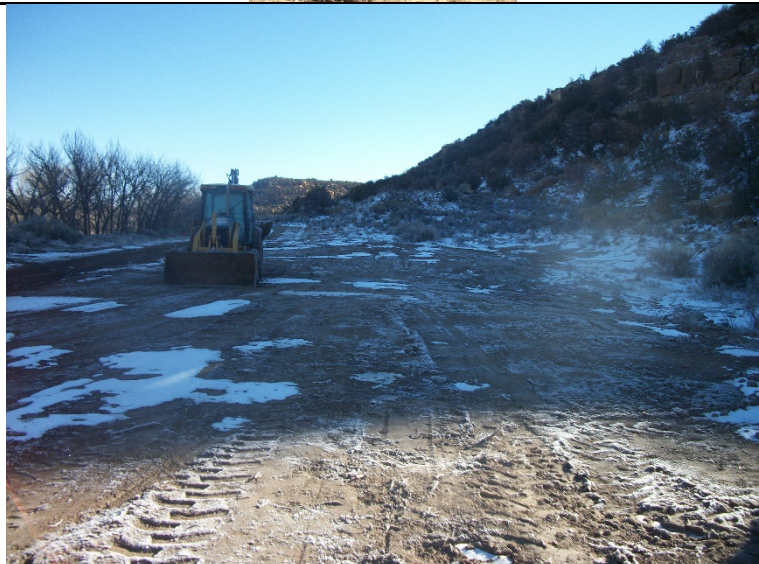
**Photograph 3**

Photograph Description: View of the site after restoration.

The excavation was backfilled with imported fill and laboratory-confirmed stockpiled soil and was then contoured to surrounding grade. Enterprise will re-seed the Site with an approved seeding mixture.
