Re: Site Assessment, Remediation, and Closure Report
Berry A Federal Tank Battery
API No. 30-015-29564
GPS: Latitude 32.8264313 Longitude -103.9787292
UL "C", Sec. 21, T17S, R30E
Eddy County, NM
NMOCD Ref. No. NAPP2115675131

Pima Environmental Services, LLC. (Pima) has been contracted by Spur Energy Partners, LLC. (Spur) to perform a spill assessment and submit this closure report for a produced water release that occurred at the Berry A Federal Tank Battery (Berry). The initial C-141 was submitted on June 14th, 2021 (Appendix C). This incident was assigned Incident ID NAPP2115675131 by the New Mexico Oil Conservation Division (NMOCD).

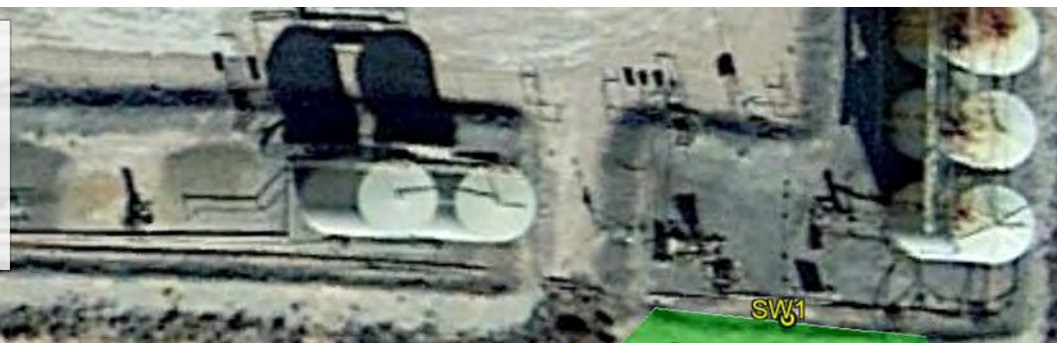
Based on the sample results, the bottom and sidewalls were below NMOCD Closure Criteria 19.15.29 NMAC. The contaminated material was transported to Lea Land, an NMOCD approved disposal site. The excavation was then backfilled with clean like material, machine compacted and contoured to match the surrounding terrain. A confirmation sample map can be found in Figure 5.

- Bottoms
- Section 1
- Section 2
- Section 3
- Section 4
- Section 5
- Sidewalls

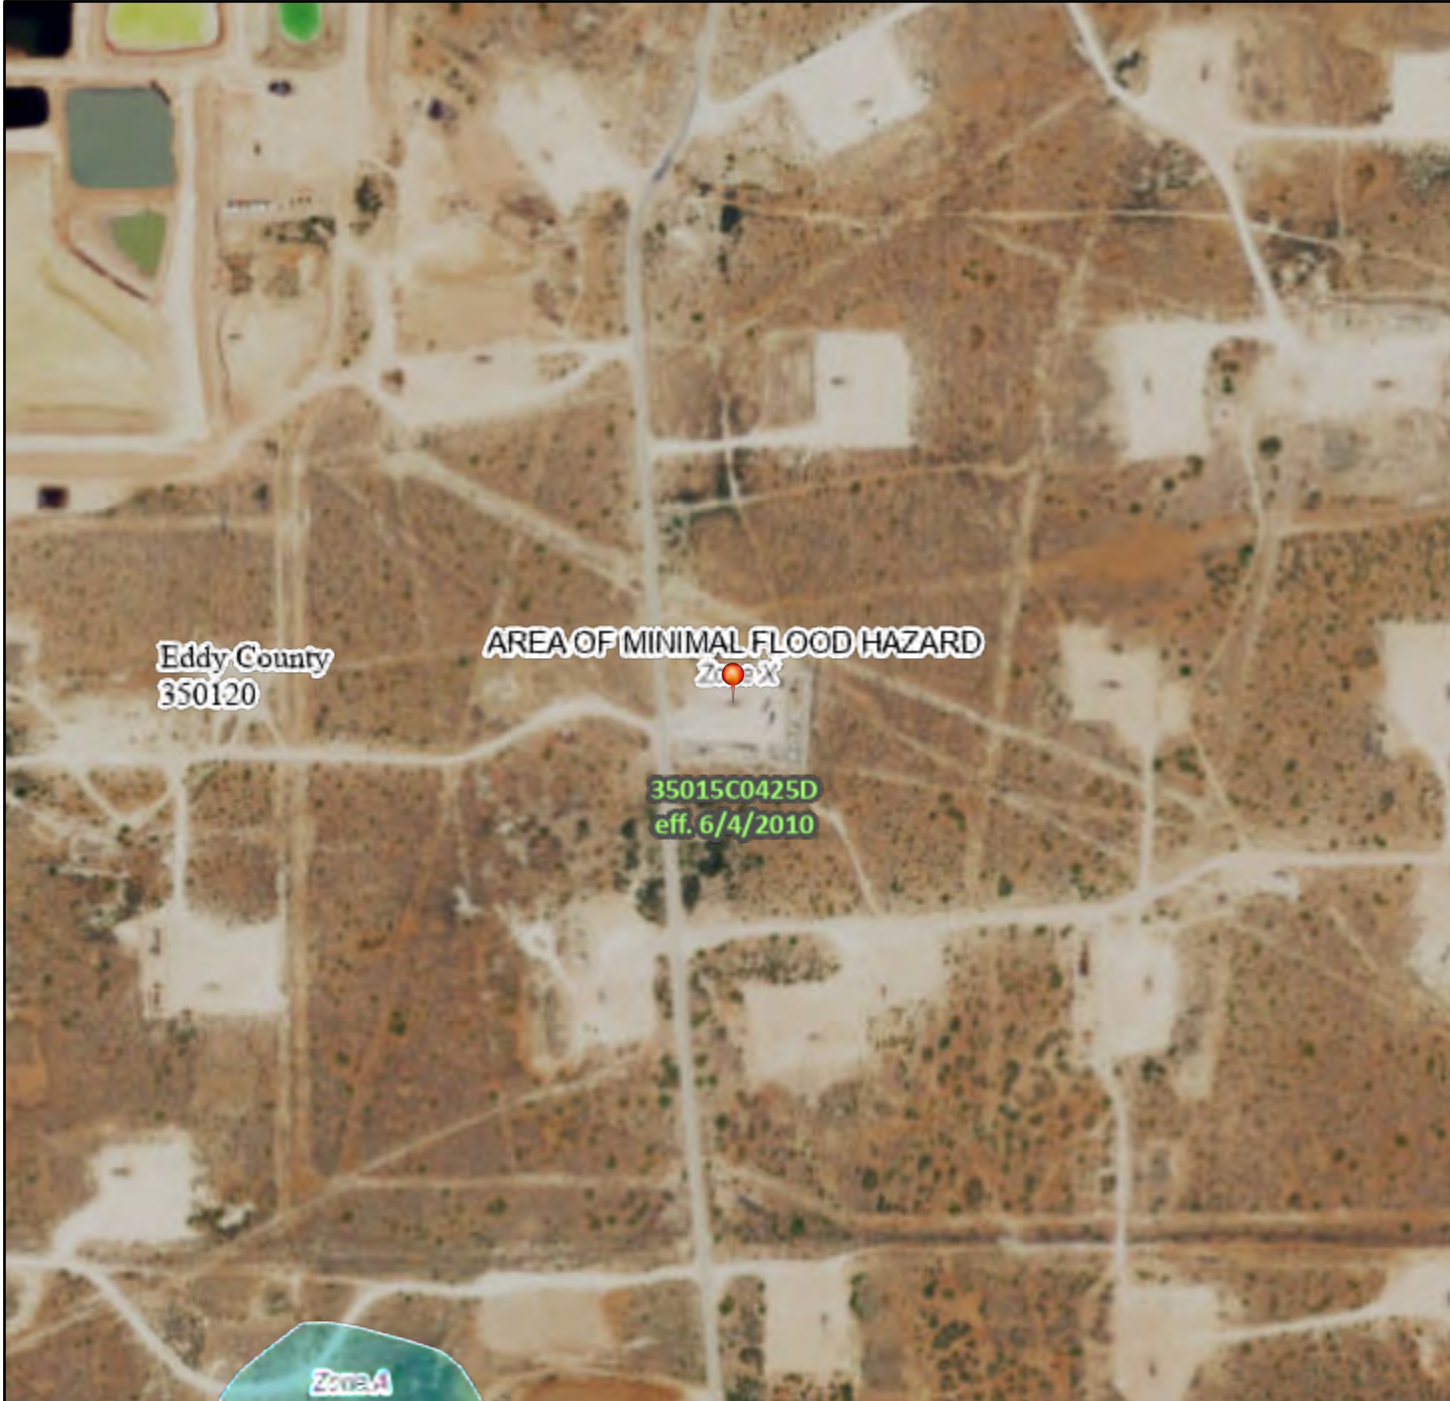
National Flood Hazard Layer FIRMette

The flood hazard information is derived directly from the authoritative NFHL web services provided by FEMA. This map was exported on 6/28/2021 at 9:59 AM and does not reflect changes or amendments subsequent to this date and time. The NFHL and effective information may change or become superseded by new data over time.
