March 28, 2022

Vertex Project #: 22E-00710

Spill Closure Report: Cotton Draw 32 State Federal Com #003H
Unit K, Section 32, Township 24 South, Range 32 East
County: Lea
API: 30-025-41171
Tracking Number: nAPP2205351635

Prepared For: Devon Energy Production Company
6488 Seven Rivers Highway
Artesia, New Mexico 88210

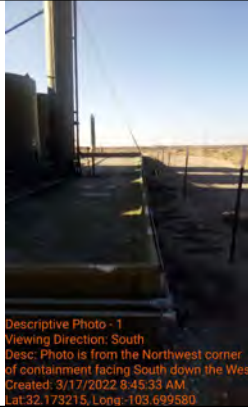
Viewing Direction: South

Photo is from the Northwest corner of containment facing South looking down the West side wall.

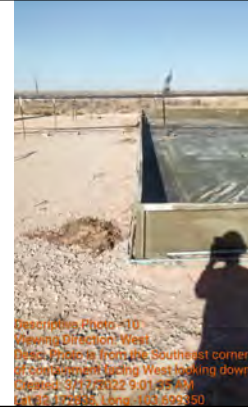
Viewing Direction: West

Photo is from the Southeast corner of containment facing West looking down the South wall.

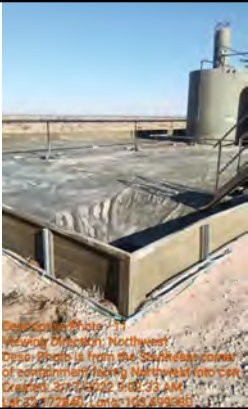
<p>Viewing Direction: Northwest</p>

<p>Descriptive Photo - 11 Viewing Direction: Northwest Desc: Photo is from the Southeast corner of containment facing Northwest into containment. Created: 3/17/2022 9:03:33 AM Lat: 32.172845 Long: -103.699646</p> <p>Photo is from the Southeast corner of containment facing Northwest into containment.</p>	<p>Viewing Direction: Southeast</p>

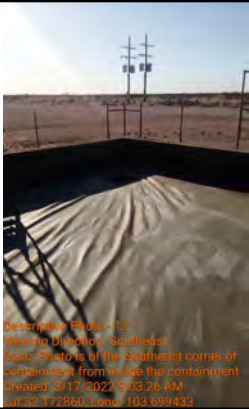
<p>Descriptive Photo - 12 Viewing Direction: Southeast Desc: Photo is of the Southeast corner of containment from inside the containment. Created: 3/17/2022 9:03:26 AM Lat: 32.172845 Long: -103.699646</p> <p>Photo is of the Southeast corner of containment from inside the containment.</p>
<p>Viewing Direction: North</p>

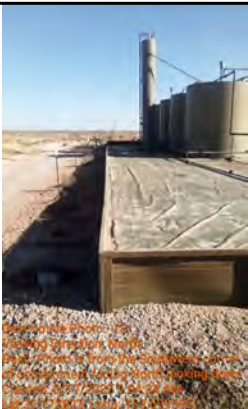
<p>Descriptive Photo - 13 Viewing Direction: North Desc: Photo is from the Southwest corner of containment facing North looking down the West wall. Created: 3/17/2022 9:05:38 AM Lat: 32.172845 Long: -103.699646</p> <p>Photo is from the Southwest corner of containment facing North looking down the West wall.</p>	<p>Viewing Direction: East</p>

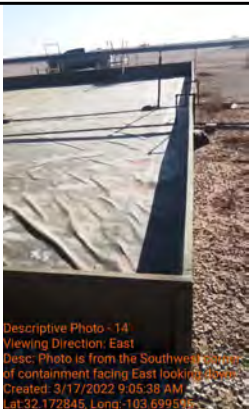
<p>Descriptive Photo - 14 Viewing Direction: East Desc: Photo is from the Southwest corner of containment facing East looking down the South wall. Created: 3/17/2022 9:05:38 AM Lat: 32.172845 Long: -103.699646</p> <p>Photo is from the Southwest corner of containment facing East looking down the South wall.</p>

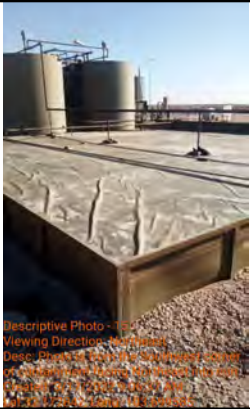
<p>Viewing Direction: Northeast</p>

<p>Descriptive Photo - 15 Viewing Direction: Northeast Desc: Photo is from the Southwest corner of containment facing Northeast into containment. Created: 3/17/2022 9:07:57 AM Lat: 32.173092 Long: 103.699507</p> <p>Photo is from the Southwest corner of containment facing Northeast into containment.</p>	<p>Viewing Direction: Southwest</p>

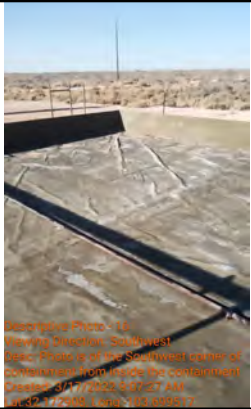
<p>Descriptive Photo - 16 Viewing Direction: Southwest Desc: Photo is of the Southwest corner of containment from inside the containment. Created: 3/17/2022 9:07:57 AM Lat: 32.173092 Long: 103.699507</p> <p>Photo is of the Southwest corner of containment from inside the containment.</p>
<p>Viewing Direction: South</p>

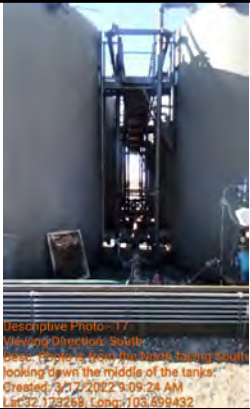
<p>Descriptive Photo - 17 Viewing Direction: South Desc: Photo is from the North facing South looking down the middle of the tanks. Created: 3/17/2022 9:09:24 AM Lat: 32.173092 Long: 103.699507</p> <p>Photo is from the North facing South looking down the middle of the tanks.</p>	<p>Viewing Direction: West</p>

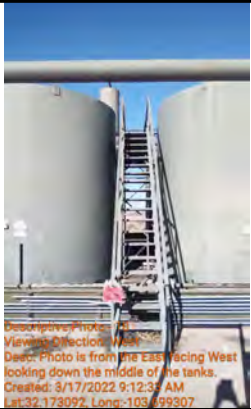
<p>Descriptive Photo - 18 Viewing Direction: West Desc: Photo is from the East facing West looking down the middle of the tanks. Created: 3/17/2022 9:12:35 AM Lat: 32.173092 Long: 103.699507</p> <p>Photo is from the East facing West looking down the middle of the tanks.</p>

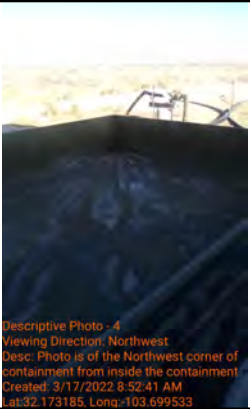
<p>Viewing Direction: Northwest</p>

<p>Descriptive Photo - 4 Viewing Direction: Northwest Desc: Photo is of the Northwest corner of containment from inside the containment. Created: 3/17/2022 8:52:41 AM Lat: 32.173185, Long: -103.699533</p> <p>Photo is of the Northwest corner of containment from inside the containment.</p>	<p>Viewing Direction: South</p>

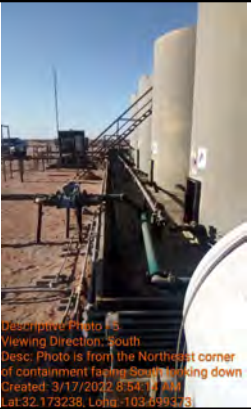
<p>Descriptive Photo - 5 Viewing Direction: South Desc: Photo is from the Northeast corner of containment facing South looking down the East side wall. Created: 3/17/2022 8:54:17 AM Lat: 32.173238, Long: -103.699428</p> <p>Photo is from the Northeast corner of containment facing South looking down the East side wall.</p>
<p>Viewing Direction: West</p>

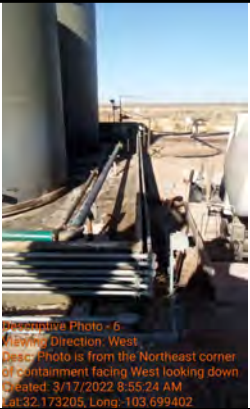
<p>Descriptive Photo - 6 Viewing Direction: West Desc: Photo is from the Northeast corner of containment facing West looking down the North wall. Created: 3/17/2022 8:55:24 AM Lat: 32.173205, Long: -103.699402</p> <p>Photo is from the Northeast corner of containment facing West looking down the North wall.</p>	<p>Viewing Direction: Southwest</p>

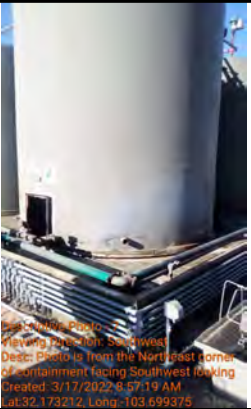
<p>Descriptive Photo - 7 Viewing Direction: Southwest Desc: Photo is from the Northeast corner of containment facing Southwest looking into containment. Created: 3/17/2022 8:57:19 AM Lat: 32.173212, Long: -103.699375</p> <p>Photo is from the Northeast corner of containment facing Southwest looking into containment.</p>

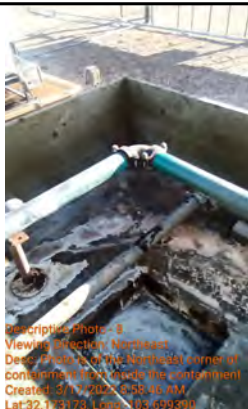
Viewing Direction: Northeast

Photo is of the Northeast corner of containment from inside the containment.

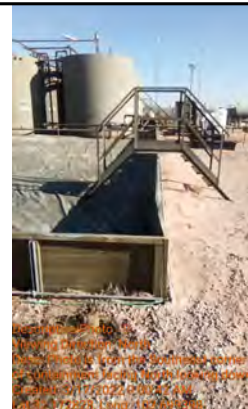
Viewing Direction: North

Photo is from the Southeast corner of containment facing North looking down the East wall.

10:52 On 03/17/2022 I completed a liner inspection for #nAPP2205351635. The liner appeared to be in good overall condition. There was only one area where the lining hadn't fully sealed around the bolt. This area was approximately 6 inches off the ground and the metal sidewall was not compromised. It was located on the East wall near oil tank #3 SN: 1-19404.

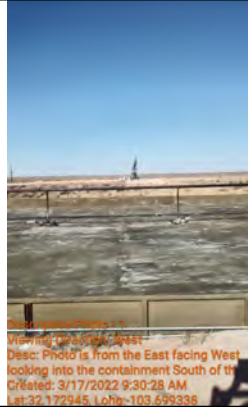
Viewing Direction: West

Photo is from the East facing West looking into the containment on the South side of the tanks.

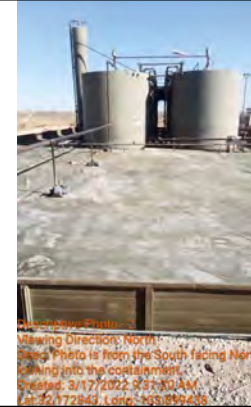
Viewing Direction: North

Photo is from the South facing North looking into the containment on the South side of the tanks.
