Release Notification

CLOSURE REPORT

**Frances Mesa Compressor Station (July 2020)
SW 1/4, S27 T30N R7W
Rio Arriba County, New Mexico**

October 7, 2020
Ensolum Project No. 05A1226112

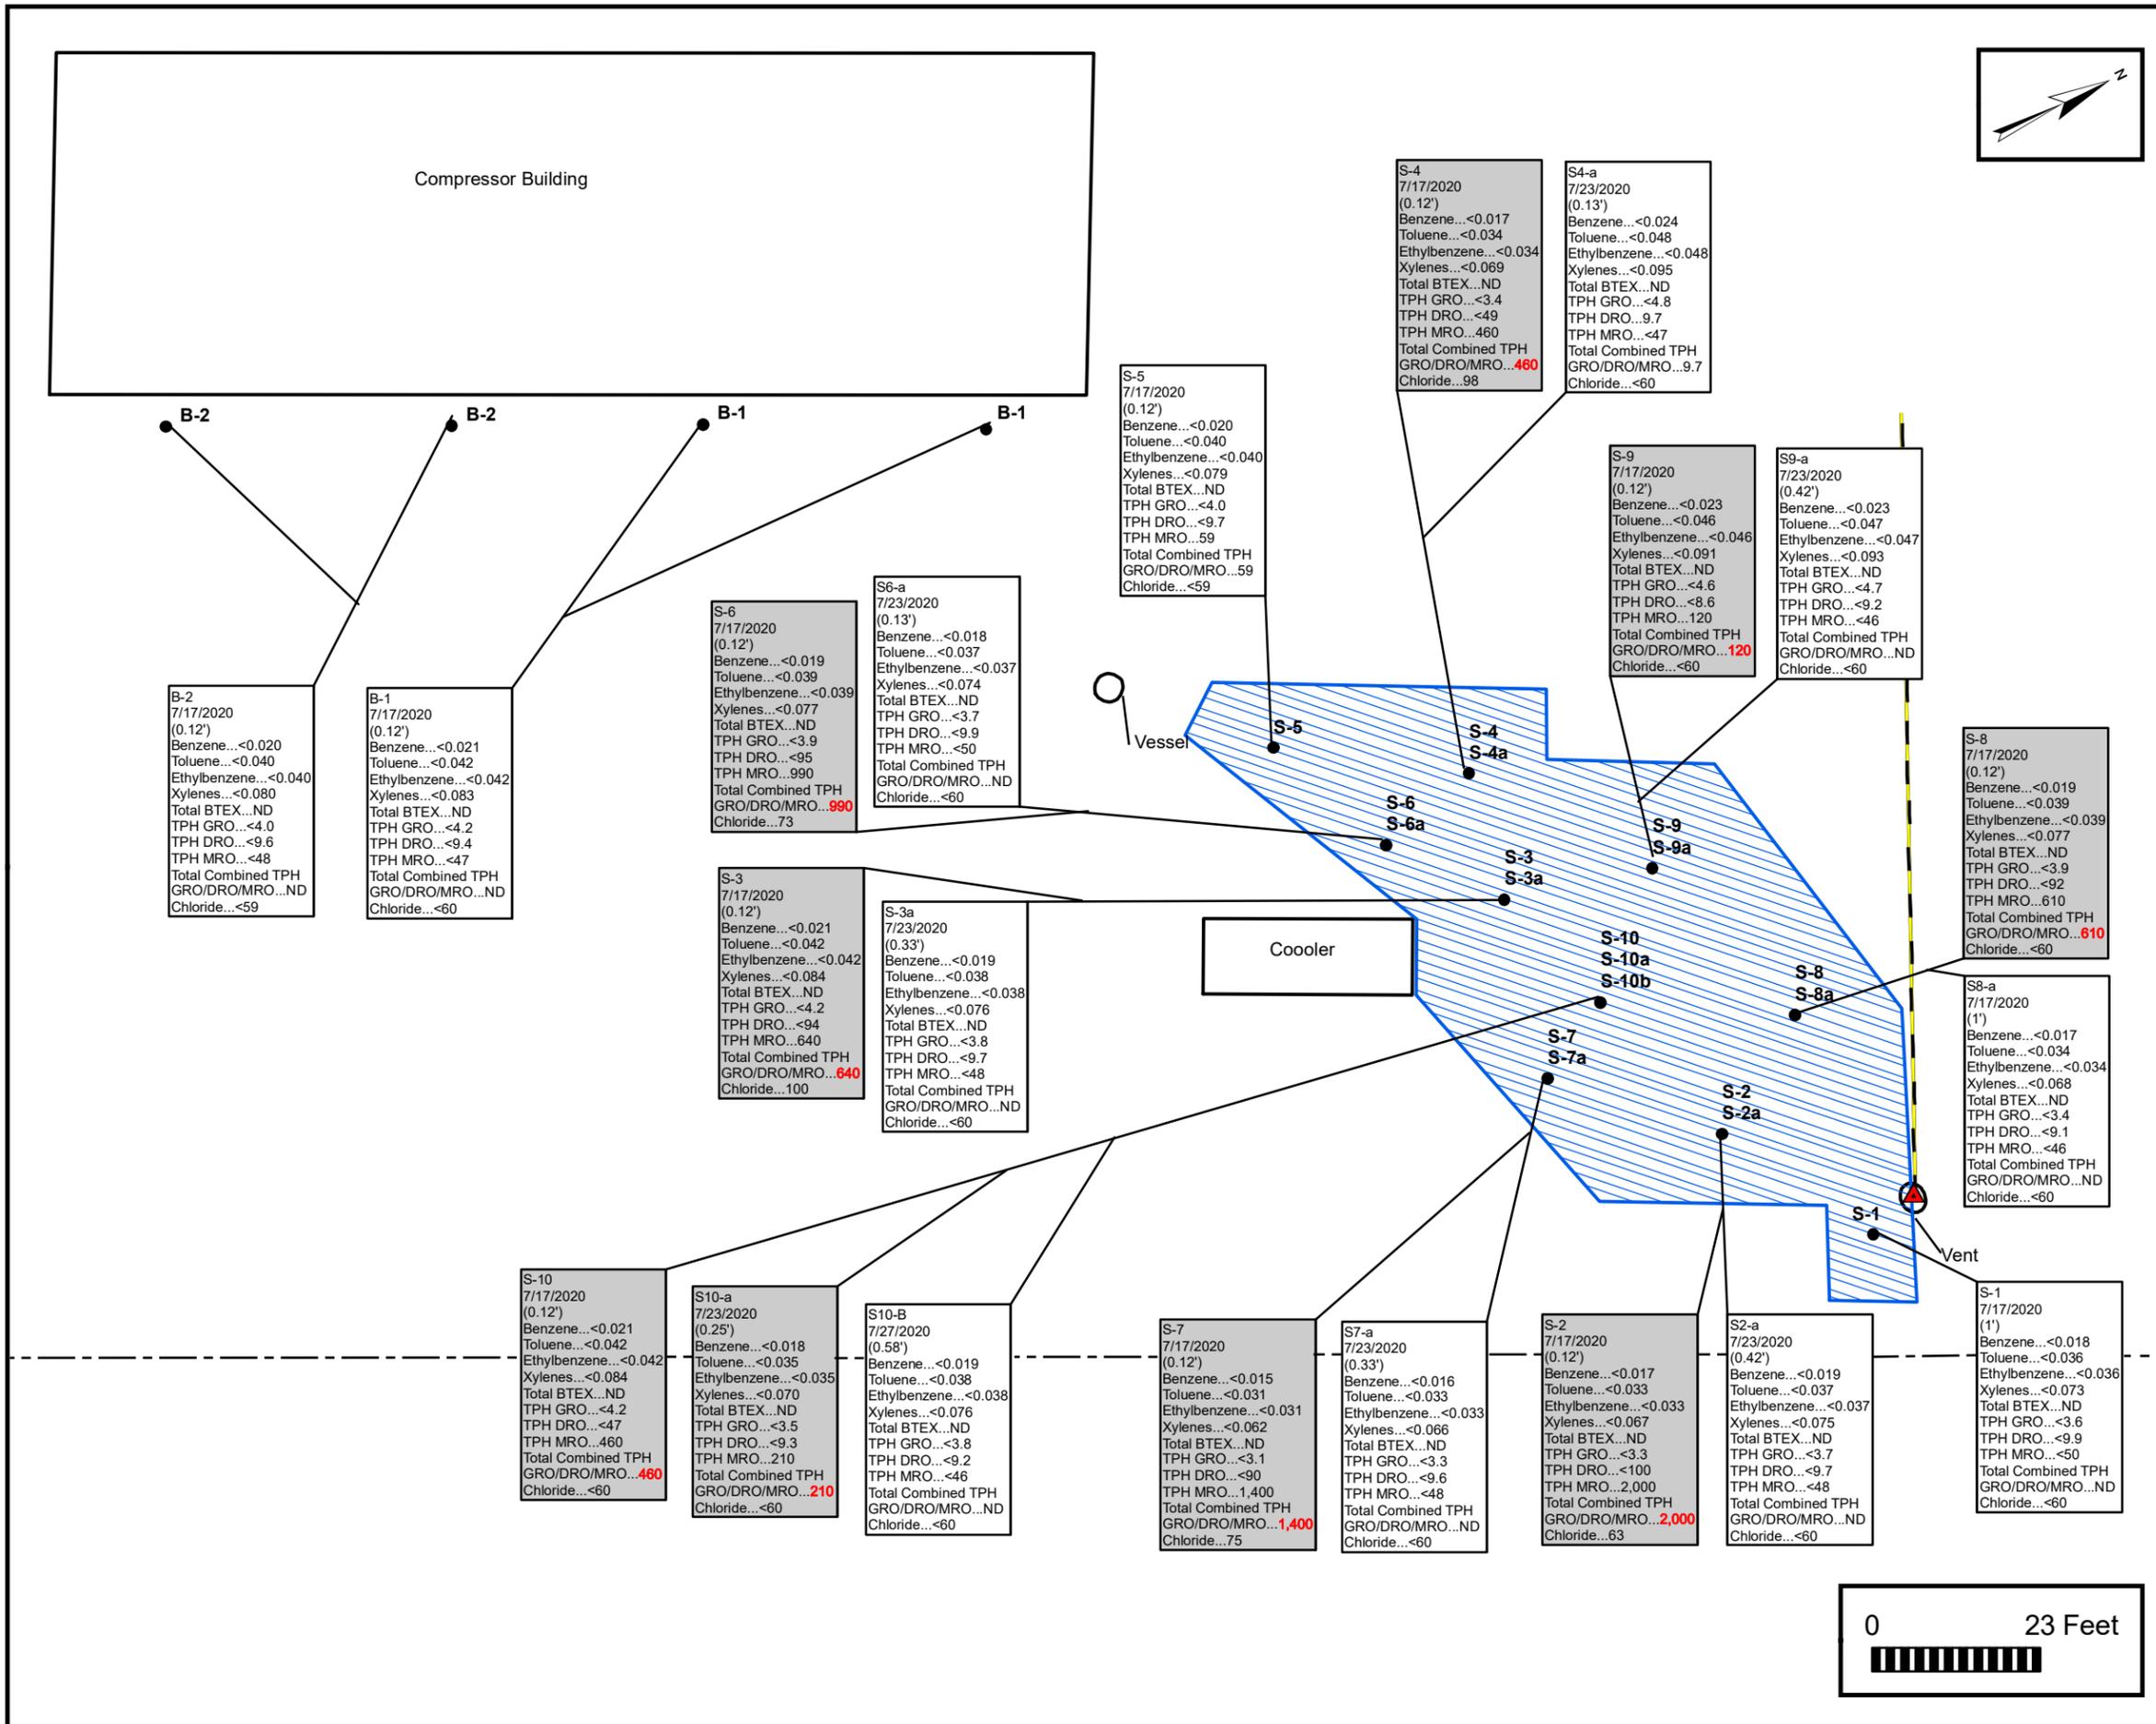
SITE MAP

The final excavated/scraped area measured approximately 96 feet long and 80 feet wide at the maximum extents. The maximum depth of the excavation measured approximately one (1) feet bgs.

Figure 3 (Appendix A) is a map that identifies approximate soil sample locations and depicts the approximate dimensions of the excavated/scraped area with respect to Site structures and appurtenances. Photographic documentation of the field activities is included in **Appendix D**.

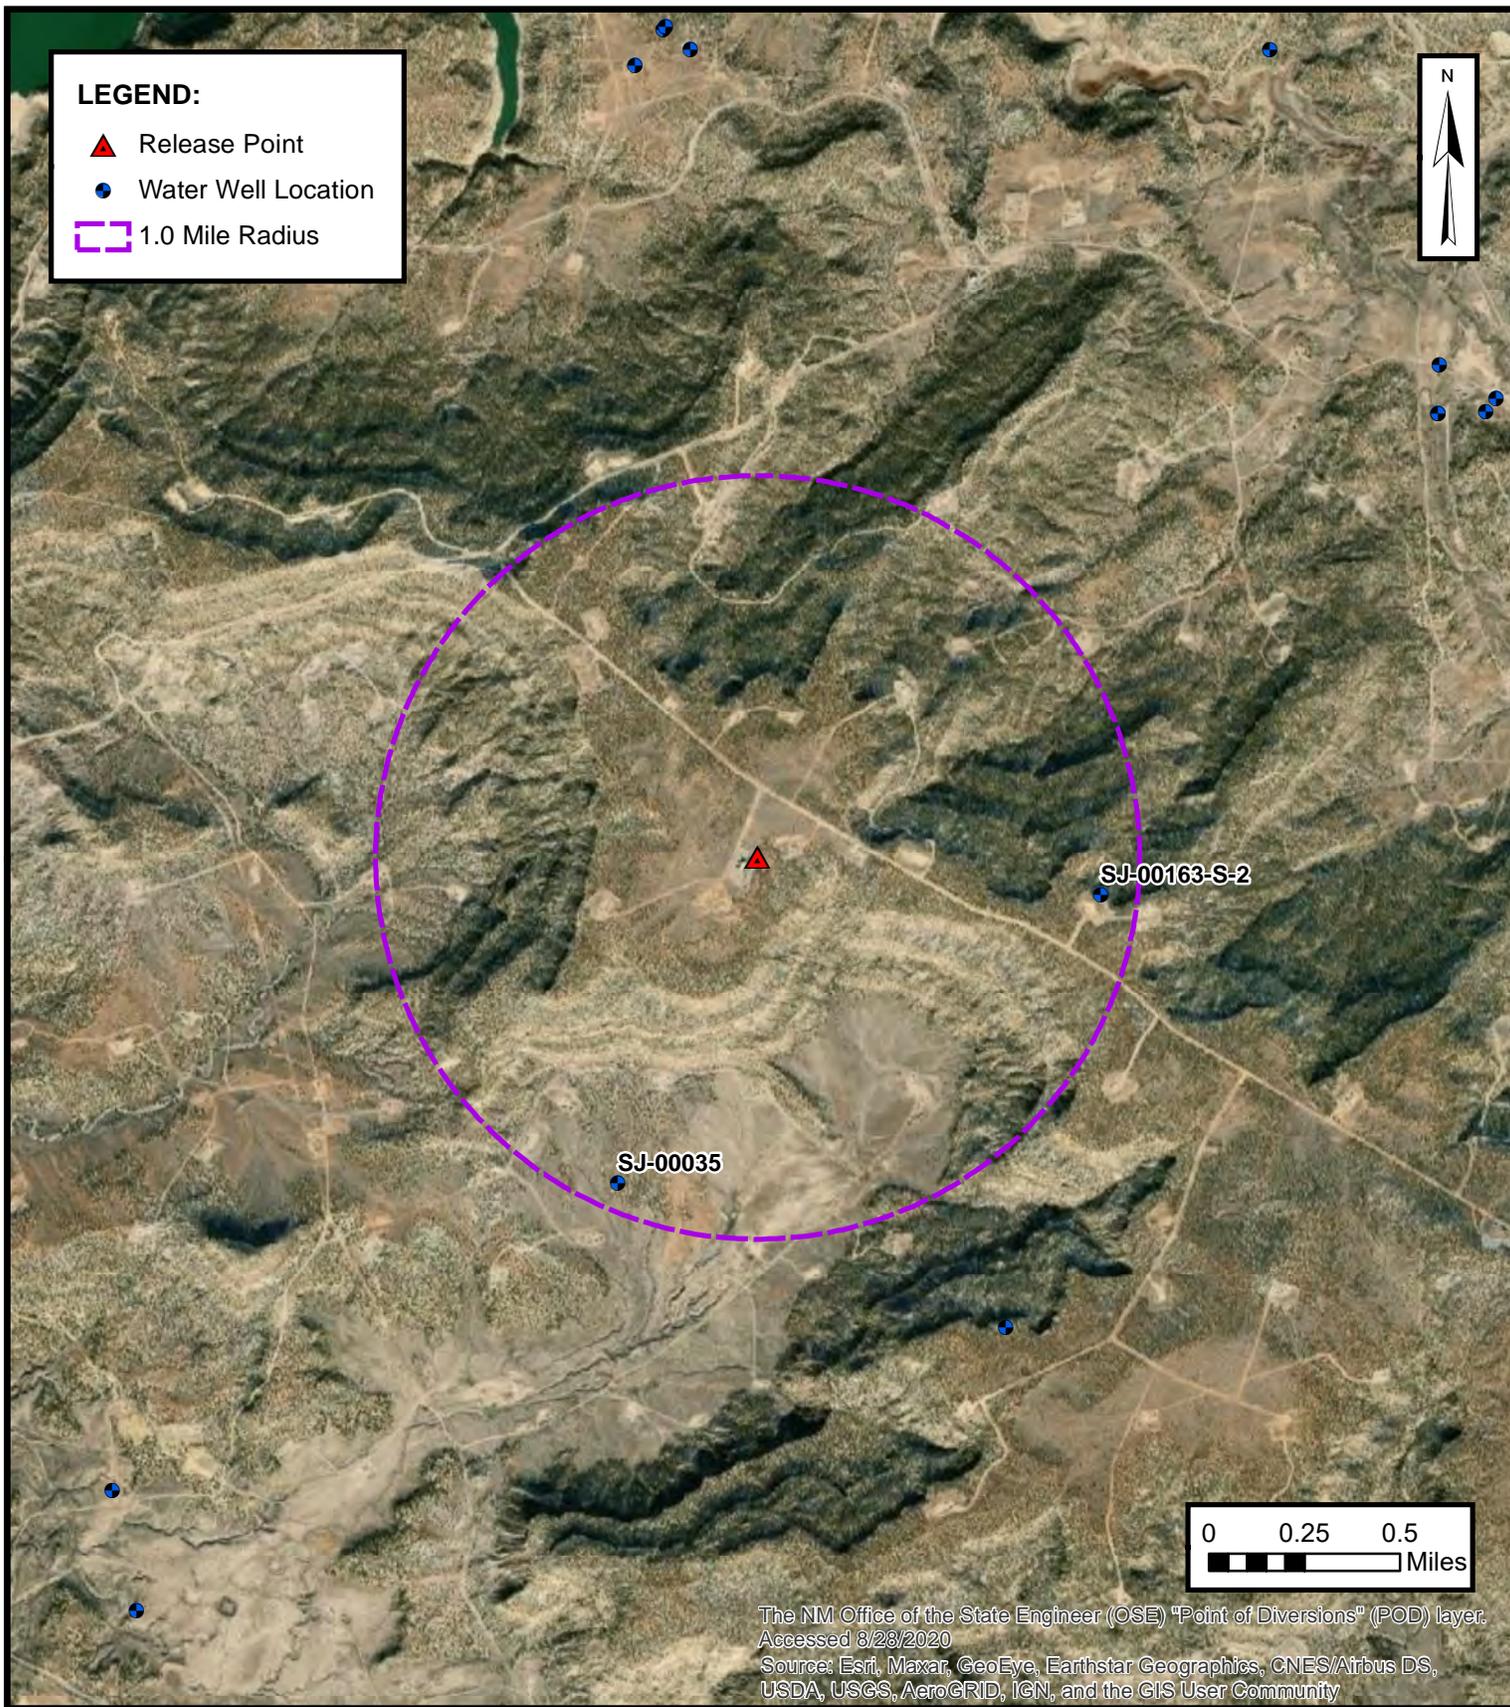
FIGURE
A

database. POD SJ-00035, with a recorded depth to water of 467 feet below grade surface (bgs), is located approximately 0.9 miles southwest of the Site and at a lower elevation (6,281 feet) than the Site (6,902 feet). POD SJ-00163-S-2, with a recorded depth to water of 800 feet bgs, is located approximately 0.9 miles east of the Site and at a lower elevation (6,870 feet) than the Site.

1.0 MILE RADIUS WATER WELL MAP

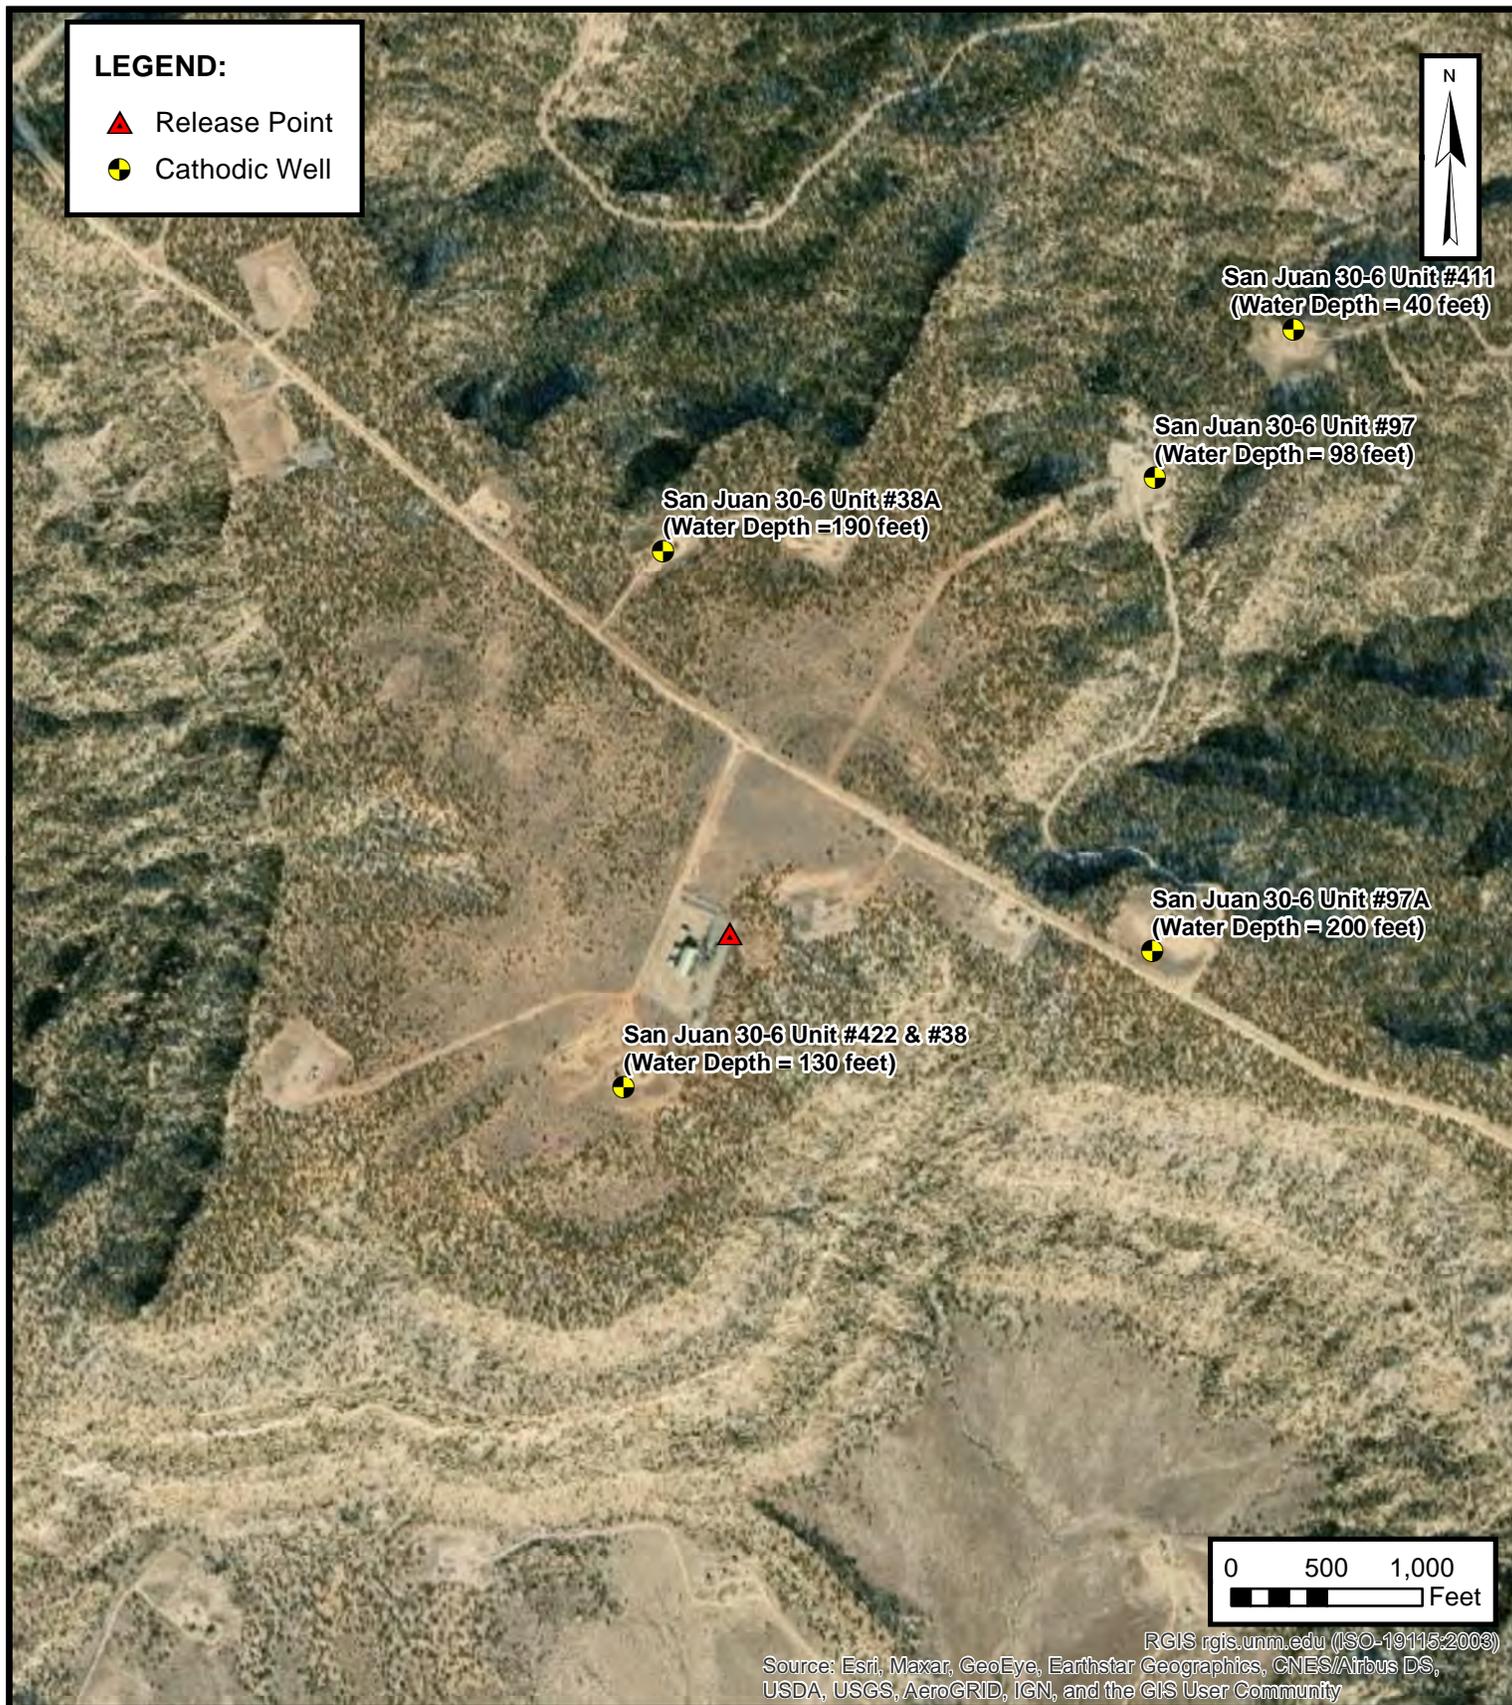
**FIGURE
B**

- Five (5) cathodic protection wells were identified within one mile of the Site. The shallowest recorded depth to water was identified at 40 feet bgs for the cathodic protection well located near the San Juan 30-6 Unit #411 well location (Unit A, Sec27 T30N R7W), which is located at a much lower elevation (6,523 feet) than the Site. The records for the closest cathodic protection well (San Juan 30-6 #422 & #38 (Unit M, Sec27 T30N R7W)), located approximately 630 feet southwest of the Site, indicate a depth to water of 130 feet bgs. The records for the cathodic protection wells located near the San Juan 30-6 #97A (Unit J, Sec27 T30N R7W), San Juan 30-6 Unit #97 (Unit NE, Sec27 T30N R7W), and the SJ 30-6 #38A (Unit E, Sec 27 T30N R7W) well locations indicate depths to water ranging from 98 feet bgs to 200 feet bgs.

**CATHODIC PROTECTION WELL RECORDED
DEPTH TO WATER**

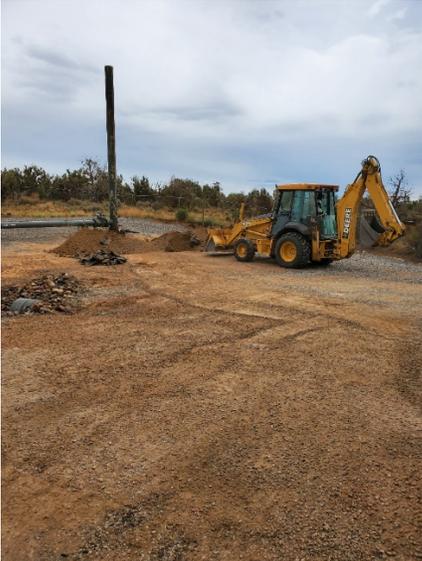
<p>Photograph 1</p> <p>Photograph Date: 7/16/20</p> <p>Photograph Description: View of in-process excavation/scraping activities (facing northeast).</p>

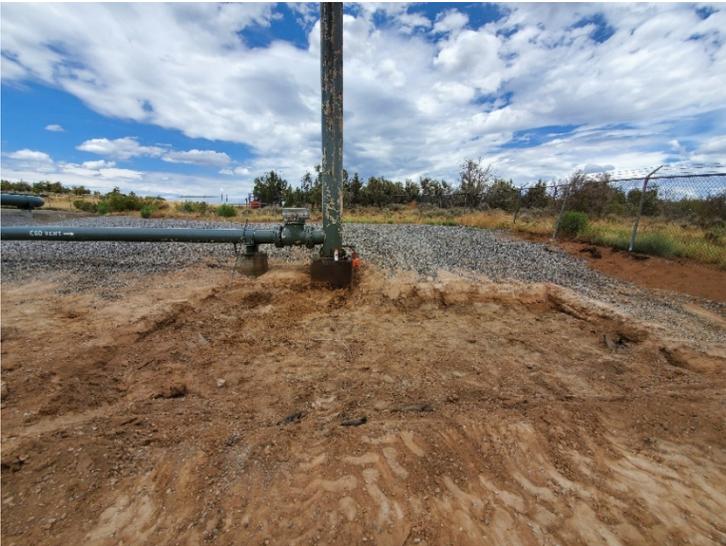
<p>Photograph 2</p> <p>Photograph Date: 7/16/20</p> <p>Photograph Description: View of in-process excavation activities (facing north).</p>

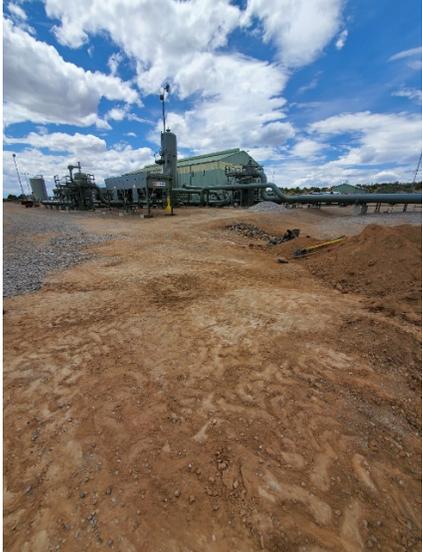
<p>Photograph 3</p> <p>Photograph Date: 7/16/20</p> <p>Photograph Description: View of the initial excavation (facing southwest).</p>

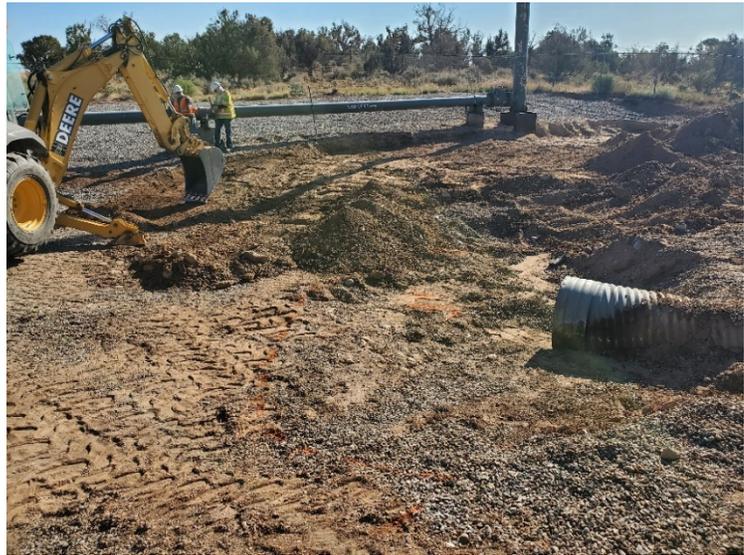
Photograph Date: 7/21/20

Photograph Description: View of in-process excavation/scraping activities (facing northeast).

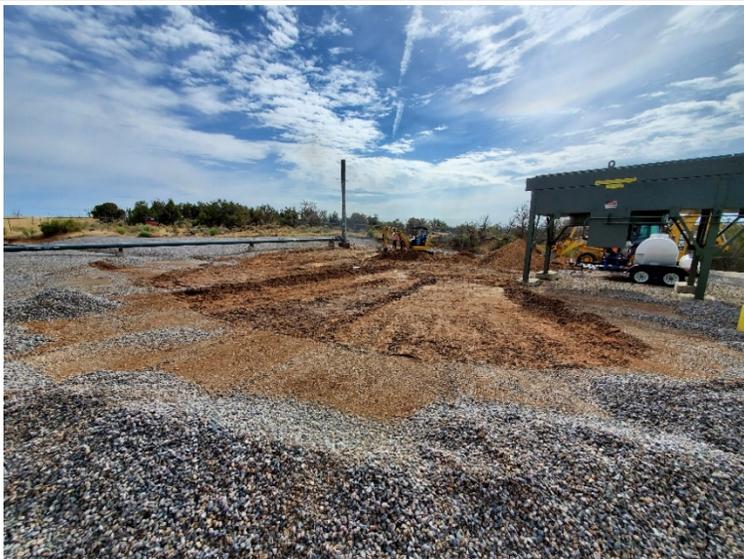
Photograph 5

Photograph Description: View of in-process excavation activities (facing northeast).

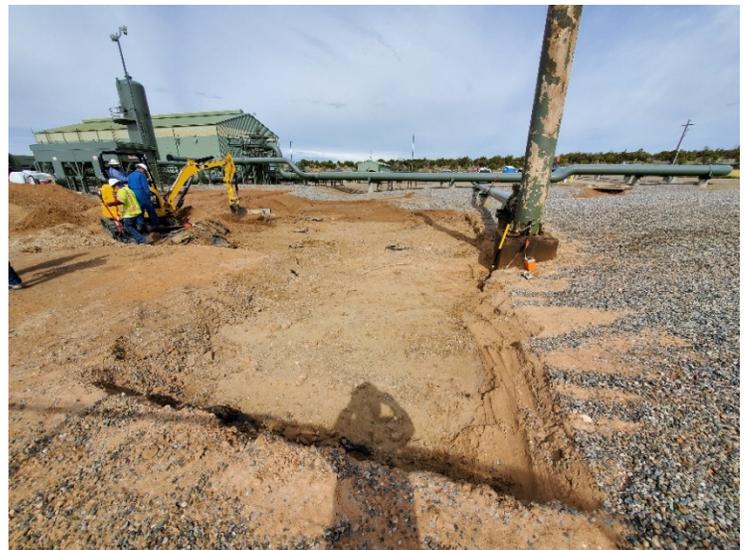
Photograph 6

Photograph Description: View of in-process excavation activities (facing west).

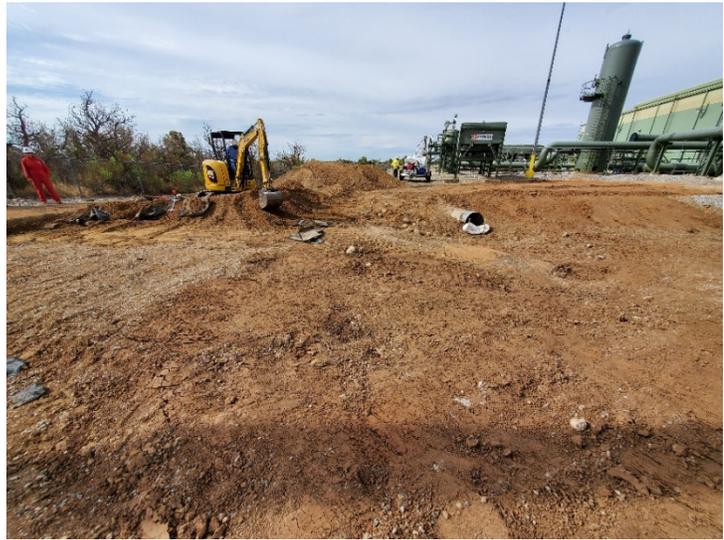
Photograph Date: 7/22/20

Photograph Description: View of in-process excavation activities (facing southwest).

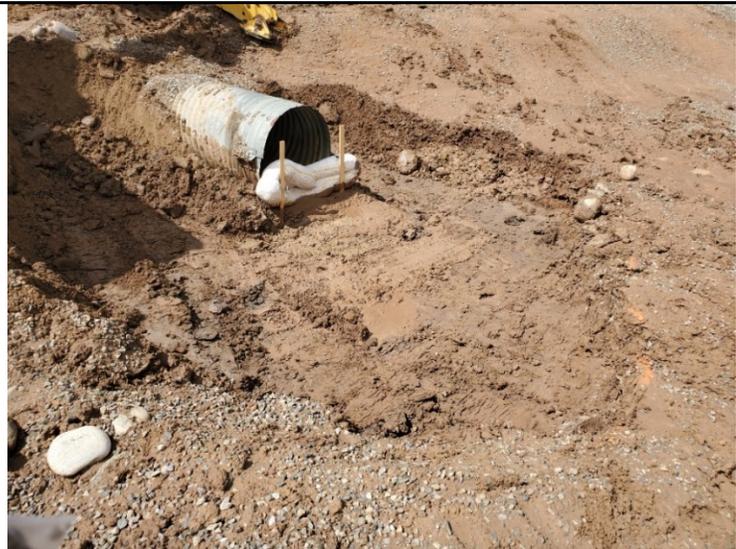
Photograph 8

Photograph Description: View of the final excavation and the sample location of composite soil sample S10-b (facing west).

On July 27, 2020, after the removal of soils associated with S10-a, a third sampling event was performed. The New Mexico EMNRD OCD was notified of the sampling event although no representative was present during the sampling activities. Composite soil sample S10-B (0.58') was collected from the excavated/scraped area.
