Release Notification

CLOSURE REPORT

**Lateral 5A-2 Y-1 Condensate Tank
NE ¼, S1 T29N R14W
San Juan County, New Mexico**

December 9, 2020
Ensolum Project No. 05A1226117

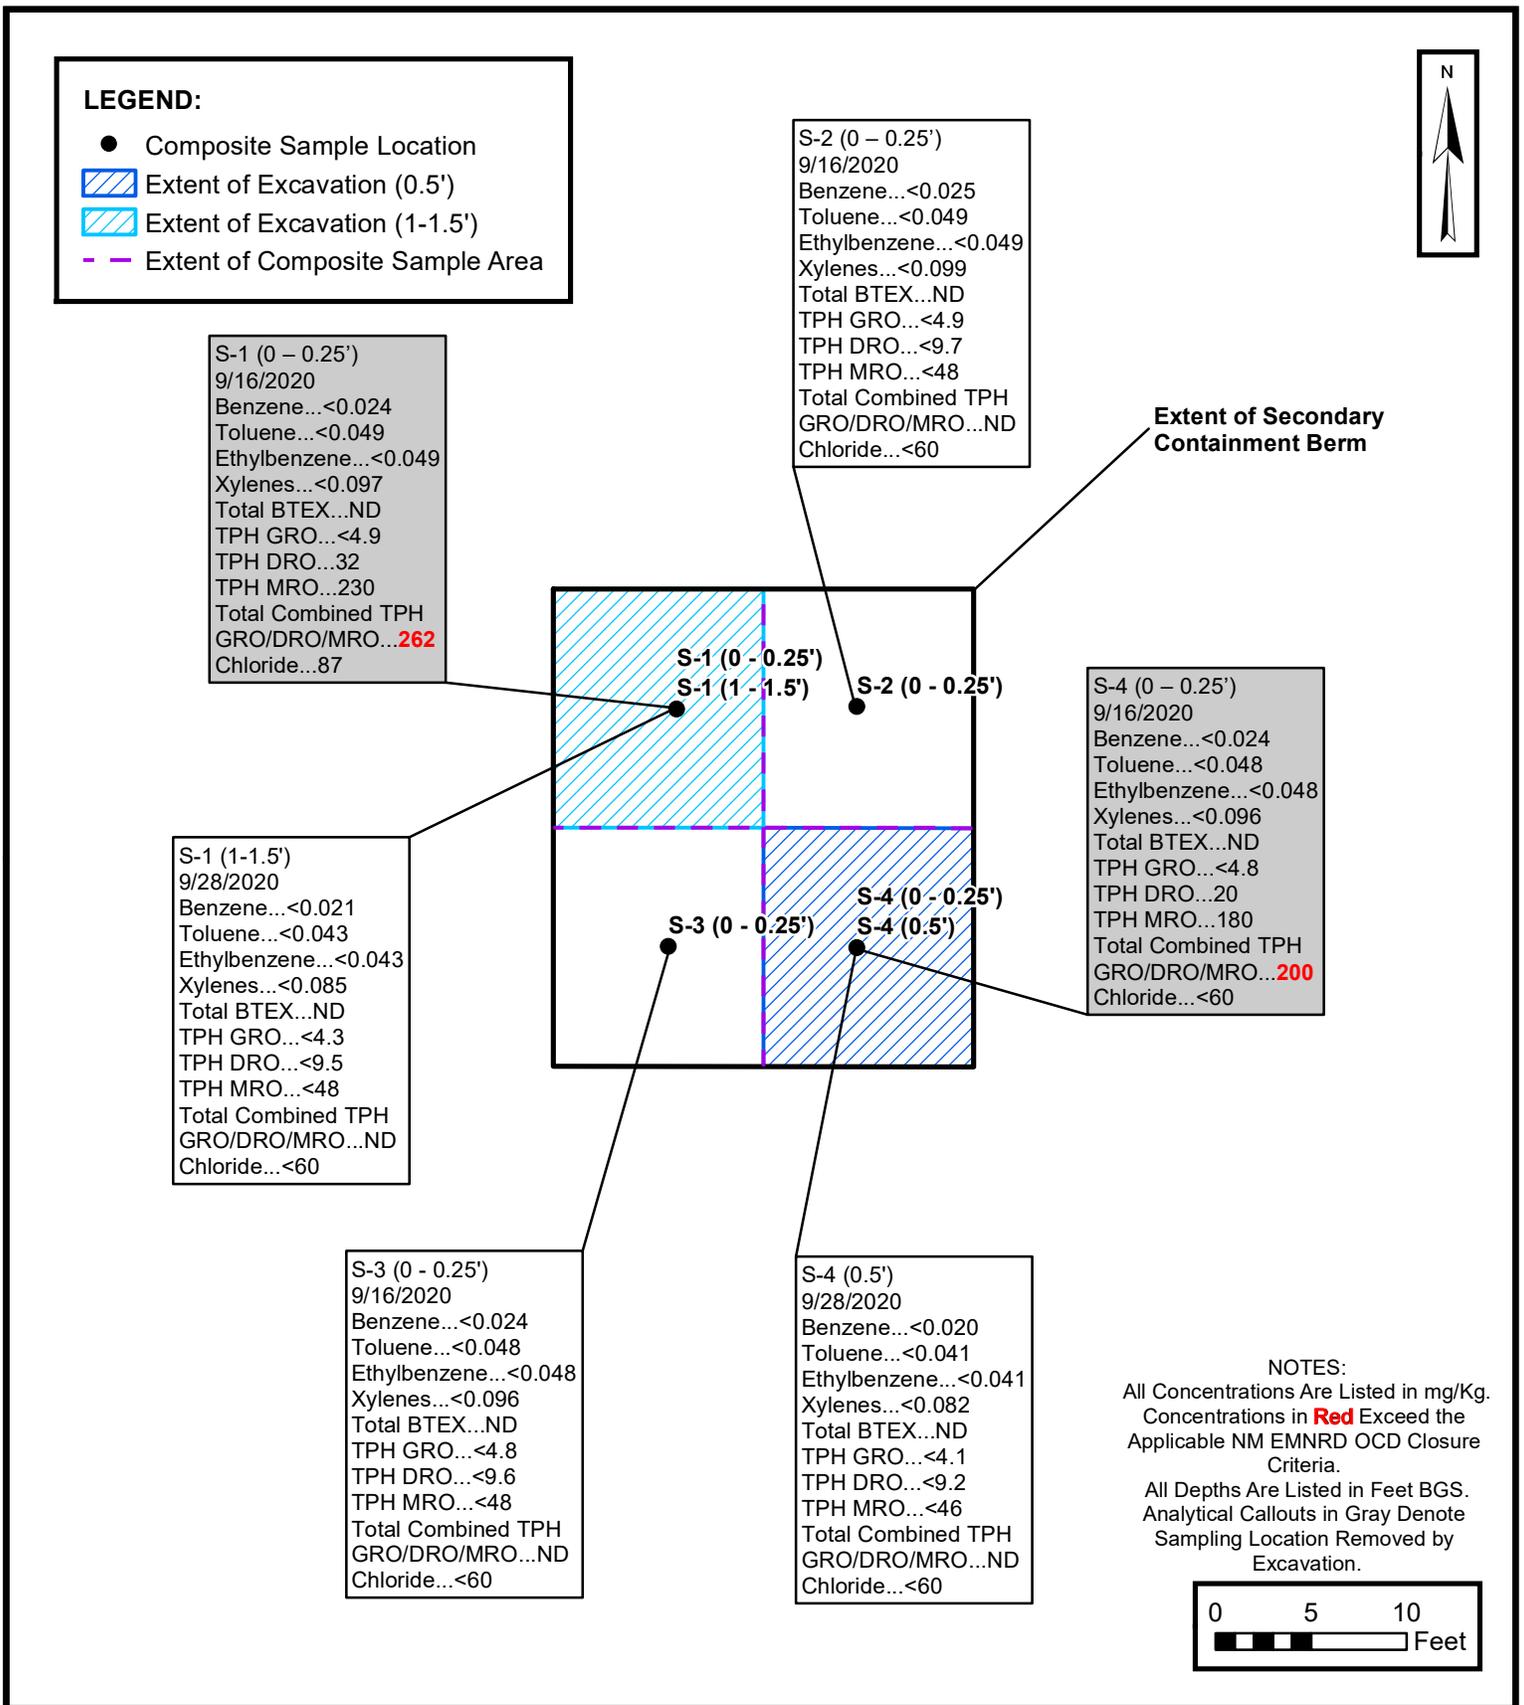
SITE MAP

The final excavation measured approximately 26 feet long and 22 feet wide at the maximum extents, with a maximum depth of approximately 1.5 feet bgs.

Figure 3 (Appendix A) is a map that identifies the approximate soil sample locations and depicts the approximate dimensions of the excavation. Photographic documentation of the field activities is included in **Appendix D**.

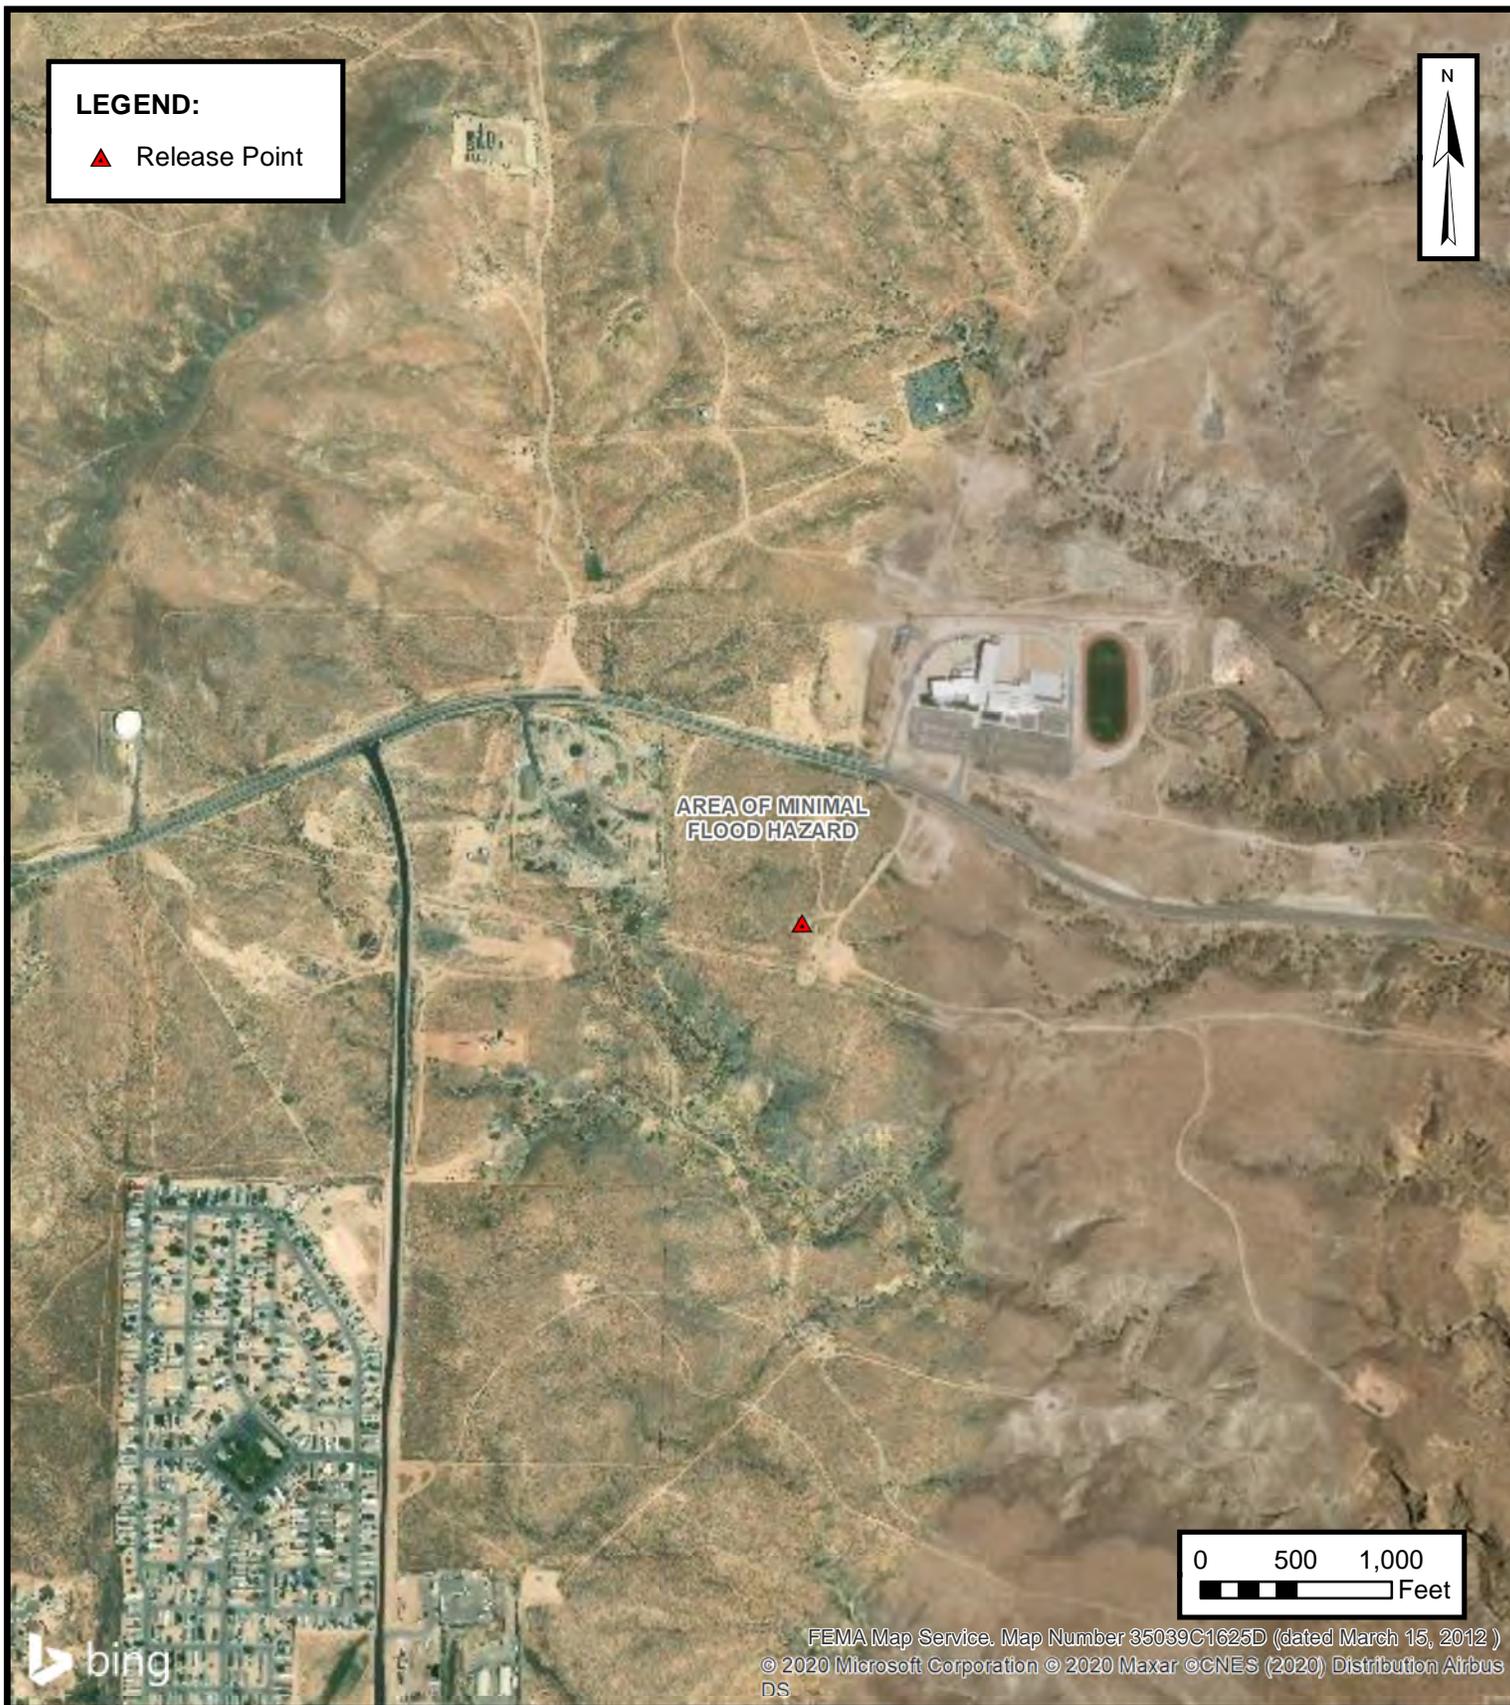
FIGURE

- The Site is not located within an unstable area.
- Based on information identified in the Federal Emergency Management Agency (FEMA) National Flood Hazard Layer (NFHL) geospatial database, the Site is not located within a 100-year floodplain.

100-YEAR FLOOD PLAIN MAP

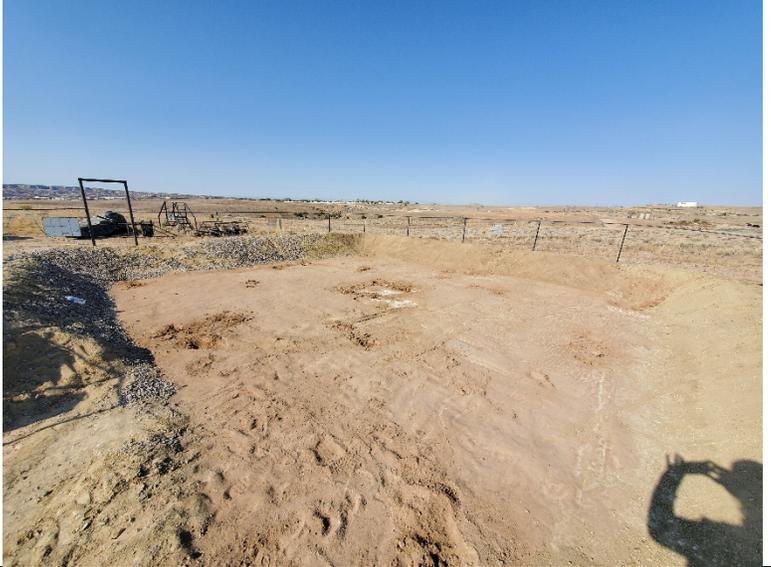
<p>Photograph 1</p> <p>Photograph Date: 9/16/20</p> <p>Photograph Description: View of the initial surface after removal of the secondary containment liner (facing southwest).</p>

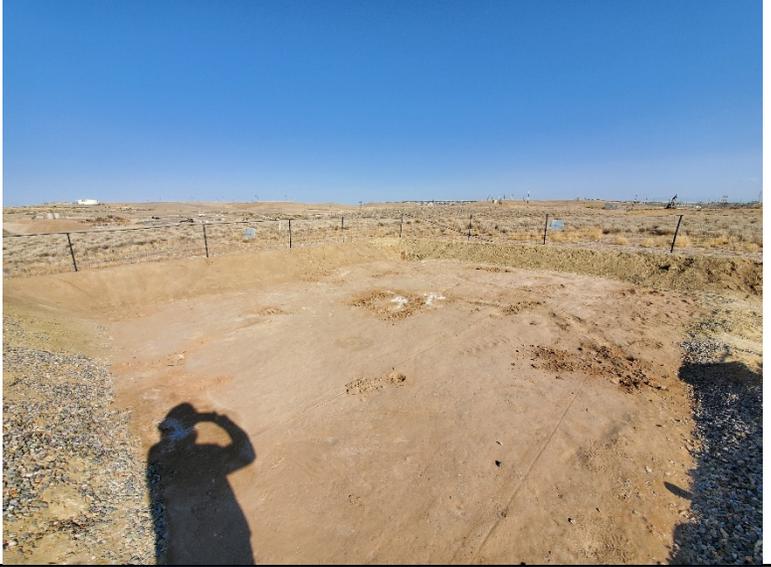
A wide-angle photograph showing a large, flat, sandy area under a clear blue sky. In the background, there is a fence line and some industrial structures. The ground appears to be a mix of sand and gravel.
<p>Photograph 2</p> <p>Photograph Date: 9/16/20</p> <p>Photograph Description: View of the initial surface after removal of the secondary containment liner (facing northwest).</p>

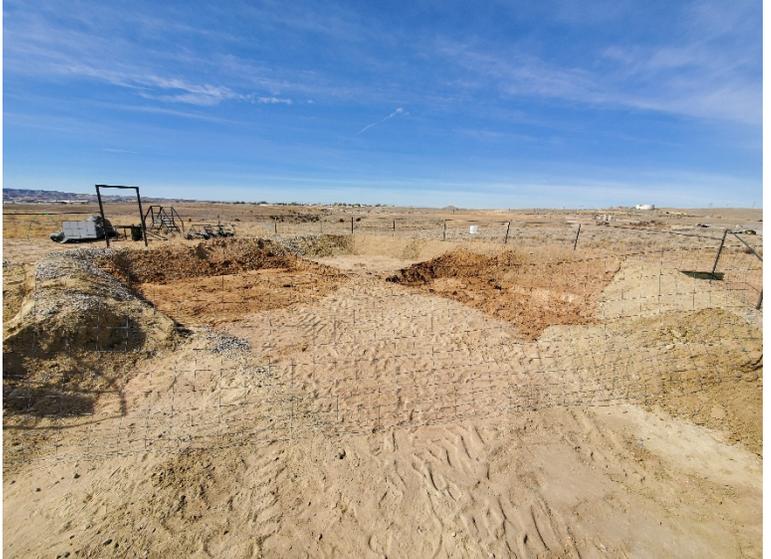
A wide-angle photograph showing a large, flat, sandy area under a clear blue sky. In the background, there is a fence line and some industrial structures. The ground appears to be a mix of sand and gravel.
<p>Photograph 3</p> <p>Photograph Date: 9/28/20</p> <p>Photograph Description: View of the final excavation activities (facing southwest).</p>

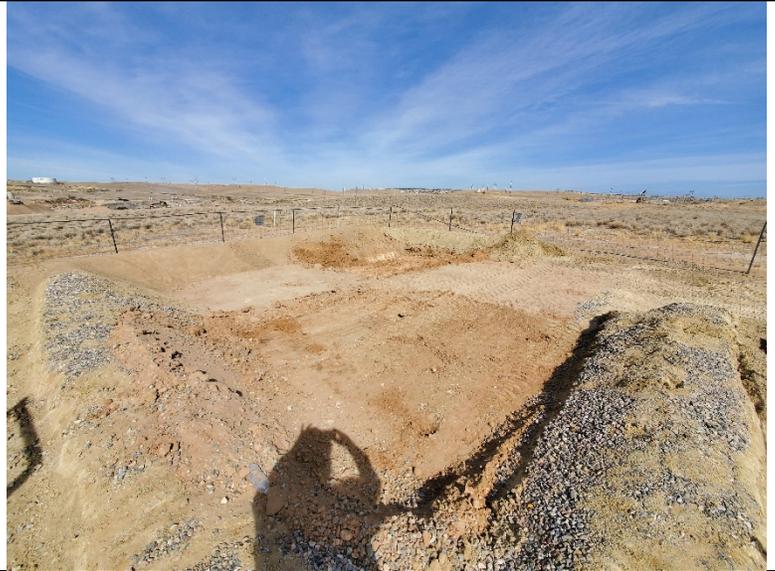
Photograph Date: 9/28/20

Photograph Description View of the final excavation activities (facing northwest).

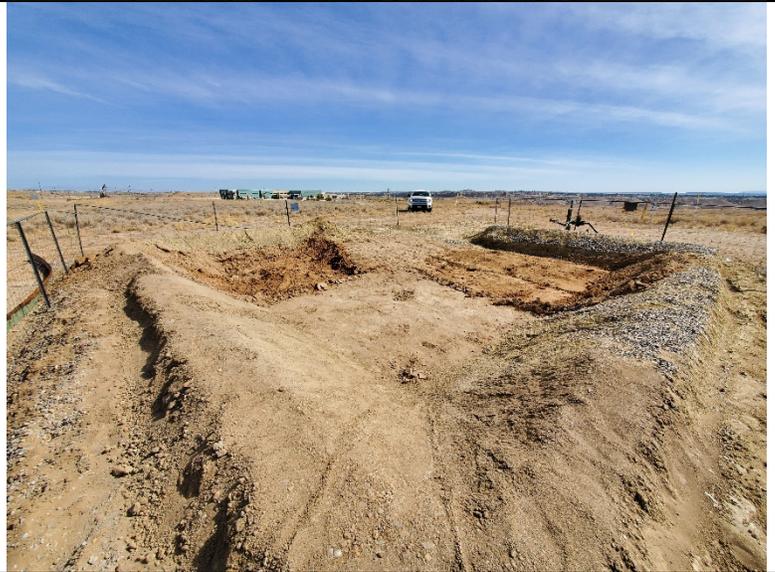
Photograph 5

Photograph Date: 9/28/20

Photograph Description: View of the final excavation activities (facing northeast).
