Site Characterization Work Plan
Saunders Salt Water Disposal #002 Release Site
Sabinal Energy Operating LLC
Incident ID: nSAP0230839785, nSAP0230537114, nSAP0232539443, nSAP0335031519, nSAP0335640026
N 03 15S 33E, Lea County, New Mexico

GHD Services Inc. (GHD), on behalf of Sabinal Energy Operating LLC (Sabinal), submits this Site Characterization Work Plan (Work Plan) to the New Mexico Oil Conservation Division (NMOCD) District 1 Office. This Work Plan proposes site characterization activities associated with Incident ID: nSAP0230839785, nSAP0230537114, nSAP0232539443, nSAP0335031519, nSAP0335640026 at the Saunders Salt Water #002 release site (Site). According to publicly available information via the New Mexico Oil Conservation Division's (NMOCD) website, there are (5) historical releases that were identified during operations by Energen Resources Corporation. Although they were identified by Energen Resources Corporation, no record of site characterization or remediation were able to be identified. Sabinal acquired the assets in 2019 and has prepared this workplan to characterize potential impacts associated with these historical releases.

PROPOSED BORING LOCATION MAP

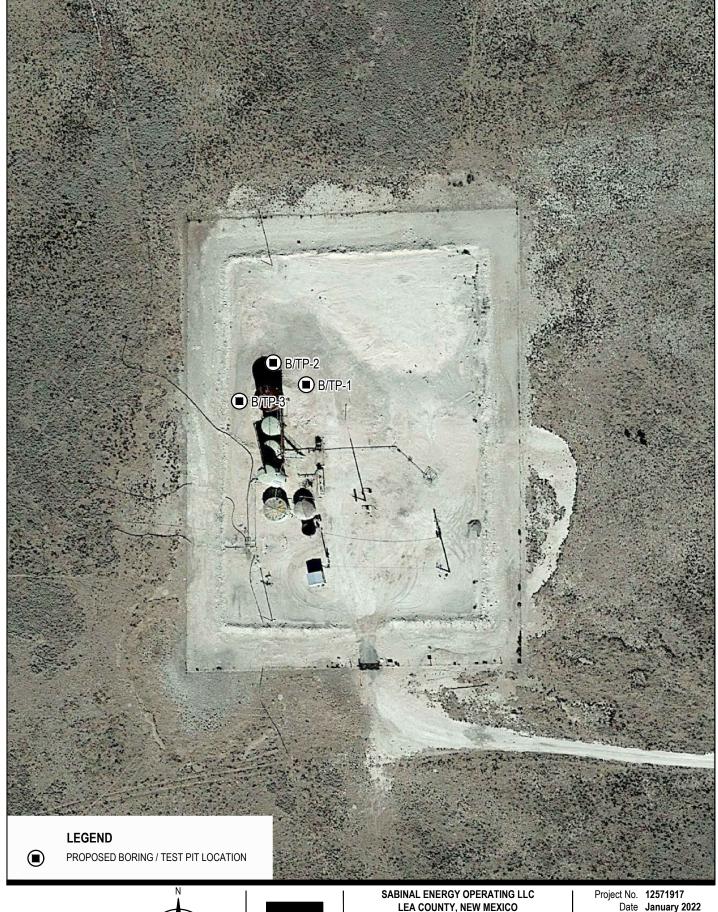
FIGURE 2

80 ft Coordinate System: NAD 1983 StatePlane-New Mexico East (US Feet)

Three borings are proposed to assess historical releases associated with incidents nSAP0230839785, nSAP0230537114, nSAP0232539443, nSAP0335031519, and nSAP0335640026. Refer to Figure 2 for proposed boring locations. Borings will be advanced via hand auger to 4 ft bgs, if refusal is not met. Two soil samples will be collected per boring - one from approximately 1 ft bgs and one from the bottom of the boring. All soil samples will be analyzed for BTEX by Environmental Protection Agency (EPA) Method 8021B, TPH by Method 8015B Modified, and chloride by EPA Method 300.
