Site Name Lateral 3B-7 Hydro Test Release	Site Type Natural Gas Gathering Pipeline
Date Release Discovered: 04/07/2020	Serial Number (if applicable): N/A

CLOSURE REPORT

Lateral 3B-7 Hydrotest Release
NE ¼, S3 T29N R11W
San Juan County, New Mexico

September 18, 2020
Ensolum Project No. 05A1226101

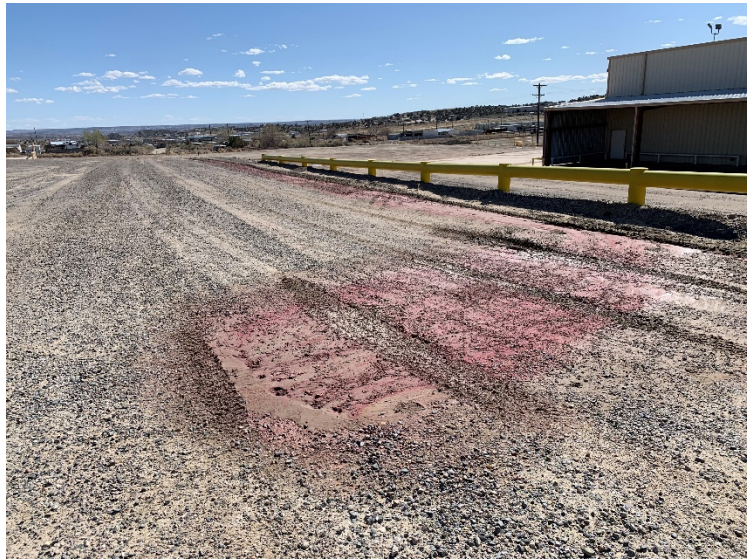
**Photograph 1**

Photograph Description: View of the flow path.

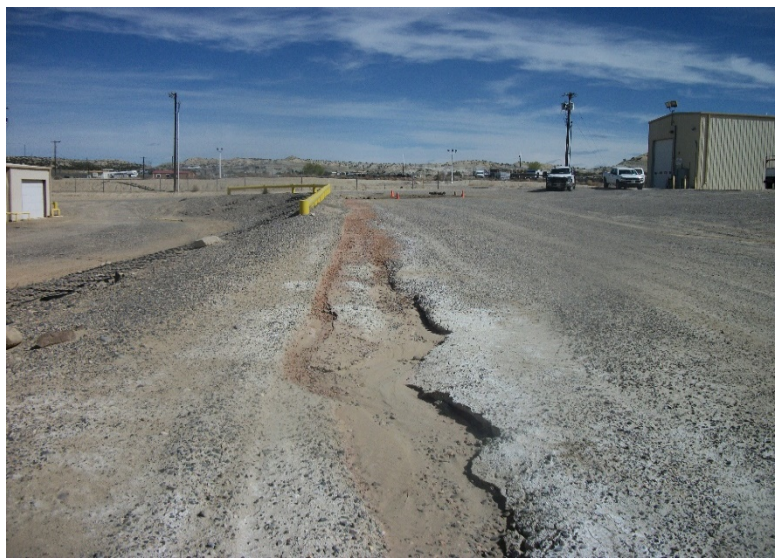
**Photograph 2**

Photograph Description: View of the flow path.

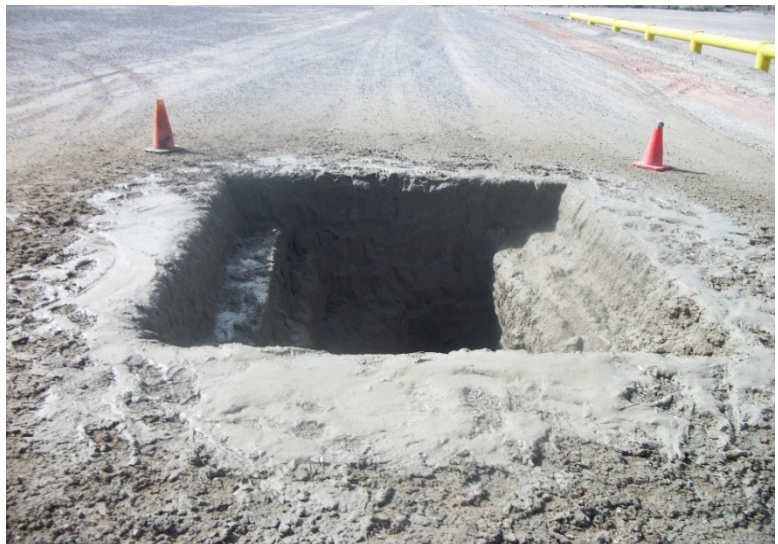
**Photograph 3**

The final excavation measured approximately 14 feet long and 10 feet wide at the maximum extents, with a maximum depth of approximately seven (7) feet bgs. The flow path measured approximately 700 feet long, with an average width of approximately two (2) feet. The flow path exhibited minimal vertical saturation.

Photograph Description: View of the final pipeline excavation.

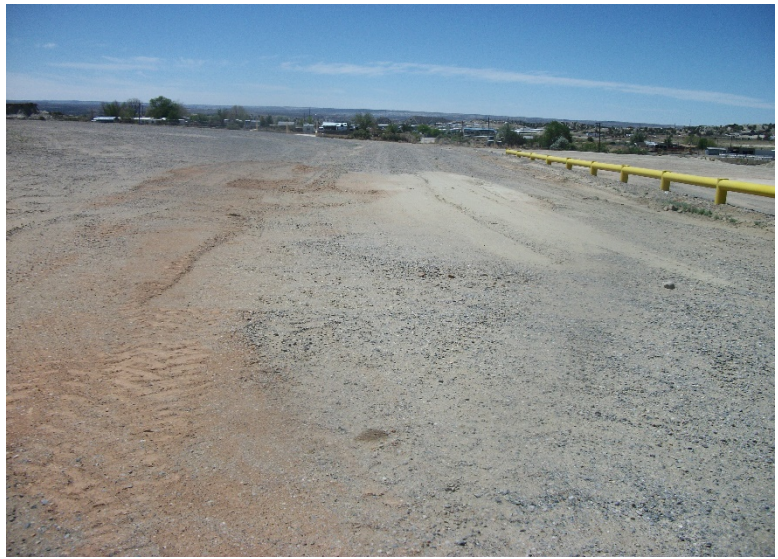
Photograph 4

Photograph Description: View of final excavation after initial restoration.

Enterprise backfilled the excavation with imported fill and resurfaced it to provide a suitable driving surface.
