## Release Notification

| Site Name Remuda Basin Central Tank Battery | Site Type Bulk Storage Facility |

# **Cave and Karst Resource Inventory Report Remuda Basin Central Tank Battery Eddy County, New Mexico**

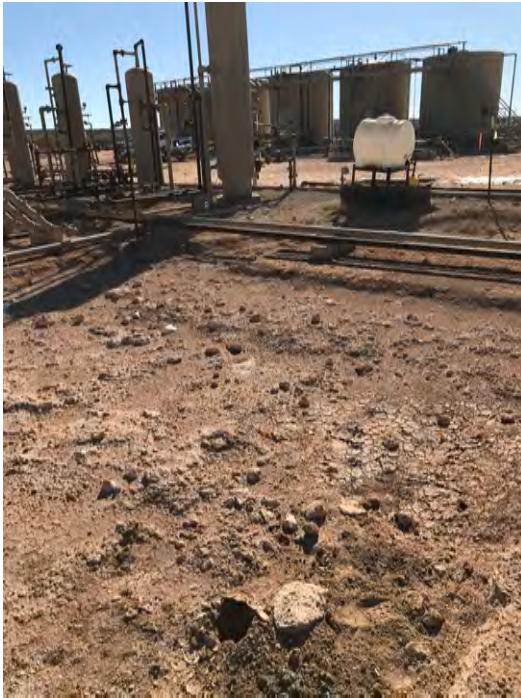
| <b>Photo No.</b> | <b>Date</b> | |
|---|---|---|
| 1 | Dec 30, 2020 | |

| <b>Photo No.</b> | <b>Date</b> | |
|---|---|---|
| Delineation sampling at BH24 facing southeast. | | |

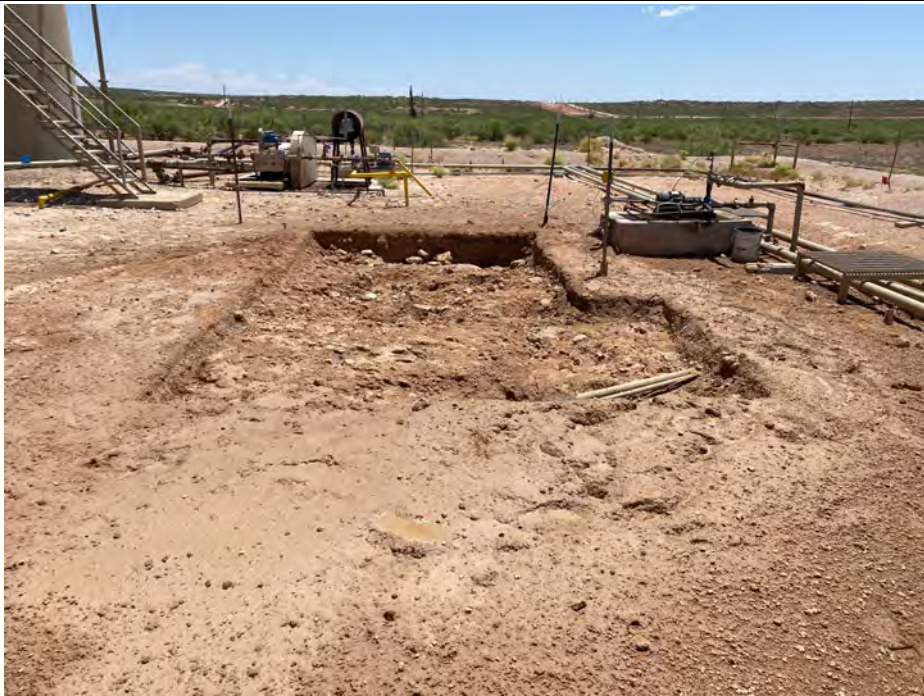
| <b>Photo No.</b> | <b>Date</b> | |
|---|---|---|
| Norther view of hydrovac excavation of delineation soil sample BH24. Note the competent bedrock encountered, proximity of production equipment and electrical line. Confirmation floor sample FS17 collected from this excavation. | | |

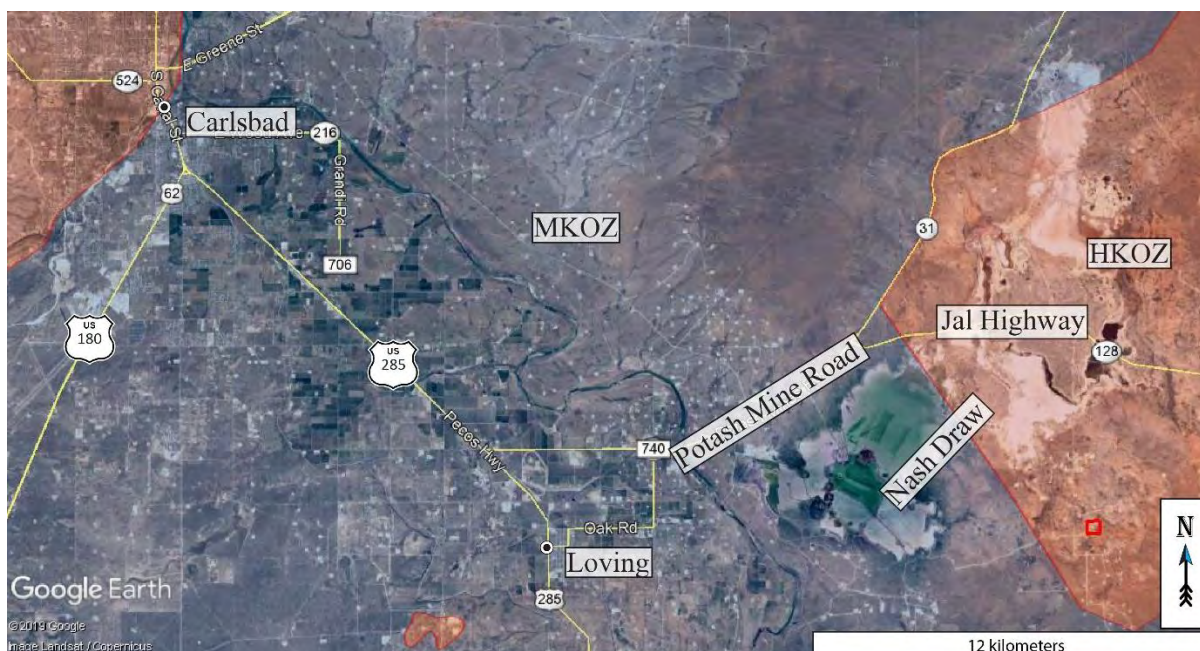
**Figure 1:** Karst occurrence overview. Red transparent area is a high karst occurrence zone; blue transparent area is a medium karst occurrence zone. Study area is the red outlined area in the lower-right portion of the image. Background image credit: Google Earth. Image date: November 02, 2017. Datum: WGS-84.

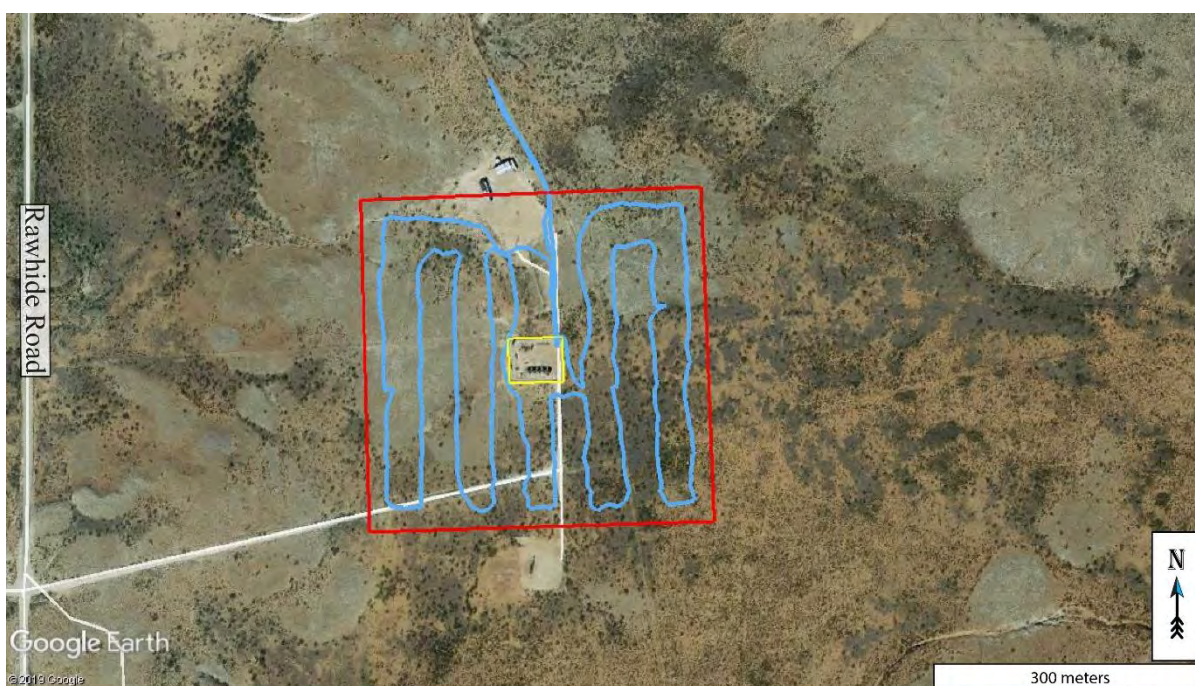
**Figure 3: Survey overview.** Light blue wavy lines are the actual survey lines walked. Yellow polygon is the pad site. Red polygon is the 200-meter buffer study area. Background image credit: Google Earth. Image date: November 02, 2017. Datum: WGS-84.
