CLOSURE REQUEST REPORT

**Clearwater Compressor Station
Eddy County, New Mexico
Incident Number: nAPP2127263561**

May 19, 2022

Ensolum Project No. 03A2013001

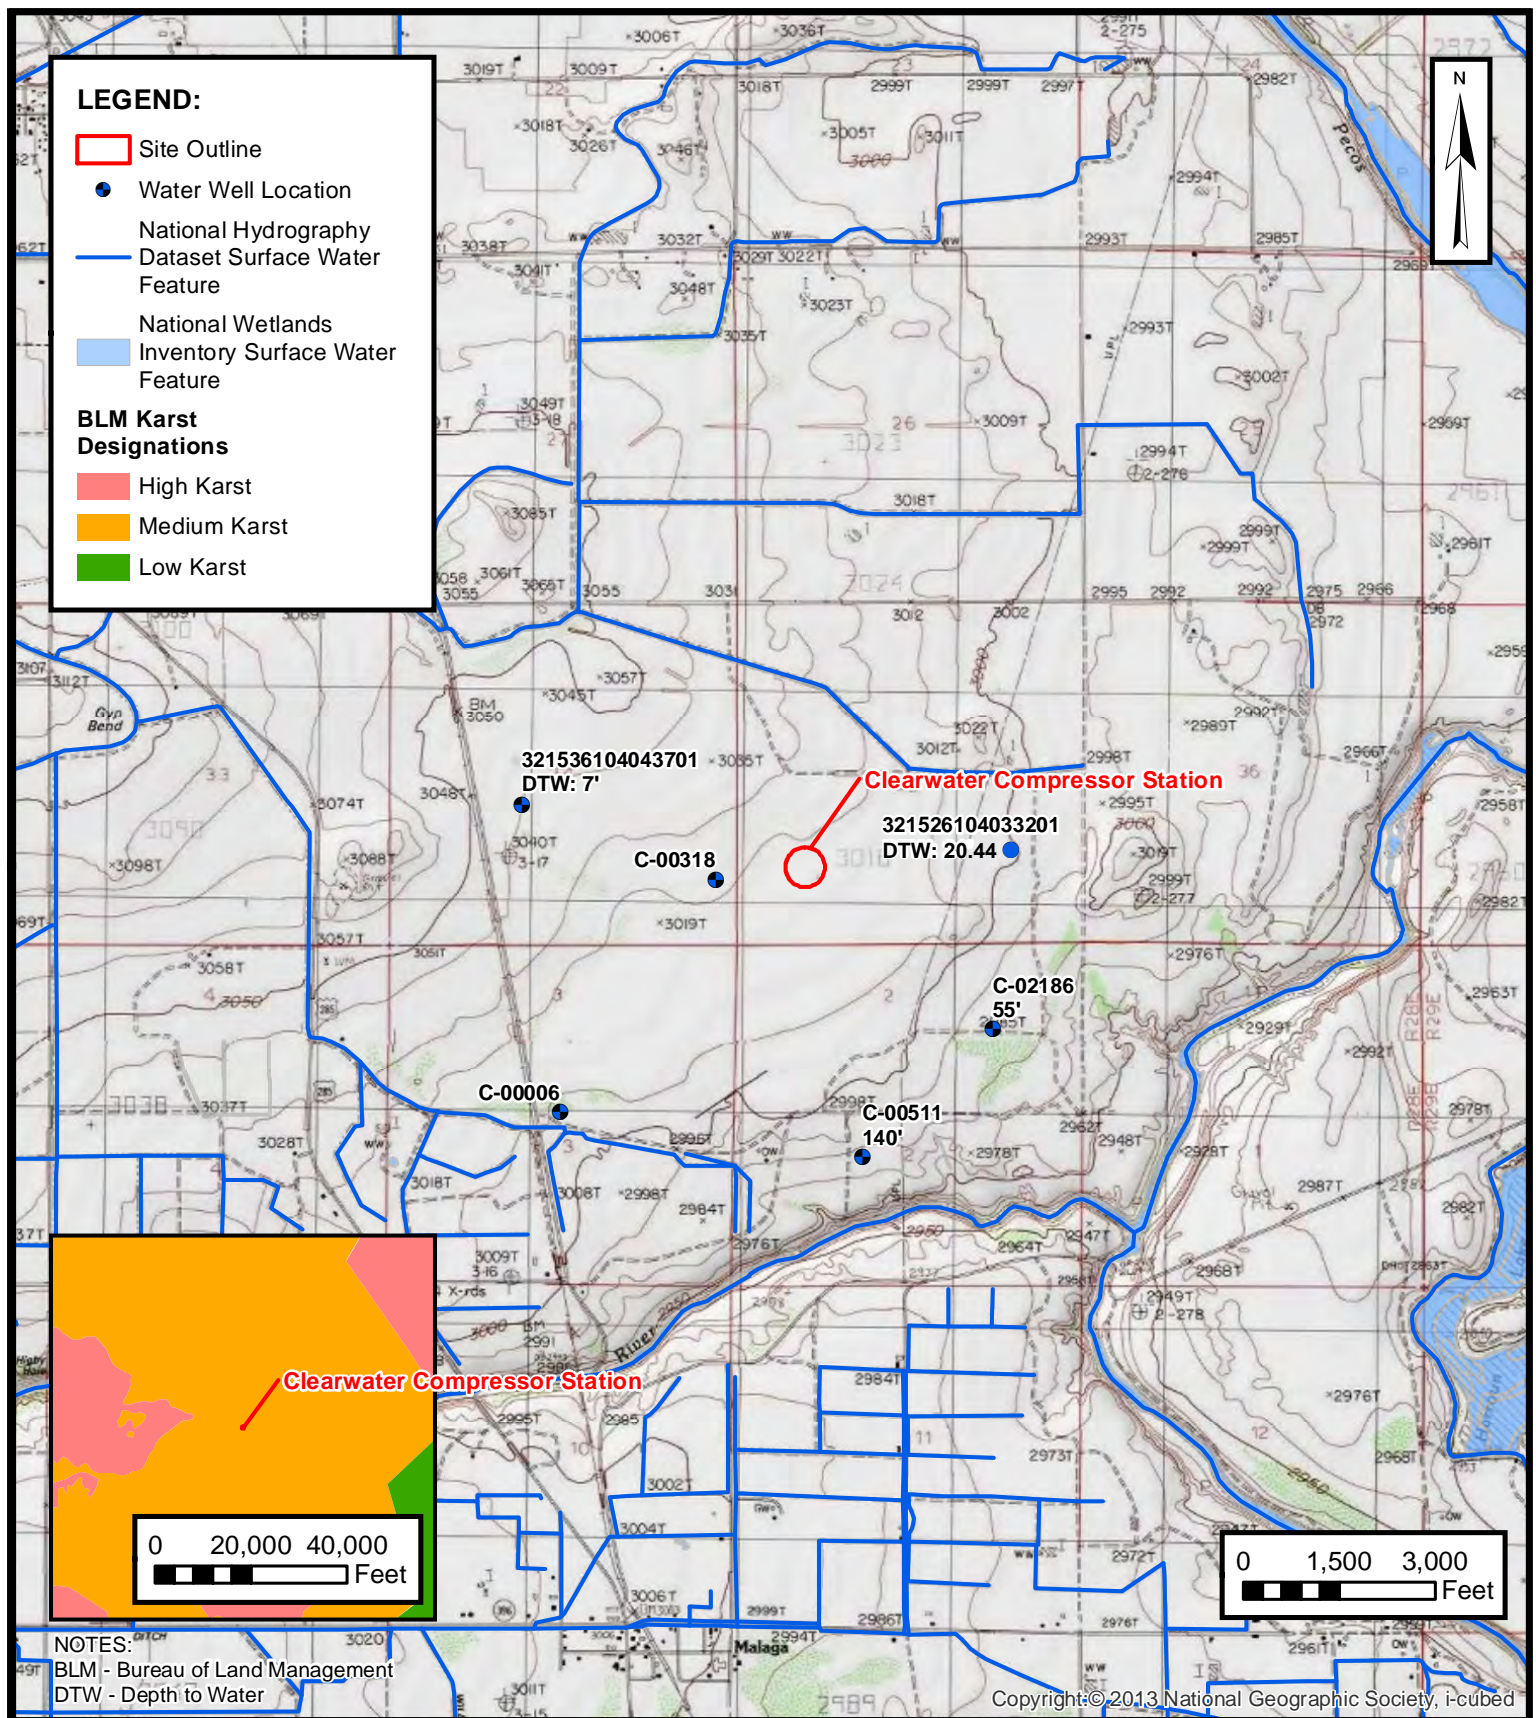
The Site is located within Eddy County, New Mexico (32.257703° N, 104.064655° W) and is associated with oil and gas exploration and production operations on Private Land (**Figure 1 in Appendix A**).

from the characterization desktop review are presented on page 3 of the Form C-141, Site Assessment/Characterization. Potential site receptors are identified on **Figure 1 in Appendix A**.

Based on the desktop review of nearby receptors and depth to groundwater determination at the Site, the following NMOCD Table 1 Closure Criteria were applied (**Figure 1 in Appendix A**):

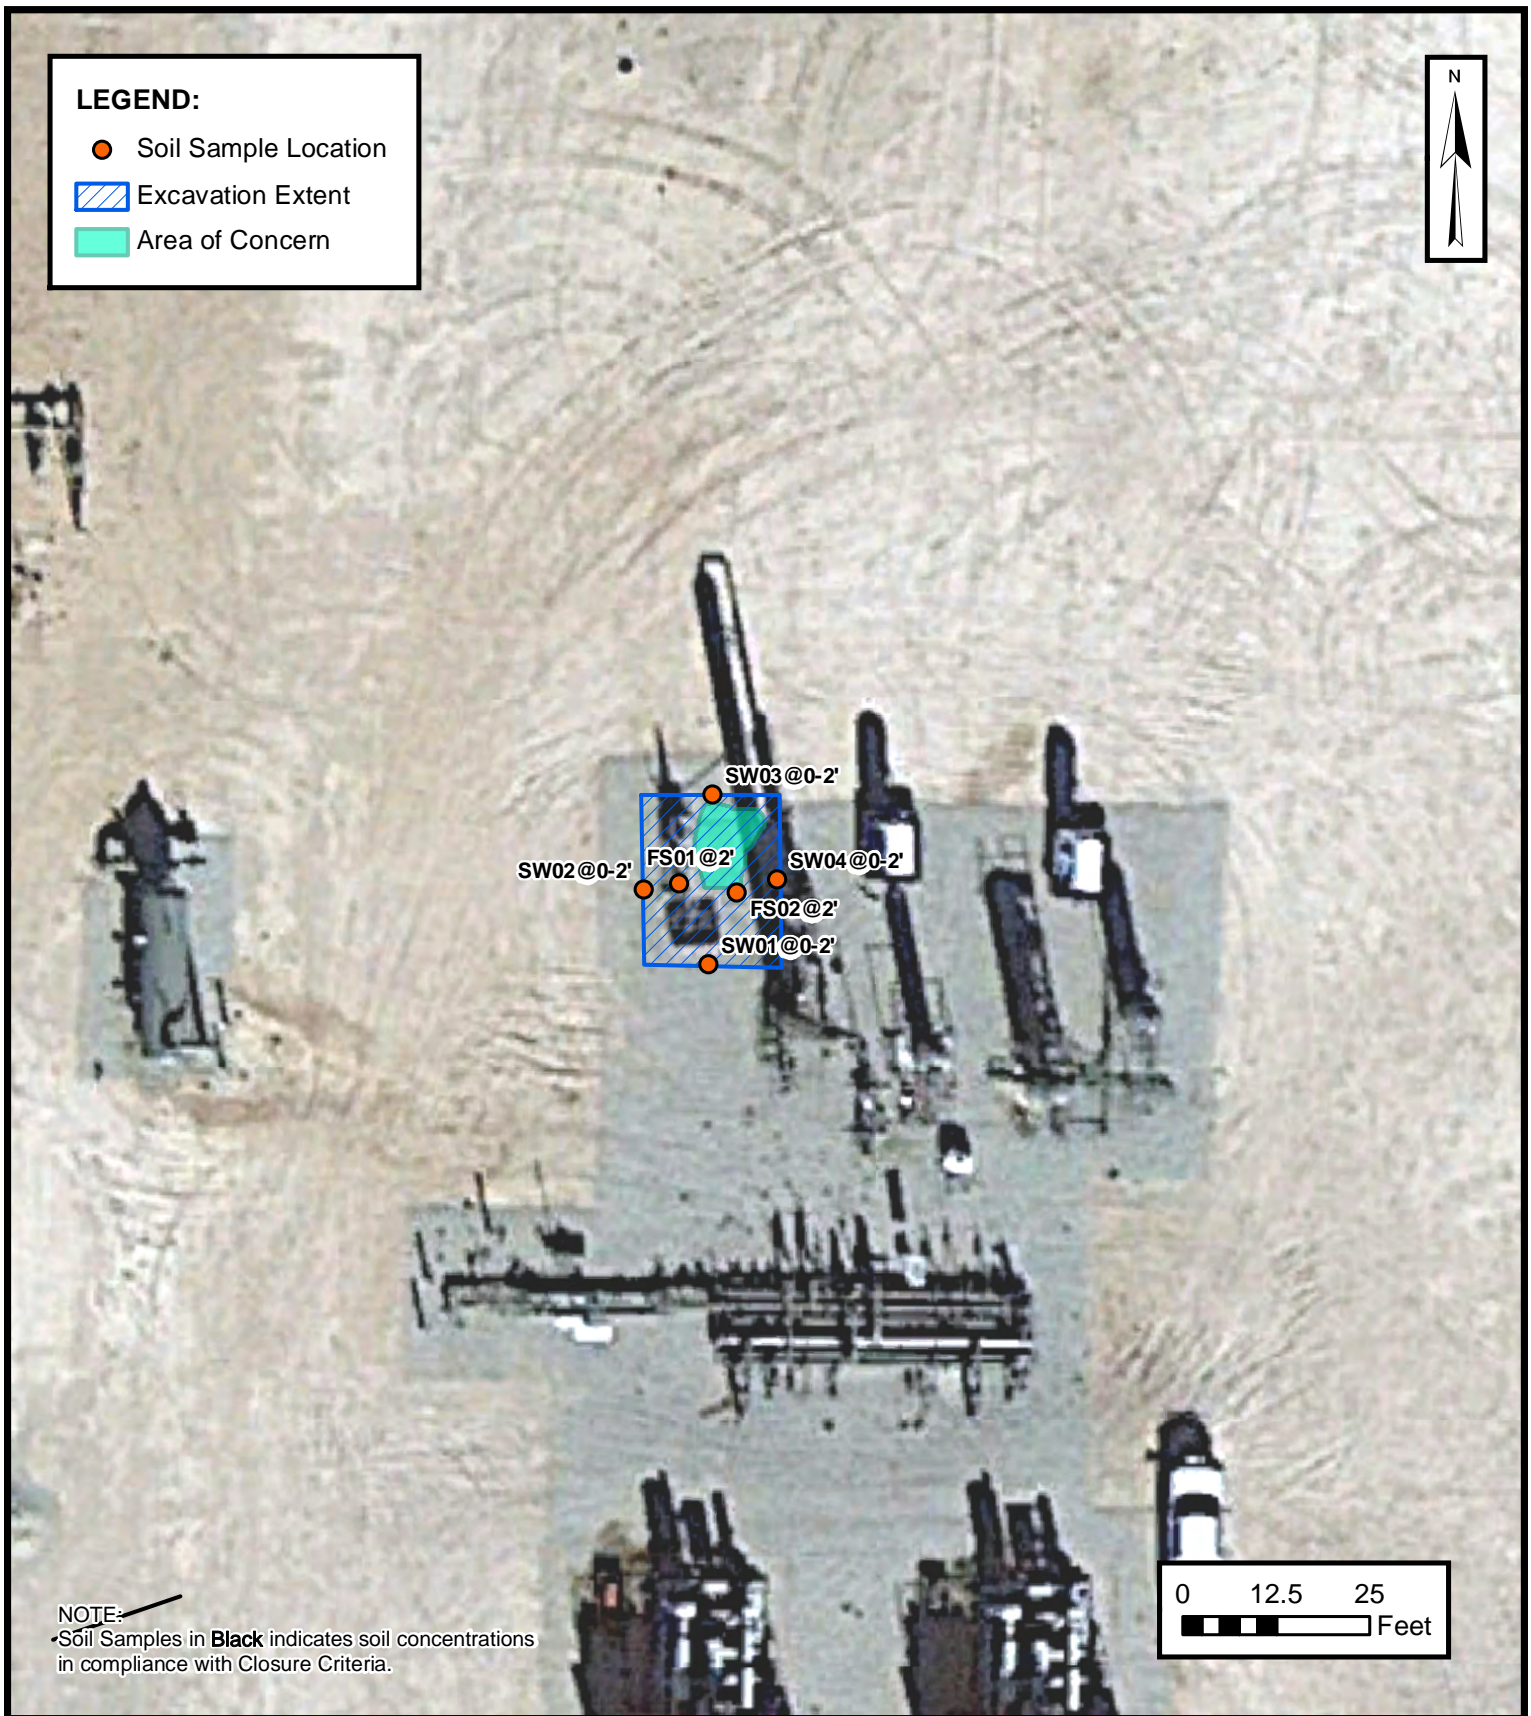
EXCAVATION SOIL SAMPLE LOCATIONS

Following removal of impacted soil, Ensolum collected composite soil samples at a sampling frequency of up to 200 square feet from the sidewalls and floor of the excavation to confirm impacted soil above the Closure Criteria was successfully removed. The 5-point composite samples were collected by placing five equivalent aliquots of soil into a 1-gallon, resealable plastic bag and homogenizing the samples by thoroughly mixing. Composite soil samples SW01 through SW04 were collected from the sidewalls of the excavation at depths ranging from the ground surface to approximately 2 feet bgs. Composite soil samples FS01 through FS02 were collected from the floor of the excavation at a depth ranging of 2 feet bgs.

The approximate extent of excavation and confirmation soil sample locations is provided on **Figure 2 Appendix A**. Photographic documentation of remediation activities is included in **Appendix C**.

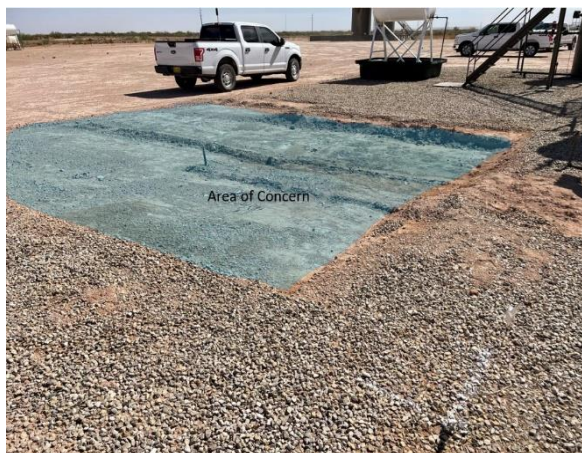
**Photograph 1**

Description: View of the Area of Concern

On September 28, 2021, a broken connection on the glycol pump sprayed glycol on the dehydrator which ignited and caused a fire. No residual glycol fluids were able to be recovered immediately. The area of concern is depicted on **Figure 2 in Appendix A**. Lucid immediately reported the release to the NMOCD via email and with a Corrective Action Form C-141 (Form C-141) on September 29, 2021. The release was assigned Incident Number nAPP2127263561. Remediation efforts were initially delayed due to the removal of production equipment to allow for impacted soil to be removed from the subject release area. Remediation activities were initiated by Lucid and subsequently assigned to Ensolum based on volume of identified stained soil in the subject release area. Ensolum submitted a 60-day extension request on behalf of Lucid which was approved by the NMOCD on April 19, 2022.

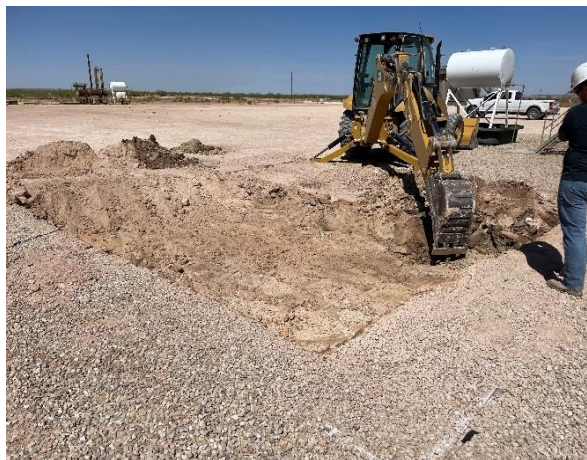
**Photograph 2**

Description: View of the Site during excavation activities

On April 20, 2022, excavation activities were conducted by Ensolum to remove impacted soil associated with the subject release area via heavy equipment. Excavation activities were directed by field screening soil within the subject release area for volatile organic compounds (VOCs) utilizing a calibrated photoionization detector (PID) and chloride using Hach® chloride QuanTab® test strips.

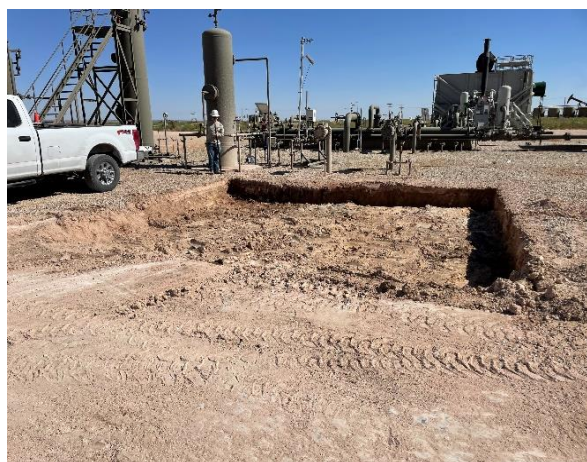
**Photograph 3**

Description: View of the Site following excavation activities

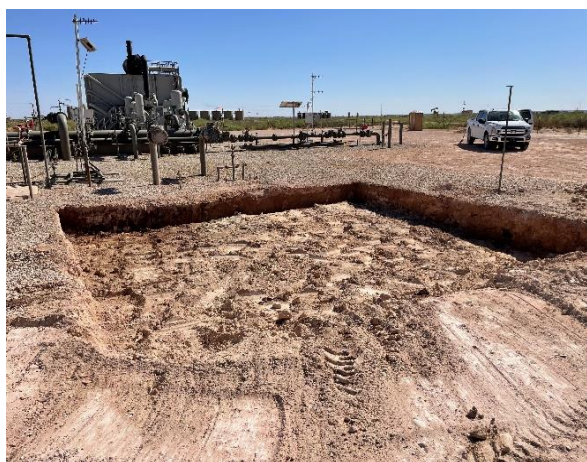
**Photograph 4**

Description: View of the Site following excavation activities
