Site Assessment/Characterization

State of New Mexico
Oil Conservation Division

Cause of Release:

Based on laboratory analytical results and field activities conducted to date, Etech recommends COG Operating, LLC, provide copies of this *Remediation Summary & Soil Closure Request* to the appropriate agencies and request closure be granted to the Raspberry 001H release site.

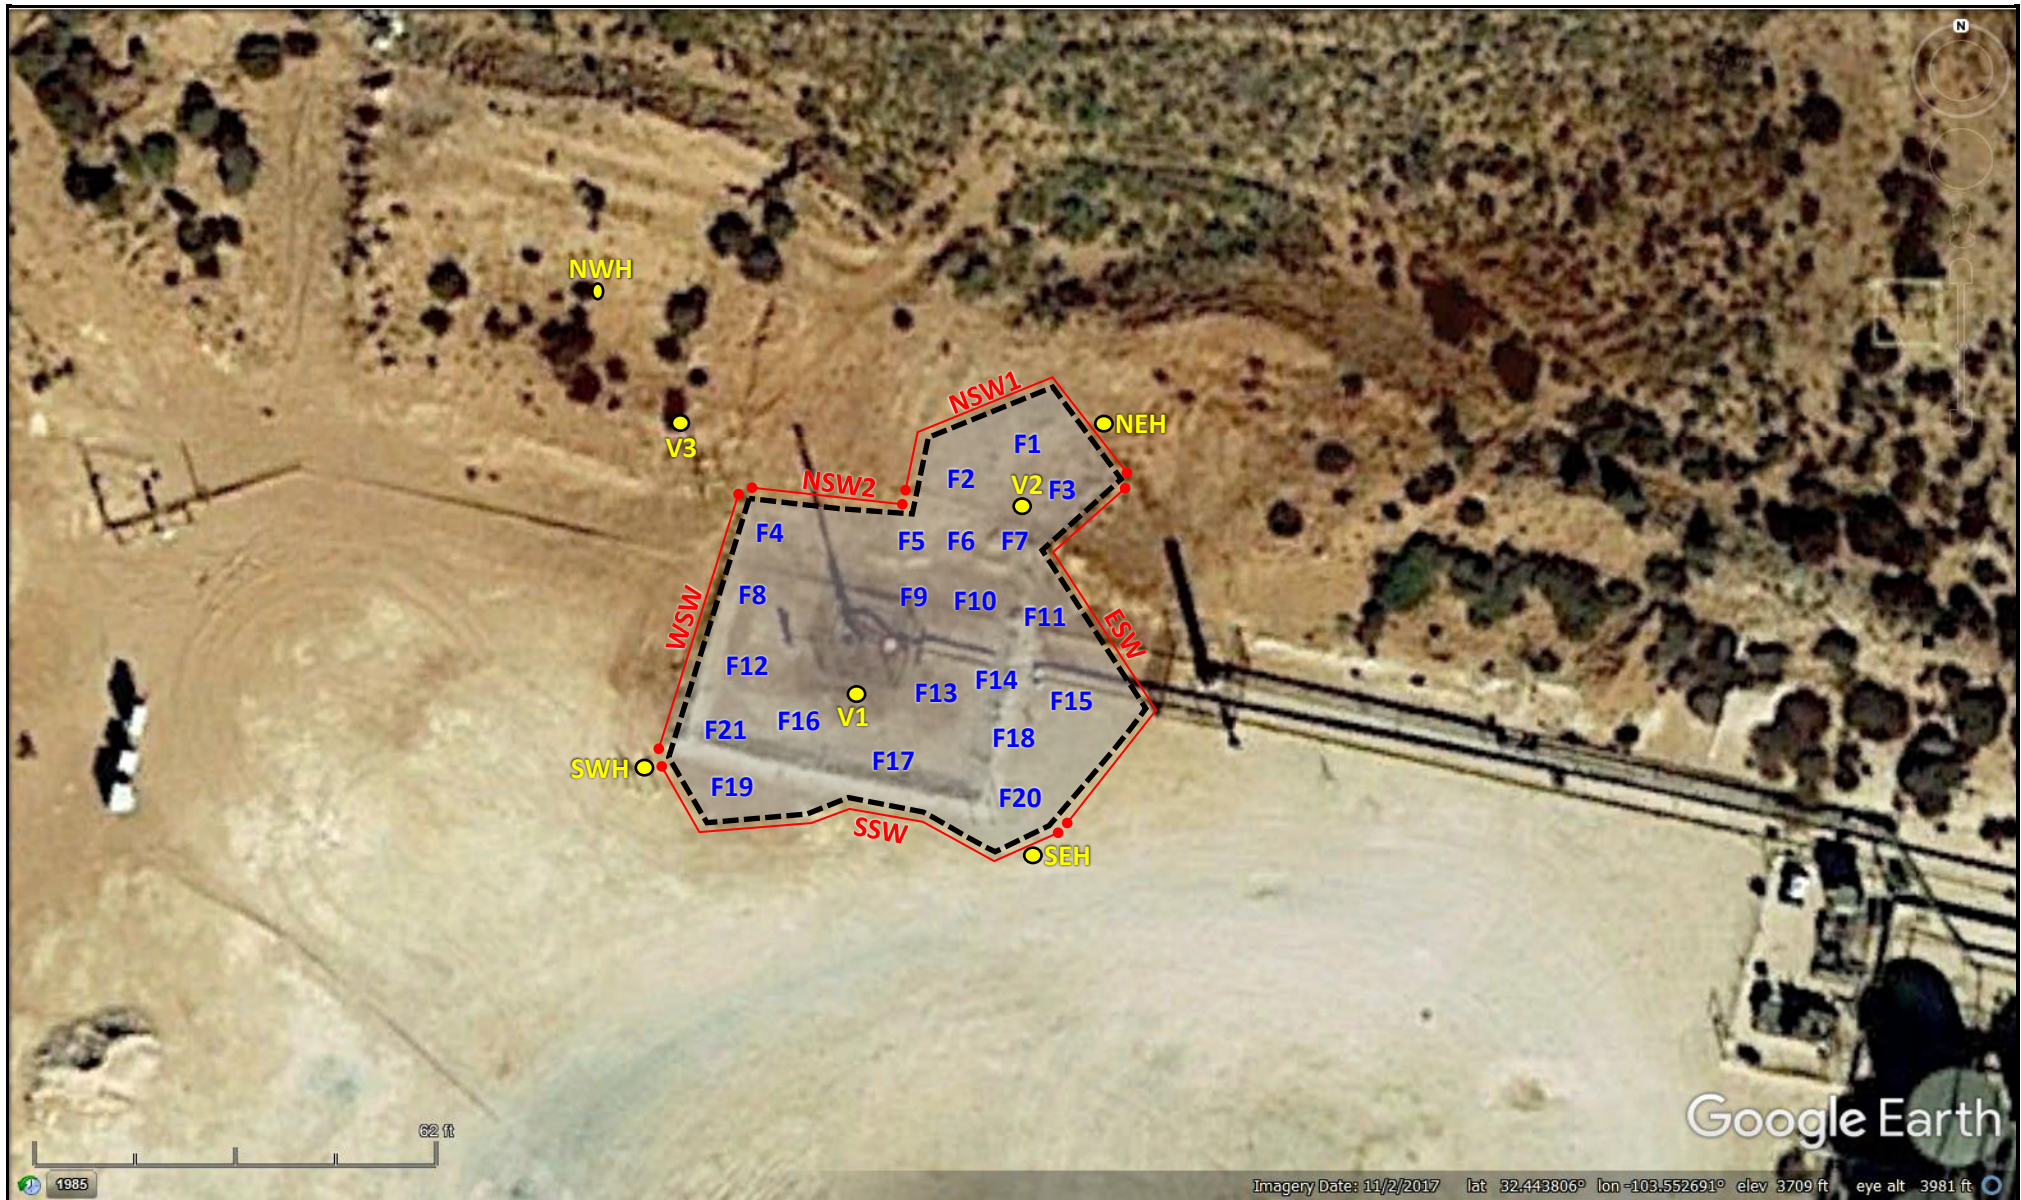
Figure 3

Site & Sample Location Map

- Excavated Area
- F# Composite Floor Sample
- Composite Wall Sample
- Delineation Sample Point

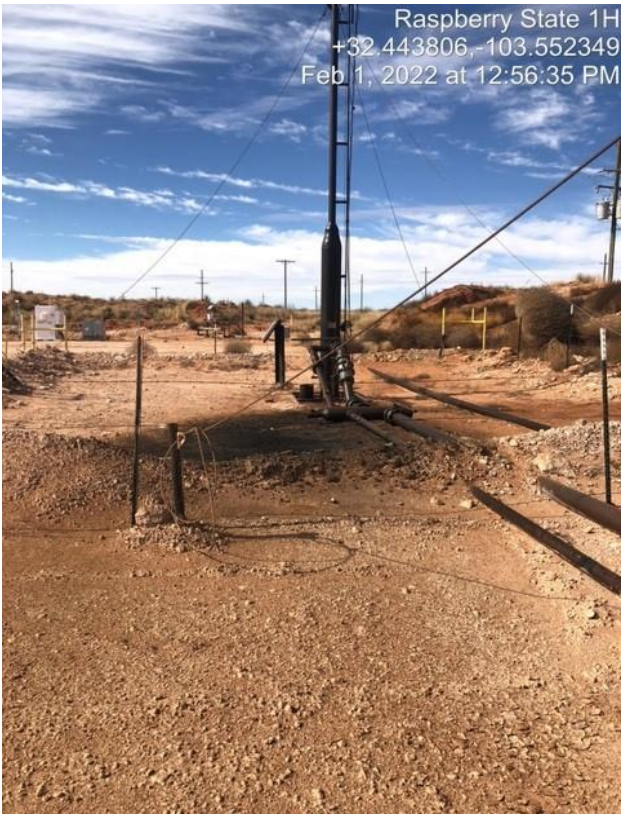
Photo Number: 1

Photo Direction: West-Northwest	
Photo Description: View of the affected area.

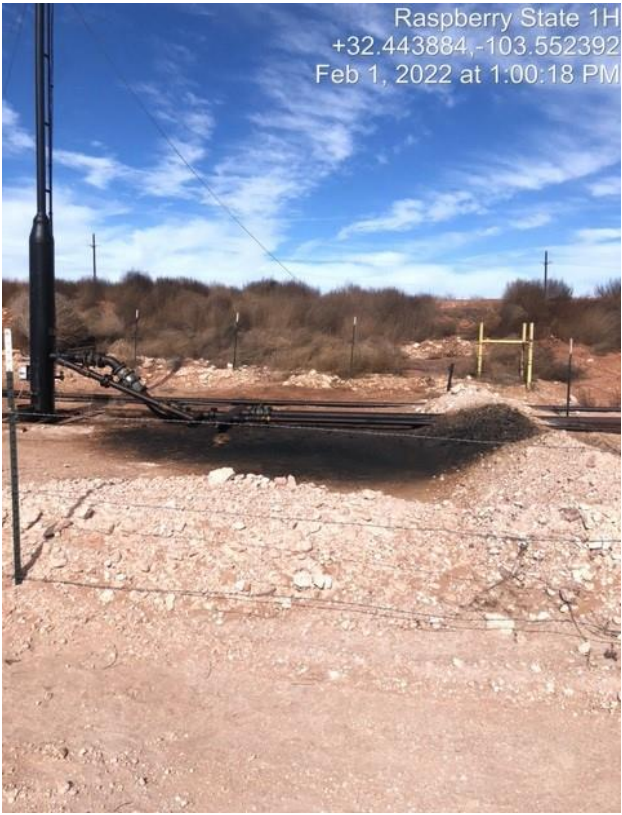
Photo Number: 2

Photo Direction: North	
Photo Description: View of the affected area.

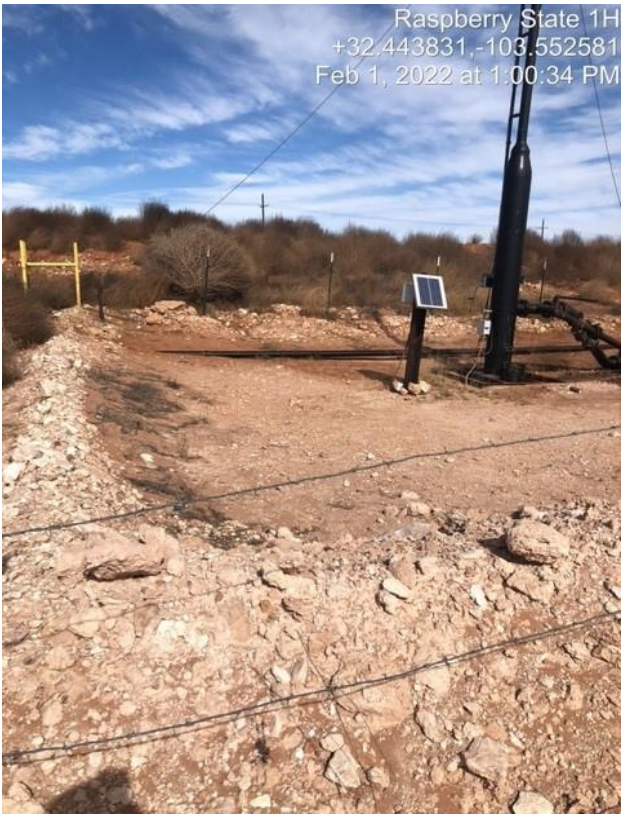
Photo Number: 3

Photo Direction: Northeast	
Photo Description: View of the affected area.

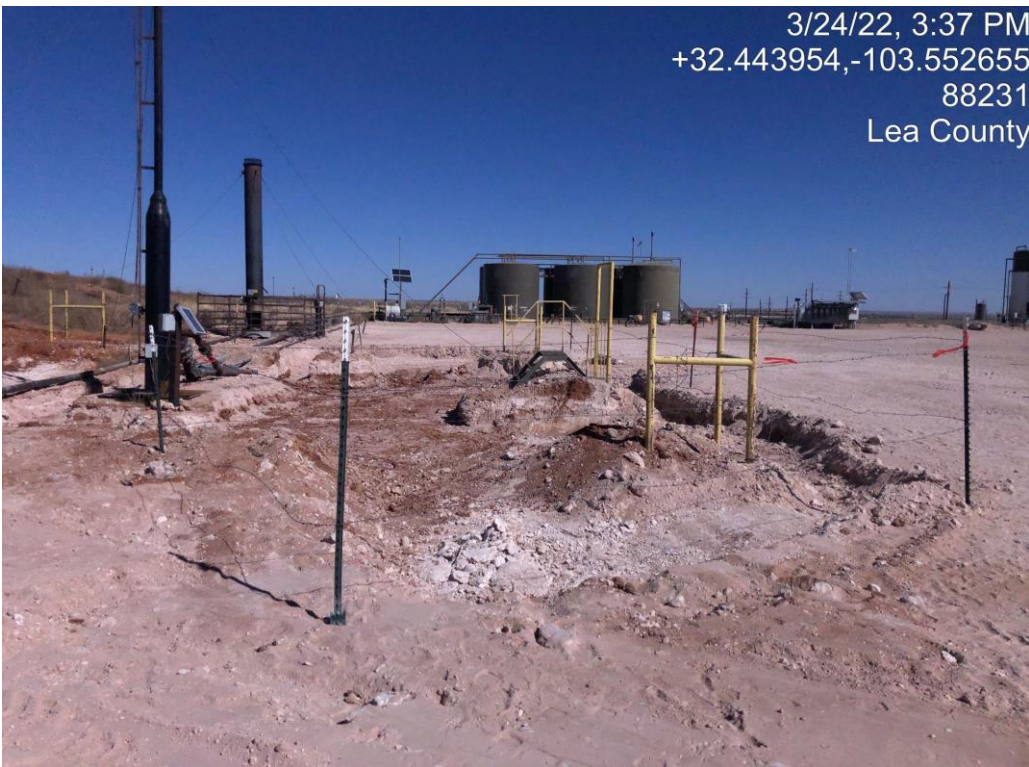
Photo Number: 5

<p>3/24/22, 3:37 PM +32.443954,-103.552655 88231 Lea County</p>
Photo Direction: East	
Photo Description: View of the excavated area.

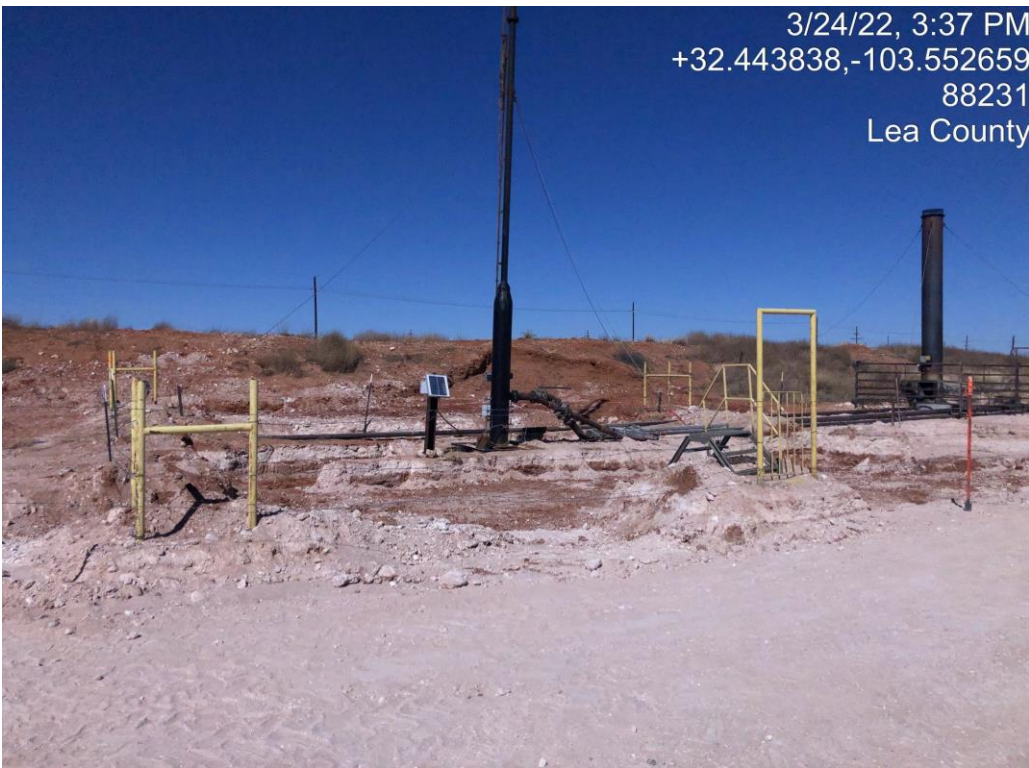
Photo Number: 6

<p>3/24/22, 3:37 PM +32.443838,-103.552659 88231 Lea County</p>
Photo Direction: North	
Photo Description: View of the excavated area.

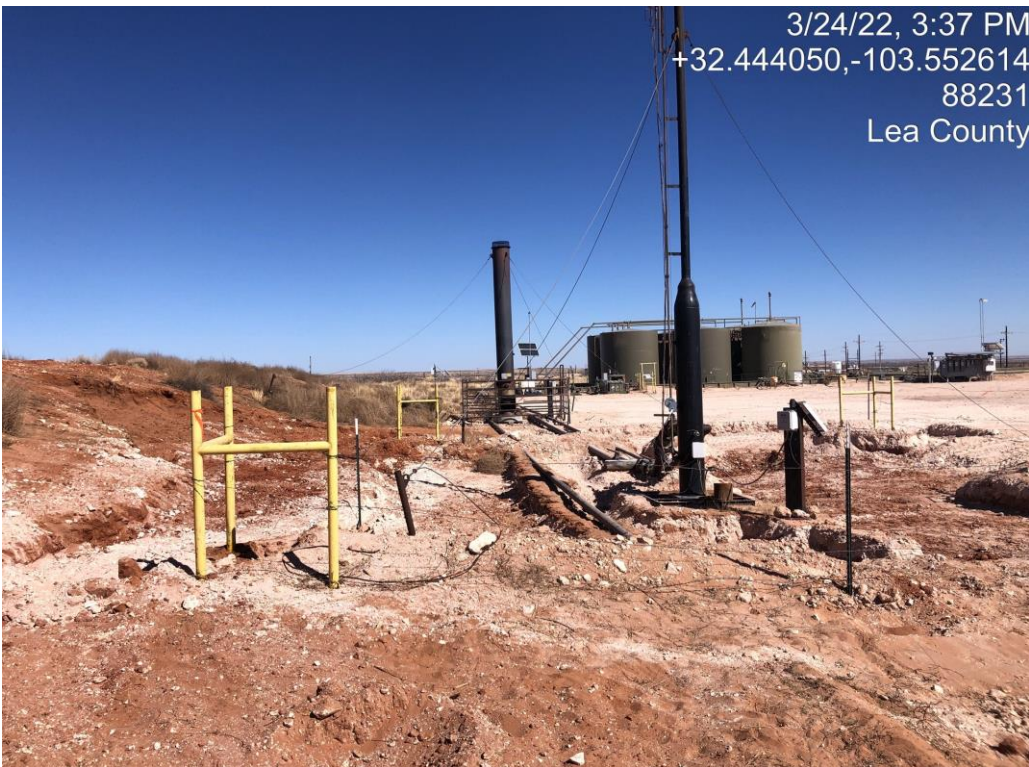
Photo Number: 7

<p>3/24/22, 3:37 PM +32.444050,-103.552614 88231 Lea County</p>
Photo Direction: East-Southeast	
Photo Description: View of the excavated area.

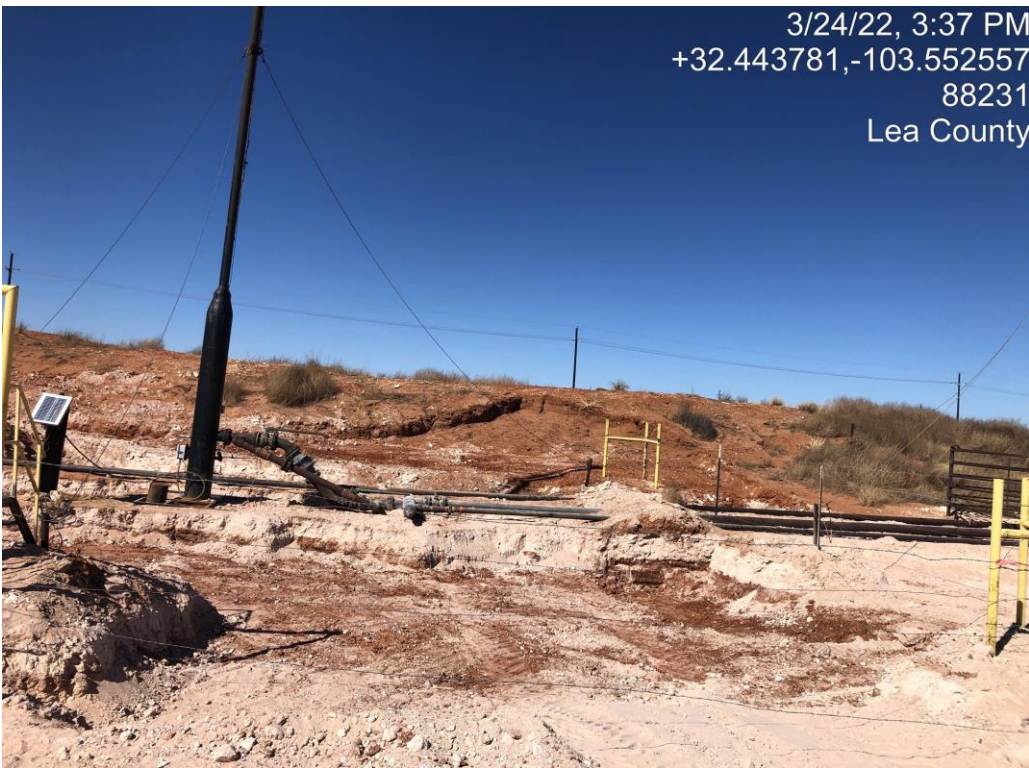
Photo Number: 8

<p>3/24/22, 3:37 PM +32.443781,-103.552557 88231 Lea County</p>
Photo Direction: North	
Photo Description: View of the excavated area.

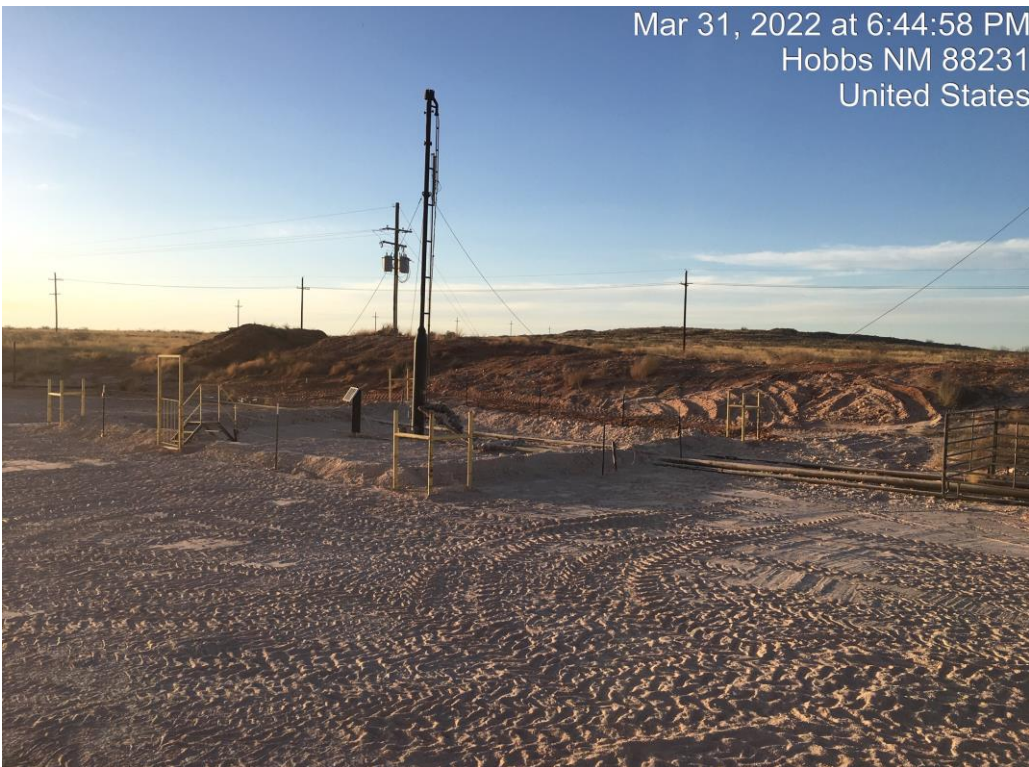
Photo Number: 9	<div>Mar 31, 2022 at 6:44:58 PM Hobbs NM 88231 United States</div>

Photo Direction: Northwest	
Photo Description: View of the remediated area after backfilling and regrading.

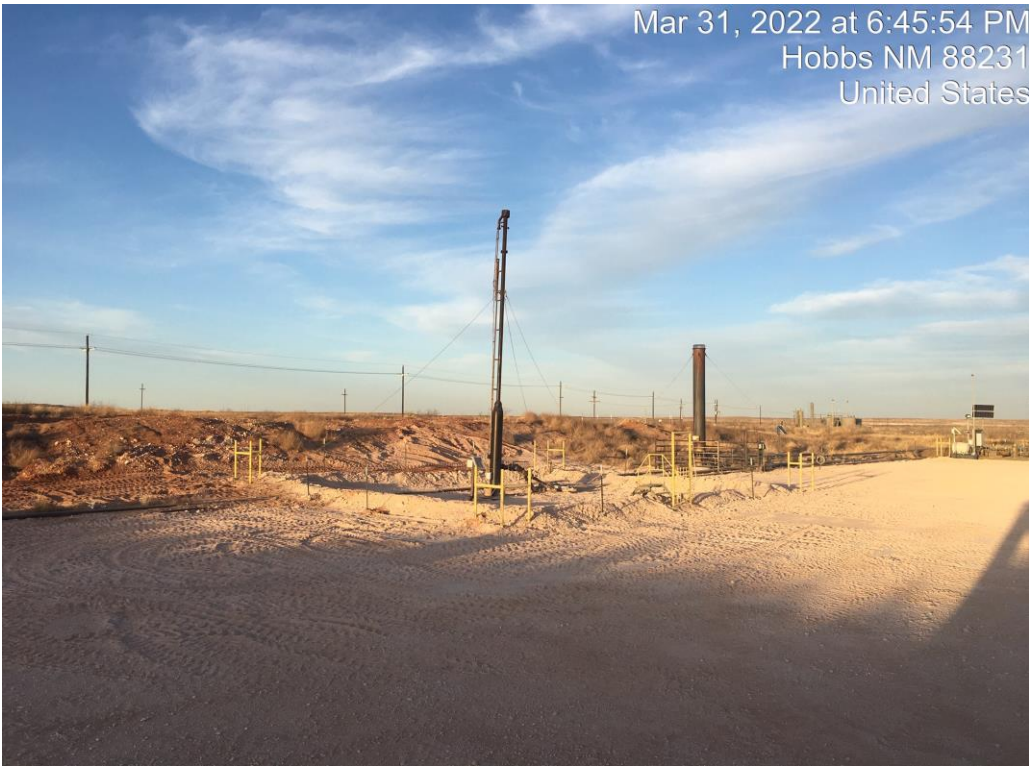
Photo Number: 10	<div>Mar 31, 2022 at 6:45:54 PM Hobbs NM 88231 United States</div>

Photo Direction: Northeast	
Photo Description: View of the remediated area after backfilling and regrading.
