Site Name Florance 18R Pipeline	Site Type Natural Gas Pipeline
Date Release Discovered 8/14/2020	API# (if applicable)

**RE: CLOSURE REPORT**  
**Florance 18R Pipeline Excavation Clearance**  
**NE¼ SE¼, Section 11, T30N, R9W**  
**San Juan County, New Mexico**

## Florance 18R Pipeline Excavation Clearance Report

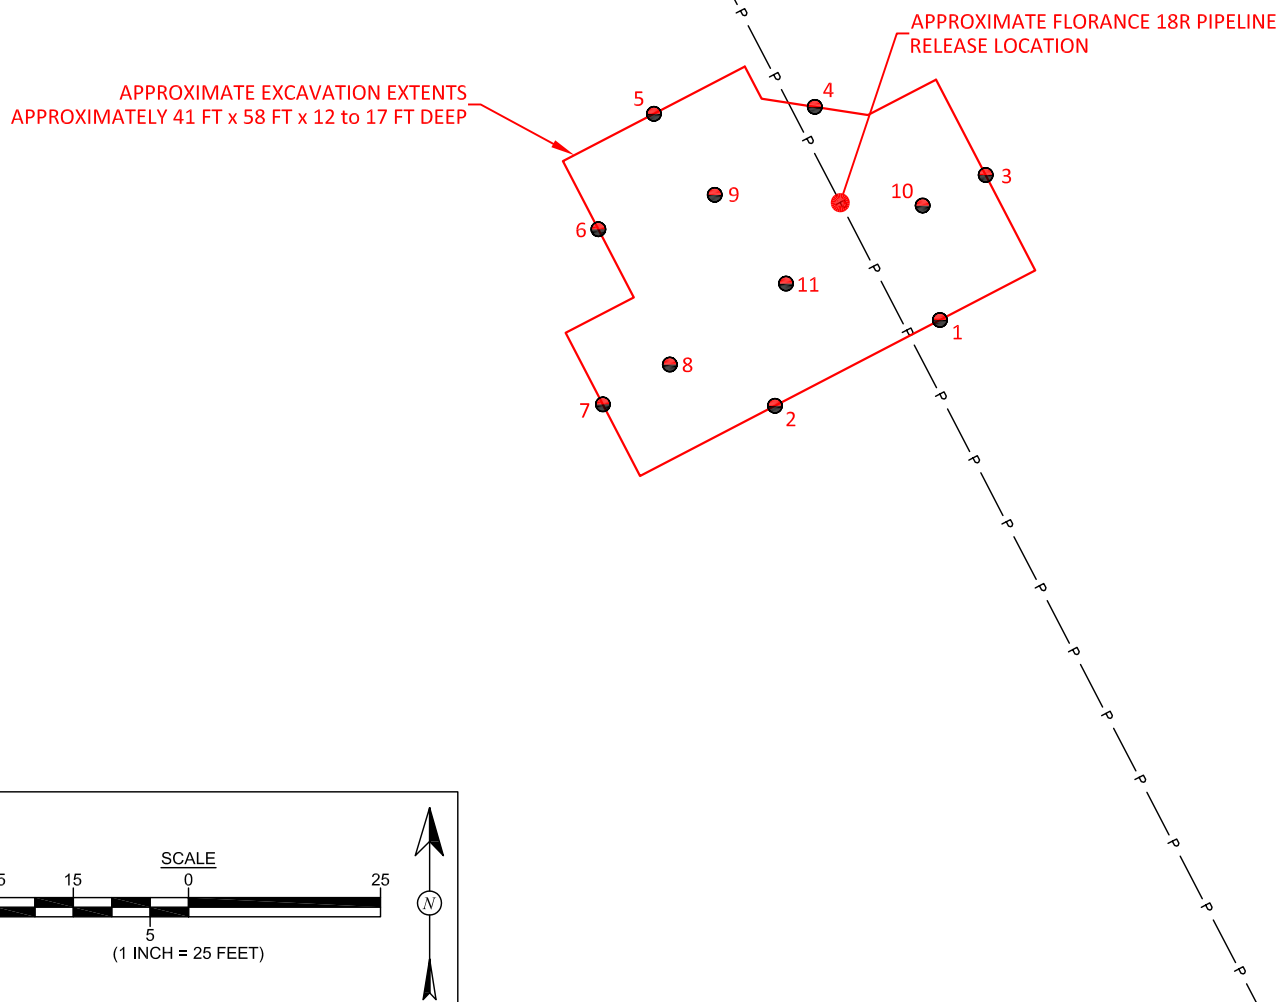
**FIGURE 3**

● SAMPLE LOCATIONS  
 — P — APPROXIMATE BURIED PIPELINE

Number	Lab Sample ID
1	North east wall
2	East wall south end
3	North Wall
4	West wall north end
5	West wall south end
6	South wall west end
7	South wall east end
8	South bottom east side
9	West bottom
10	North bottom
11	East side bottom

All samples were composite samples.

**EXCAVATION AREA MAP  
 AND SOIL SAMPLE LOCATIONS**  
 HARVEST MIDSTREAM  
 FLORANCE 18R PIPELINE  
 NW¼ SW¼, SECTION 11, T30N, R9W  
 SAN JUAN COUNTY, NEW MEXICO  
 N36.823825, W107.755538

Initial soil samples were collected by Harvest on September 2, 2020. However, because of the presence of damage to the environment in the form of substantial dead vegetation, which qualified the release as “major”, soil confirmation samples were collected under oversight of NMOCD and Harvest on September 9, 2020. Notification of soil confirmation sampling was made to NMOCD on September 4, 2020. Soil confirmation sampling activities included collection of 11 confirmation soil samples from the walls and base of the excavation. Sample locations are presented on Figure 3, and project notification is attached.

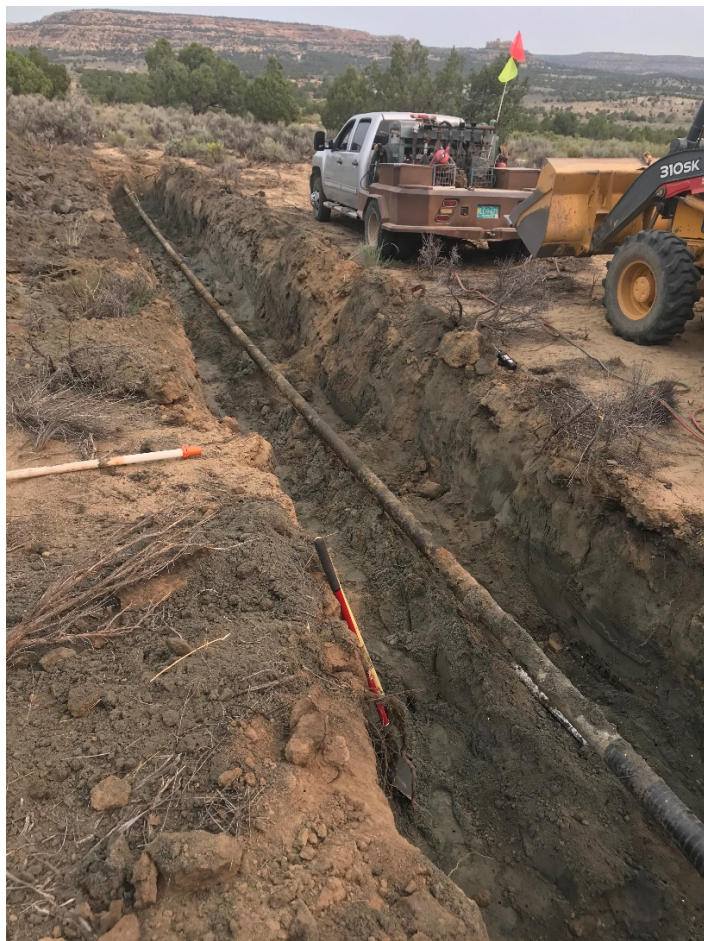
Photo 1: Excavation Around 4-Inch Pipe.

the line was blocked in and depressurized. Gas loss was reported at 3.80 Mcf with no liquids. On August 19, 2020, Harvest personnel dug out the 4-inch pipeline and discovered a 1/4-inch x 1/8-inch hole present. Soil staining and an odor were present. Approximately 84 ft of pipe was replaced and 500 to 600 yards of historic contaminated soil were excavated. Line repairs are complete. Cory Smith of NMOCD was informed of the release on September 4, 2020, via email.

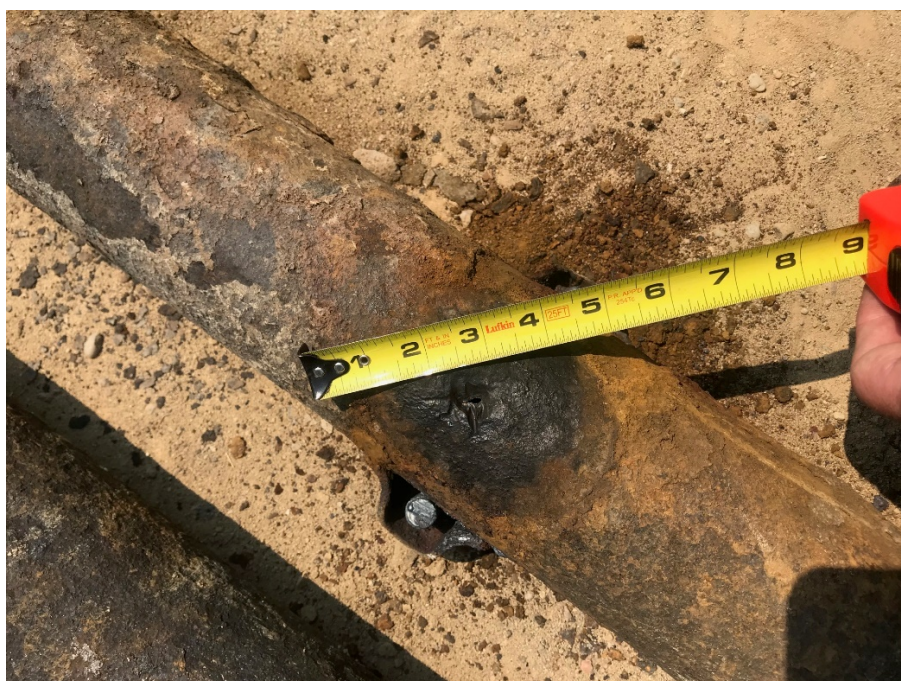
Photo 2: Hole in 4-inch pipe.

Leak was below-ground and has been repaired.
