# **Release Notification**

#### Remediation Narrative

#### Rincon Unit 133R

Enduring Resources, LLC Incident Report Rincon 133R Tank Release

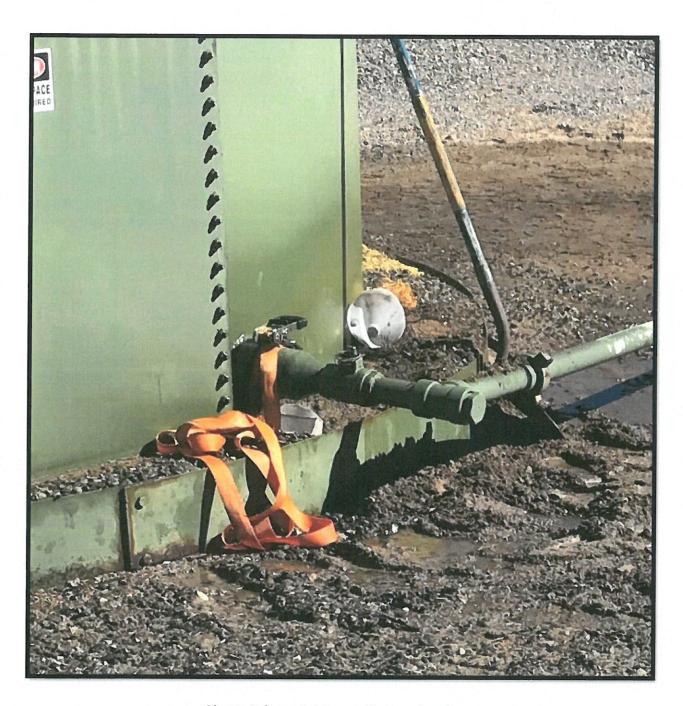
An Enduring Lease operator discovered a release at the Rincon Unit 133R wellsite. It was discovered that the release came from the water draw line of the condensate tank when a hole formed on the threads of a swedge caused by corrosion. 6.7 bbls of condensate released from the tank staying inside of the secondary containment area. The volume of the release was determined by the level inside the tank before the release and the level after the release was stopped. 6ft 1"(108.79bbls) was the level before the release occurred and 5ft 9"(102.11bbls) was the level after the release was stopped. See attached "Photo Page" for reference.

Photo: Release Point were Orange strap is.

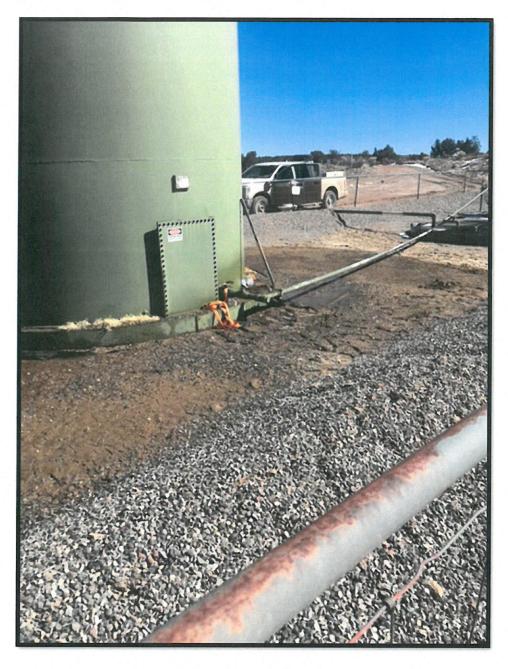
Photo: Contaminated area

Excavation was completed. Removing a total of 254 yards of contaminated soil. The excavation area measured 30ft L x 26ft W x 4ft deep. Email notification was sent to the NMOCD and the BLM scheduling confirmation sampling for March 2<sup>nd</sup> 2022 beginning at 9:30am. See attached "Email Notification" for reference.

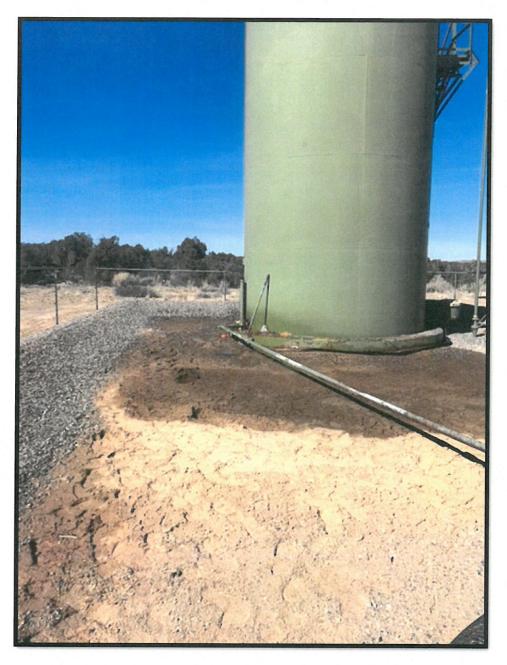
Photo: Contaminated area

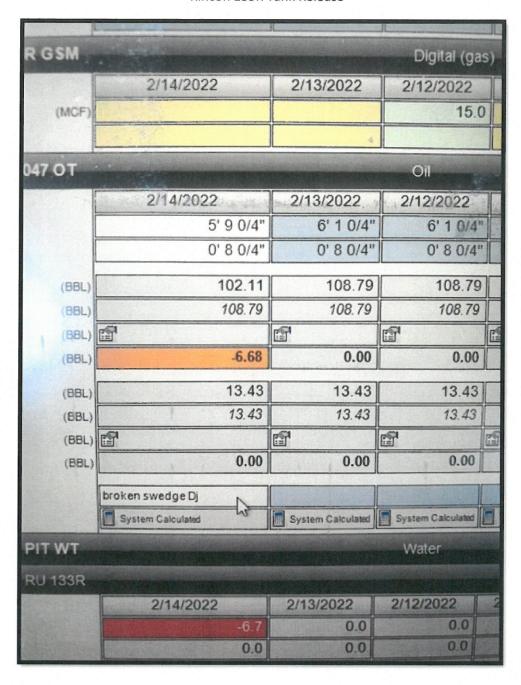
## TANK GUAGE READING AT RINCON 133R

BEFORE SP 6'1" 108.79 AFTER 5'9" 102.11 RELEASED 6.68

Photo: Spill Amount Calculations Based on Tank Gauge Before/After

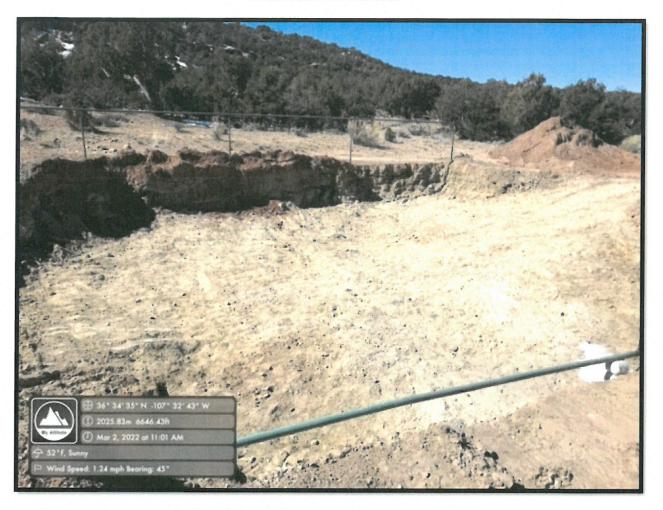
Confirmation sampling activities took place with Abiodun Adeloye (Emanuel) of the BLM on site to witness. A total of seven composite samples were collected and sent in for lab analysis of TPH (DRO,GRO,ORO), BTEX and Chlorides. The four "Bottom" samples collected measured 26ft x 7.5ft totaling 195 square ft for each section. Three "Wall" samples were collected which the "North and South

Wall" measured 30ft x 4ftD equaling 120 square foot. The East wall measured 26ft x 4ft D equaling 104 square foot.

Photo: Sampling event facing toward "South Wall"

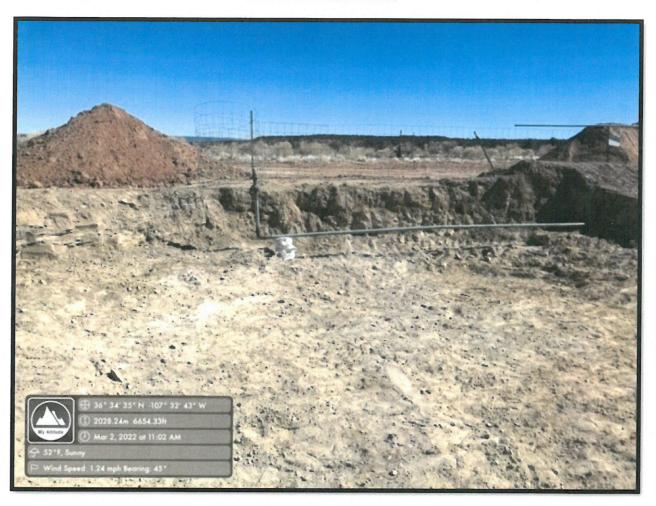
Photo: Sampling Event facing "North Wall"

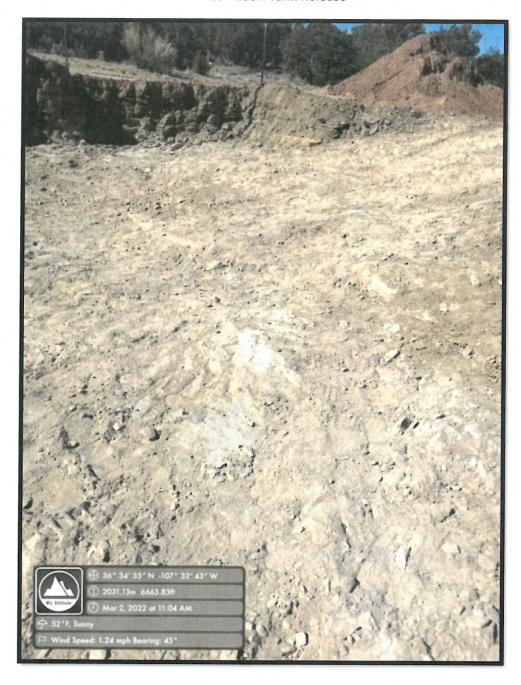
Photo: Sampling event picturing bottom

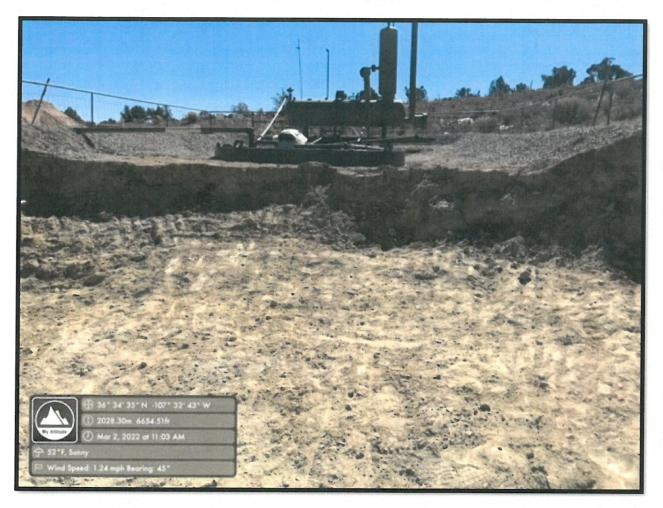
Photo: Sampling event facing "East Wall"

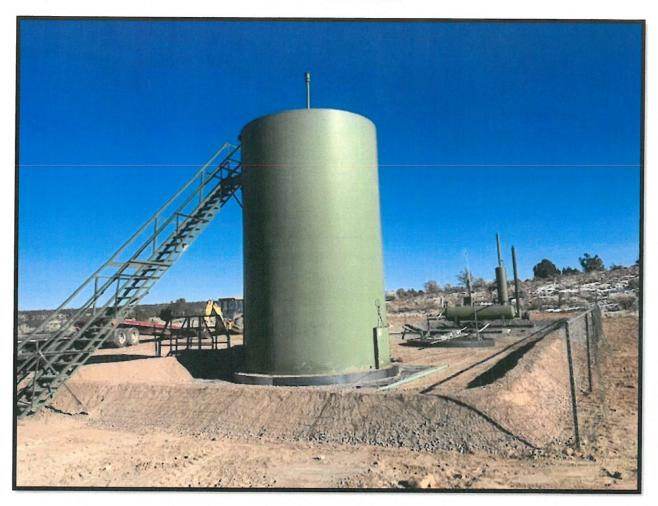
Photo: Area backfilled and tank set.

Backfill and reconstruction was completed. All necessary documents/maps are attached for reference. No further action is required at this time.
