**SITE ASSESSMENT/CHARACTERIZATION UPDATE AND  
PROPOSED REMEDIATION PLAN**

**STATE CO SWD SYSTEM (CATCLAW/HUISACHE BATTERY)  
UNIT H, SECTION 2, TOWNSHIP 20S, RANGE 24E  
EDDY COUNTY, NEW MEXICO  
32.60527, -104.55187  
RANGER REFERENCE NO. 5375**

**JULY 5, 2022**

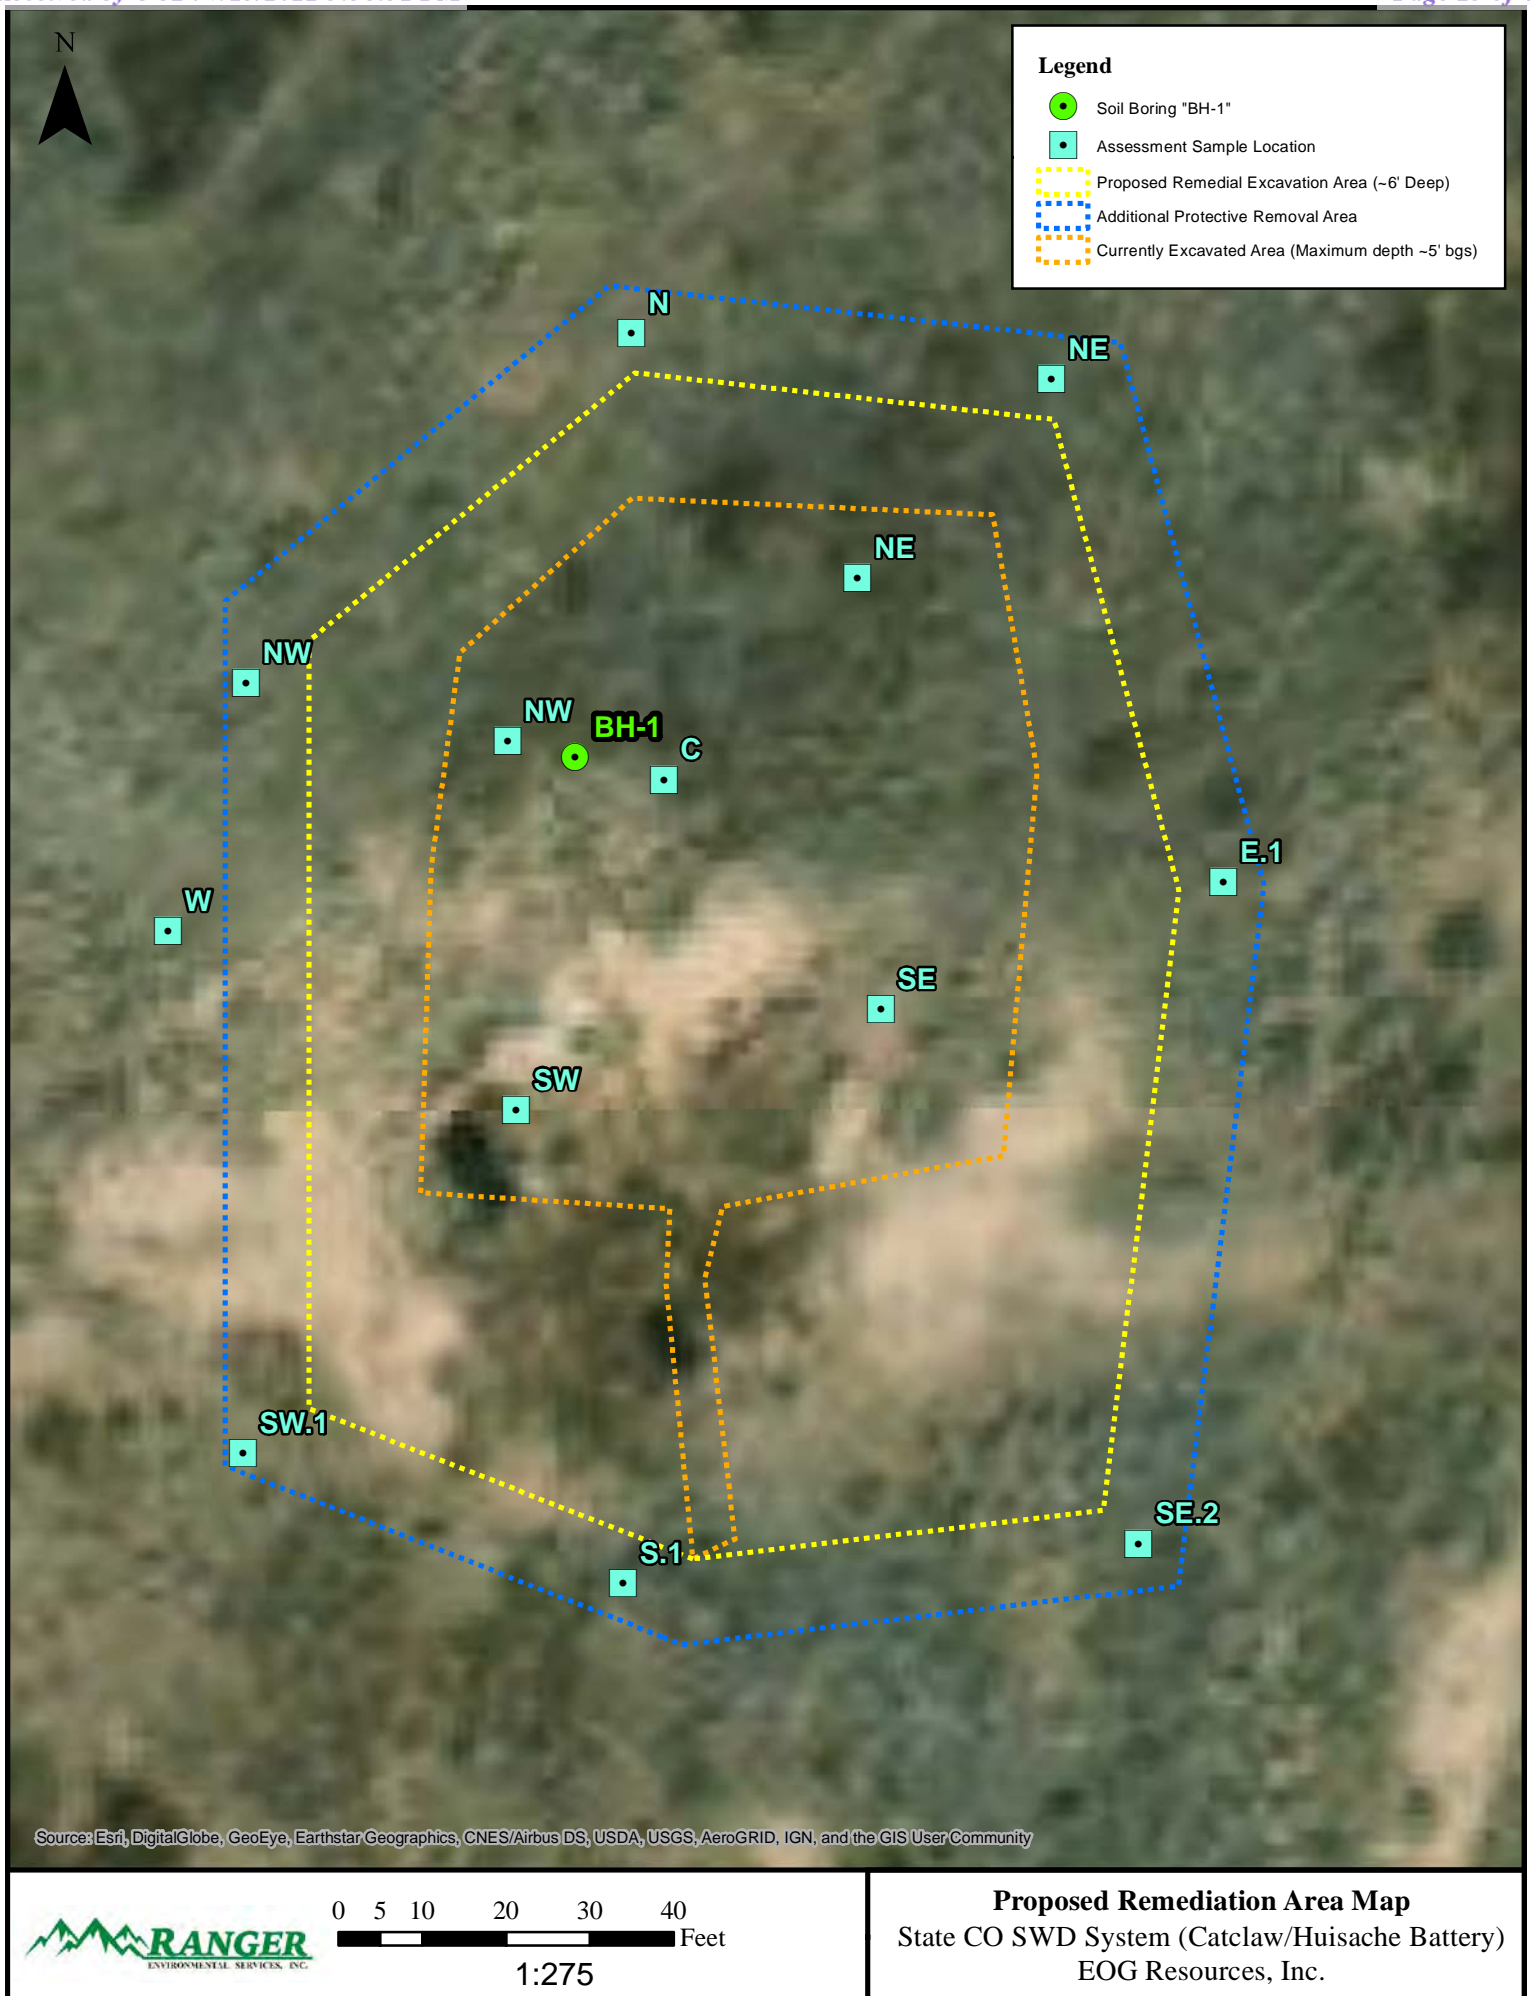
\*Confirmaiton samples from the excvaton side walls will be collected in accordance with NMAC 19.15.29.12(D), as five-part composite samples with each sample representing no more than 200 square feet.

Currently Excavated Area (Maximum depth ~5' bgs)

Upon completion the final extent of the excavation area is anticipated to be primarily rectangular in shape and is anticipated to have maximum dimensions of approximately 162 feet wide by 123 feet long. A site map depicting the proposed excavation areas is attached.

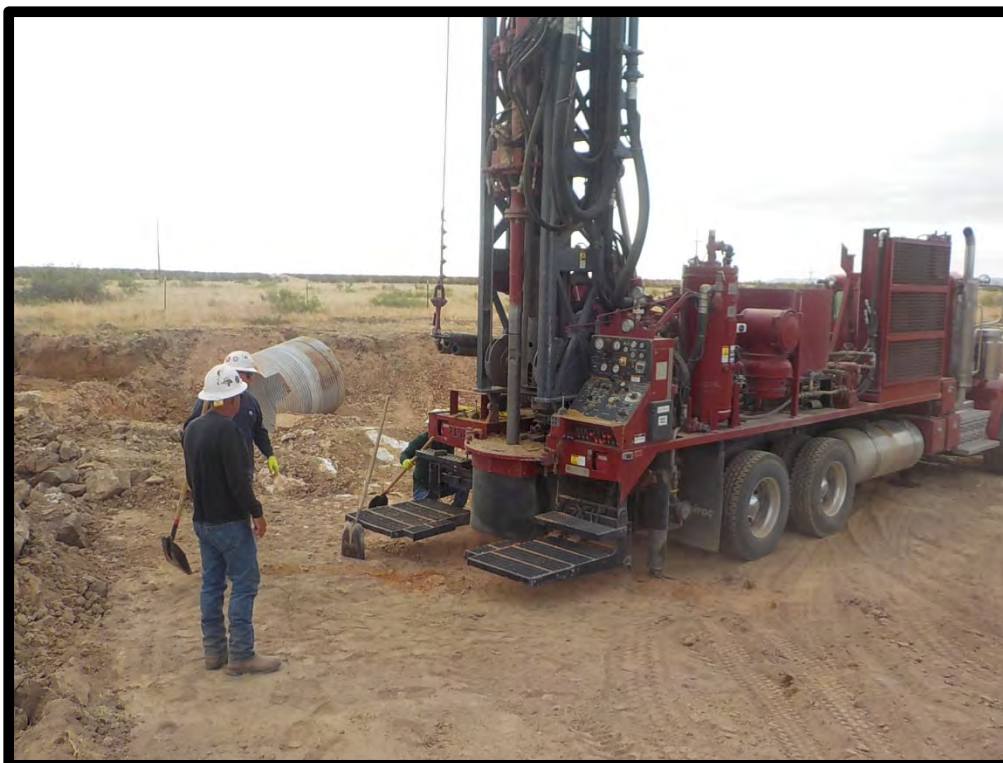
**PHOTOGRAPH NO. 1 – A view of the Site during the May 24, 2022, soil boring activities. The view is towards the northeast.**

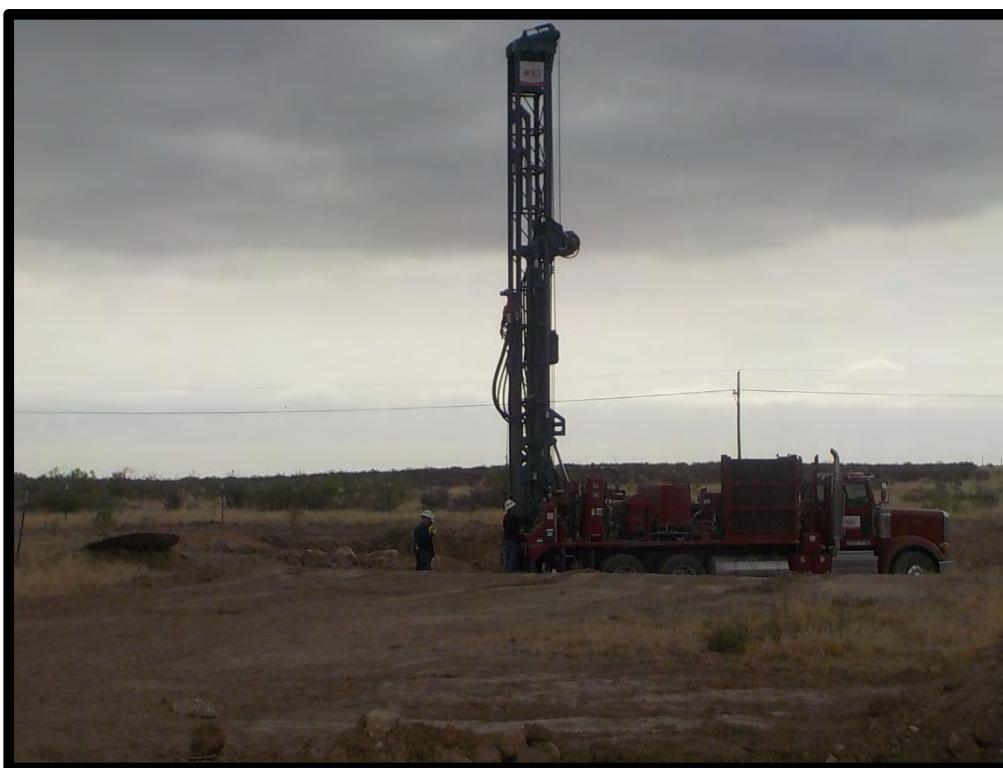
**PHOTOGRAPH NO. 2 – An additional view of the Site during the May 24, 2022, soil boring activities. The view is towards the northeast.**
