Release Notification

Closure

RE: Closure Report
Incident ID: nAPP2217150365
AEP #: 20220511-1216-hydrovac
Location: Merchant State Unit 504 "B" Pad

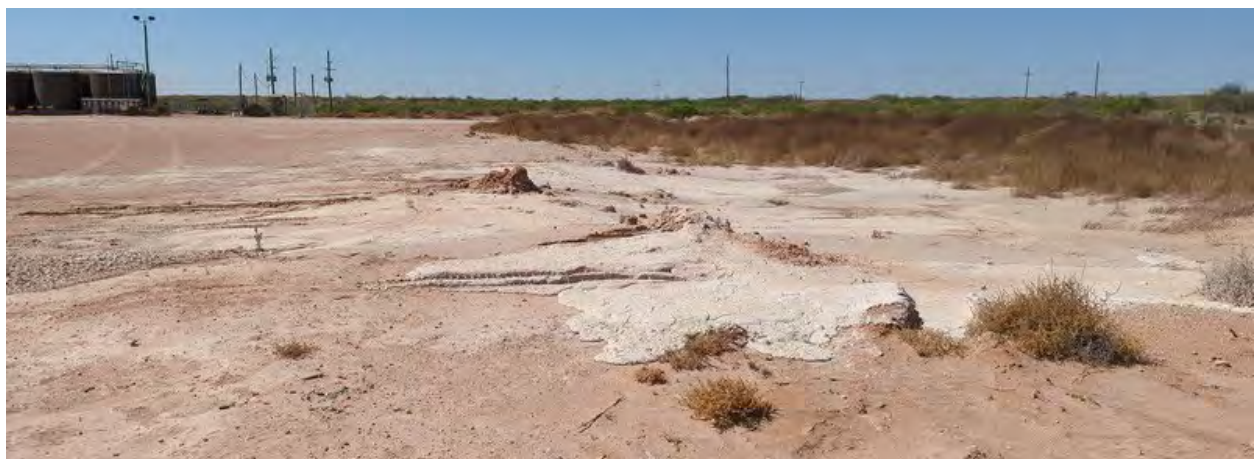
The unauthorized release was discovered on May 5, 2022, on the NW corner of Merchant State Unit 504 "B" Pad. Surface is owned by Merchant Livestock. Field investigations suggest that a hydrovac released excavated soil (Figure 1) after performing surface trenching for construction purposes for the installation of flowlines and electrical associated with oil and gas operations. The release extent covered approximately 614 sq feet and had a maximum thickness of approximately 1 ft.

Figure 1: Photo of release viewing south-southwest from the north-northeastern extent of the release.
GPS: 32.4424608 N, 103.5396967 W. Date/Time: 2022-05-05 10:08:53

On May 19, 2022; approximately 23 cubic yards of source material was removed and hauled offsite for proper disposal.

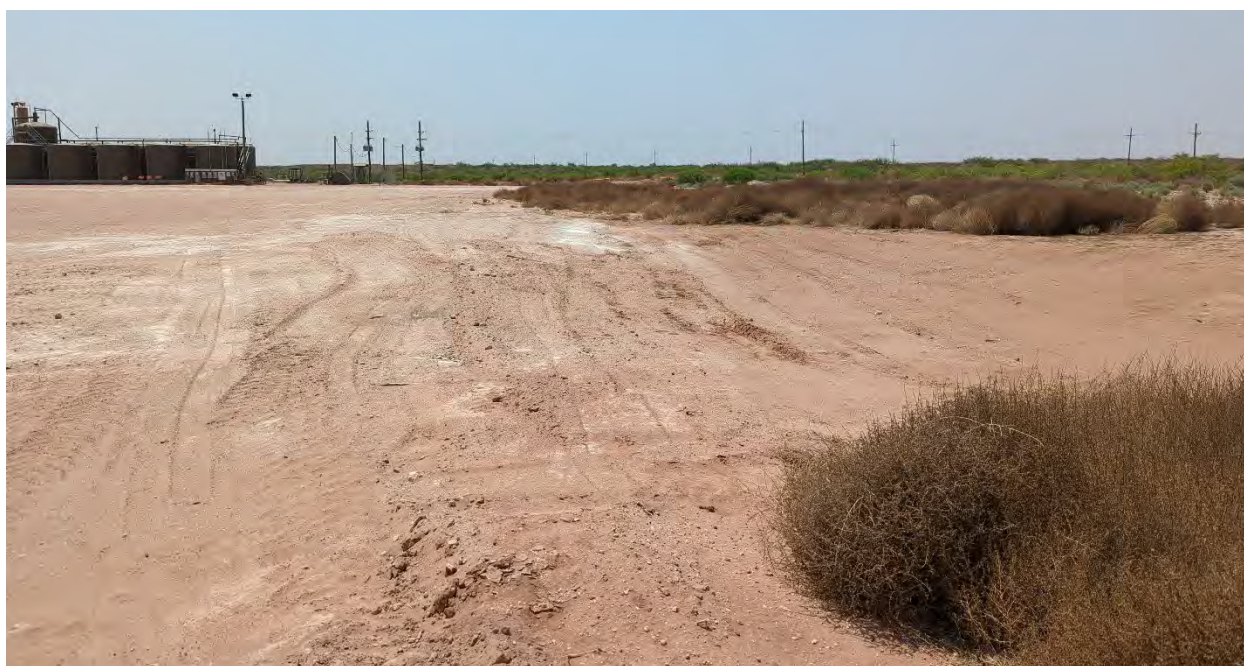
The surface was restored per 19.15.29.13.A-C NMAC to prior existing condition as an active production pad.

Figure 2: Restored surface viewing south-southwest from north-northeastern extent of the release.
GPS: 32.4425147 N, 103.5397081 W. Date/Time: 2022-05-19 11:43:27
