# Release Closure Report

## Lybrook D 22 2206 #1H

API #30-043-21131

Project #17035-0250

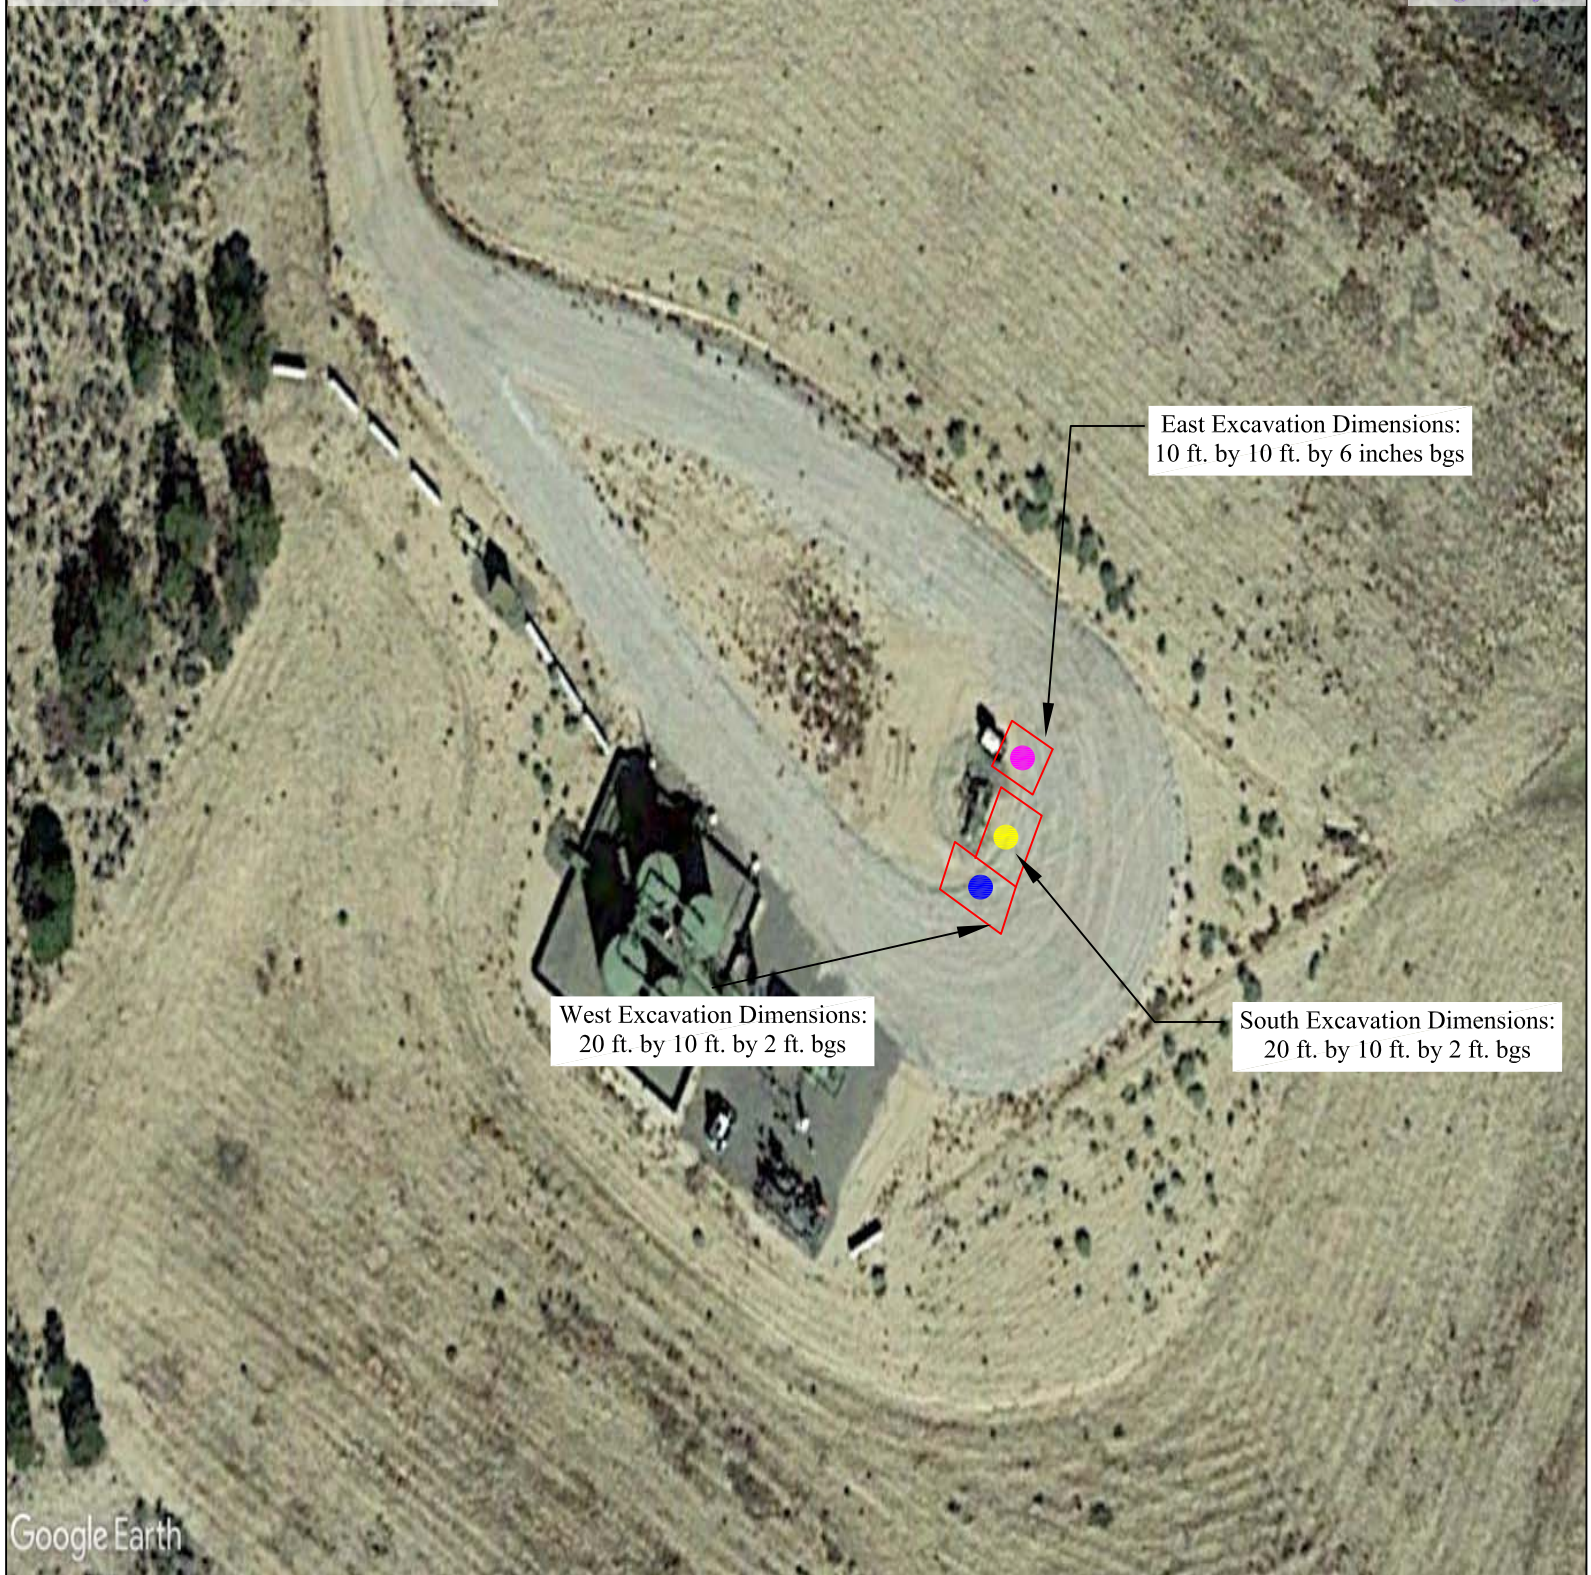
**Figure 2, Site Map**

East Excavation Dimensions:  
10 ft. by 10 ft. by 6 inches bgs

West Excavation Dimensions:  
20 ft. by 10 ft. by 2 ft. bgs

South Excavation Dimensions:  
20 ft. by 10 ft. by 2 ft. bgs

soil sample locations are illustrated in **Figure 2, Site Map and Appendix B, Site Photography**.

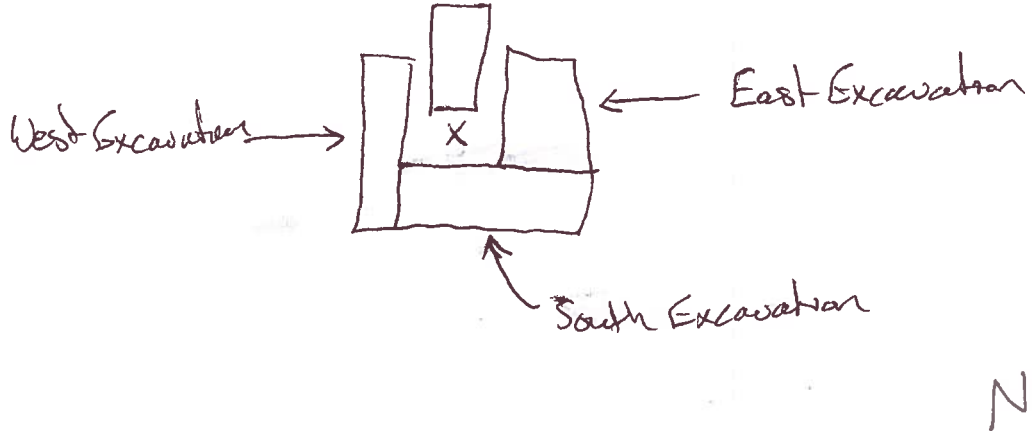
**SPILL PERIMETER:** Draw a schematic of the spill site. Attach photos and other diagrams as needed.

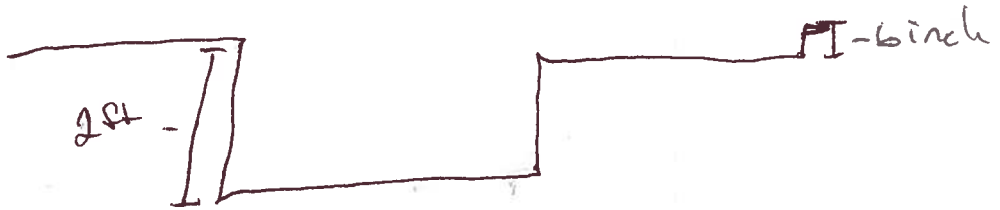
**EXCAVATION PROFILE:**

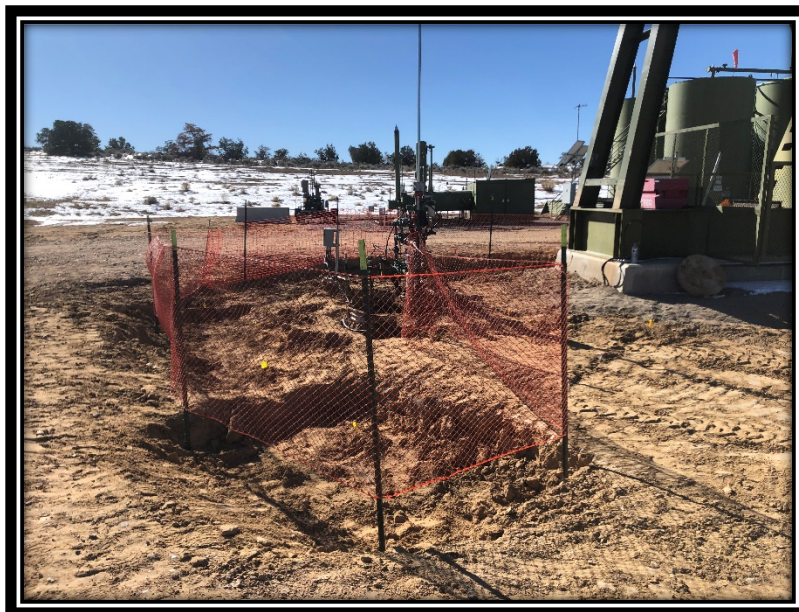
Picture 2: View of Excavations

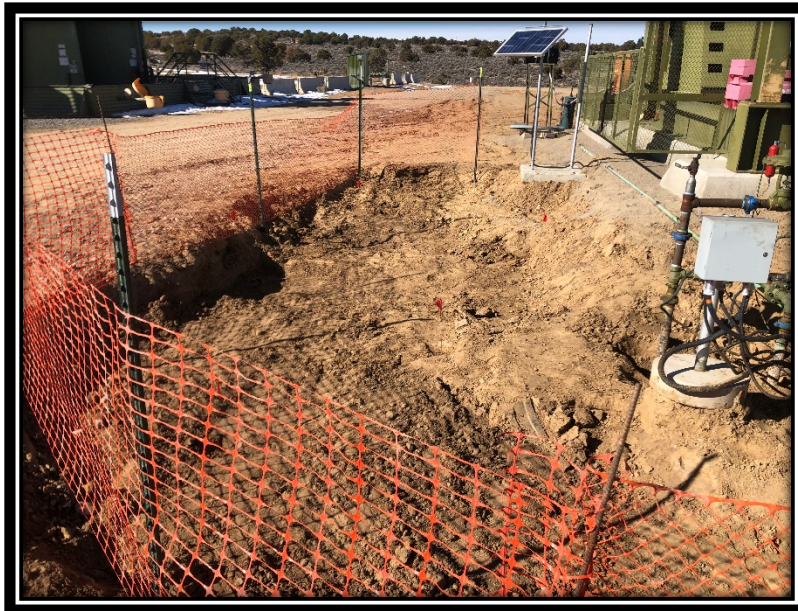
Picture 3: West Excavation with Sampling Points

Sample ID	TPH (mg/kg)
West Excavation	64
South Excavation	08
East Excavation	172

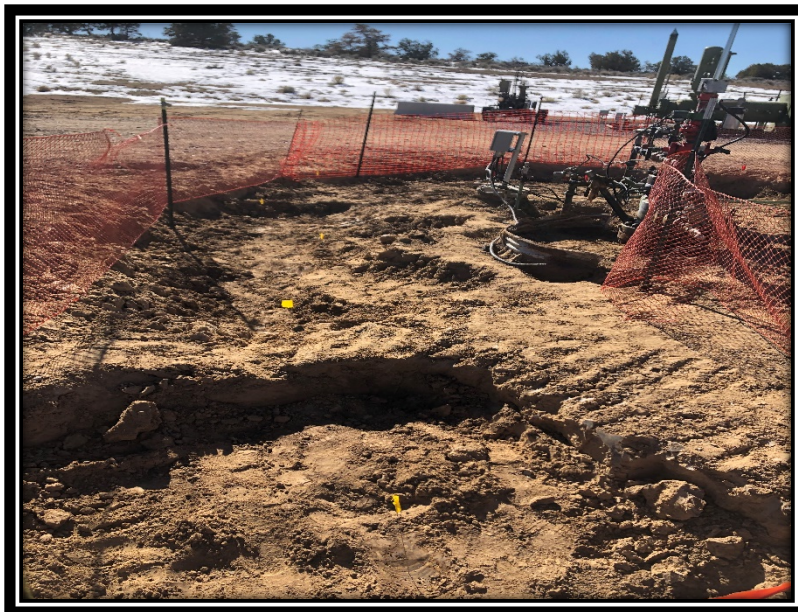
Picture 4: South Excavation with Sampling Points

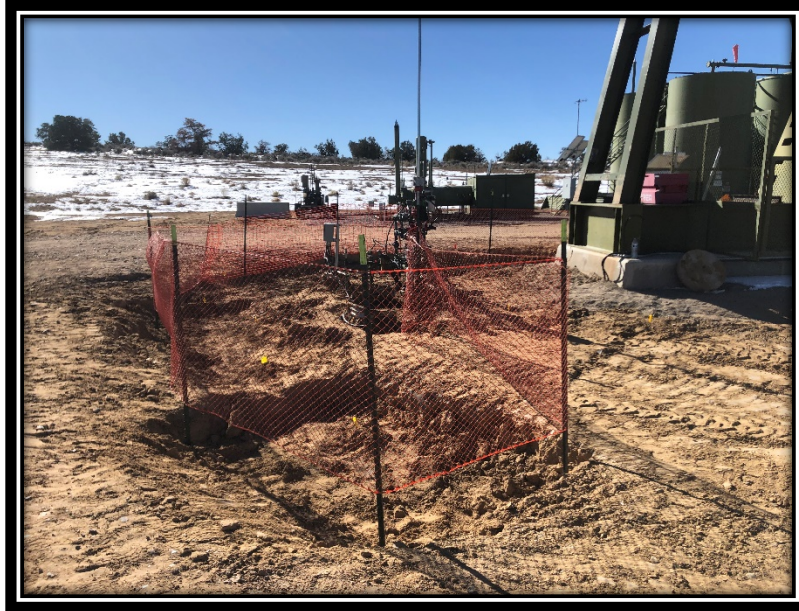
Picture 5: East Excavation with Sampling Points

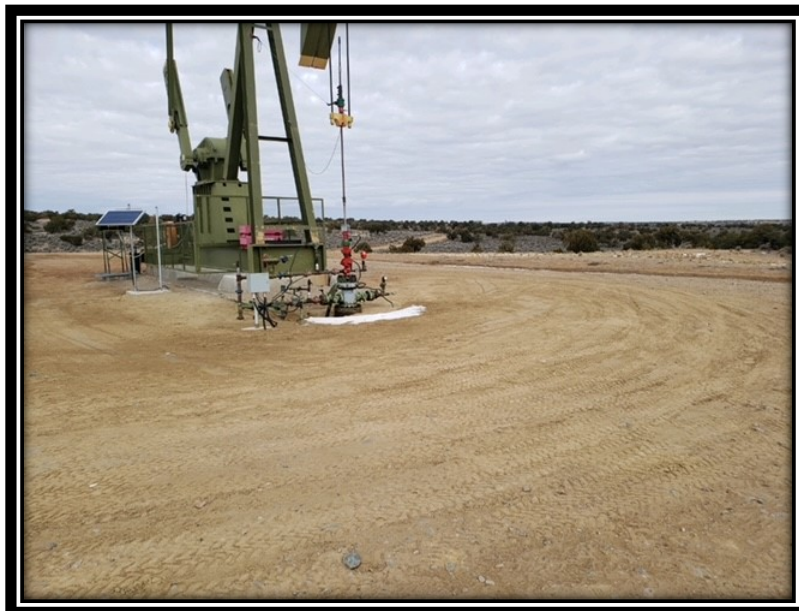
Picture 6: Backfilled and Recontoured Area

DJR's contractor completed the backfilling of the subject excavations. The excavations were backfilled with non-waste containing, earthen material. The site was recontoured and graded to prevent ponding and erosion. The site is active; therefore, reseeding was not necessary. Backfill photos are provided in **Appendix B**.
